SPIRE Project Document	Ref: SPI_BSM_REP_00009.doc Issue: 1.0 Date: 27-Feb-04 Author: DMcN Page 1 of 4
	BSM LAB TESTS LOG SHEET

Document Title:	SPIRE LAB TESTS LOG SHEET
Document Number:	SPI_BSM_REP_00009.doc
Issue:	1.0
Date:	18-Mar-04

SPIRE: Beam Steering Mirror

REPORT No: AIV-2004-016-VIB

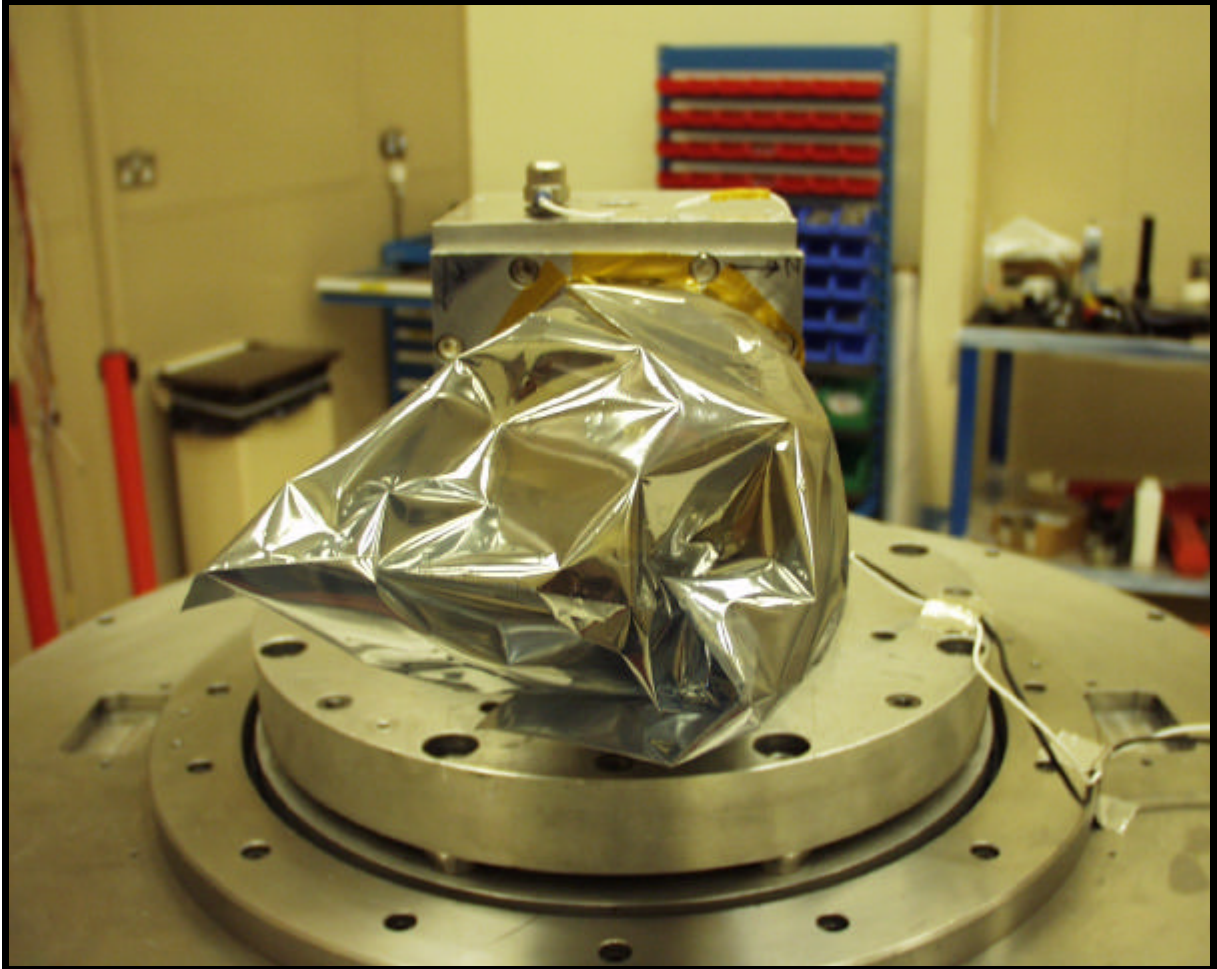
X AXIS VIBRATION TEST CONFIGURATION

A view of the test item mounted on its vibration fixture.

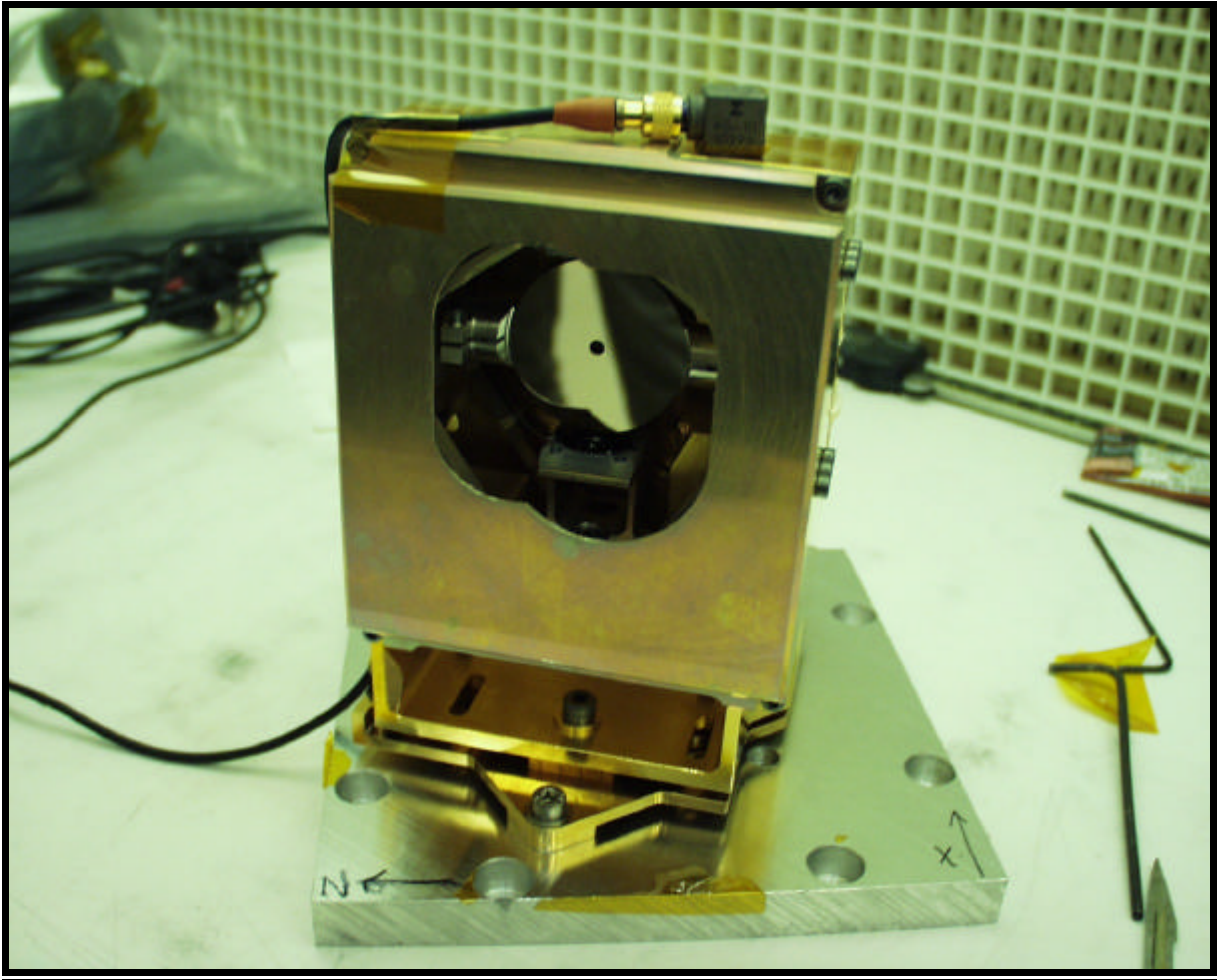
The BSM showing the location of the monitoring Accelerometer

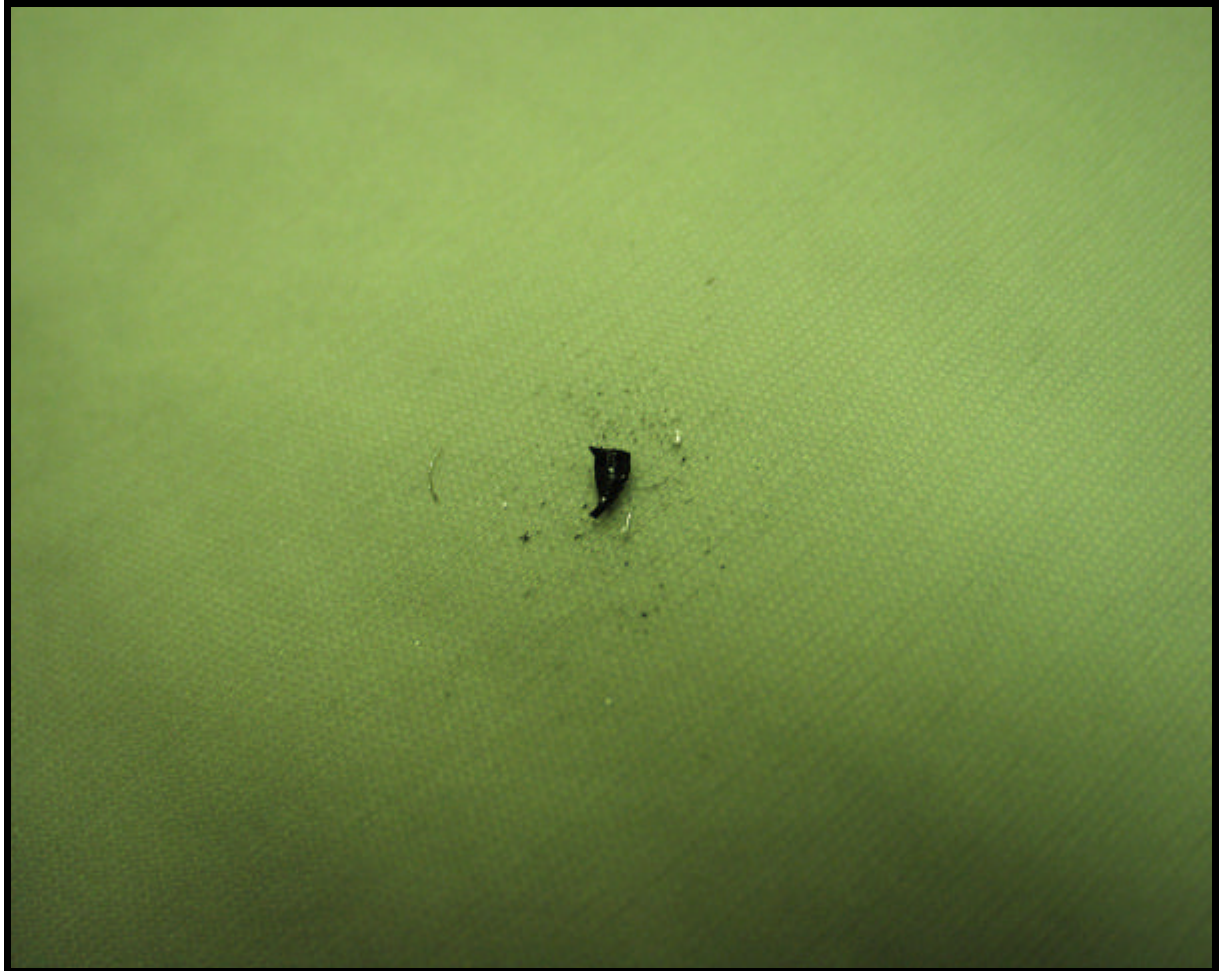
On completion of the sine sweep in the Z axis (Fig 7) it was observed that some debris was present within the test item bagged enclosure. The test item was removed from the fixture for further investigation. The largest component of the debris appeared to be a piece of heatshrink, also there were some small pieces of tinned copper wire.

The test items were subjected to the Qualification levels of vibration extracted from the ICD issue 4.0 dated October 2003. No visible damage occurred to the BSM. The debris collected after the Z axis sine sweep test is shown below: - (the largest component, black heatshrink, being approx. 4mm in length)
