**MINUTES OF MEETINGS
(MoM)**

Subject / Title:	CQM JFET grounding anomaly NRB	Document No:	SPIRE-RAL-MoM-002243 Issue 1.0	Date	6 Dec 04	Page 1 of 3
-------------------------	---------------------------------------	---------------------	---	-------------	-----------------	--------------------

Spacecraft / Project	Herschel / SPIRE	Meeting Place	Telecon ES Office
Instrument / Model	CQM	Subsystem	JFET

NCR Title	SPIRE EQM Electrical Interface Bench Test Anomalies
------------------	---

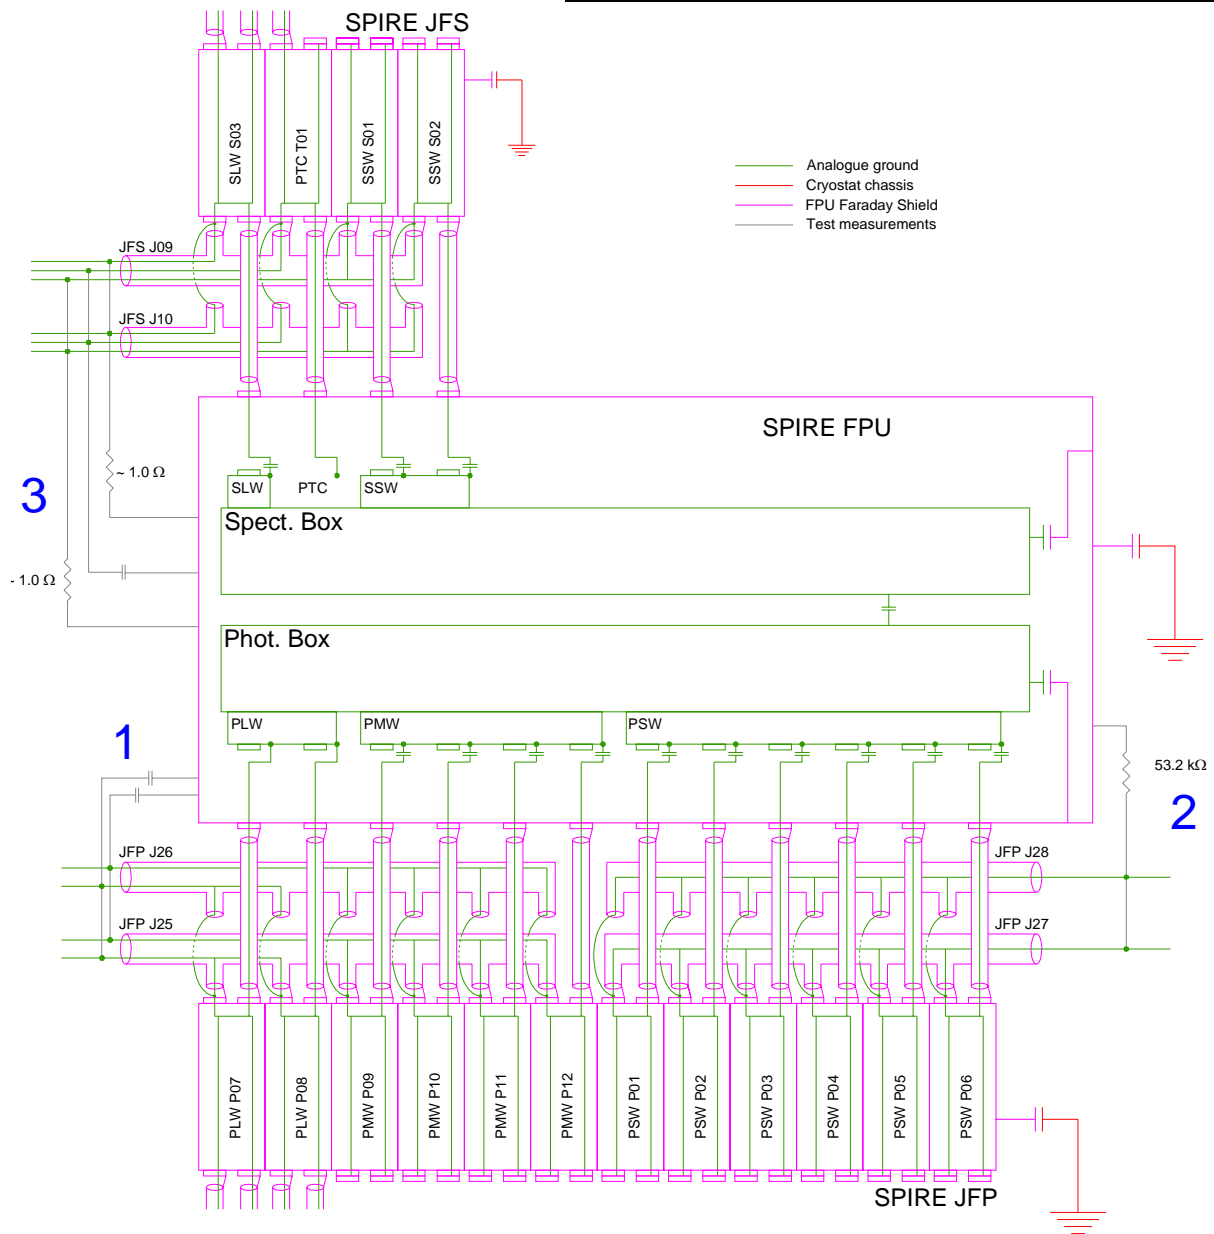
Number	Comment / Description
1	<ul style="list-style-type: none"> ▪ Pins 3 and 22 on JFP J26 (redundant PSW JFET Bias 2) are open circuit. The corresponding pins on the prime Backharness are not open circuit. ▪ This function is not used during the test campaign. The fault could either be in the internal wiring within the STM JFET module or within the back harness. ▪ No meaningful diagnostic can be carried out with the JFP mated to the FPU. The problem is to be reviewed when the instrument is returned to RAL at the conclusion of the EQM programme.
2	<ul style="list-style-type: none"> ▪ PSW analogue ground is shorted via 53.2kΩ to the chassis of the JFP. This can be seen in Figure 1 which illustrates the part of the bench test which verifies isolation between FPU Faraday Shield and analogue ground. This violates the SPIRE grounding scheme.
3	<ul style="list-style-type: none"> ▪ SLW and SSW analogue grounds are shorted to chassis of JFS via approximately 1.0 Ω.

Figure 1 - Schematic illustration of the SPIRE grounding scheme within the cold plane units. Signal wires are not shown. For description, see Table 1. The PLW and PMW grounds (1) are correctly isolated. PSW ground (2) is connected to FPU Chassis by 53.2k Ω . SSW and SLW grounds (3) are hard shorted to ground via ~1.0 Ω and PTC ground is correctly isolated.

The error in the grounding scheme (Numbers 2 and 3 above) can be corrected by inserting MWDM37 way adaptors on JFP J27, JFP J28, JFS J09 and JFS J10. These adaptors would break the ground links for the PSW and JFP/JFS and are specified in Table 2 and Table 3. The adaptors would have the same physical envelope as a connector saver.
