SSTD Incoming Inspection Report

Spacecraft/Project **HERSCHEL / SPIRE**

Document Number **SPIRE-RAL-REP- 002378**

Sub System **BDA Sn 13**

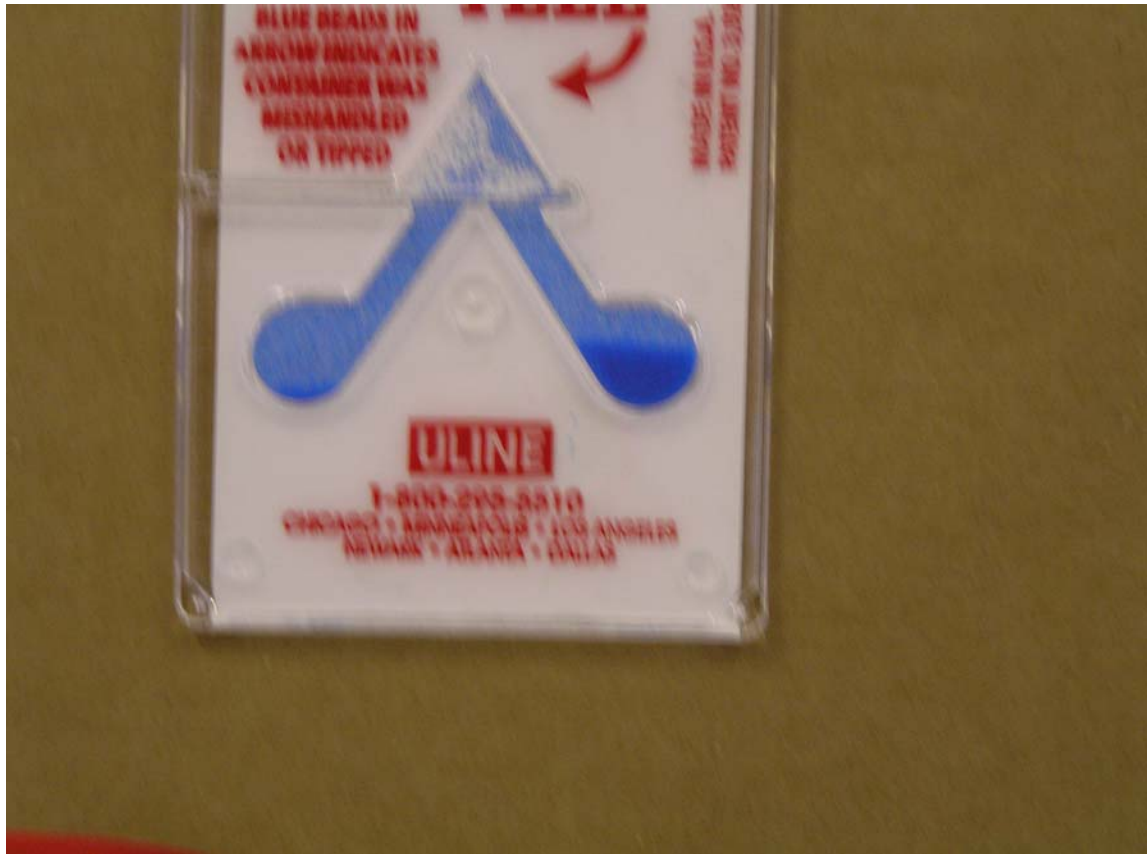
TRANSPORT CONTAINERS INTERNAL CONDITION	REMARKS	Status
Check Mounting fixtures fitted internal packaging		Checked
Internal padding / packaging required		Checked
Mounting provisions secure		Checked
Any additional Comments	Tip & Tell Monitor attached to outside of Cardboard Box tripped, indicates Clockwise tilt has occurred see Photo attached.	See Remarks

Tip & Tell Monitor on PFM BDA SN 13 box indicating a 90° Tilt has occurred

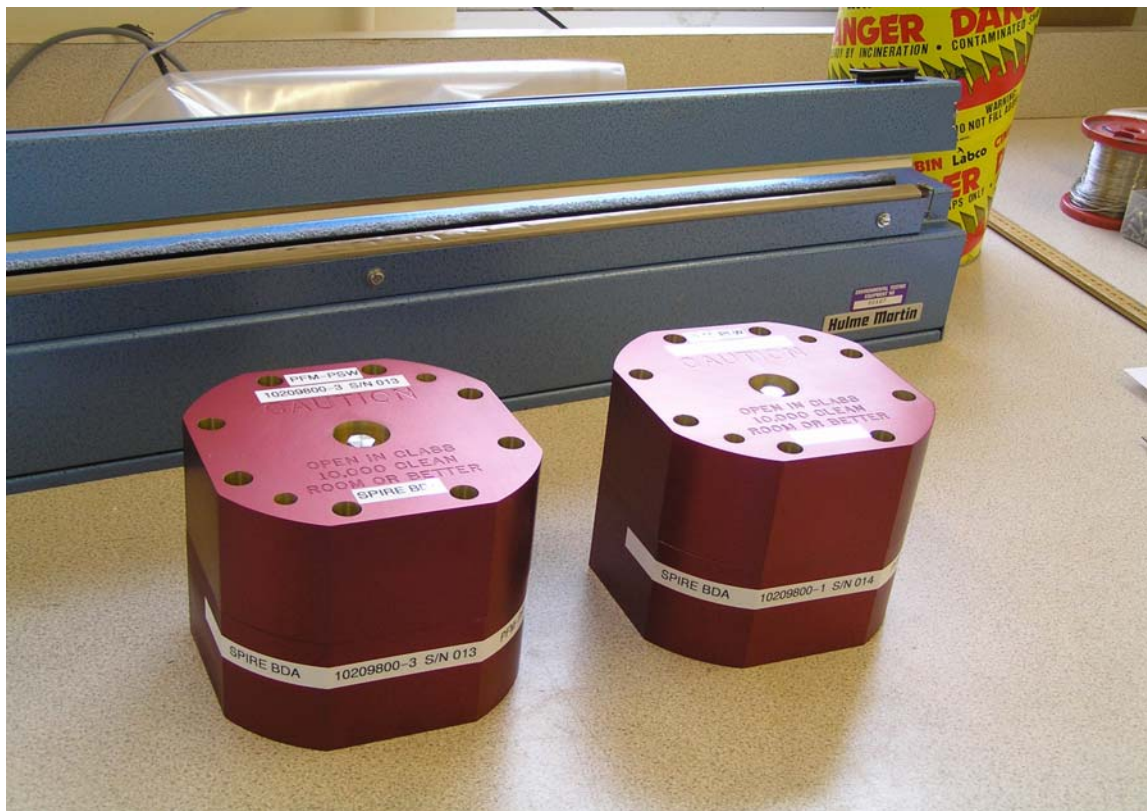
PFM BDA SN 13 & 14: In G56 Prep Area. Outside surfaces have been cleaned with IPA prior to taking into the Class 100 Clean Room for further inspection.
