**From:** Aramburu, AA (Asier)  
**Sent:** 16 February 2006 20:19  
**To:** Sawyer, EC (Eric); 'AUGUERES Jean-Louis DAPNIA'; 'Renato Orfei'; 'Sergio Molinari (E-mail)'; 'CARA Christophe SMTP'; 'TRIOU Henri DAPNIA'; 'Pinsard Frederic'  
**Cc:** 'Matt Griffin'; Swinyard, BM (Bruce); Griffin, DK (Doug); Sidher, SD (Sunil); Smith, DL (Dave); King, KJ (Ken); Long, JA (Judy); Polehampton, ET (Edward)  
**Subject:** RE: Investigations on the SPIRE Warm units.

Here is a brief summary of all the "known" problems:

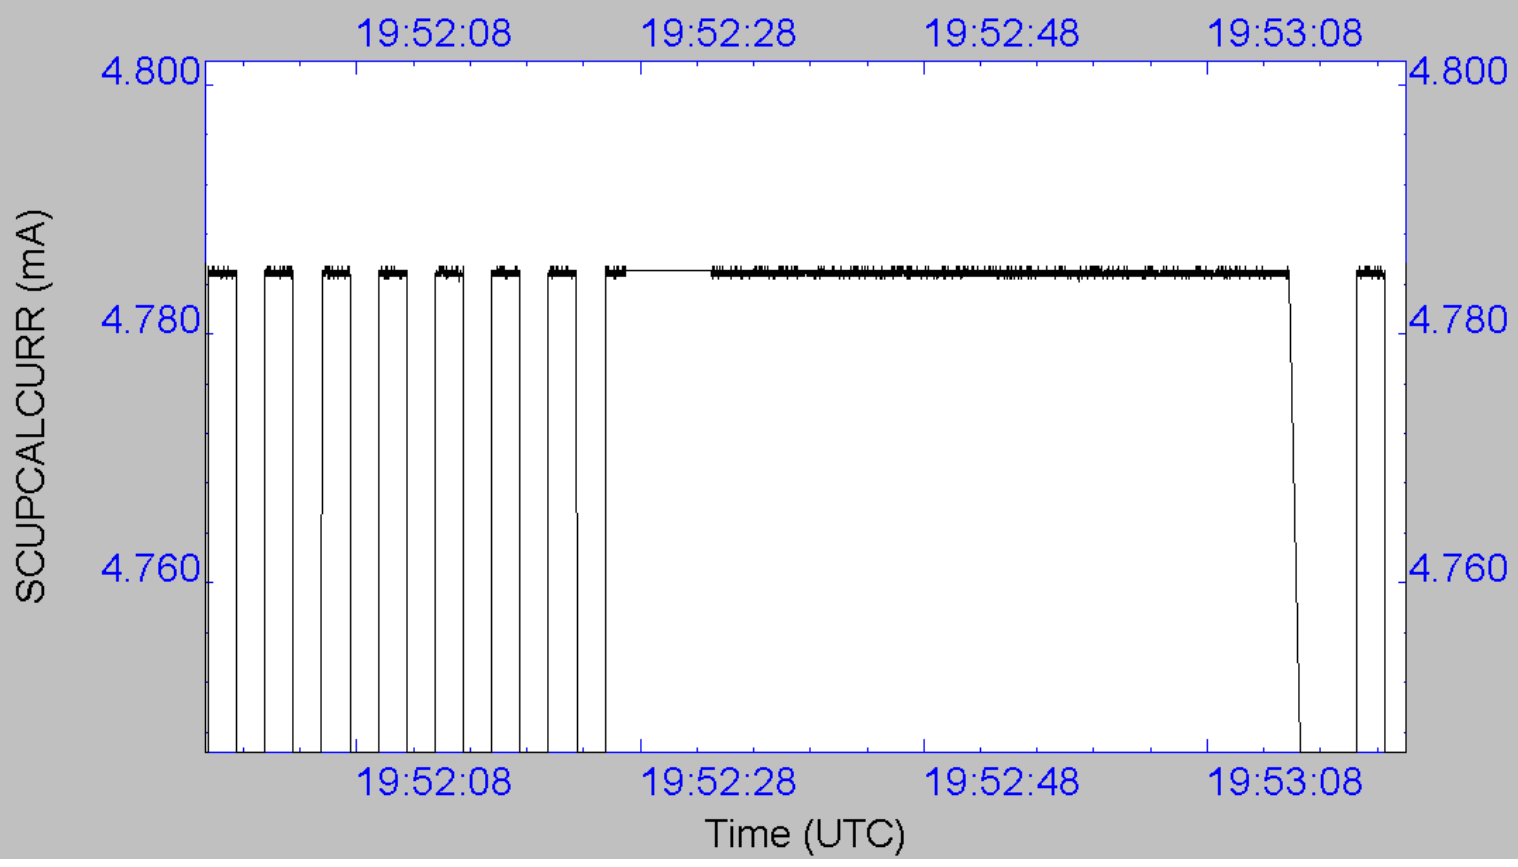
pcal\_15feb\_1952.p  
ng (16 KB)

The attached plots show an anomalous PCAL flash generated using a Command List with 1ms interval between commands (same Command List as used for PFM2) on Wednesday 15th Feb. with HK generation on: 1st plot shows a timeline of PCAL current during three standard PCAL flashes, the middle one showing the anomaly. 2nd plot is a zoom at the high levels of the anomalous PCAL flash. As can be seen the PCAL current remains at the high level when it should be switching between low and high levels.

During the period of this anomalous flash 7 packets were received with APID = 508 type = 21 subtype = 4 SID = 0xcc02. The APID, type and subtype of these packets are consistent with an SCU science packet, except that the SID value of 0xcc02 is undefined in the SPIRE Data ICD. The SCU nominal science data correspond to APID = 508 type = 21 subtype = 4 SID = 0x0a20.

Interestingly the times of the strange packets appear to coincide exactly with the start of constant high value of the PCAL current.
