SPIRE-AST-REP-002628

Title: PACS IMT

This test report describes the results of the IMT until the failure of the PACS DPU performed for the Herschel PACS Instrument.

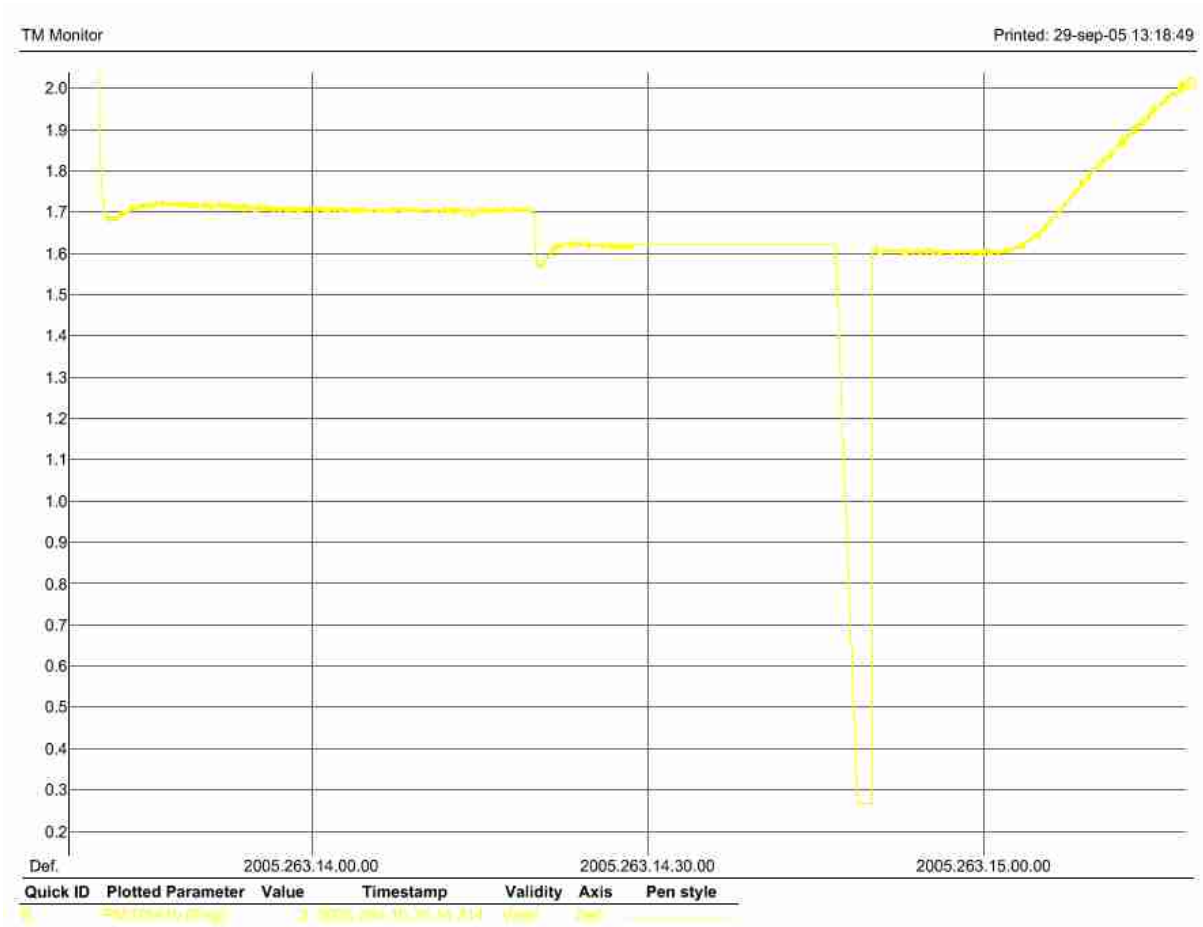
7.10 Test ID: 410 – Cooler Recycling

Step #	Action	Comments	Check
1	<p>Execute: BOLO_cooler_OBS_shell.tcl</p> <p>During the script, PACS requested to send a manual stack command to request more HK packets. The script is not stopped. The following command is send: PC003380 (DPU_SET_HK_LIST) With the following parameter: PP005380 = PHOT PP025380 = BOTH Array</p> <p>During the cooldown the DEC/MEC connection was lost. To recover from this without loosing the cooler recycle, DEC/MEC is manually powered down and up again. After this all DEC/MEC commands in the PACS_POWER_ON.tcl are executed with the manual stack. This was not successful. Another approach is tried:</p> <ul style="list-style-type: none"> • power down SPU, DEC/MEC, DPU (manually from PLM SCOE) • Execute PACS_POWER_ON_BOLCout.TCL (see Appendix 7) • PC003380 (with PP005380 = PHOT and PP025380 = BOTH Array) <p>This problem is track by a new NCR (ASED NCR 1494).</p> <p>The cooler recycle itself was not successful. An NCR is raised to track this problem. (ASED NCR 1495)</p>		NOK

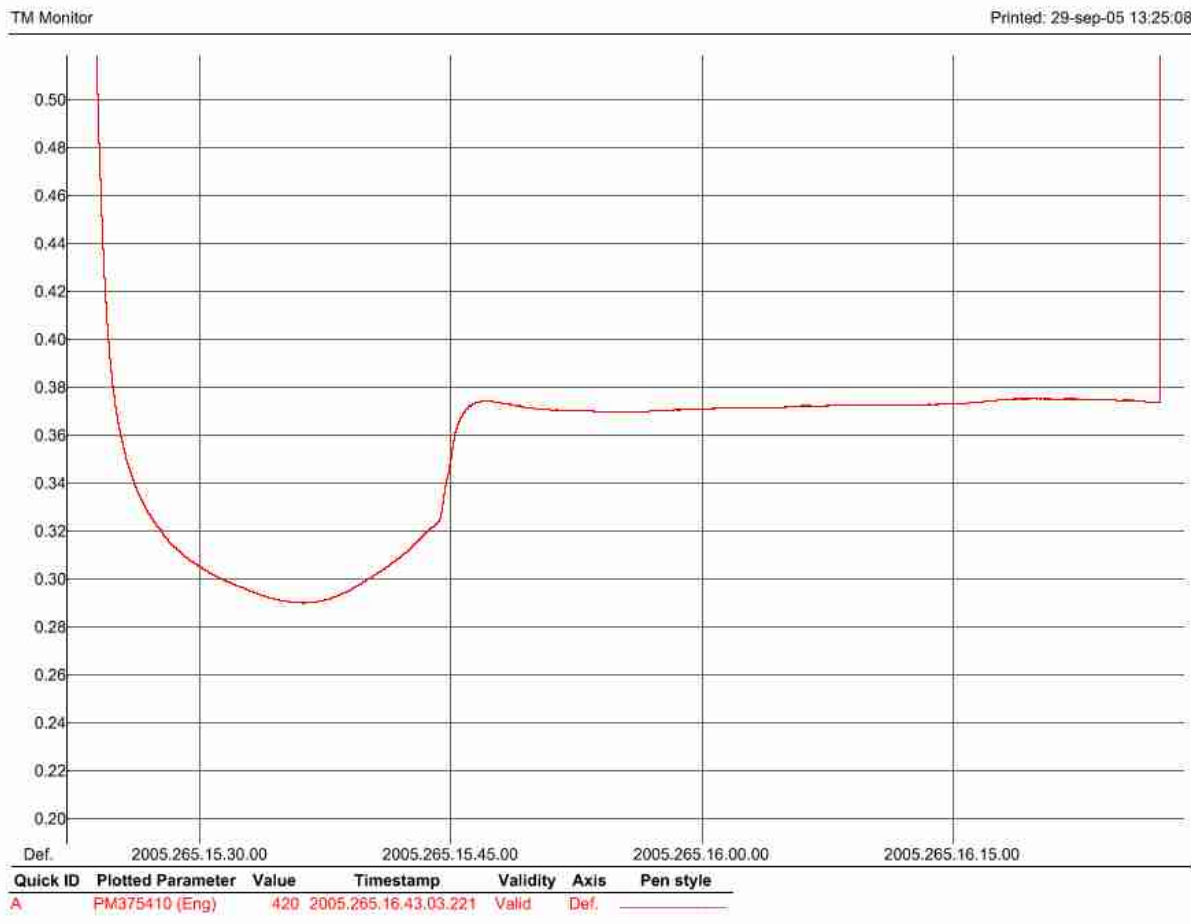
Step #	Action	Comments	Check
1	Execute: BOLO_cooler_OBS_shell.tcl	Heater currents are set as commanded	
		TEMP_EV should be close to 0.3 K after the execution of the script (110 min)	
		TEMP_EV should be below 300mK 120

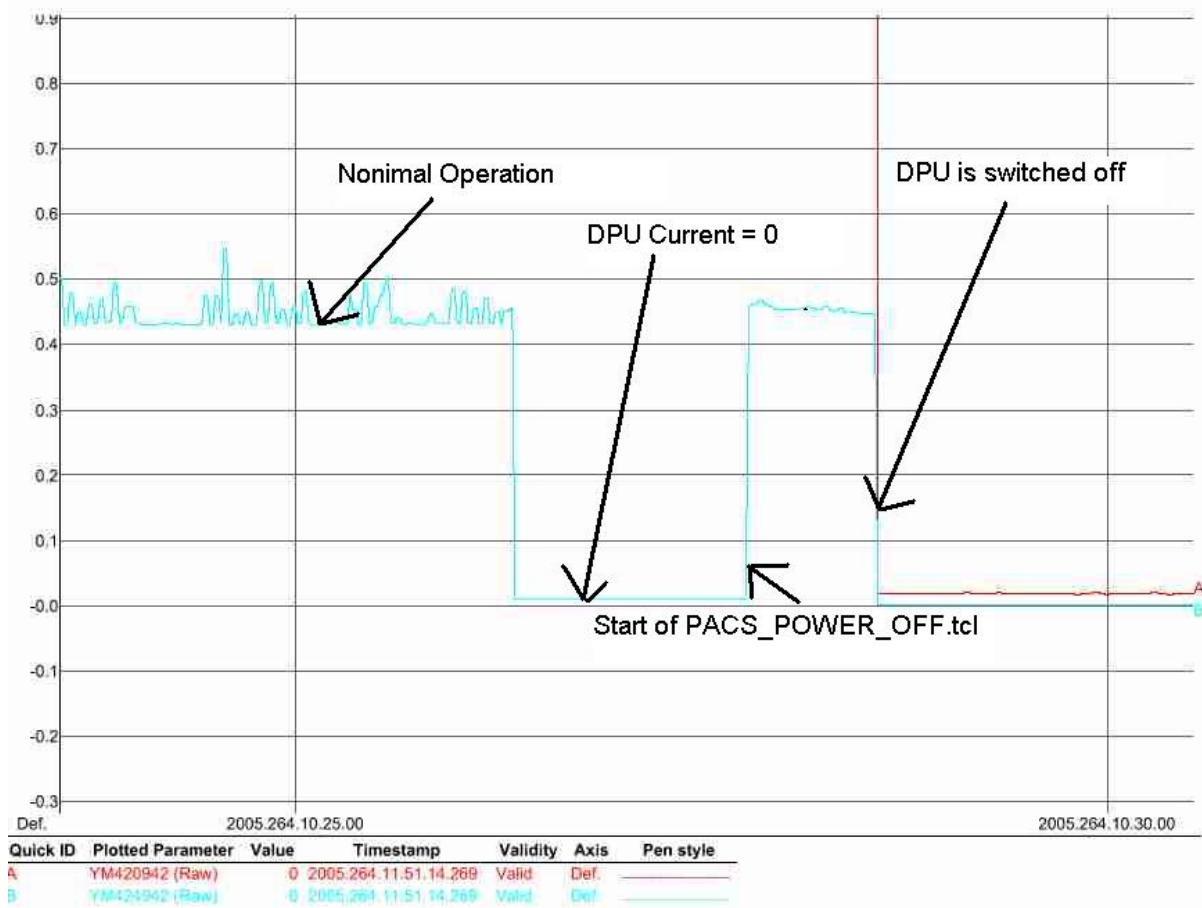
Appendix 18: Power Profile (from PLM SCOE) during DPU power down

The DPU AVM is changed for the DPU CFM (OBSW 7.68). More details can be found in ASED NCR 1491. PACS indicates that the operation of both DPU's should be very similar. The only differences are:
