SSTD Incoming Inspection Report

Spacecraft/Project **HERSCHEL / SPIRE**

Document Number **SPIRE-RAL-REP- 002677**

Sub System **DPU**

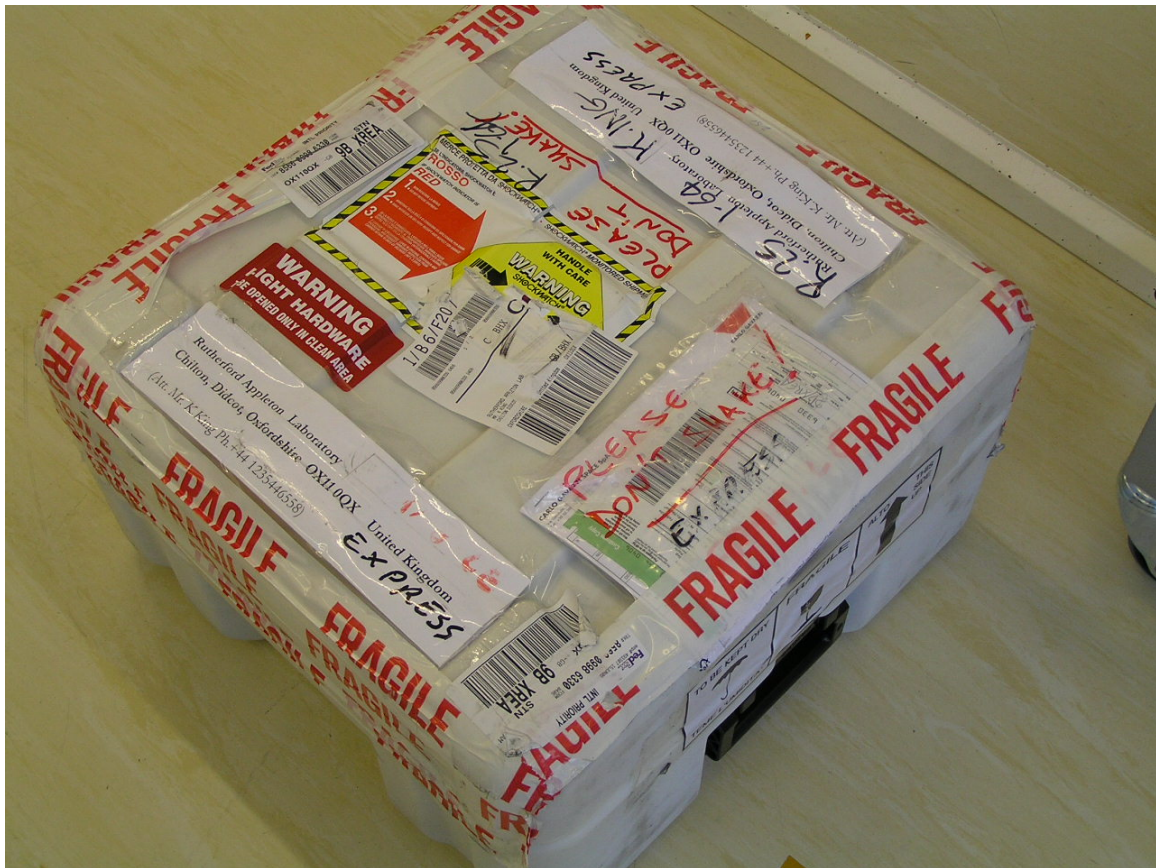
Container as delivered to PA section ready for Incoming Inspection.

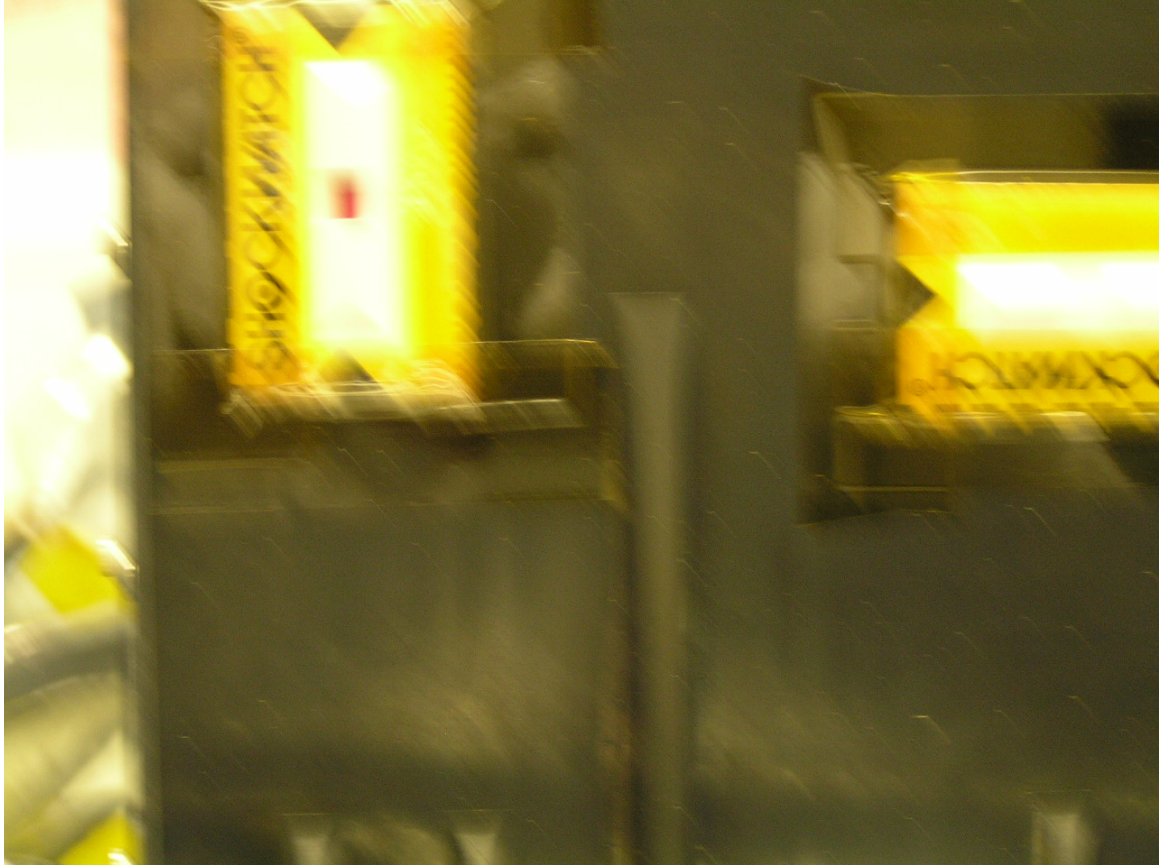
SHOCH WATCH Monitors OK Y axis

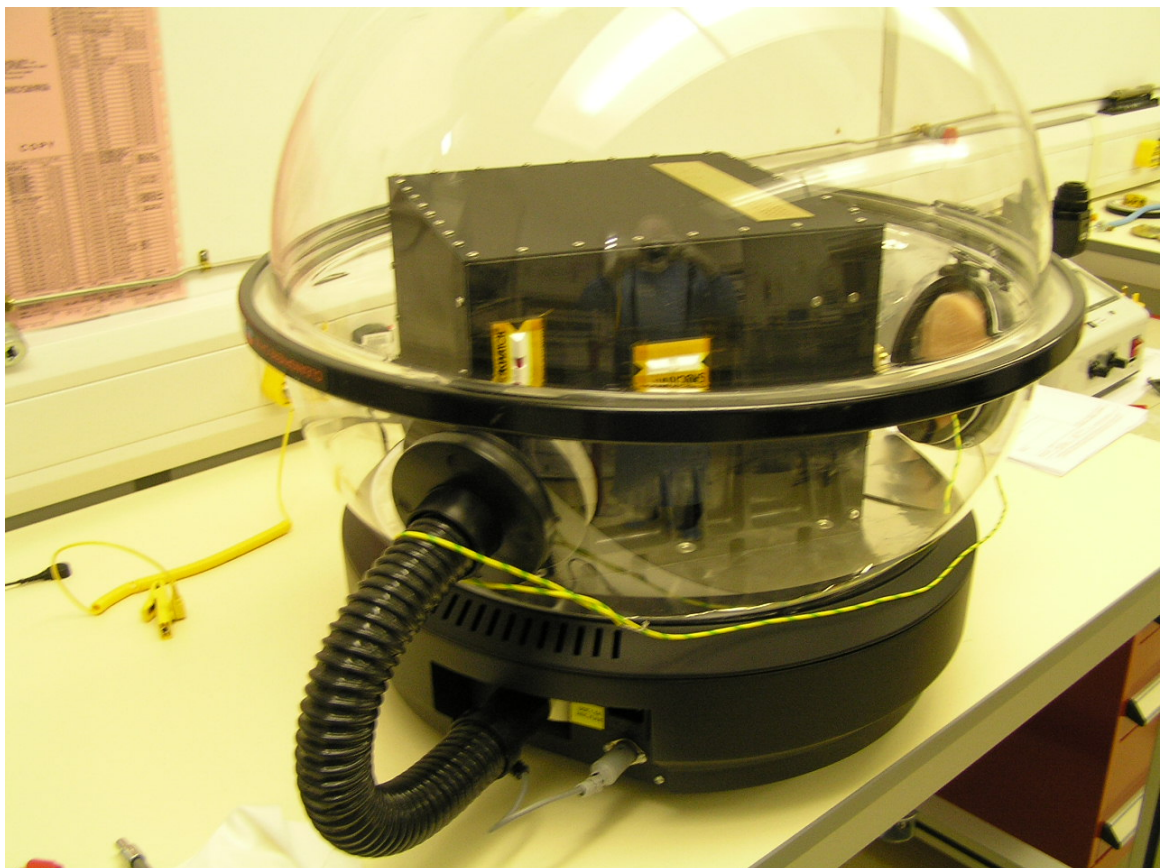
CHECK LIST	REMARKS (LIST CONNECTOR NUMBERS)	RESULTS
Pin Alignment		Pass
Damaged Sockets		None
Internal Debris		Pass
Connector Covers fitted		Pass
Connector Savers Fitted	Fitted by Massimo in G56 claen room. Using torque setting of less than 0.030Nm (0.025Nm)	See remark
EMC Covers Fitted		Pass
RED Tag Item / Green Tag Items fitted		N/A
Additional Comments

Inside Laminar Flow chamber showing connector savers Fitted.

Connector Savers and Jack screws cleaned at RAL
