Delivery Review Board Minutes of Meetings (MoM) & Check list

EIDP DRB Subject: FM DPU Deliv	very DRB MoM N°	SPIRE-RAL-MoM-002678	Issue No: 1	Page 1 of 3
EIDP Doc N\(\frac{1}{2}\)issue:	DRB Location:	RAL SPIRE Project	t Office DRB Date:	20-June 06
Spacecraft / Project: HERSCH	EL / SPIRE Instrument / Mo	odel: FM	Ser No:	<u>.</u>

SPIRE-RAL-MoM-002678

_			
Sub System	DPU		Date	20th June 2006	Model FM
		INCO	MING INSPECT	ION REPORT	
	FROM]	ТО	
	CGS			Proje Rutherford Applete Space Science and Tecl Chilto DIDCO OXOI OX11 0	on Laboratory nnology Department in OT N
	P 11 4		<u>.</u> 1	5	
	applicable sections	T		Drawings / Docum	
	Containers	Yes		Photo	'S
	I Visual Inspection rnal Connector	Yes			
	rnal Connector ocumentation	Yes Yes			
	tion of Interfacess	No			
	Comments Sheets	Yes			
INSP NAME	PECTION CONDUCTED BY	ATE	y 1	WITNESS	BY DATE
Massimo Vitta / Ale Ricciu	acandra	une 2006		Eric Clark (PA) & Eric Sawyer	20th June 2006

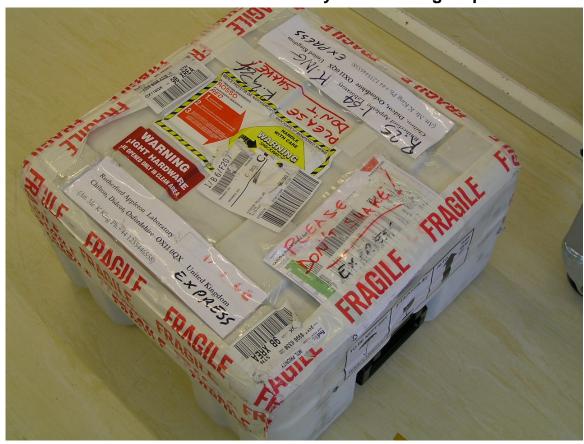
Container as delivered to PA section ready for Incoming Inspection.

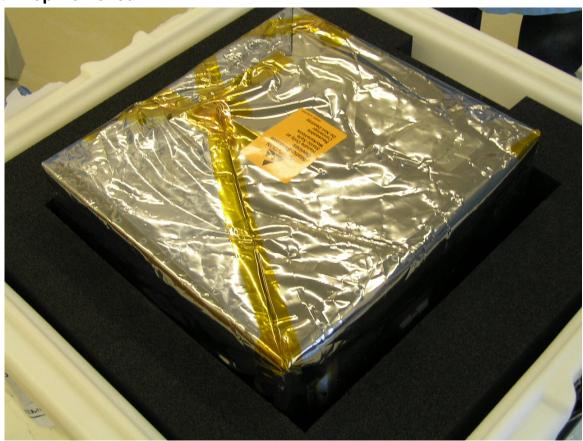
With Top Removed

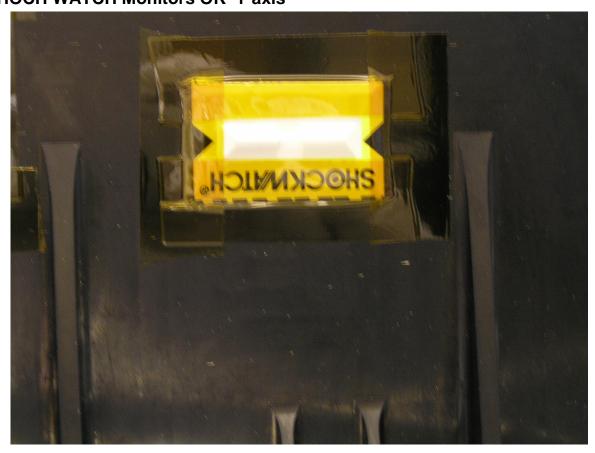
SHOCH WATCH Monitors OK Y axis

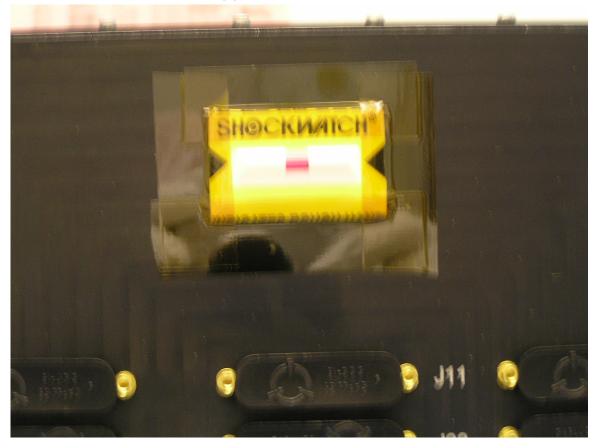
Spacecraft/Project	HERSCHEL / SPIRE	Document	Number SPIRE-RAL-REP-002677	Issue 1
Sub System	DPU	Date	20th June 2006	Model FM
		CONTAIN	IER INSPECTION	
TRANSPORT C	ONTAINERS EXTERNAL CO	NDITION	REMARKS	Status
Mechanical damage to handling provisions	o container fasteners, locks, o	lips or		Checked
Security / Locking Fitt	ted		Each fastener was locked with wire	See Remarks
Markings for destination	on and description			Checked
	g to handling lifting and stac	king limits		Checked
Any additional Comme			Delivered in a metal suitcase type containe	er See Remarks
TRANSPORT C	CONTAINERS INTERNAL COM	IDITION	REMARKS	Status
Check Mounting fixtur	es fitted internal packaging			Checked
Internal padding / pacl	kaging required			Checked
Mounting provisions s	ecure			Checked
Any additional Comme	ents			None
		ENVIROME	NTAL MONITORS	
Temp Monit Fitted: Condition:	Fitted:	tiy Monitors	X Axis Two of the three Shock	erd Information 15g 25g 50g watch monitors were tripped ephoto's

FM DPU Incoming Inspection Report SHOCH WATCH Monitors Tripped X axis

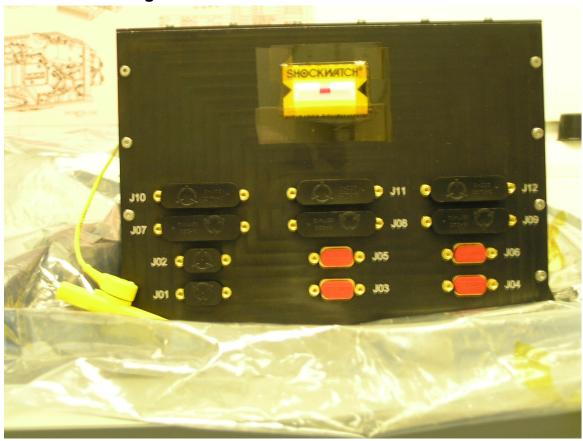
End view showing Connector covers in Place

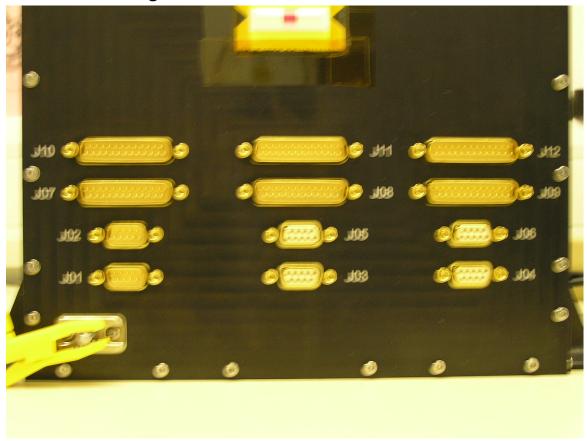
FM DPU Incoming Inspection Report SPIR End View showing Connector covers removed

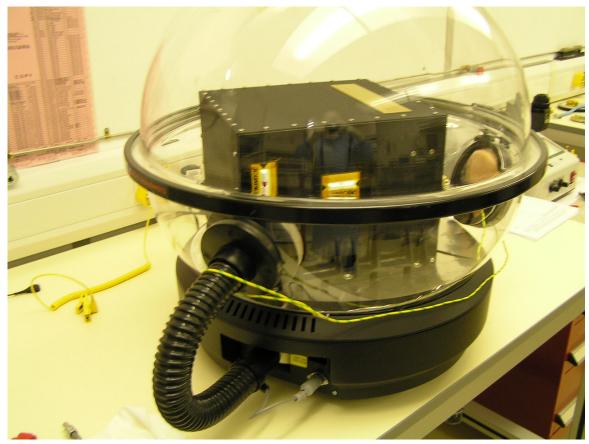
Placed inside Laminar low chamber

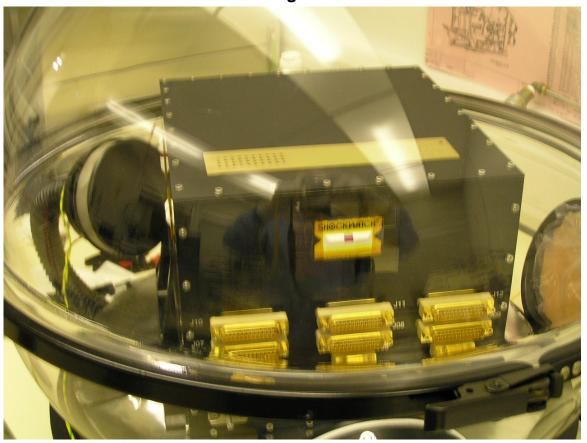
Sub System DPU	J	Date	20th June 2006	Model FM
		INSPECTION OF ALL C	CONNECTORS	
CHECK LIST		REMARKS (LIST CO	DNNECTOR NUMBERS)	RESULTS
Pin Alignment				Pass
Damaged Sockets				None
Internal Debris				Pass
Connector Covers fitted				Pass
Connector Savers Fitted	Fitted by Mas (0.025Nm)	simo in G56 claen room. Using	torque setting of less than 0.030Nm	See remark
EMC Covers Fitted				Pass
RED Tag Item / Green Tag Items fitted				N/A

FM DPU Incoming Inspection Report SPIRE-RAL-REP-0026777 issue 1 Inside Laminar Flow chamber showing connector savers Fitted.
