SSTD Incoming Inspection Report

Spacecraft/Project **HERSCHEL / SPIRE**

Document Number **SPIRE-RAL-REP- 002724**

Sub System **FPU**

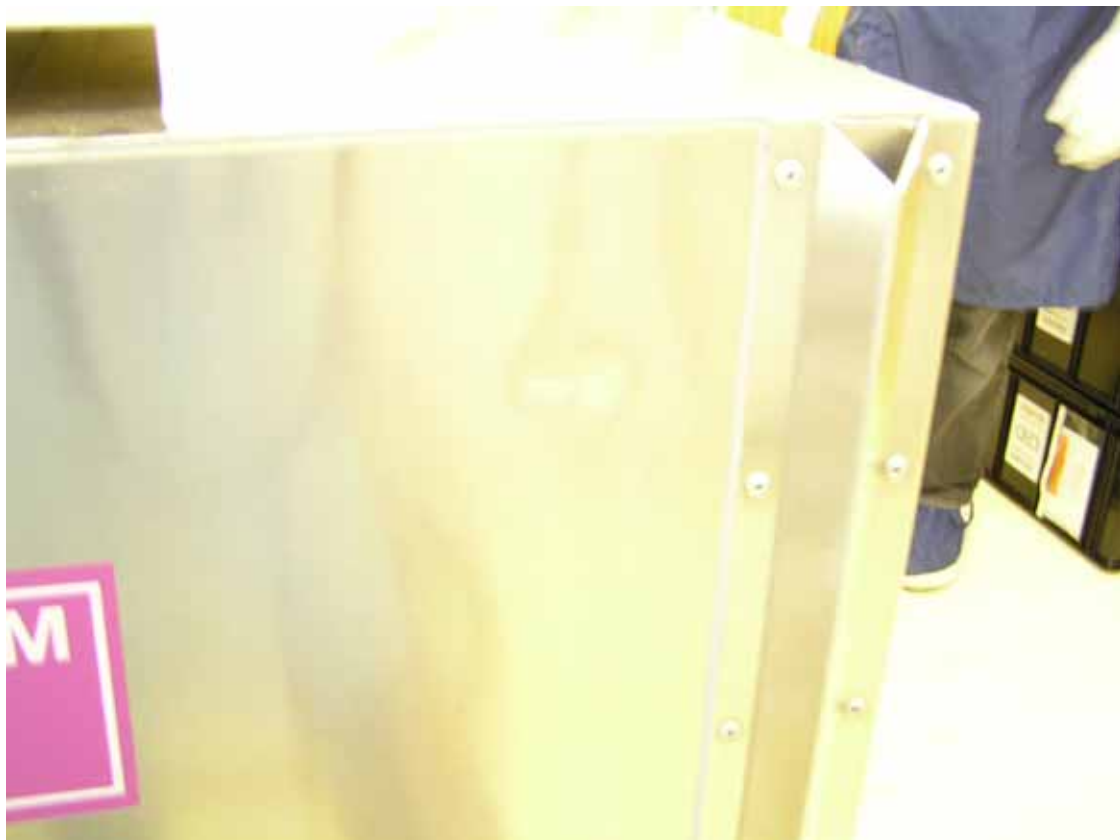
Dent in Transit case

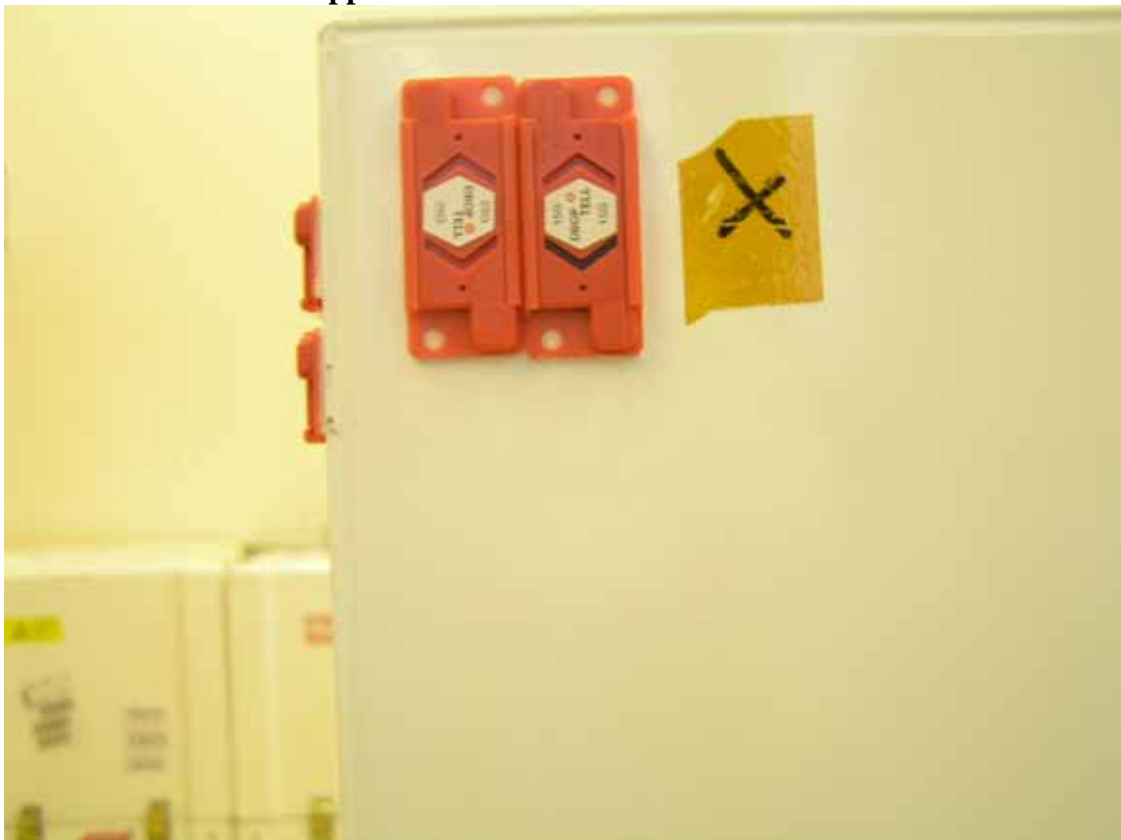
-15G "X" Shock monitor Tripped

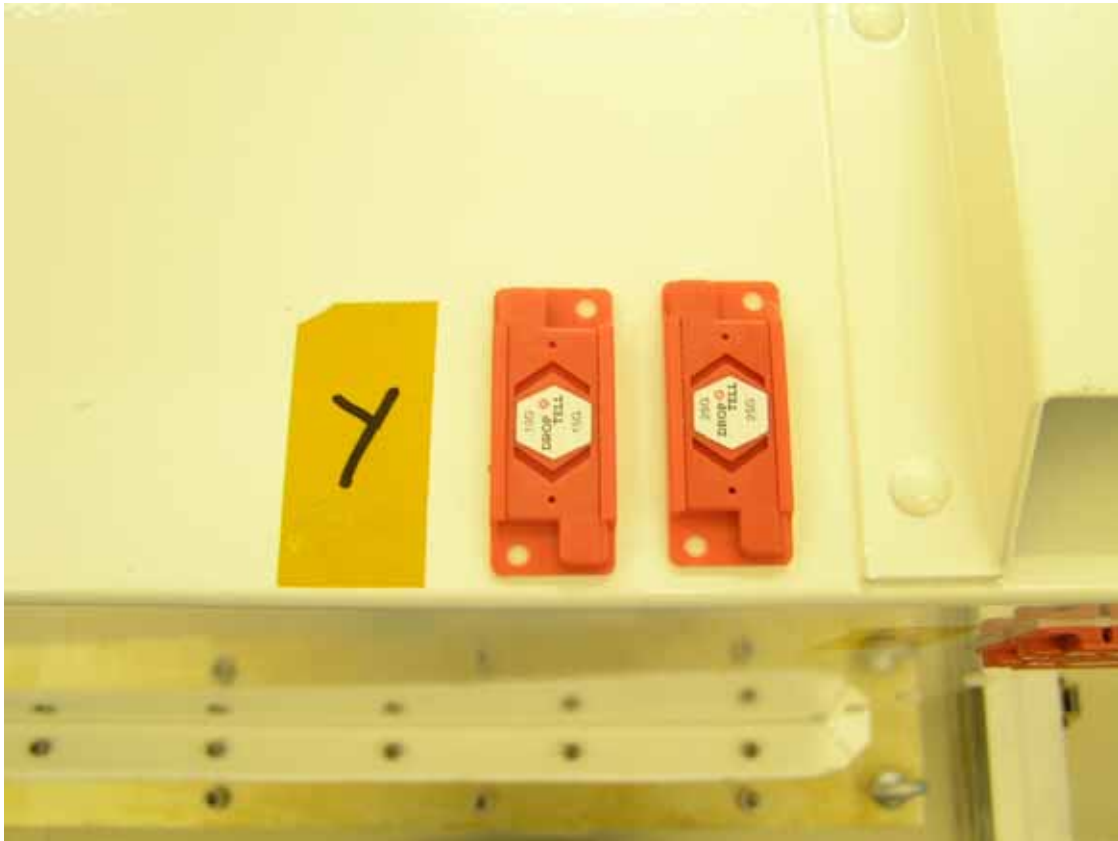
“Y” Shock Monitors OK

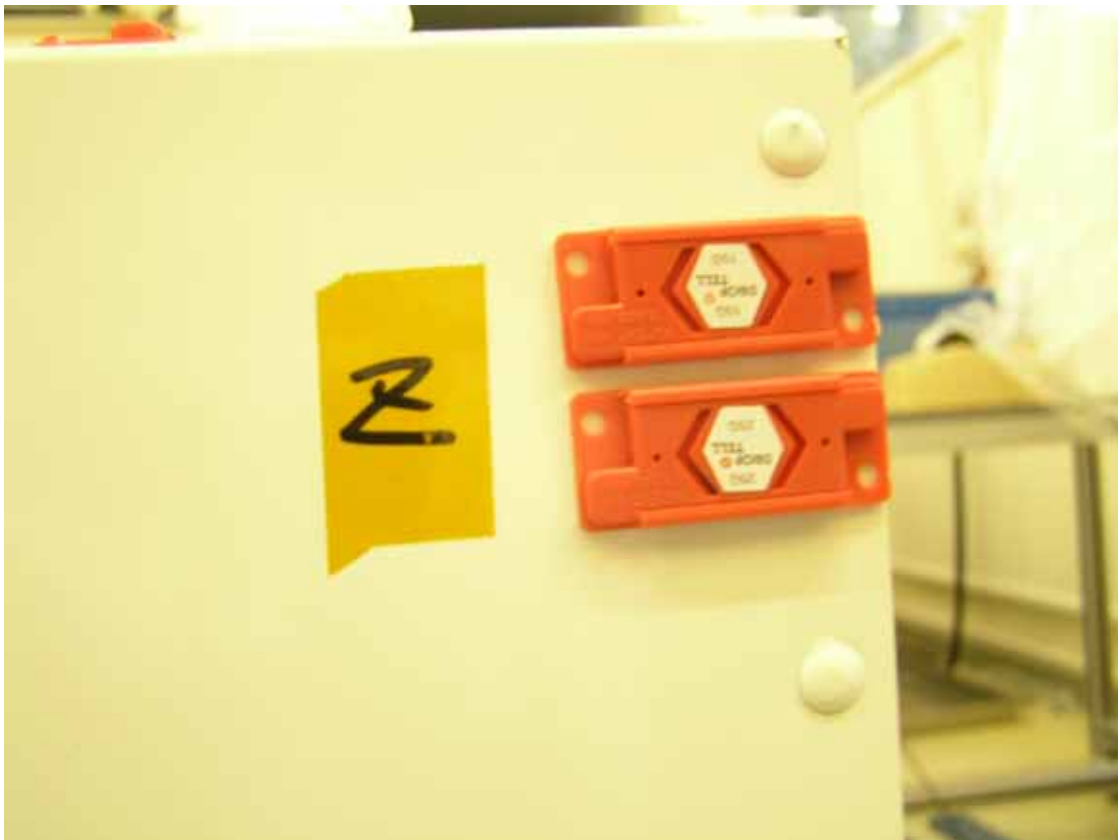
“Z” Shock Monitors OK

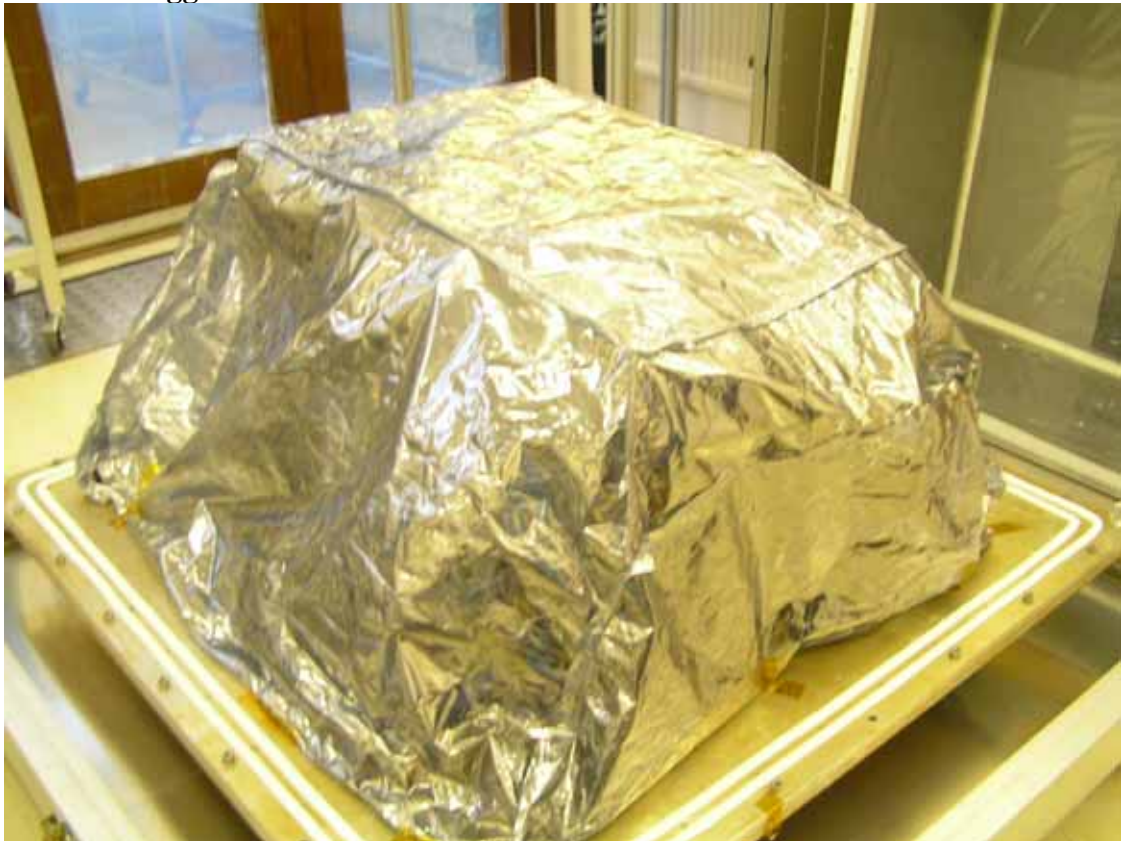
FPU Doubled Bagged

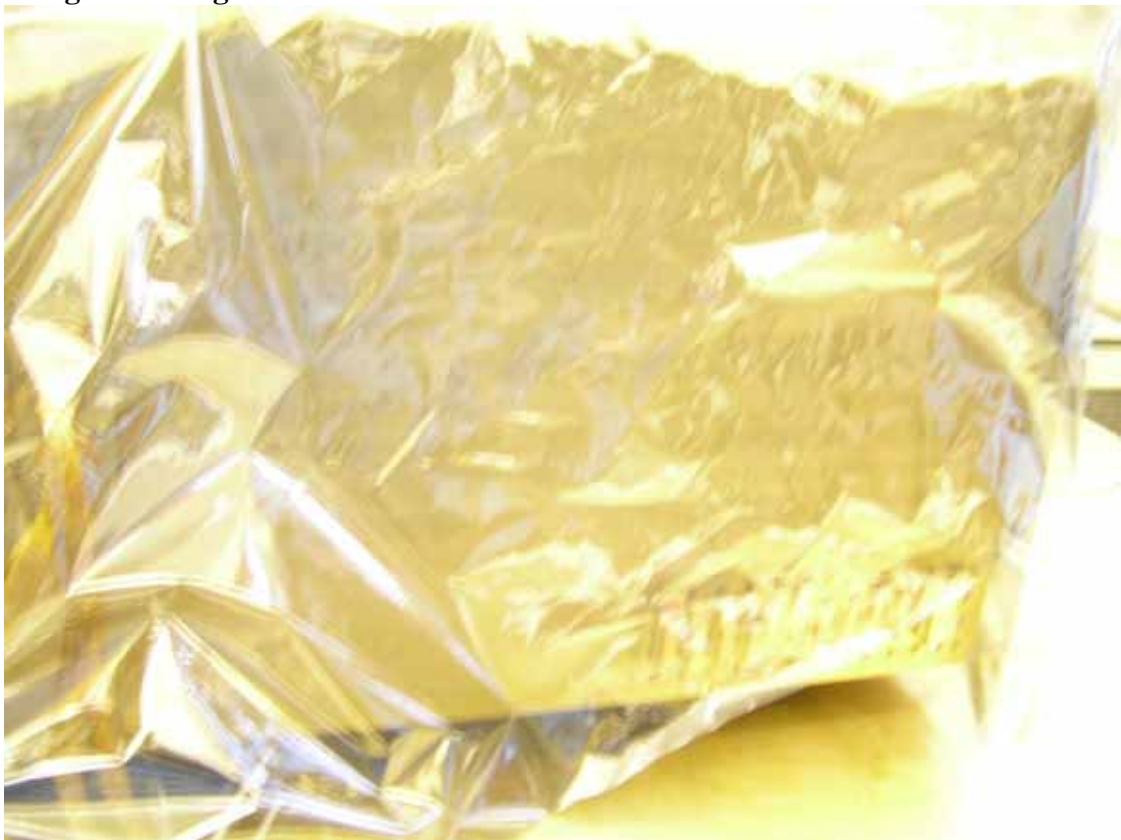
Single Bag remaining

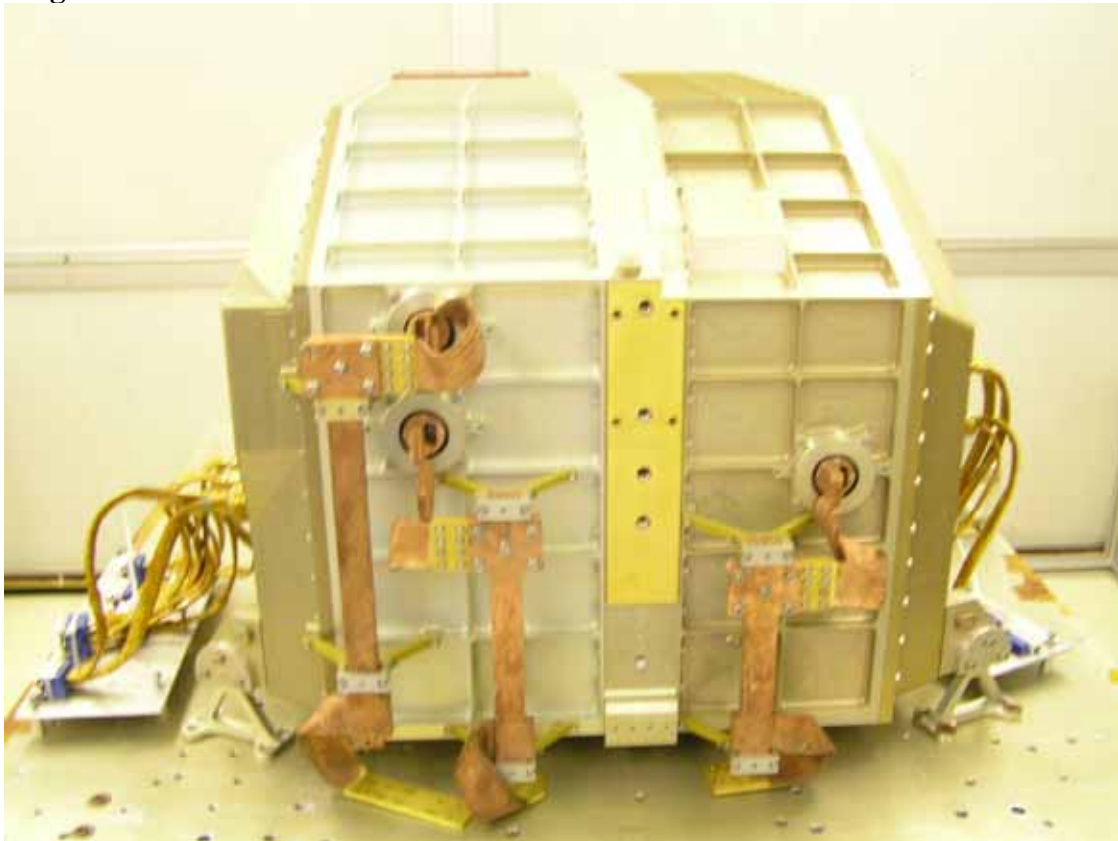
With Bags removed

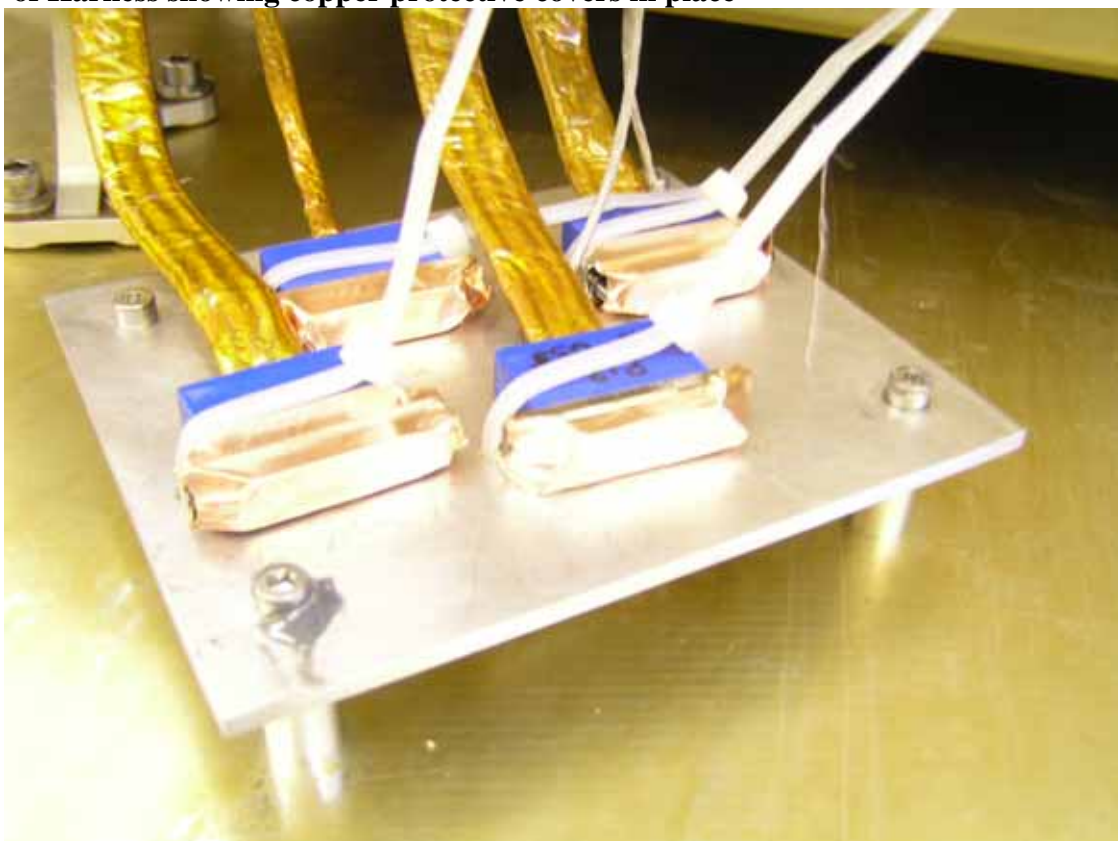
View of Harness showing copper protective covers in place

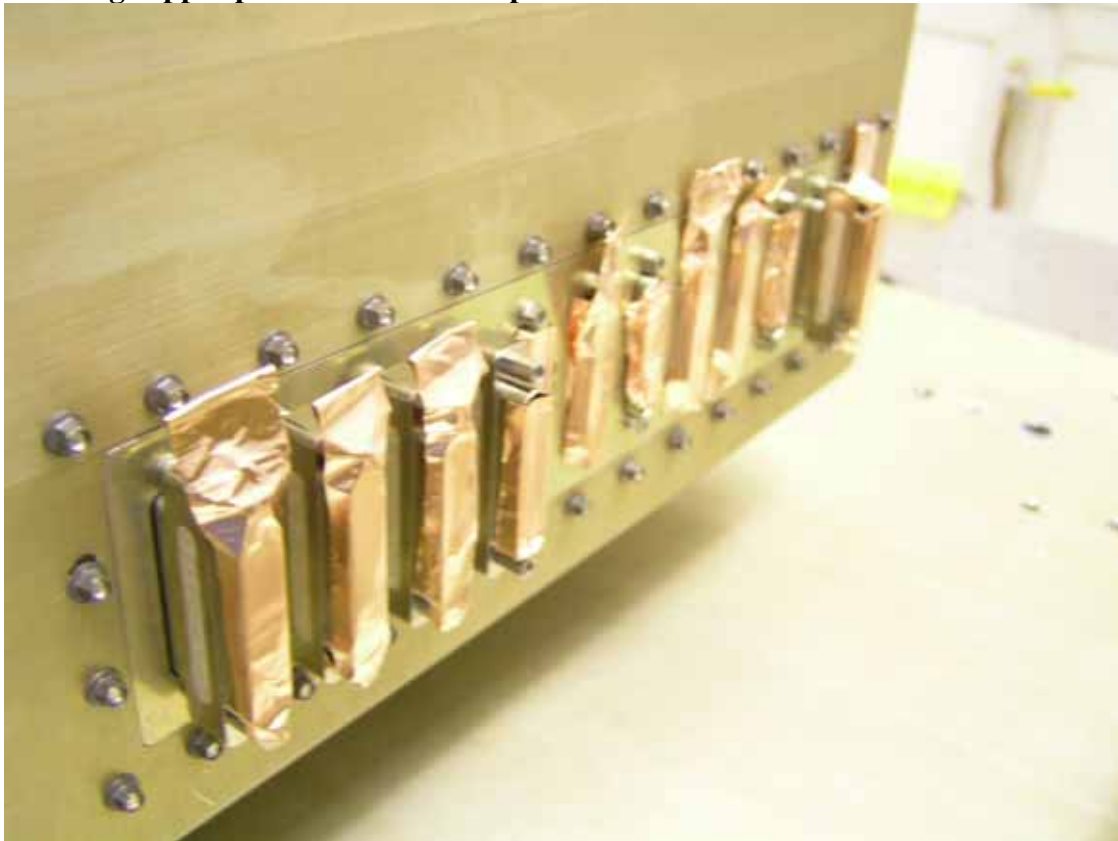
View showing copper protective covers in place and savers fitted to some connectors

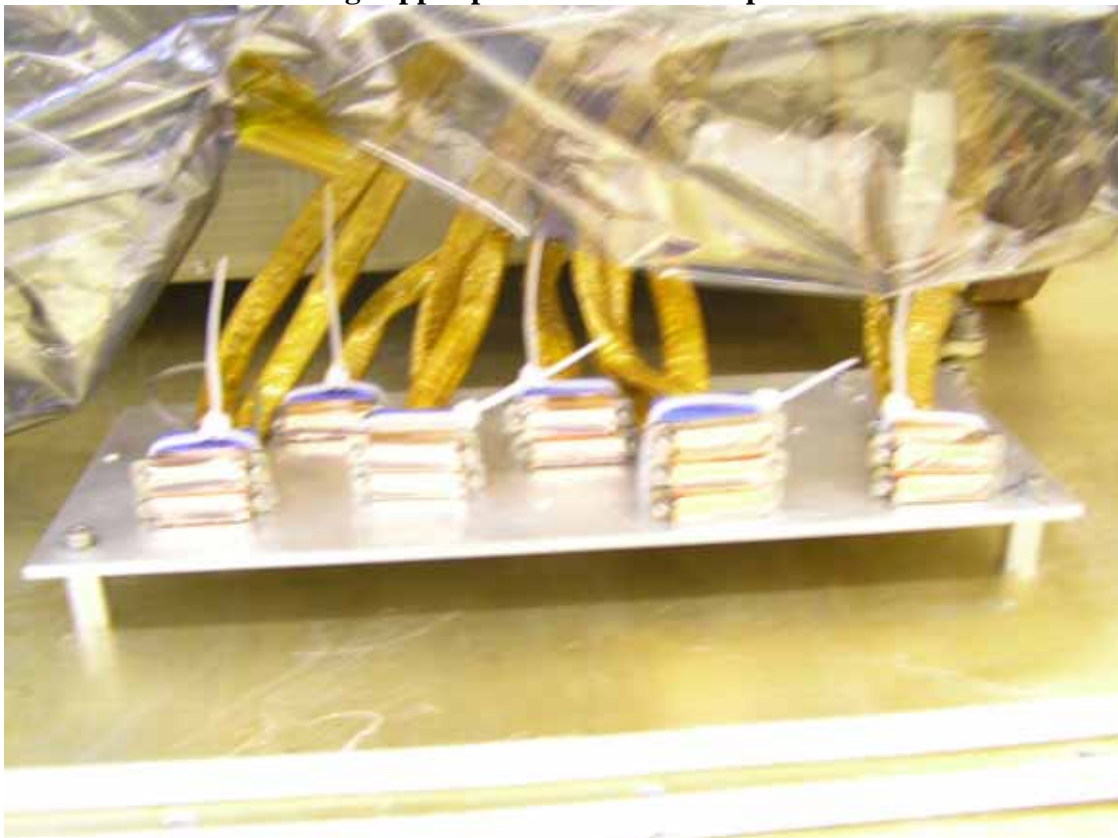
View of other Harness showing copper protective covers in place
