Spacecraft/Project HERSCHEL / SPIRE Document Number SPIRE-RAL-REP- 002764 Issue 1.0 Sub System L0 Straps pre Gold Plating PFM Date 30-Oct-06 Model **INCOMING INSPECTION REPORT** FROM TO MSSL Project Mullard Space Science Lab, Surrey Rutherford Appleton Laboratory Space Science and Technology Department Chilton DIDCOT OXON OX11 0QX Applicable sections **Drawings / Documents Attached** Containers Photo's Yes **External Visual Inspection** Yes **External Connector** No **Documentation** Yes **Verification of Interfacess** No **Extra Comments Sheets INSPECTION CONDUCTED BY WITNESS BY** DATE NAME DATE NAME Eric Clark (PA) 30/10/2006 30/10/2006 Alan Pearce

Spacecraft/Project	HERSCHEL / SPIRE]	Document Number	SPIRE-RAL-REP-002764]	Issue	1.0]
Sub System	L0 Straps pre Gold Plating		Date	30-Oct-06		Model	PFM]
			NSTRIMENT VISUAL	INSPECTION	1

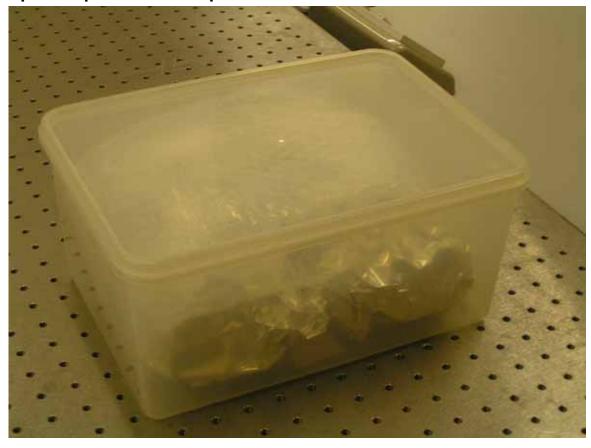
Pump & Evaporator Lo Straps Transit Box.

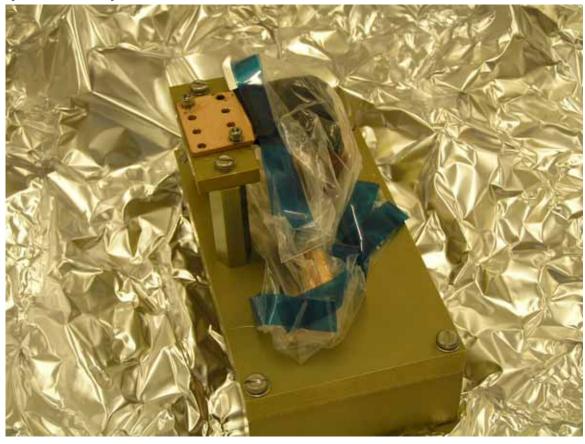
Evaporator Strap General View

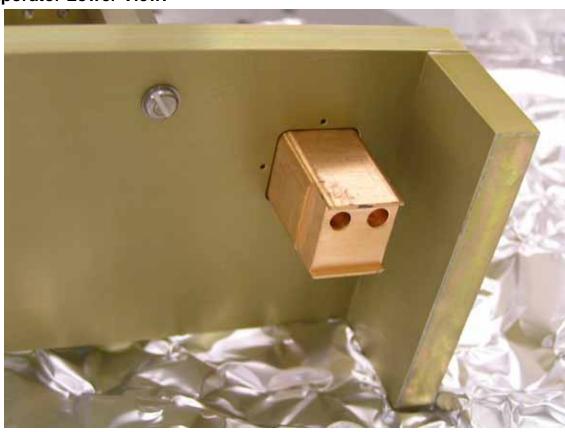
Evaporator Lower View.

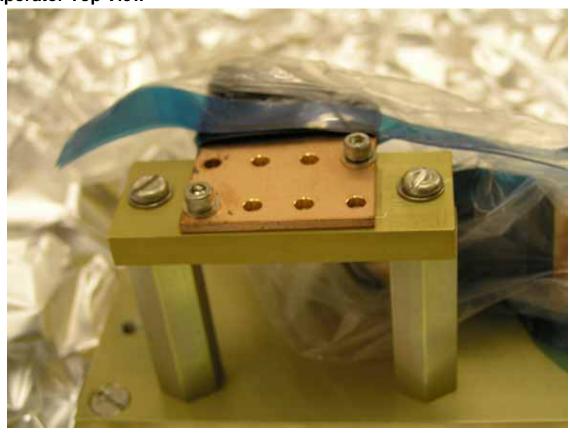
Evaporator Top View

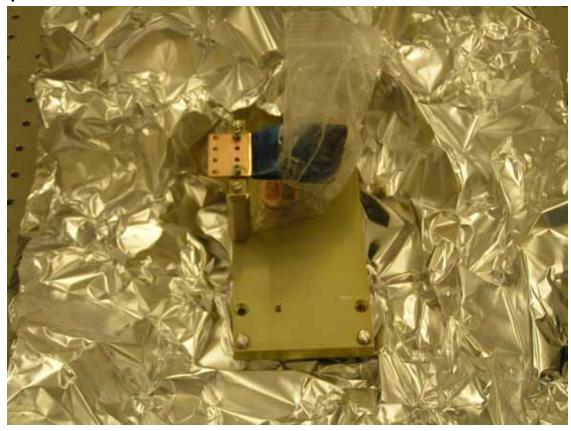
Pump General View

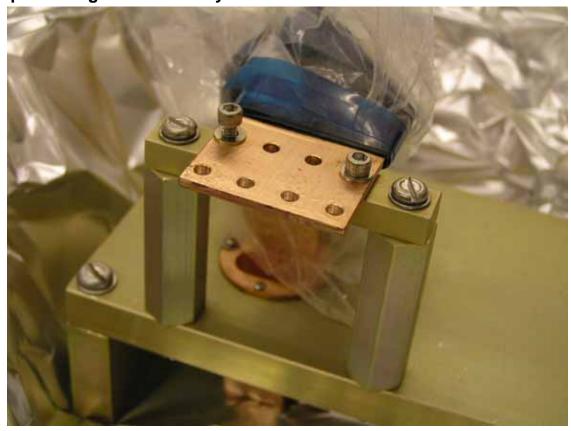
CHECK LIST	REMARKS	RESULTS
Contents against shipping list	Pump and Evaporator End parts only delivered	See Remarks
Instrument label	Parts were not labeled	See Remarks
Note status of external contamination	Pump strap had one screw not fully screwed in, and mark on one section, see Photos. Evaporator Strap OK	See Remarks
Degradation of paintwork or Coating?	As Above	See Remarks
Fasteners correctly locked?	As Above	See Remarks
Check protective covers are correctly labelled and fitted?		N/A
Additional Comments		None

Pump Showing screw not fully down

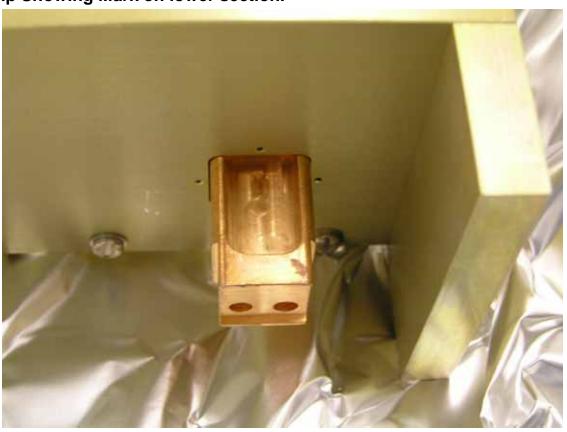
Pump Showing Mark on lower section.

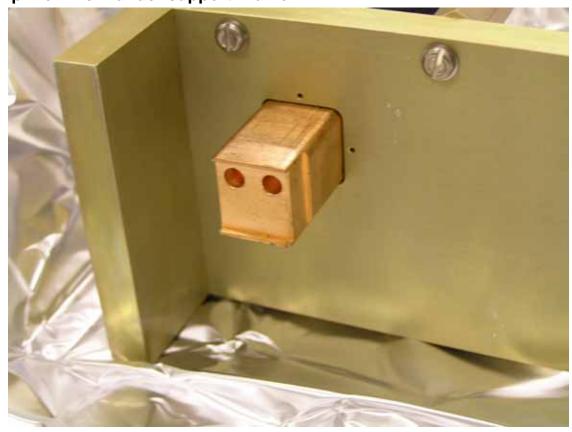
Pump View from under support Frame
