SSTD Incoming Inspection Report

Spacecraft/Project **HERSCHEL / SPIRE**

Document Number **SPIRE-RAL-REP- 002785**

Sub System **WIH**

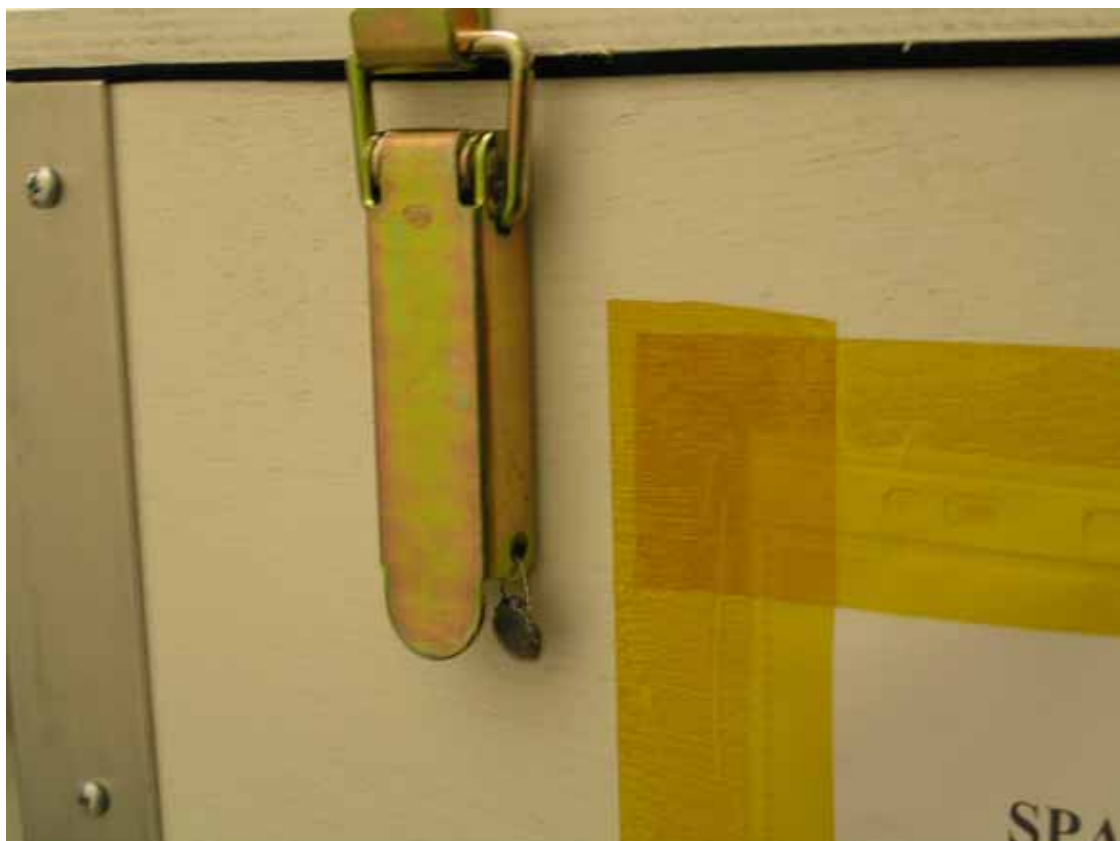
All six Latches were sealed as shown

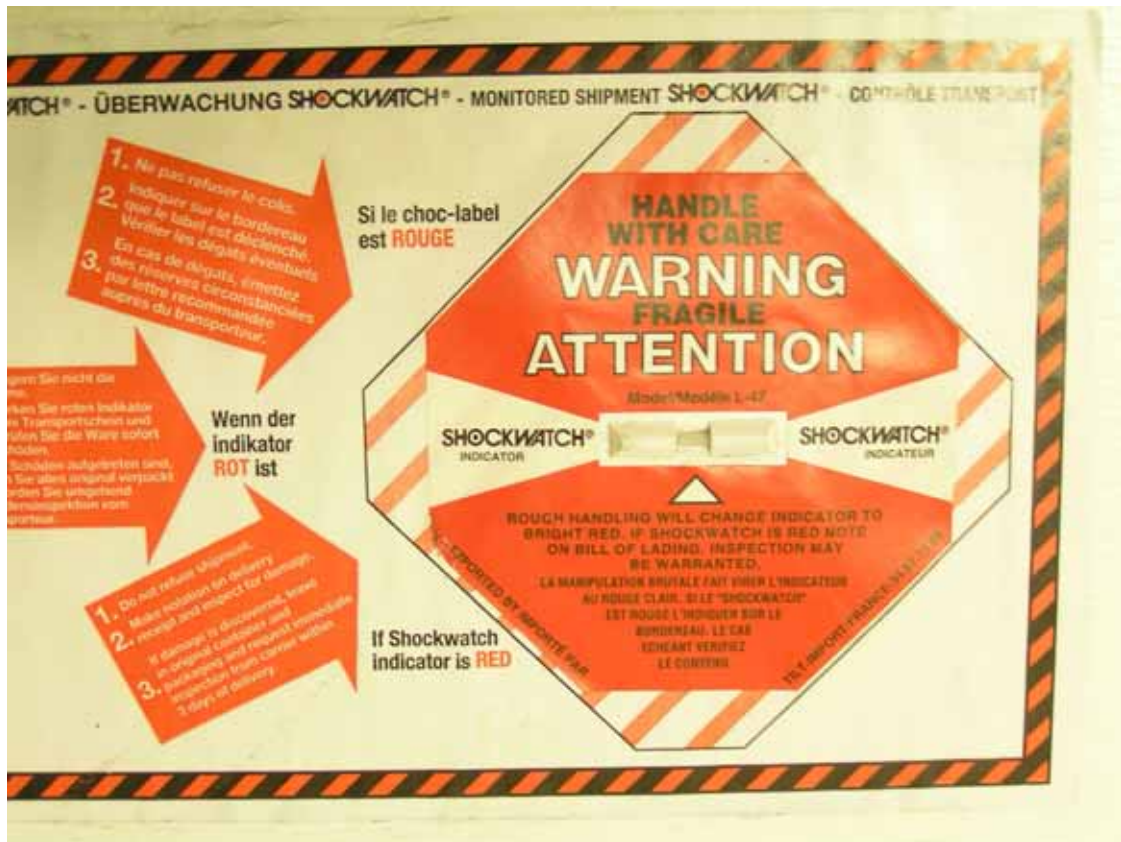
Shock watch monitor on Top of container OK

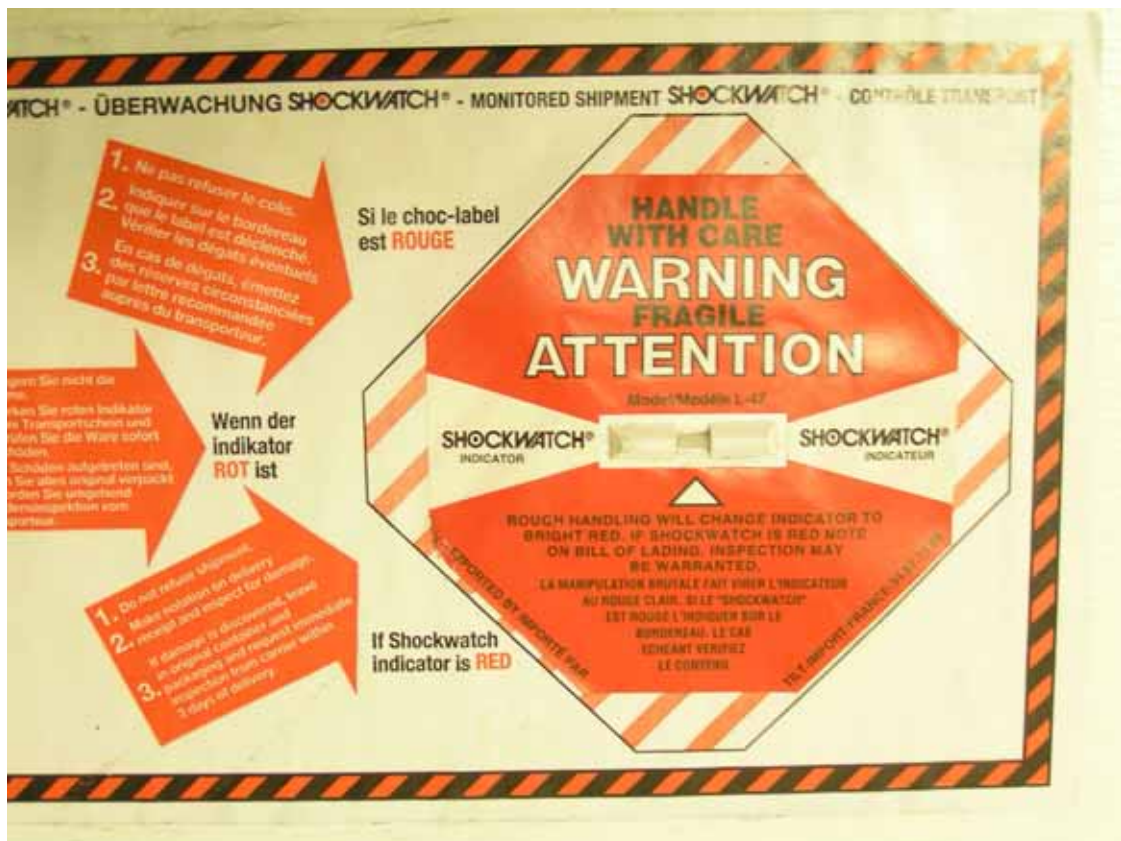
Shock watch monitor on End of container OK

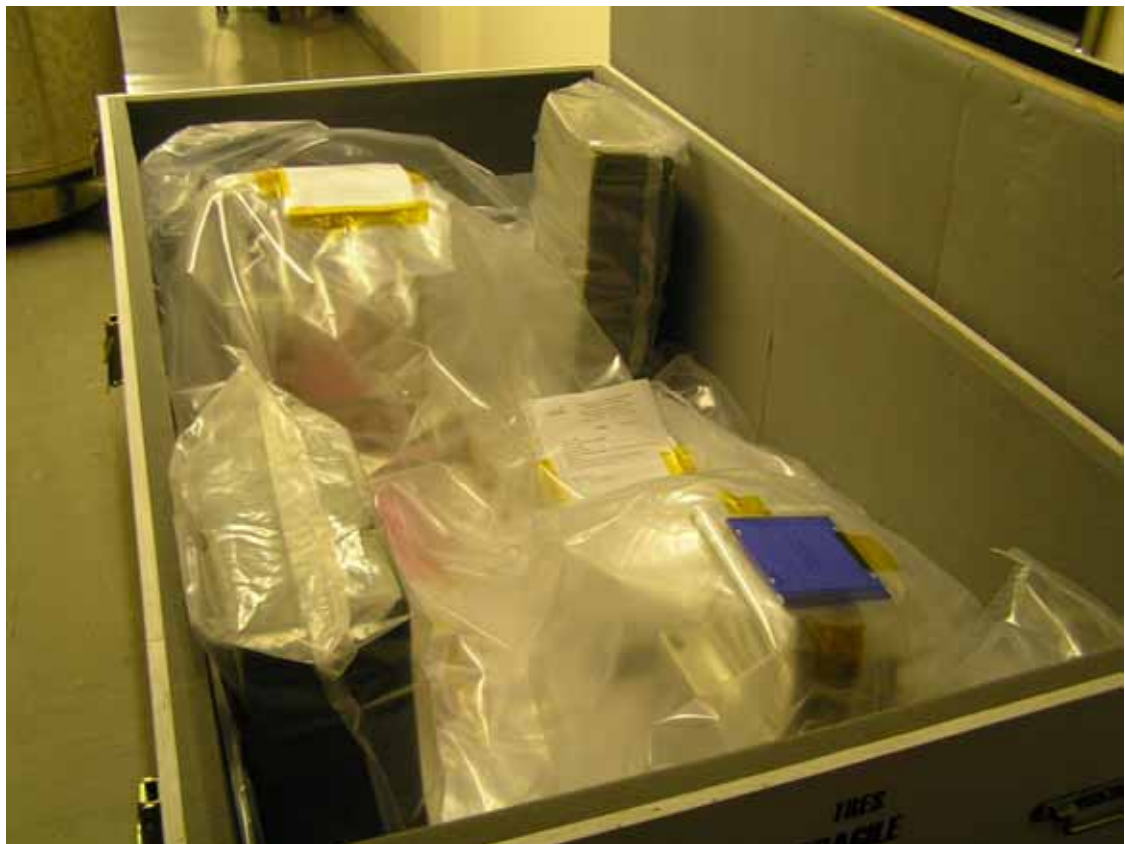
The Harness was delivered attached to a support frame all Double Bagged in Polythene sheeting, however Polythene is not allowed in SSTD (RAL) ESD safe areas due to its ability to become highly Charged with static.
As the instrument was inside the Cryostat, and therefore protected from Contaminants, the polythene was removed before taking into the SPIRE Clean room
The Polythene covering the Support frame will either be replaced, or covered with ESD safe material before onward shipping of the Harness.

With container Lid removed showing Polythene sheeting & EIDP CD

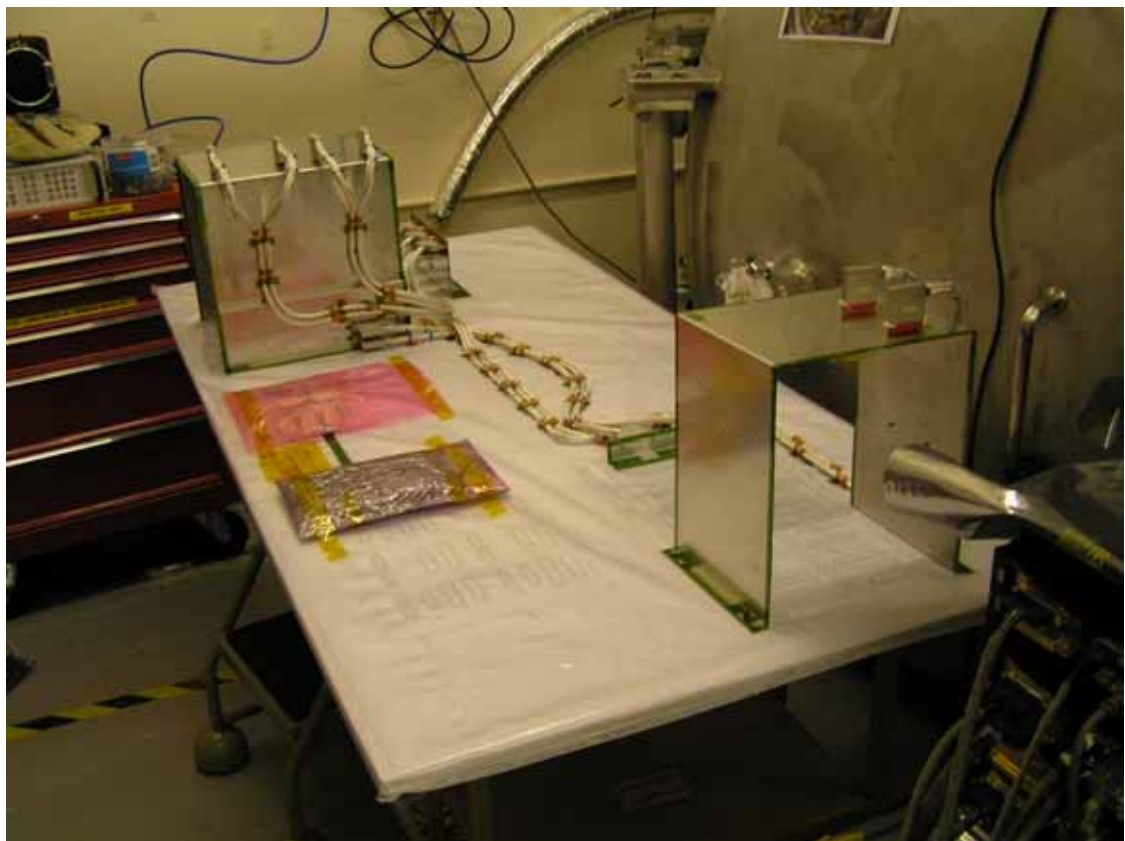
Polythene removed and in position in Clean room

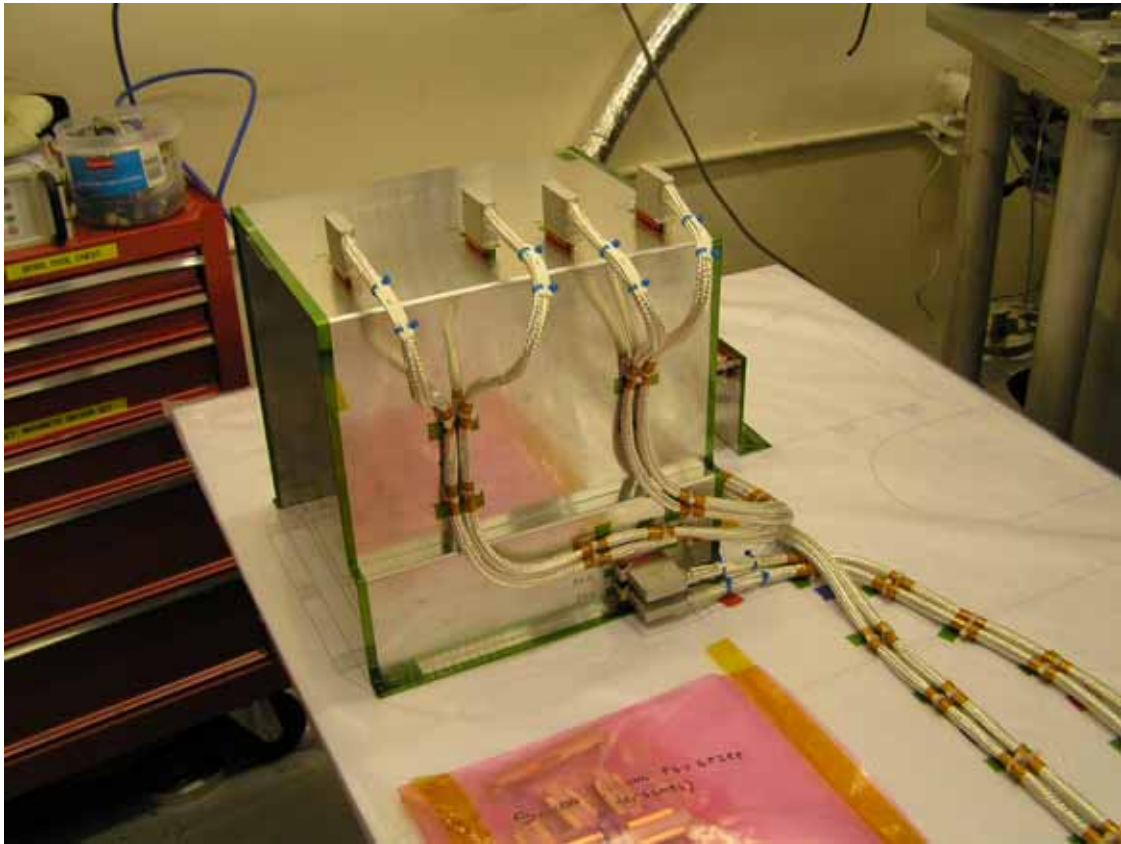
Close up of one end showing connector termination

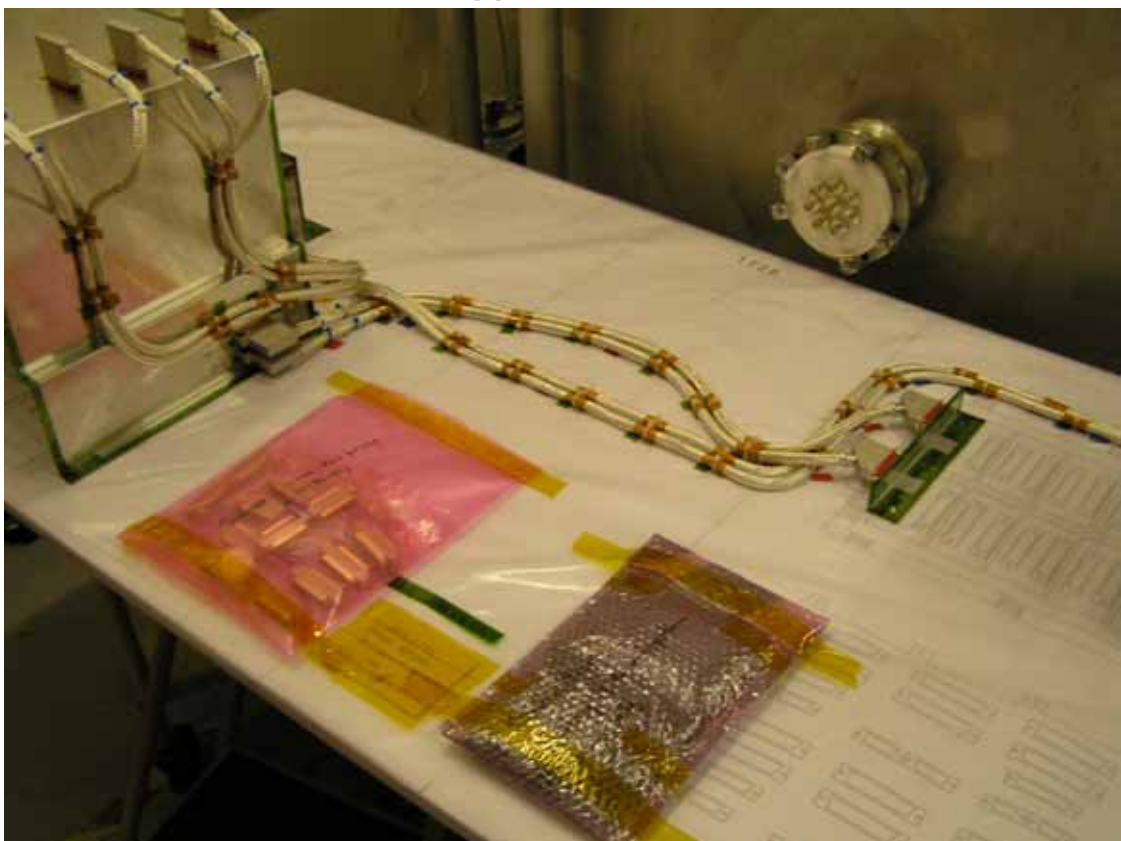
Each connector was visually inspected and fitted with the Connector Saver supplied it and its mating connector was connected to the ESD grounding point before Mating. The same procedure will be performed on de-mate.

View of Connector Savers etc supplied
