PROJECT : Herschel		NON CONFORMANCE REPORT	
Subsystem : SMECm		Unit : SPIRE	
Model : FM		Identif. Number : Structure de base # 10	
NCR occurred during : Manufacture <input checked="" type="checkbox"/> Inspec [] Test [] Integ [] Other []			
NCR Title : Flatness of the contact area on the SOB and attachment point damaged during machining			
NCR Description : <ul style="list-style-type: none"> ✓ The flatness of the contact area is out of spec by 4 μ. (Spec is 10 μ) ✓ One of the attachment point has been damaged during the machining (See the attached pictures) 			
Originator Name : G. Rousset		Date 22/06/2005	Signature :

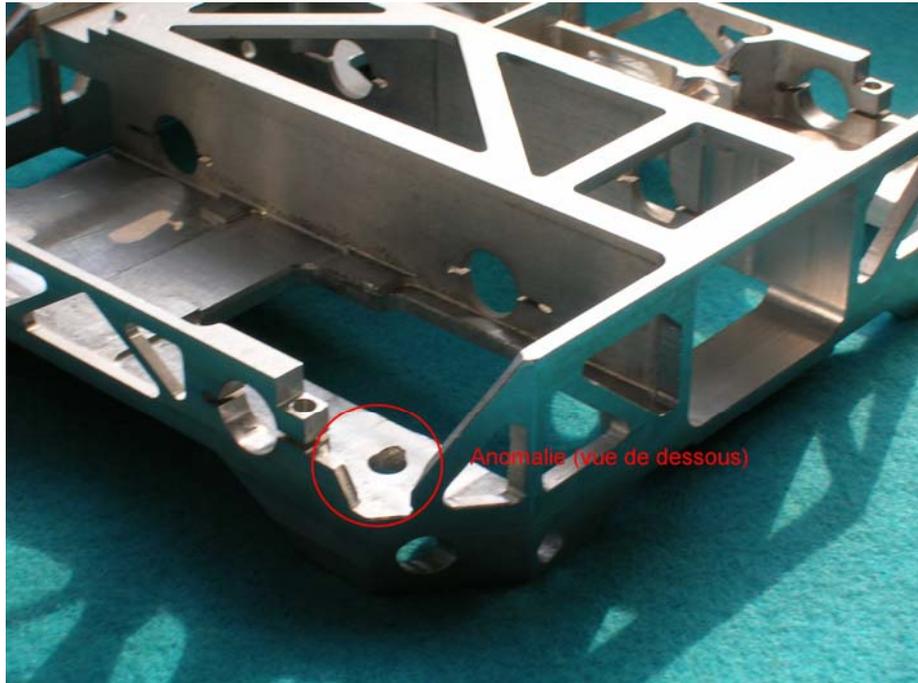
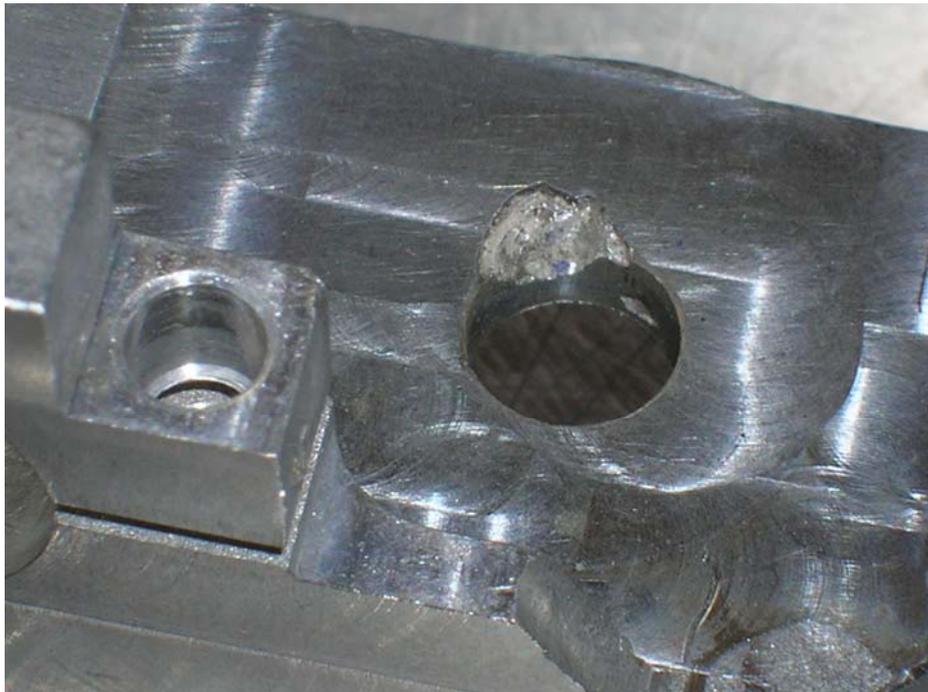
Cause of the NCR : Deviation during the machining		Major []	Minor [X]
Disposition/Corrective Action :		Corrective action carried out : Name : Date :	
MRB date :	MRB Minute Ref :		
MRB Conclusion : <p style="text-align: center;">Use as is</p>			
Responsible for corrective Actions :		All Corrective Actions Carried Out : Yes [] No []
