PROJECT : Herschel		NON CONFORMANCE REPORT	
Subsystem : SMECm		Unit : SPIRE	
Model :		Identif. Structure de base # 10 Drawing ref : SPI-MEC-10-DD-01-G	
NCR occured during : Manufacture [] Inspec [] Test [X] Integ [] Other []			
NCR Title : Wrong location of the holes used to attach the clamp for the harness			
NCR Description : Wrong location (0.7mm) of the two M2.5 holes used to attach the clamp for the harness. One of the hole is half part on the rib half part on the recess			
Originator Name : G. Rousset		Date 29/06/2005	Signature :

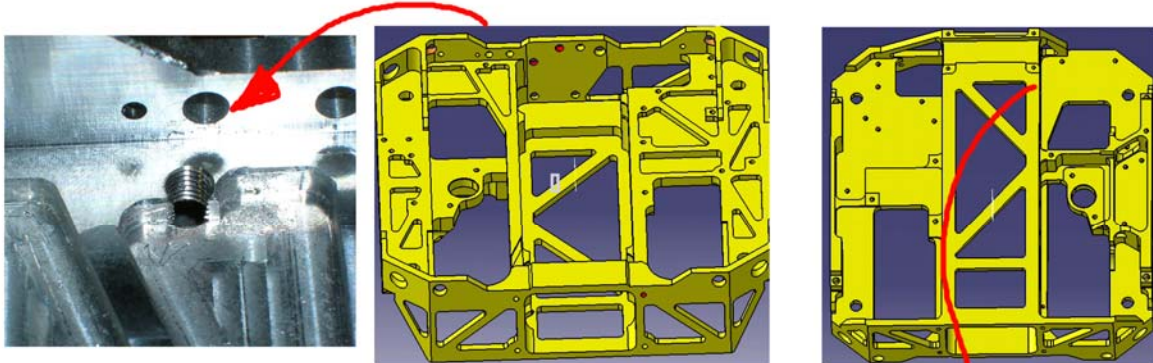
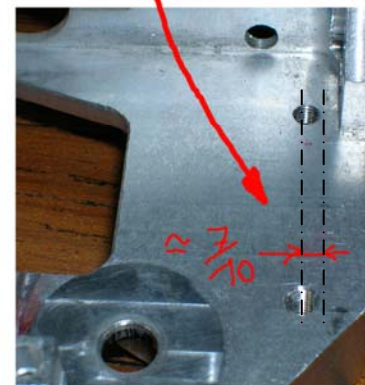
(Base n° 10)

Décalage de 7/10^e des trous de fixation
de la bride serre cable

Cause of the NCR : Deviation during manufacture		Major []	Minor [X]
Disposition/Corrective Action :		Corrective action carried out : Name : Date :	
MRB date : 29/06/2005		MRB Minute Ref : No report	
MRB Conclusion: A counterboring dia 6mm depth 2mm will be machined in the axe of the M2.5 hole. An Inox washer (XN26TW) Ext Dia 5.5mm with a M2.5 hole in the centre will be manufactured. The washer will be glued with DP 490.
