PROJECT : Herschel		NON CONFORMANCE REPORT	
Subsystem : SMECm		Unit : SPIRE	
Model :		Identif. Motor Coil N° 520312	
NCR occured during : Manufacture [] Inspec [X] Test [] Integ [] Other []			
NCR Title : Wrong location of one of the holes used for the screws of the aluminium frame of the coil			
NCR Description : One of the hole used for the screws is shifted wrt the nominal location and the screws can't be installed			
Originator Name : G. Rousset		Date 03/02/2006	Signature :

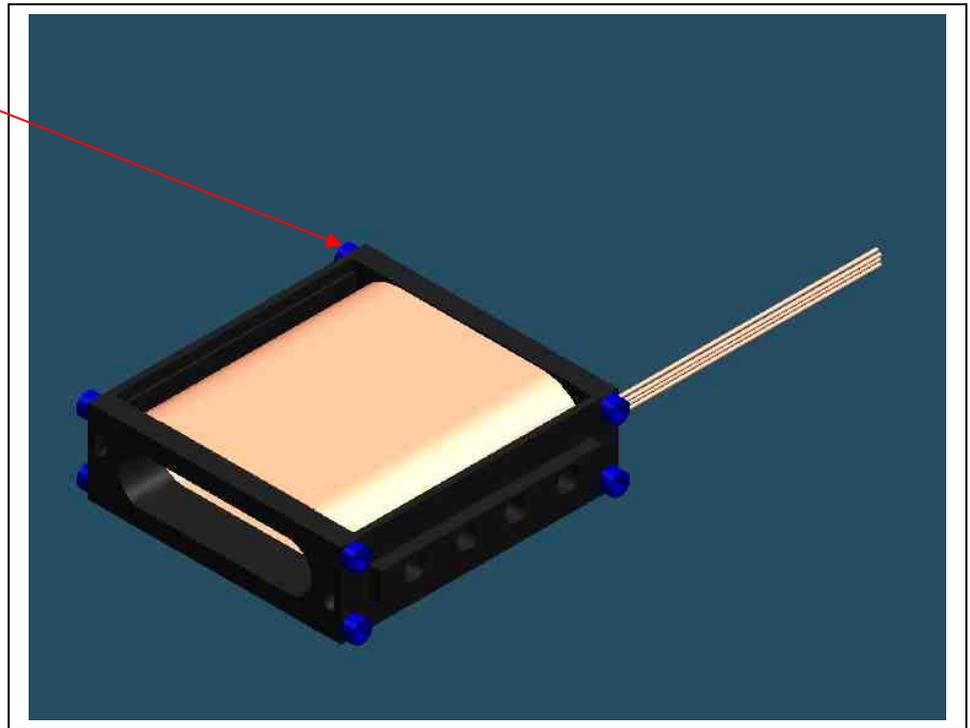
Cause of the NCR : Deviation during manufacture		Major []	Minor [X]
Disposition/Corrective Action :		Corrective action carried out : Name : Date :	
MRB date : 29/06/2005		MRB Minute Ref : No report	
MRB Conclusion: don't use the screw is this location the frame will be attached tyhanks to the 3 other screws			
Responsible for corrective Actions :		All Corrective Actions Carried Out : Yes [] No []	
	Date	Signature	
RAL Project manager :

Missing screw
