PROJECT : Herschel		NON CONFORMANCE REPORT	
Subsystem : SMECm		Unit : SPIRE	
Model : FM		Identif. Roof top S/N 12 Drawing : SPI-MEC-40-DD-01 D1	
NCR occured during : Manufacture [] Inspec [] Test [X] Integ [] Other []			
NCR Title : Scratch on the FM roof top mirror (S/N #12) (This issue supersedes the preceding one for which the NCR was addressed, by mistake, to the S/N 10)			
NCR Description : A scratch was done on the optical surface of the mirror during the vibration handling operations; After investigations, this scratch is out of the useful area.			
Originator Name : G. Rousset		Date 10/03/2006	Signature :

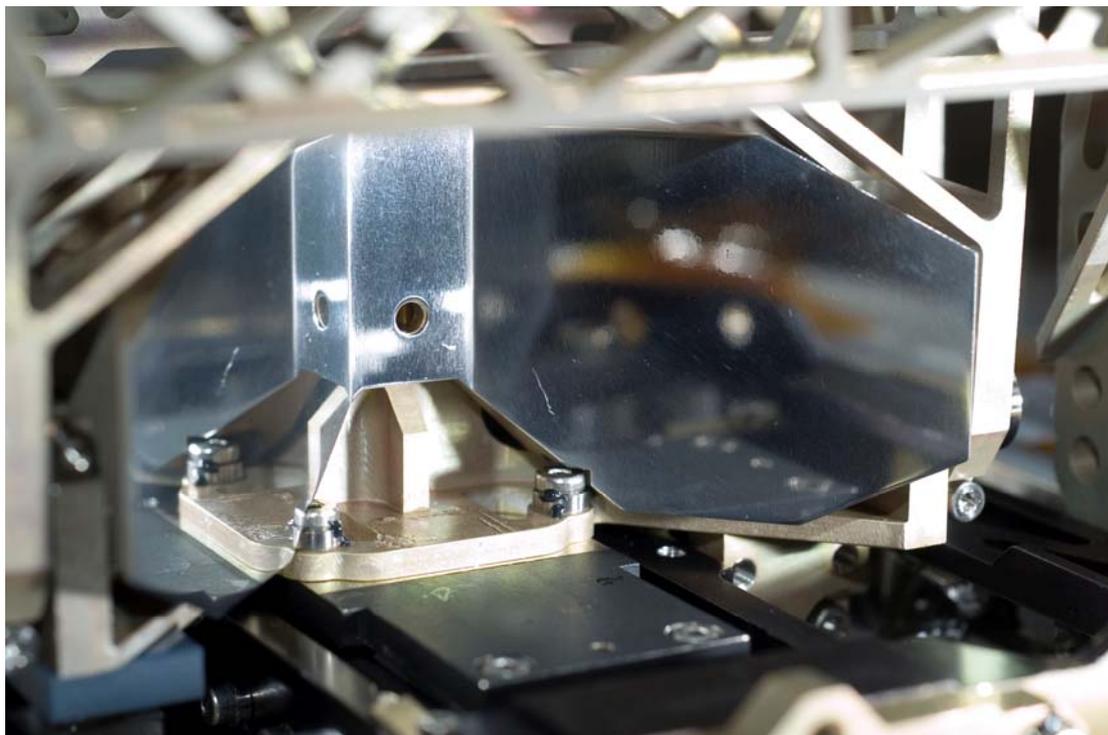
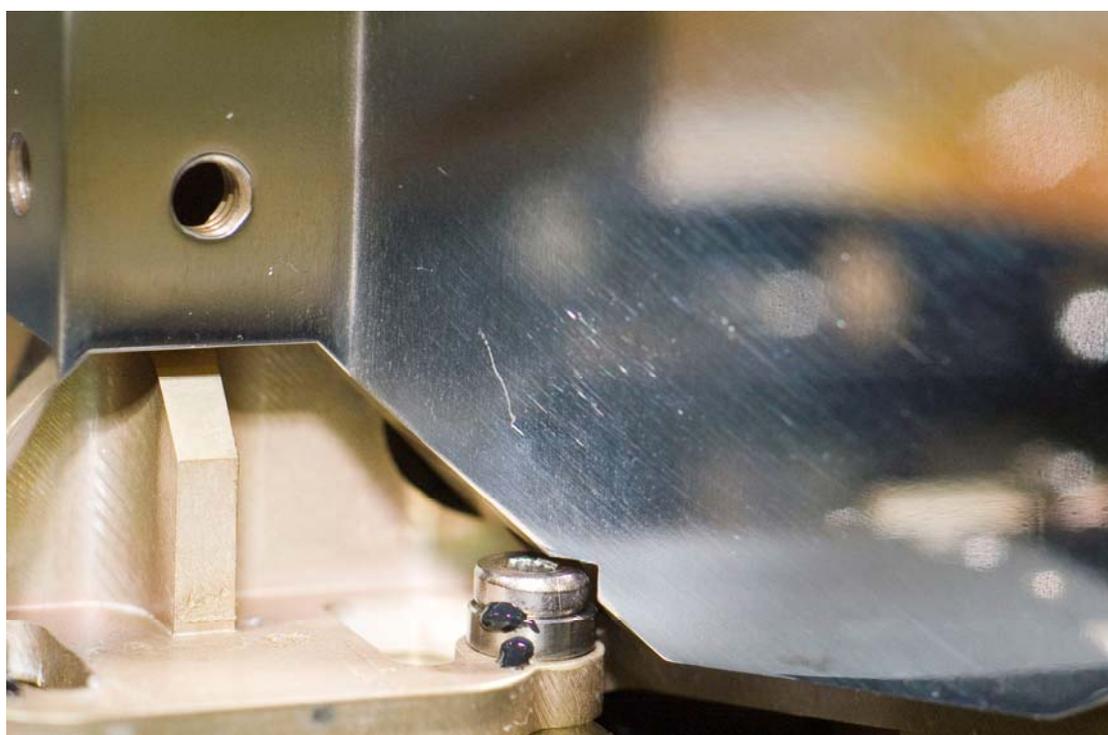
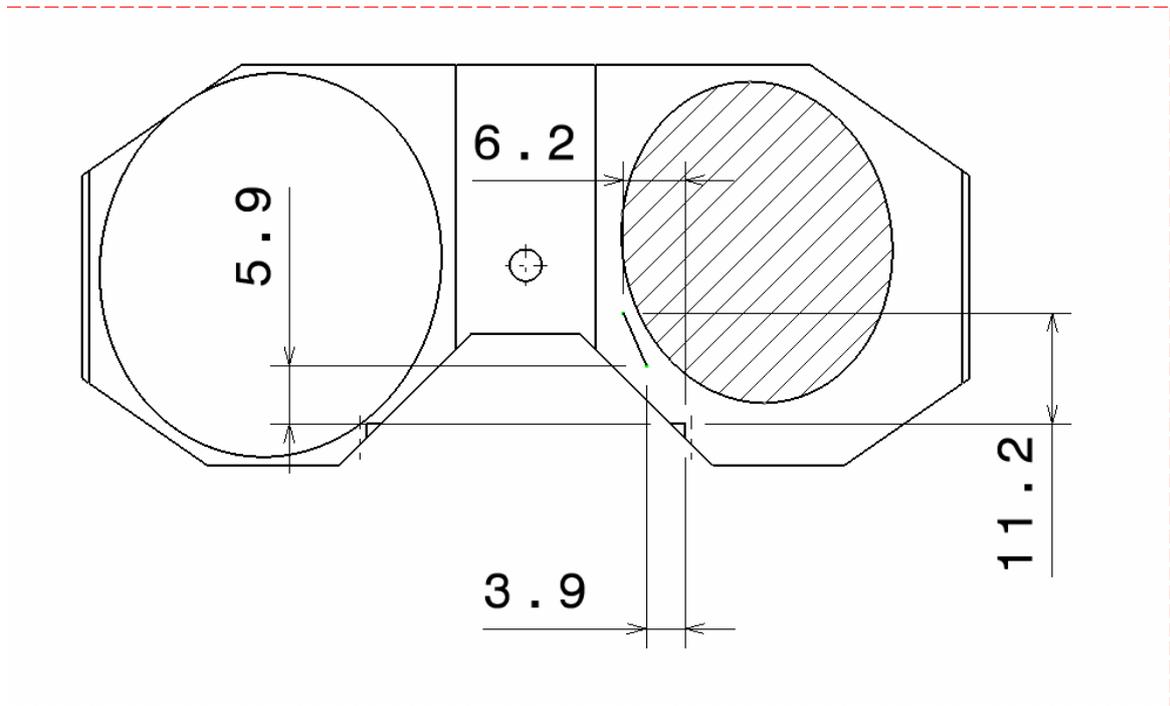
Cause of the NCR : contact with a tool.		Major [X]	Minor []
Disposition/Corrective Action :		Corrective action carried out : Name : Date :	
MRB date : 10/03/2006		MRB Minute Ref : see the conclusion here after	
MRB Conclusion: The scratch is out of the useful area. Let's assume that it was inside the useful surface, the dimensions of the scratch are roughly 7mm length and 0.15mm width, so a surface of about 1.05mm ² . The impact of the optical beam on the mirror has a diameter of about 25mm (pessimistic assumption since the impact is elliptic and has a larger surface) so a surface of 491mm ² . The ratio between the damaged area and the useful area is 1.05/491=0.002. This means that 2/1000 of the useful light is lost and convert into stray light in the instrument. Even in this assumption the roof top would have been acceptable. (K.Dohlen, A. Origné, G. Rousset)
