NCR Number: HSO-CDF-NCR-100

Spacecraft / Project	Herschel	Originator's Name	Peter Hargrave	
Experiment / Model	SPIRE / PFM	Signature		
Sub-System	300mK strap support system LTS-PFM-000	Date	June 29 th 2005	
Assembly	300mK photometer light baffle	Level (Highlight if applicable)	Major	Minor
Sub-Assembly				
Item		NRB Reference		
Serial Number	LTS-PFM-400

NCR Title	Difficulty fitting light baffle to photometer box
------------------	---

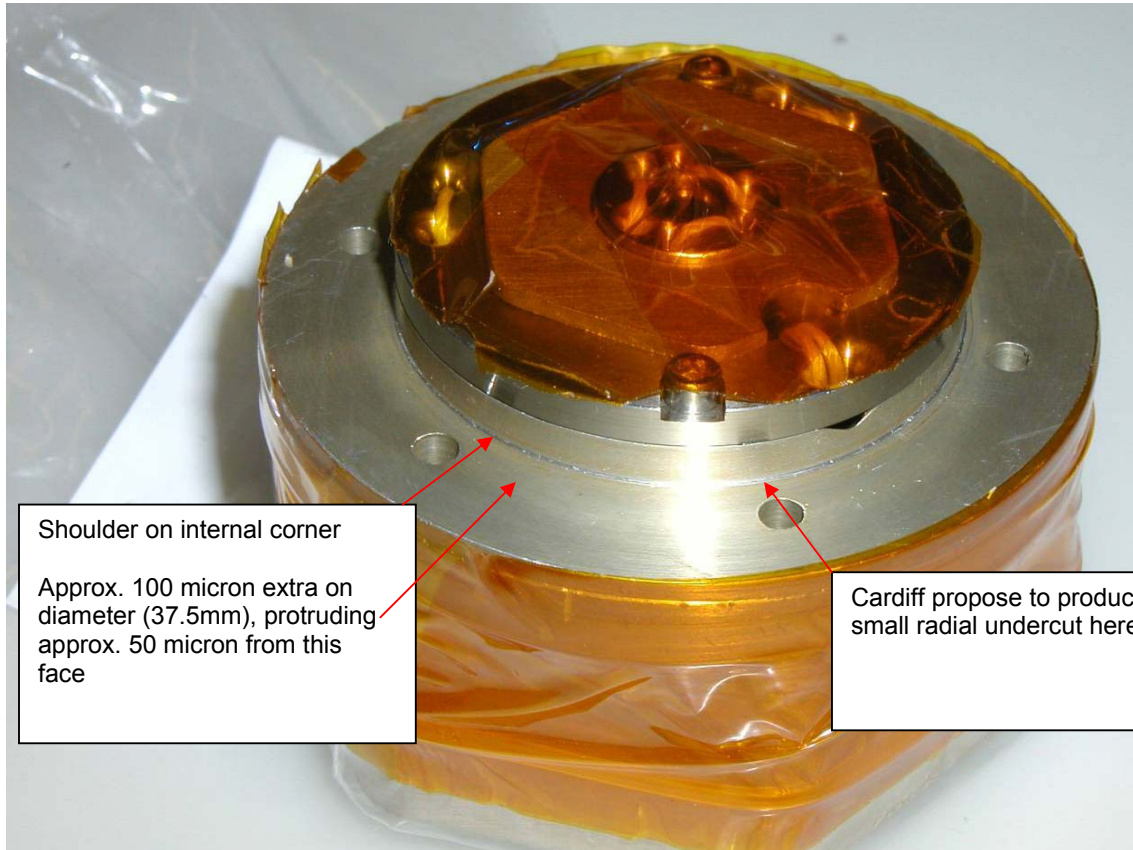
Close inspection revealed a very small "shoulder" at the inner corner of the light baffle / photometer box interface (see attached figure). This is due to the difficulty in producing a perfectly square inner corner, which requires very careful machining and very carefully ground turning tools.

Shoulder on internal corner

Approx. 100 micron extra on diameter (37.5mm), protruding approx. 50 micron from this face

Cardiff will undertake to produce a small undercut at this interface, to compensate for the lack of the chamfer. This is because, at the time of writing, the photometer box is ~90% integrated, and modifying the light baffle is less upheaval overall.

Cardiff propose to produce very small radial undercut here

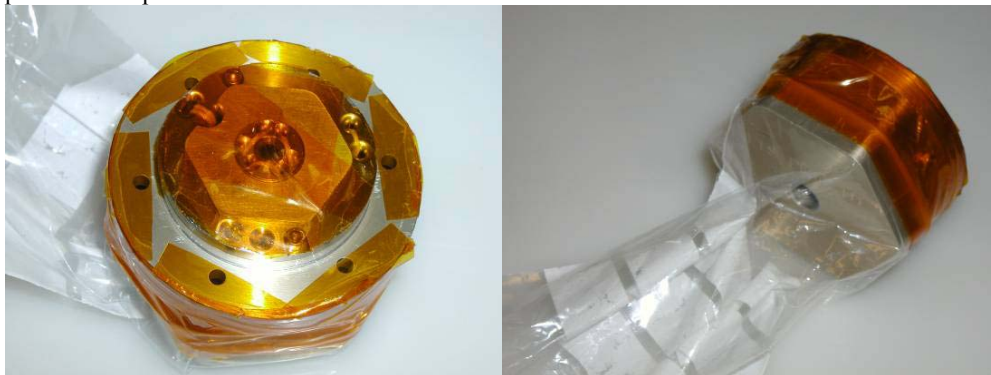
The baffle was fully bagged and sealed with Kapton tape, as shown below. Note that the alignment jig was in place for this procedure.

The radial undercut was made using a sharp tool bit, and undercut the offending corner by 50 microns. Modification carried out by I. Thomas, Cardiff AIG.

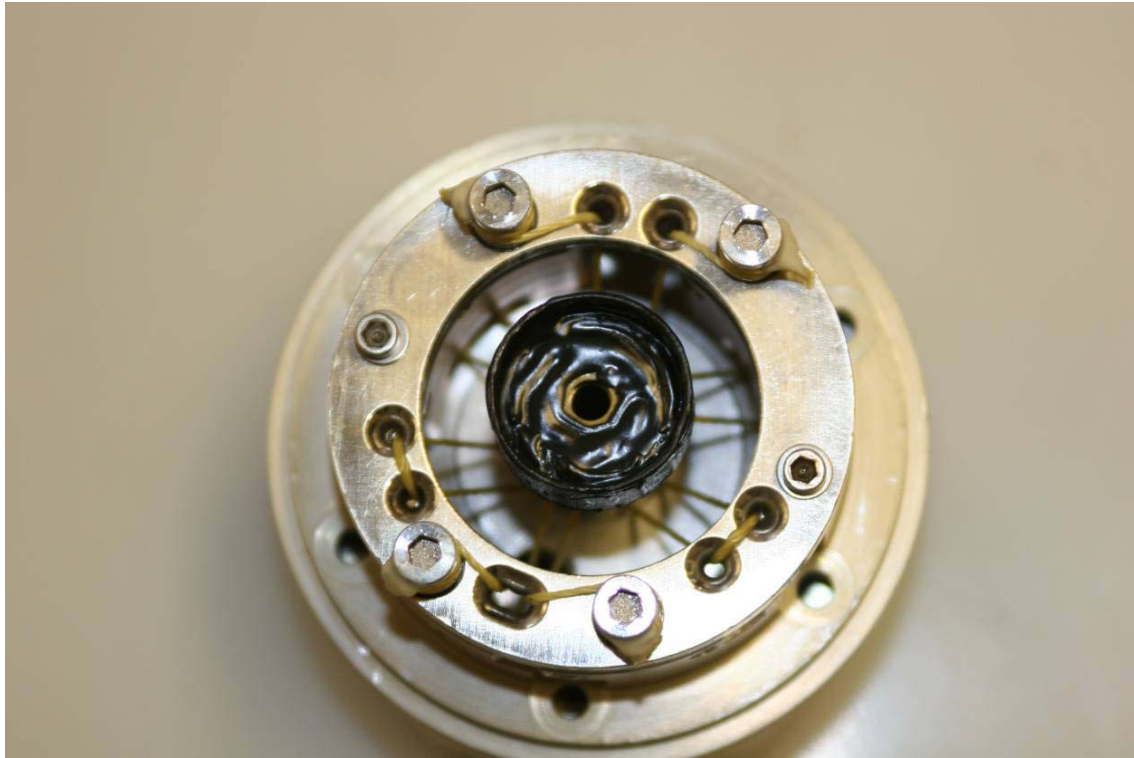
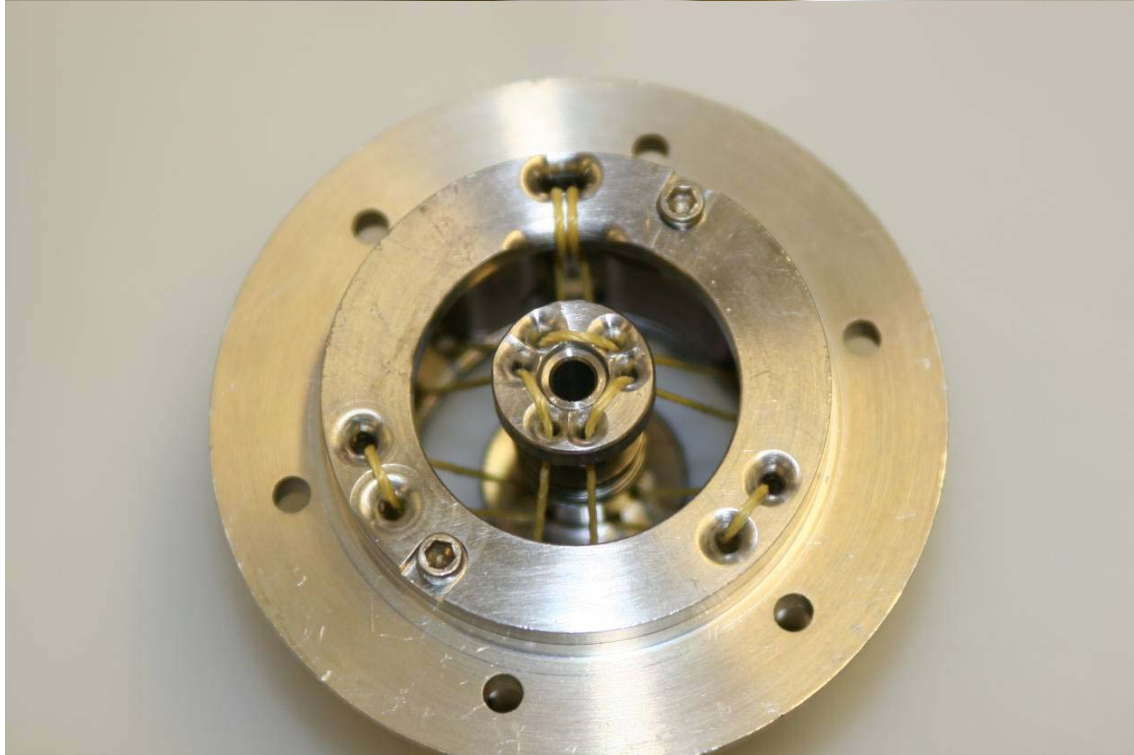
The baffle was then taken to the clean room and un-bagged. Microscopic visual inspection was carried out by P. Hargrave, Cardiff AIG. No signs of contamination or Kevlar distress were evident. The component was then ultrasonically cleaned in a bath of iso-propyl-alcohol for 30 minutes. The baffle was then removed and dried in an oven at 80°C for one hour. A second visual inspection was then carried out by P. Hargrave, and photographs were taken of the component (see below). The component passed visual inspection, and was then placed back in the oven at 80°C, and baked for 24 hrs.

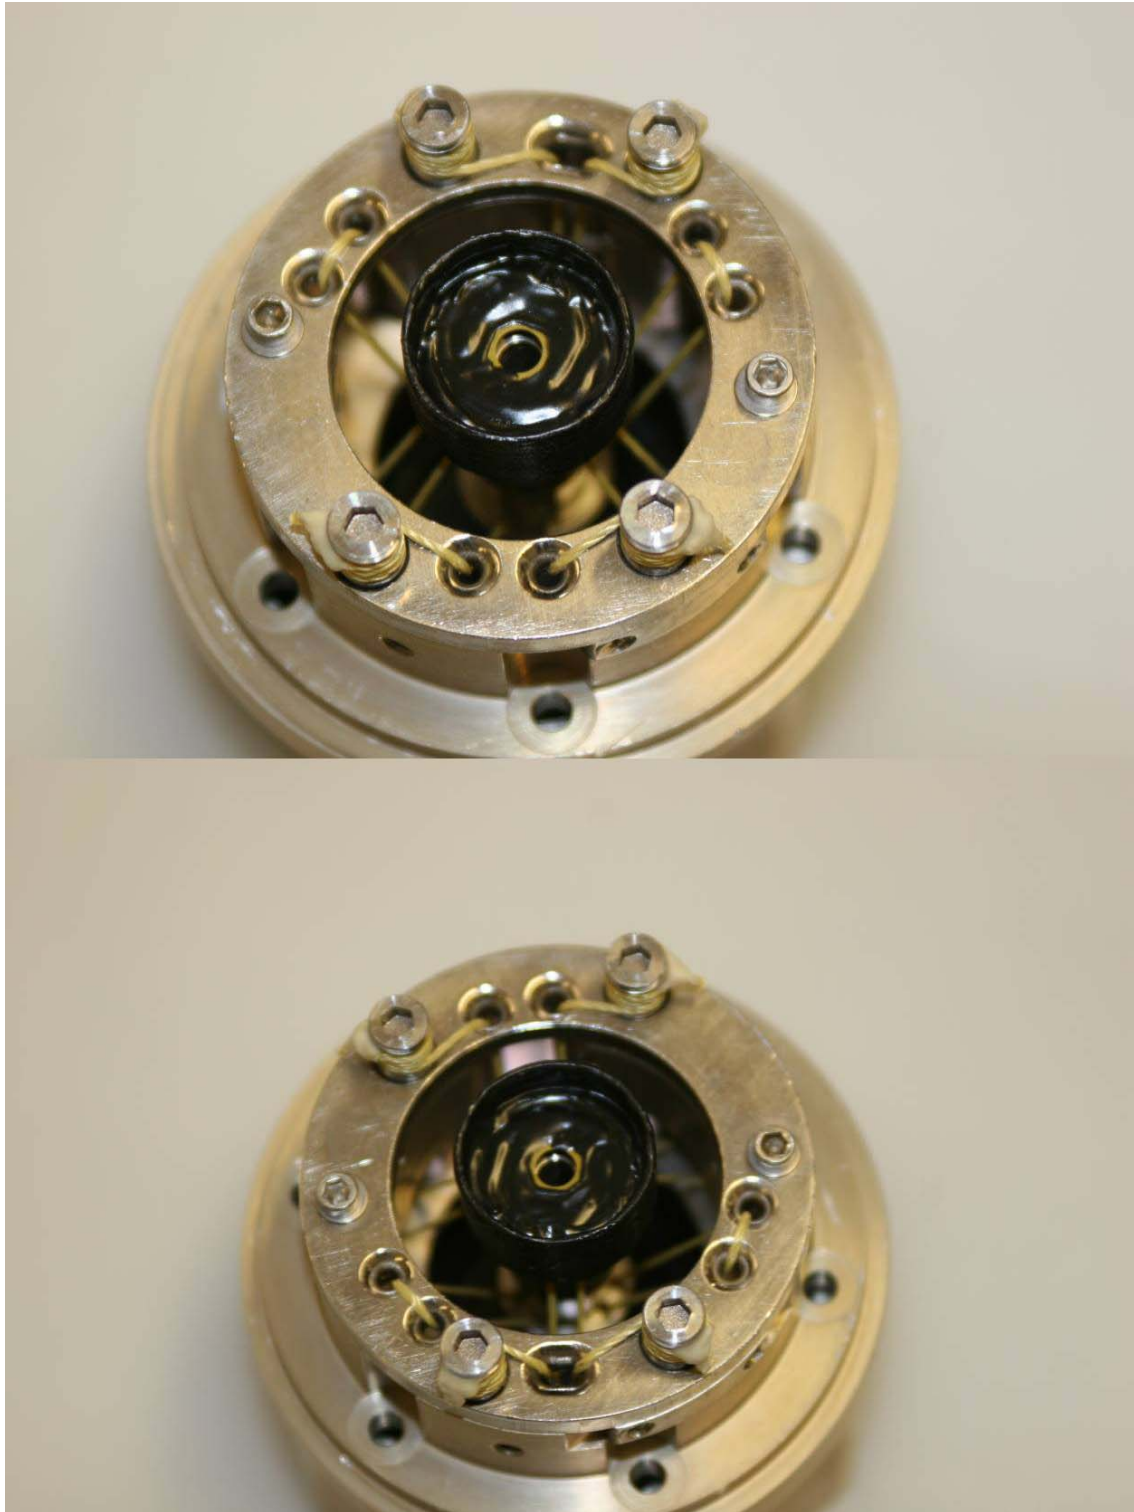
Pre-delivery visual inspection passed by P. Hargrave, 30/06/05
