## HERSCHEL/SPIRE

### HS\_DRCU (HS\_DCU & HS\_FCU) FM Configuration Item Data List / As Built Configuration List

**Reference:** Sap-SPIRE-QA-0417-06  
**Issue:** 1.0  
**Date:** 31/07/06

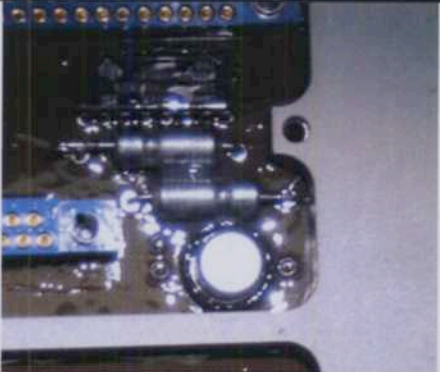
**TITLE :** Short circuit on Redundant side of MCU, between +15V secondary line and chassis

**DESCRIPTION :**  
After integration of MCU boards in FCU box, first tests (facing powerbench and not PSU FM) have shown a disruption of the powerbench.

3) <b>TECHNICAL INVESTIGATION :</b> Investigations with ohm-meter have shown a short circuit between +15V motor and 0V (0V is same potential as chassis). Visual investigation after disintegration of MCU daughter boards have shown a capacitor pin in contact with chassis (C15, See photo left). See FA -MCU-024a in MCU subsystem EIDP for complete description of investigation.

4) <b>CORRECTIVE ACTIONS (model concerned by NCR/CR) .</b> New method for pin bending of involved "through hole" capacitors, Involved capacitors replaced Stress analysis performed and potentially damaged components replaced CEA's procedure for integration enhanced (now includes impedance checking on secondary power inputs for MCU & SCU) See FA -MCU-024a in MCU subsystem EIDP for complete description of repair.	<b>RESPONSIBLE(S) :</b>	<b>FINALE DECISION(S)</b> <input type="checkbox"/> USE AS IS <input type="checkbox"/> WAIVER (FM) <input type="checkbox"/> DOCUMENTATION CHANGE <input checked="" type="checkbox"/> REPAIR <input type="checkbox"/> SCRAP <input type="checkbox"/> MODIFICATION <input type="checkbox"/> ACTION ON OTHER PRODUCT
<b>PREVENTIVE ACTIONS (further models) .</b> None	<b>RESPONSIBLE(S) :</b>

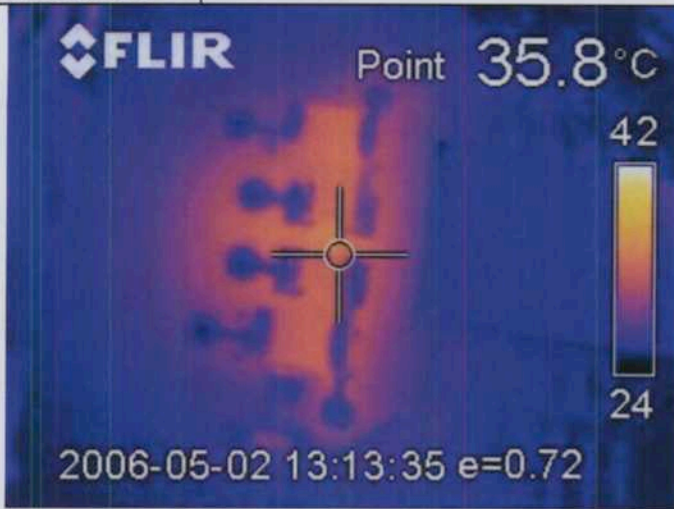
**TITLE :** TEMP Board s/n 4003 have shown excessive power-drain during test at board level

**DESCRIPTION :**  
Test at board level before board coating have shown an excessive power drain on +/-9V secondary power lines : 270mA instead of 100mA expected.

3) **TECHNICAL INVESTIGATION :** **RESPONSIBLE(S) :**  
Investigations performed with I/R camera have shown OP400 amplifier (refdes U42) as well as resistors R289/R290 and capacitors C181/C182 as suspicious (high temperature in this area) Further visual inspection have shown that OP400 U42 have been wrongly encapsulated in its package. The pin 1 reference point on the cover is inconsistent with the reference mark on the ceramic body of the component (See photo on next page). During board manufacturing, OP400 placement has be done according to the pin 1 reference of the cover, so the amplifier has been rotated 180°, this has the consequence of permuting +9V/-9V supplies, this implies a short circuit through clamping diodes. The only limitation is the series resistor on the OP400 +/-9V pins (2\*47.5Ω, for 18V, consistent with about 170mA of excessive power drain)

Hot spot on R289, R290 seen with I/R Camera

Stress analysis performed, only potentially damaged components are U42 (OP400) and R289/R290 + C181/C182. Components replaced with new components from attrition stock. Board tested OK after replacement.

All OP400 amplifiers used for Herschel have now been encapsulated. CEA has the action to come back to the company who has encapsulated the OP400 and define preventive actions for next projects.

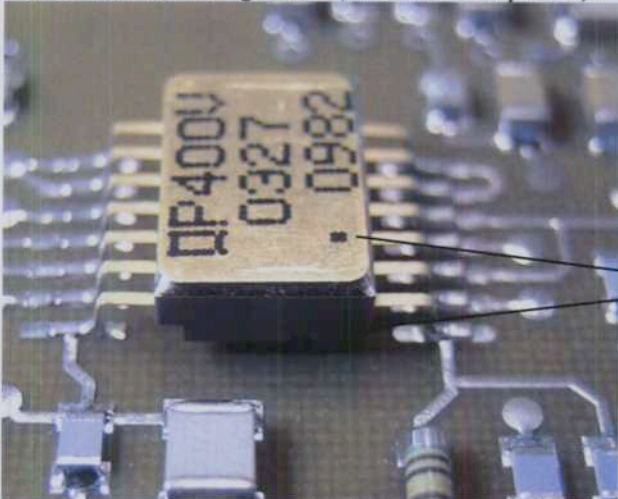
Standard OP400 configuration (all OP400 except U42) :

Consistency on marking

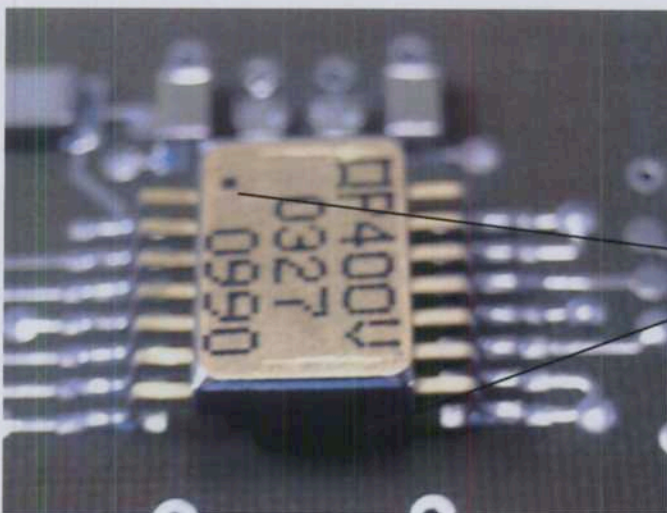
Unusual configuration of marking (U42) :

Inconsistency of marking

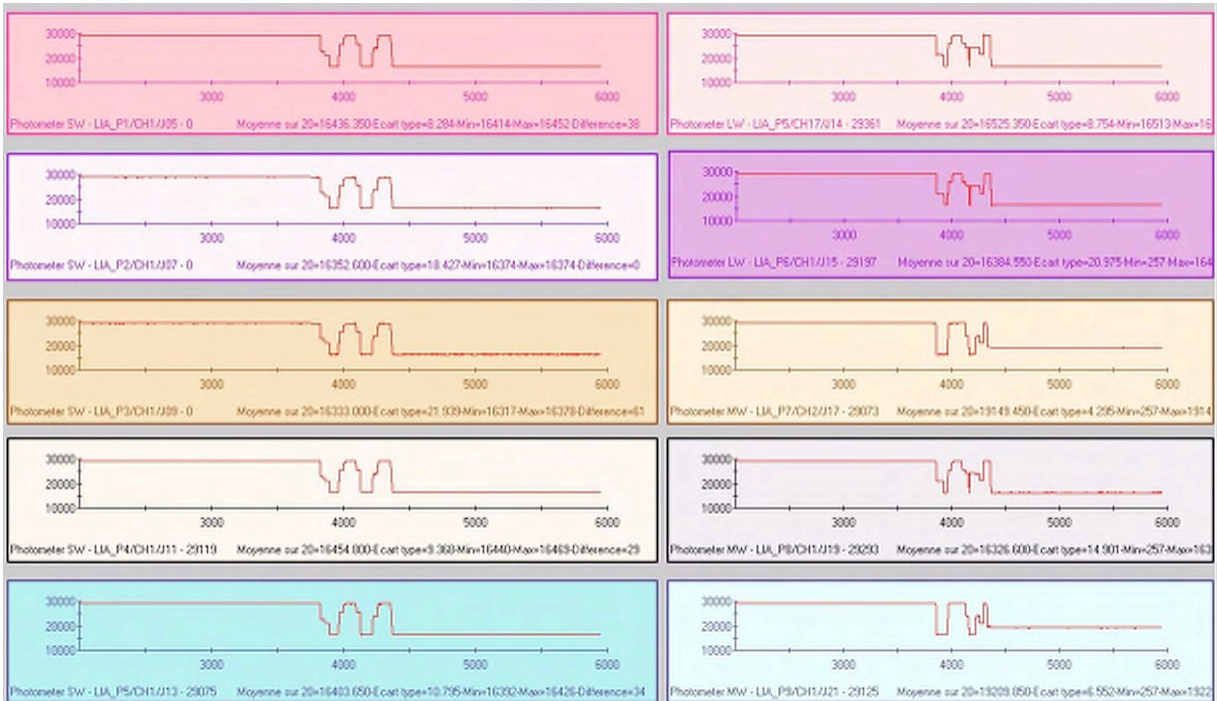
1. NO SUSCEPTIBILITY
2. NO SUSCEPTIBILITY
3. NO SUSCEPTIBILITY
4. Susceptibilities found on BIAS-P and DAQ-IF connector backshells. All bias levels are affected as shown on figures below.

Nominal bias levels are recovered using relevant setting commands. No material damage.

Failure detection and manual operator actions are required to recover nominal performances. This situation does not fully cope with the basic requirement, the DUT is then considered as not compliant.

Bias level changes on every channel, example 1

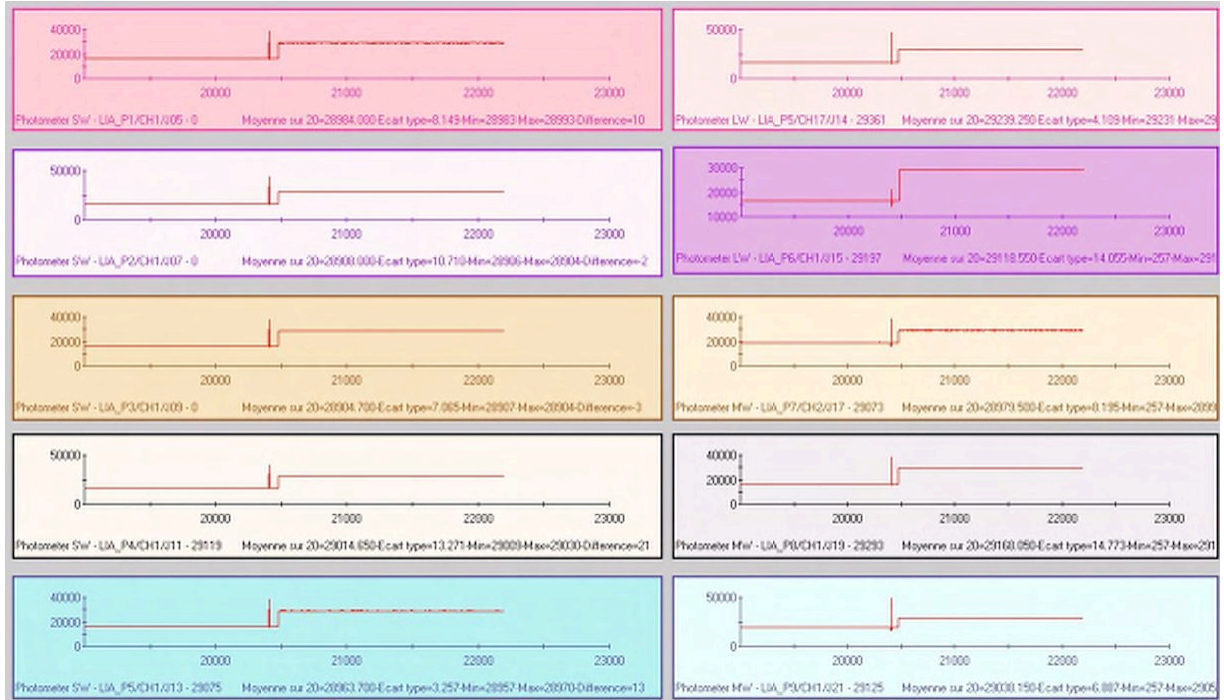
Bias level changes on every channel, example 2

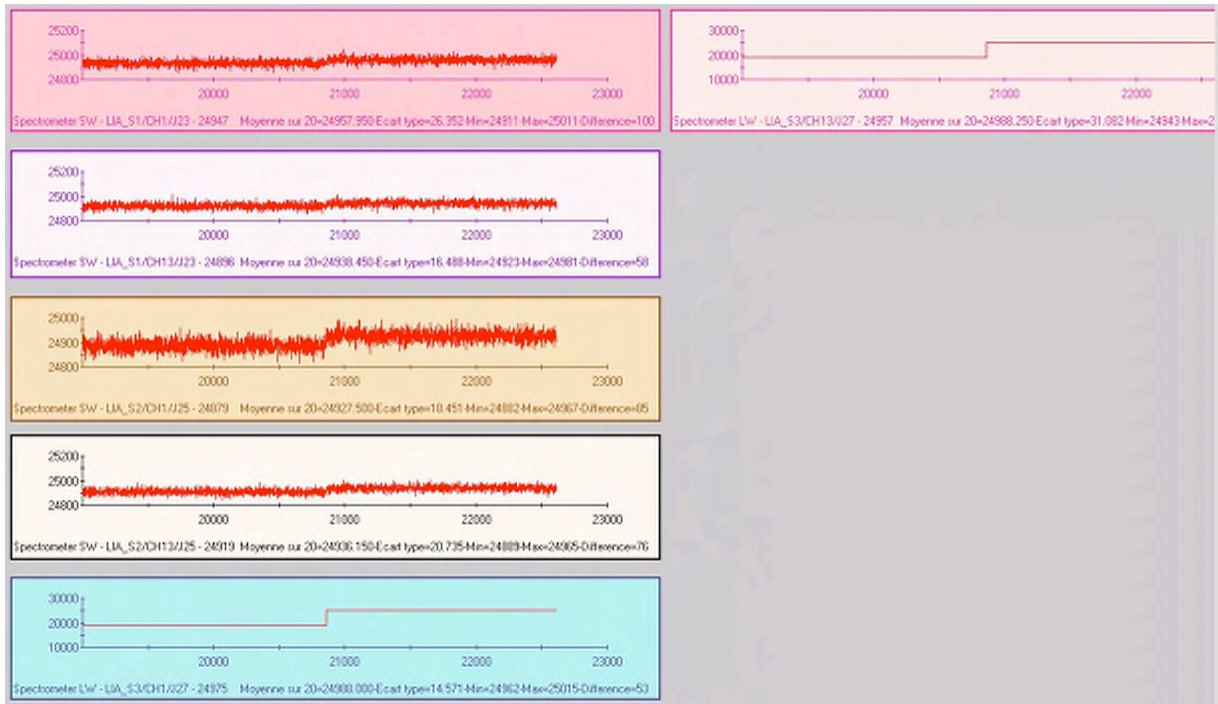
1. NO SUSCEPTIBILITY
2. Susceptibility found on left rear corner box close to the BIAS connectors. Most of the bias levels are affected as shown on figure below.
3. NO SUSCEPTIBILITY
4. Susceptibilities found on BIAS-R connector backshell. All bias levels are affected as shown on figures below.

Nominal bias levels are recovered using relevant setting commands. No material damage.

Failure detection and manual operator actions are required to recover nominal performances. This situation does not fully cope with the basic requirement, the DUT is then considered as not compliant.

Bias level changes, discharges on the left rear corner box

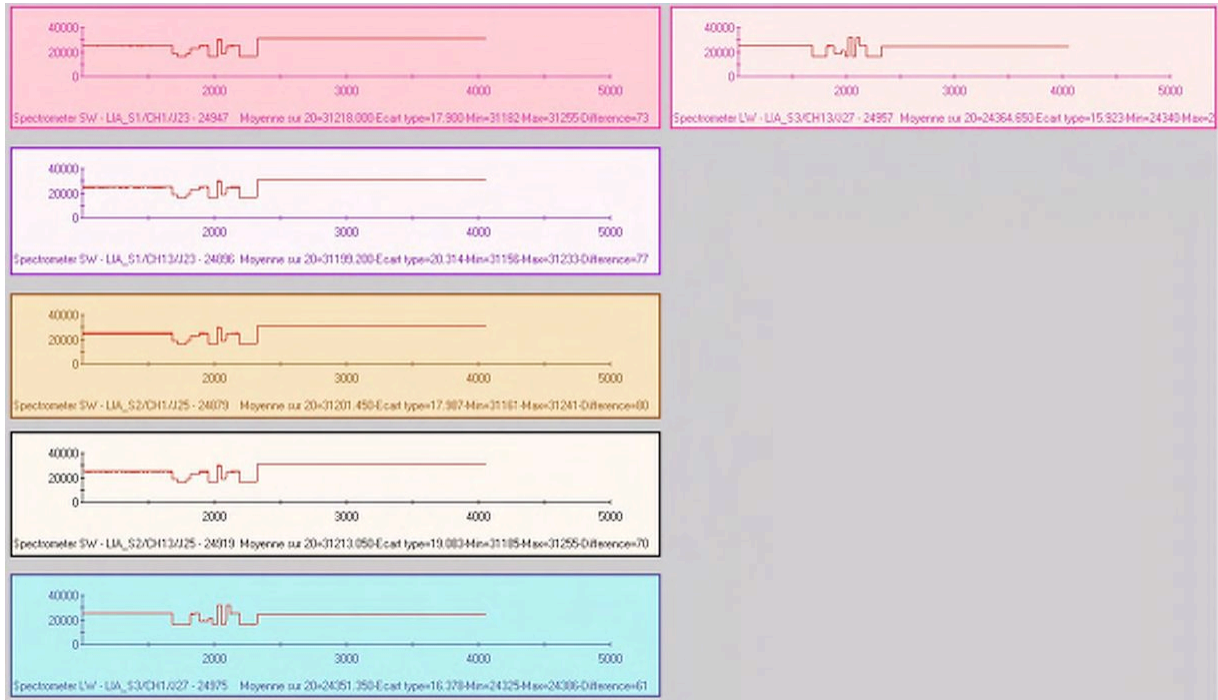
Bias level changes on every channel, discharges on BIAS-R front connector backshell

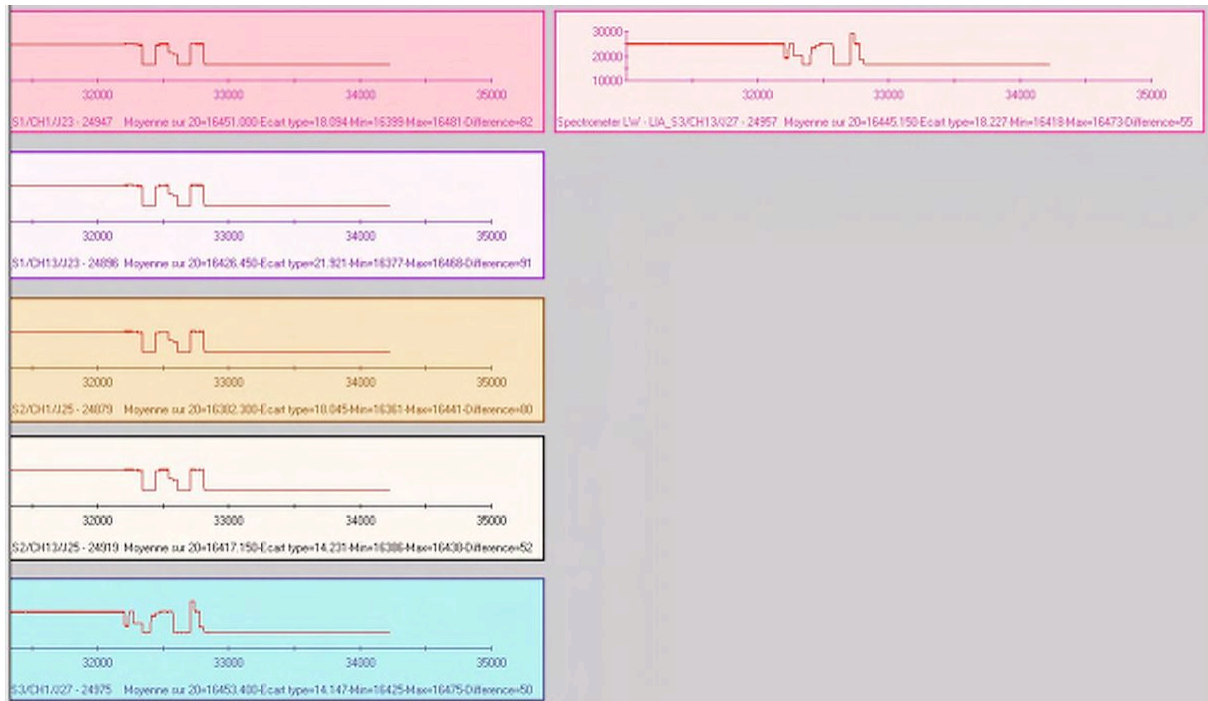
Bias level changes on every channel, discharges on BIAS-R rear connector backshell
