SSTD Incoming Inspection Report

Spacecraft/Project **HERSCHEL / SPIRE**

Document Number **SPIRE-RAL-REP- 002883**

Sub System **FPU Inc JFETs**

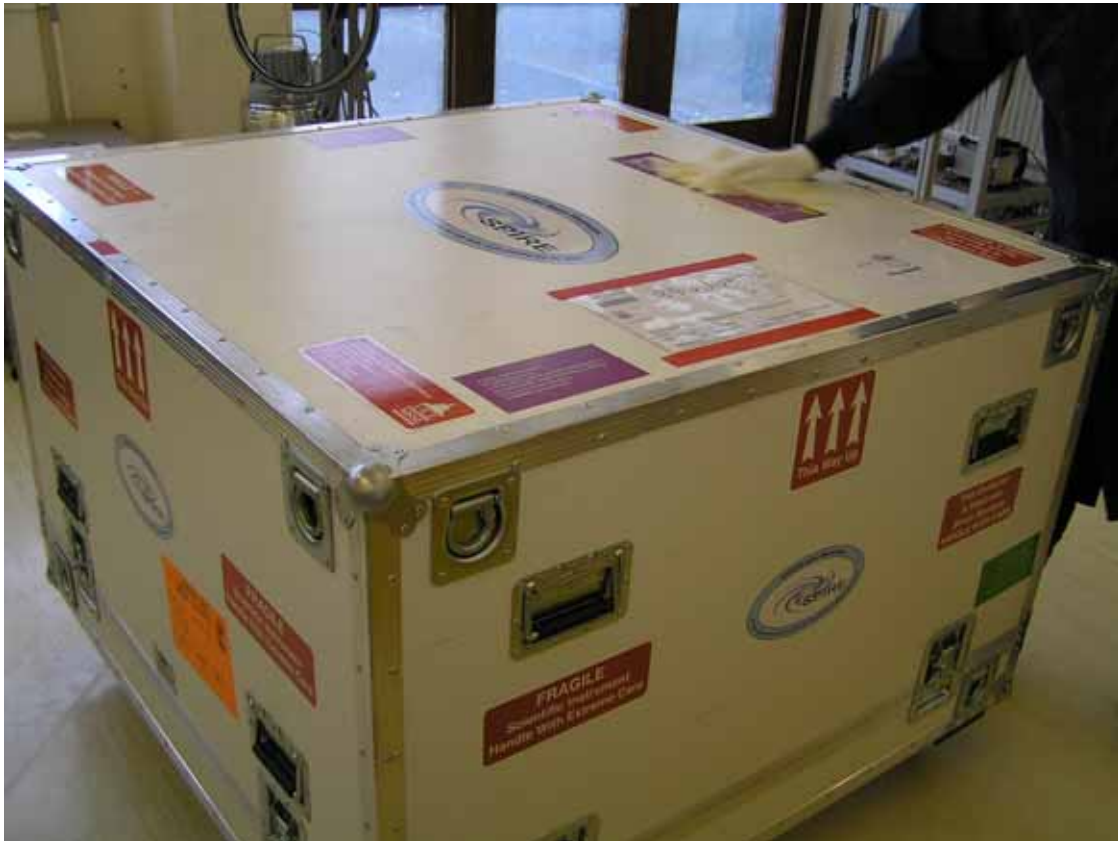
CQM in Transit case In Prep Area (EIDP in second container not shown)

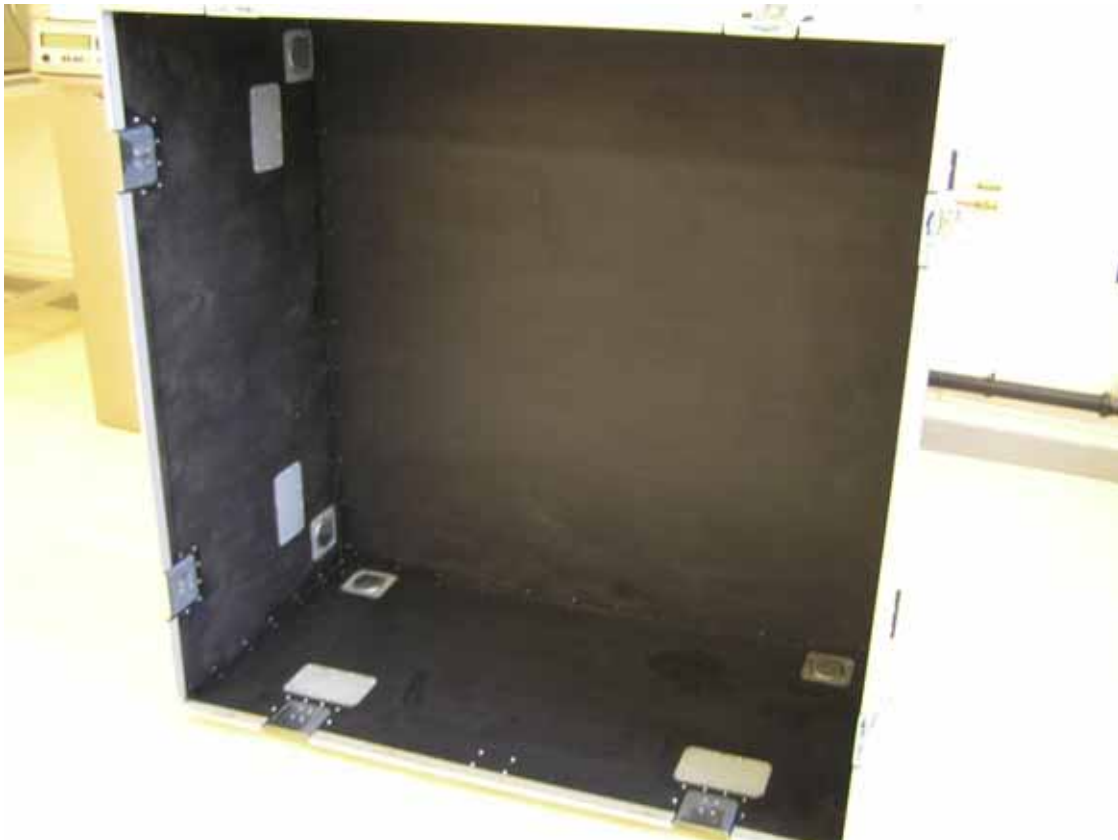
Transit case Top Internal view (In Prep Area)

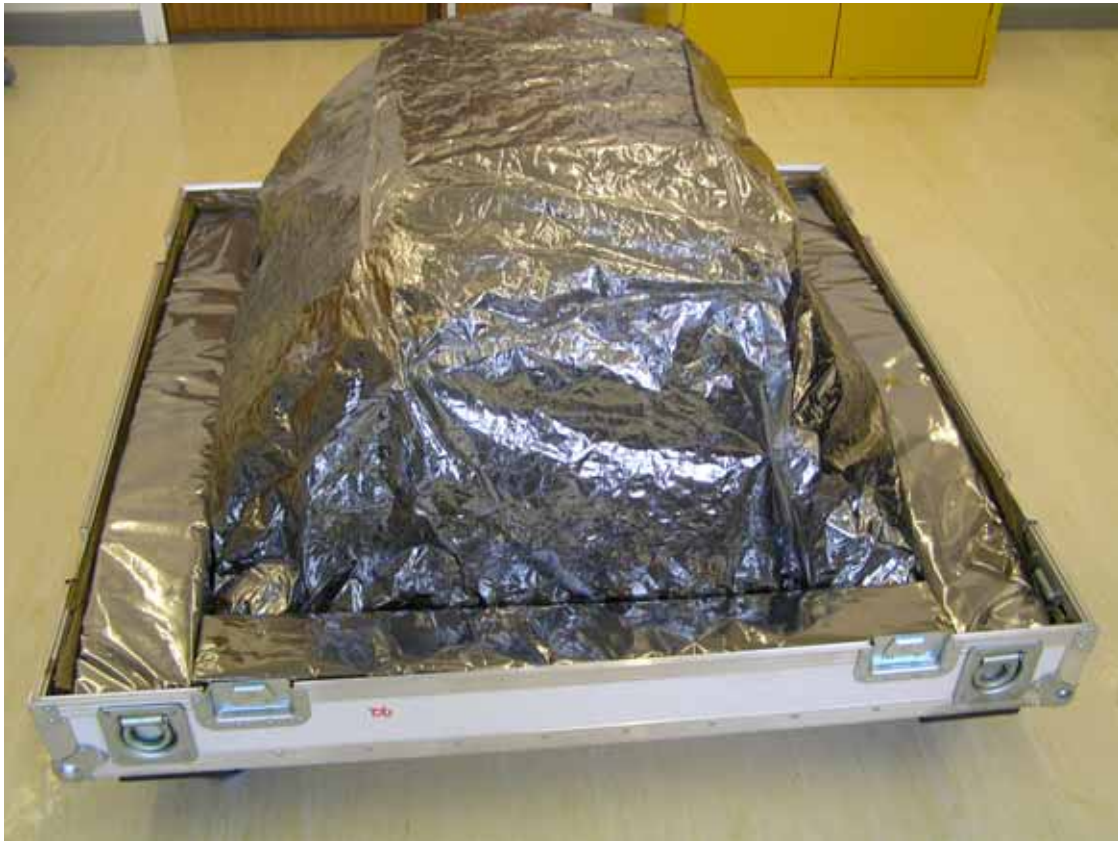
CQM on Transit container Base Triple Bagged (In Prep Area)

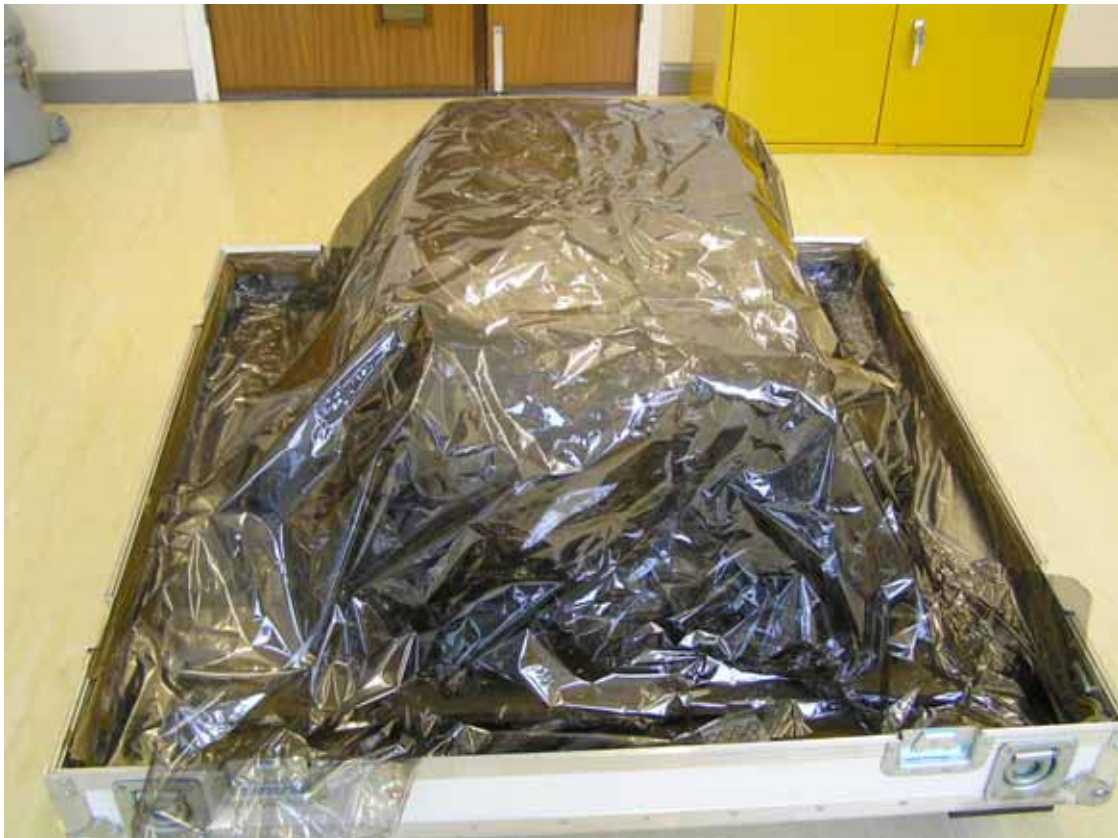
First Bag removed prior to taking into Clean Room

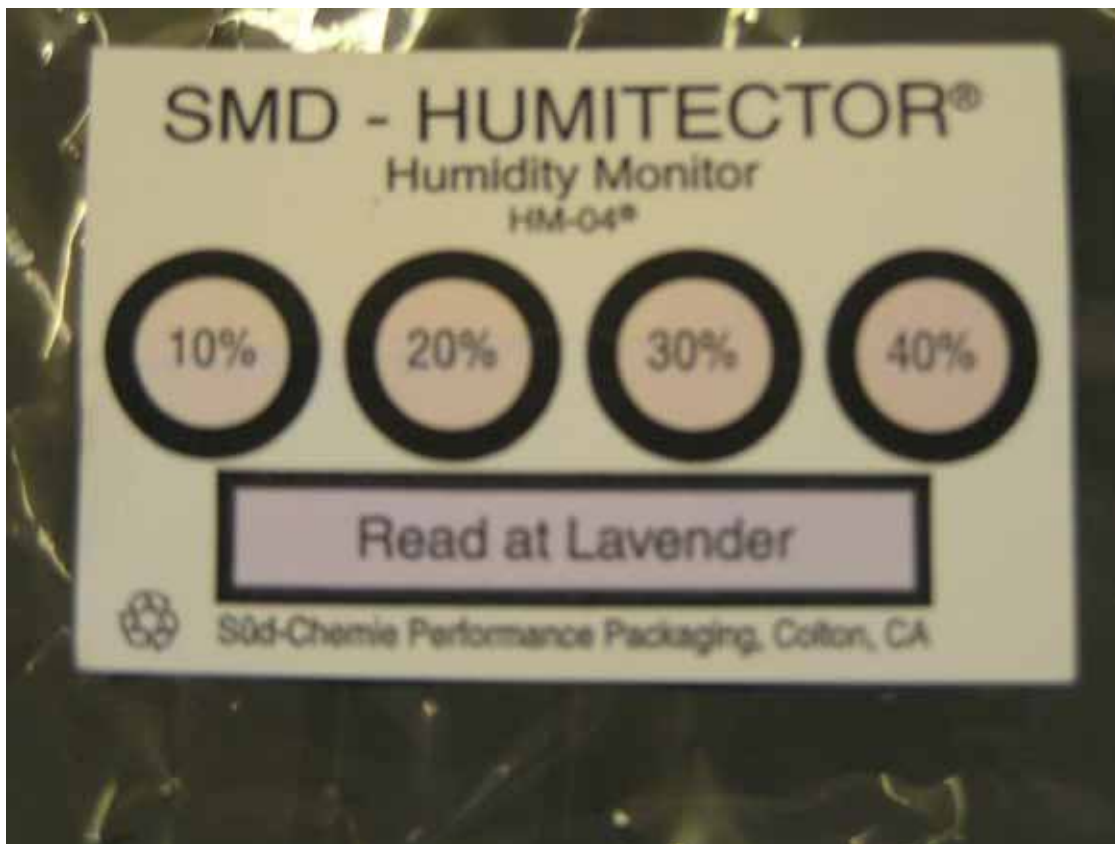
Humidity detector OK

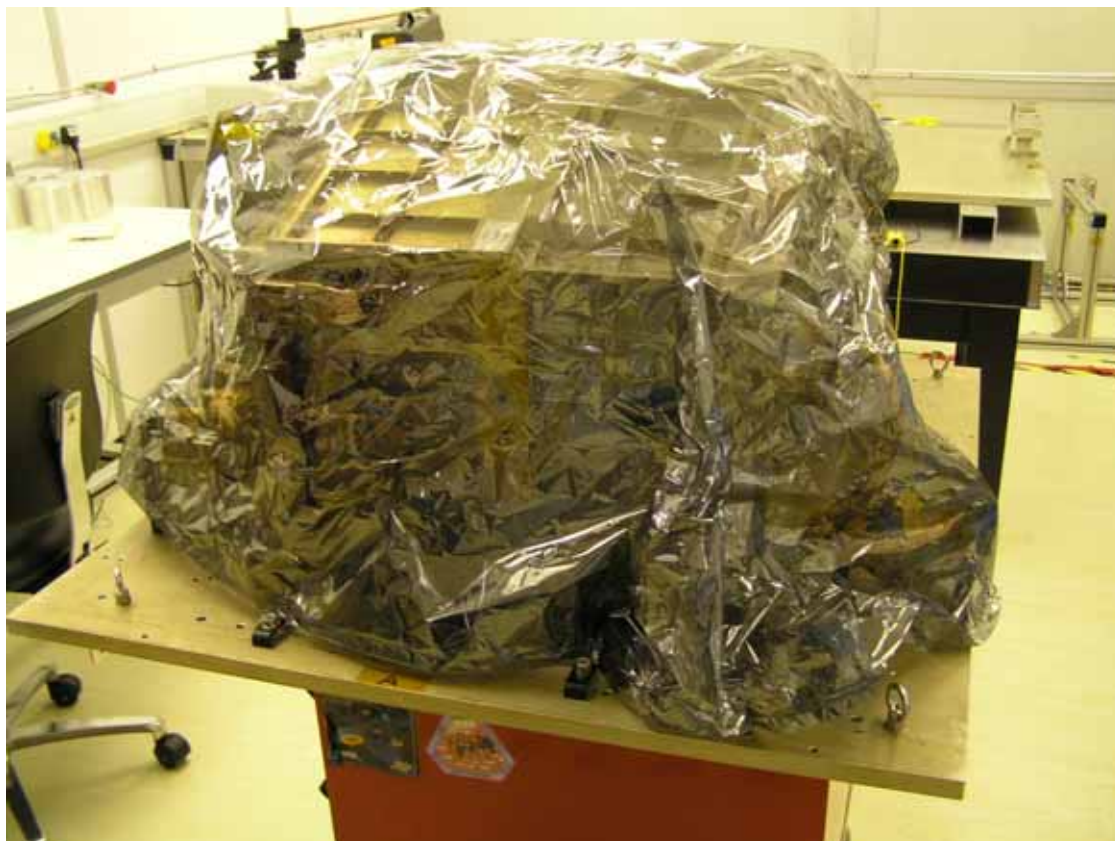
Second Bag removed prior to entering Class 100 Tunnel in Clean Room

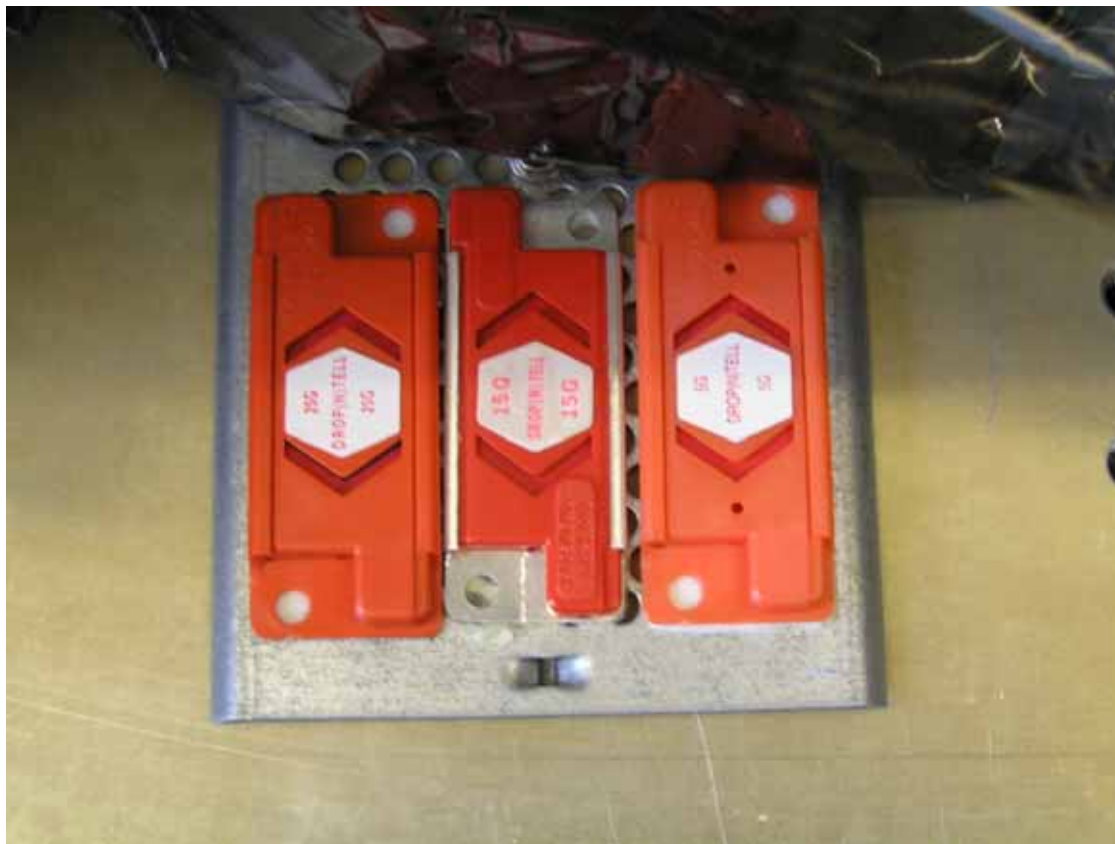
VIEW of SHOCK Monitors 25g, 15g, 5g X axis all OK

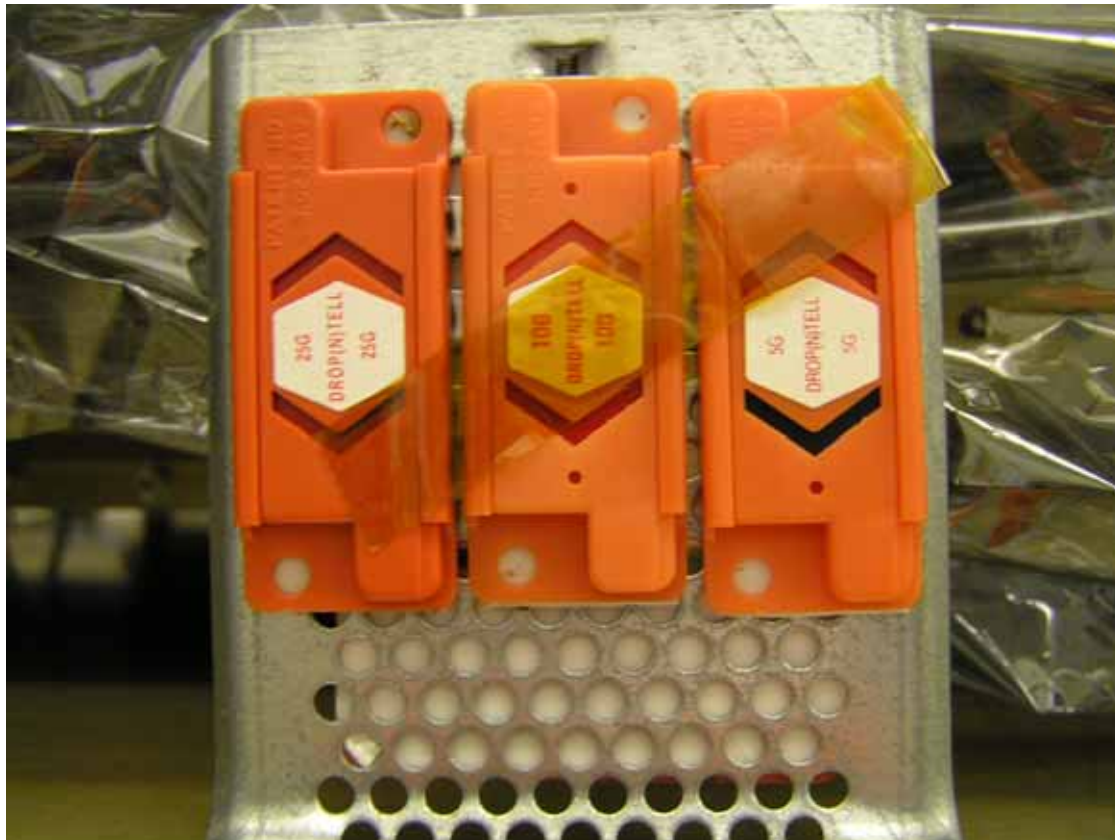
Instrument shipped with three layers of dust protective wrap.
Z axis 5G minus trip activated - all others not tripped.

VIEW of SHOCK Monitors 25g, 10g, 5g Z axis 5g Minus Tripped

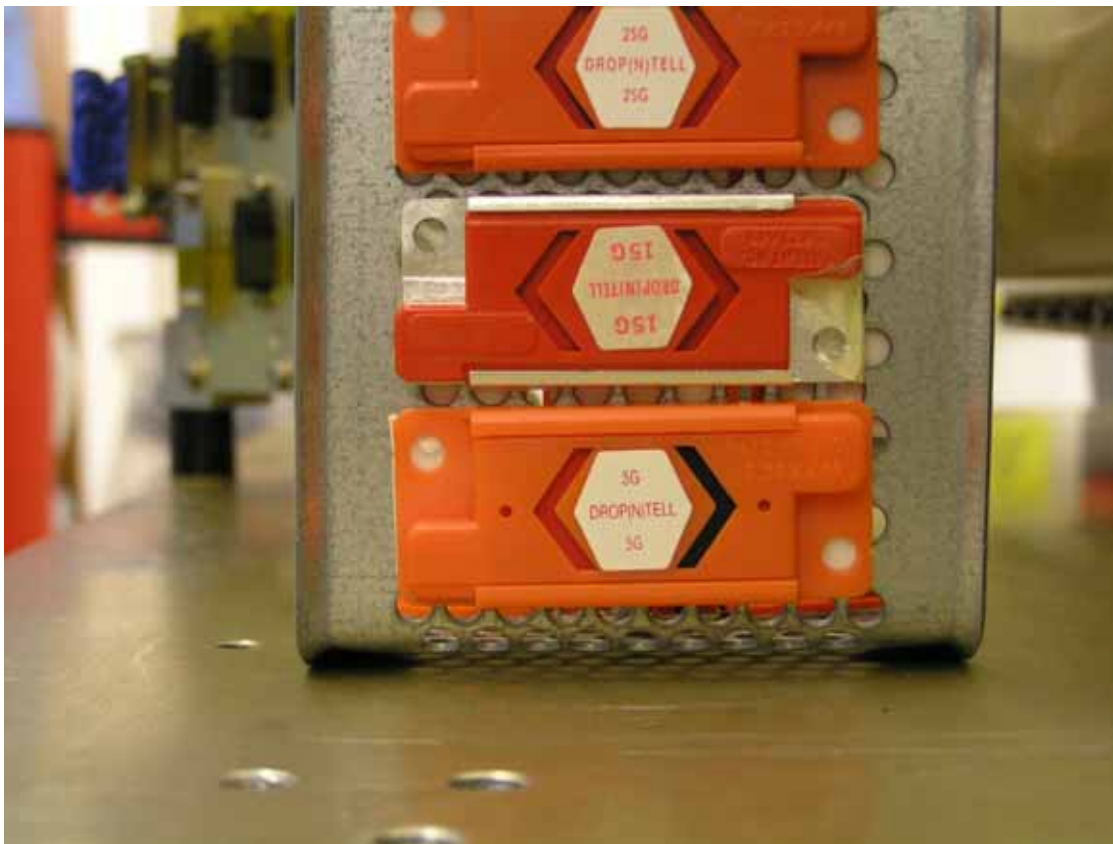
VIEW of SHOCK Monitors 25g, 15g, 5g Y axis 5g Minus Tripped.

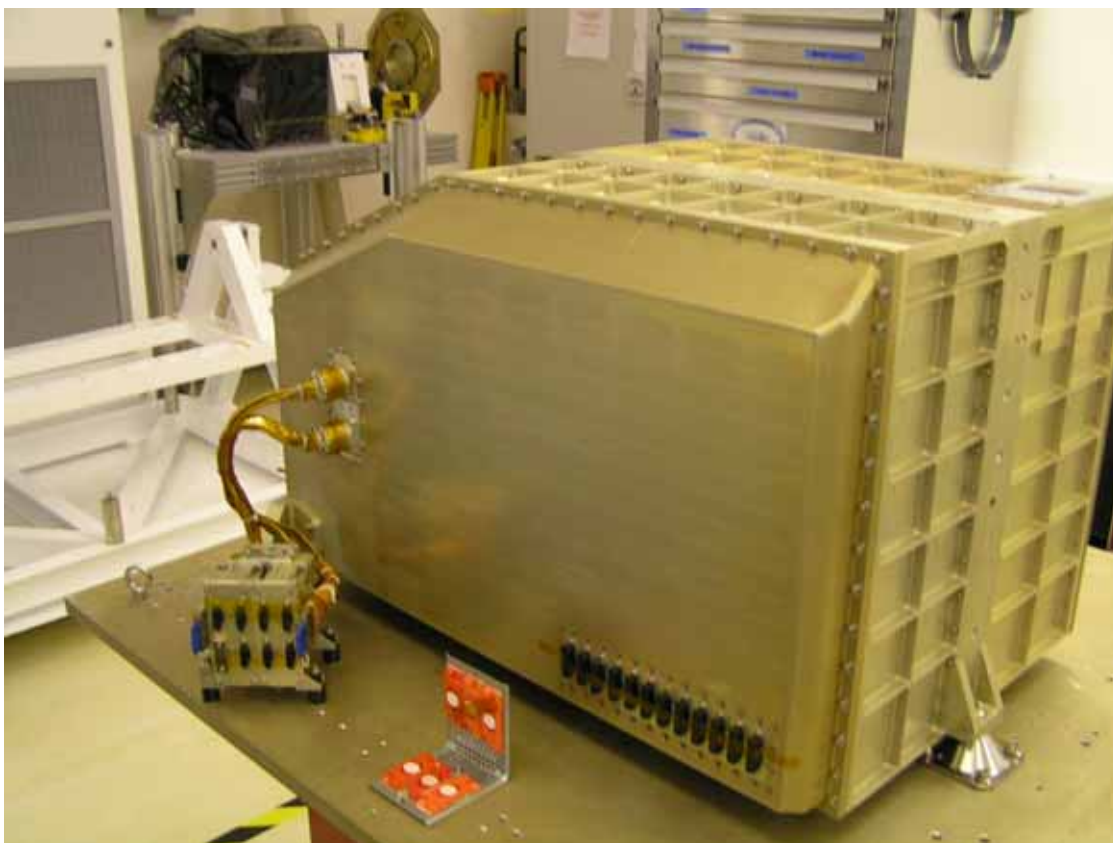
Side view showing position of Shock detectors, JFET's and ESD connector covers fitted

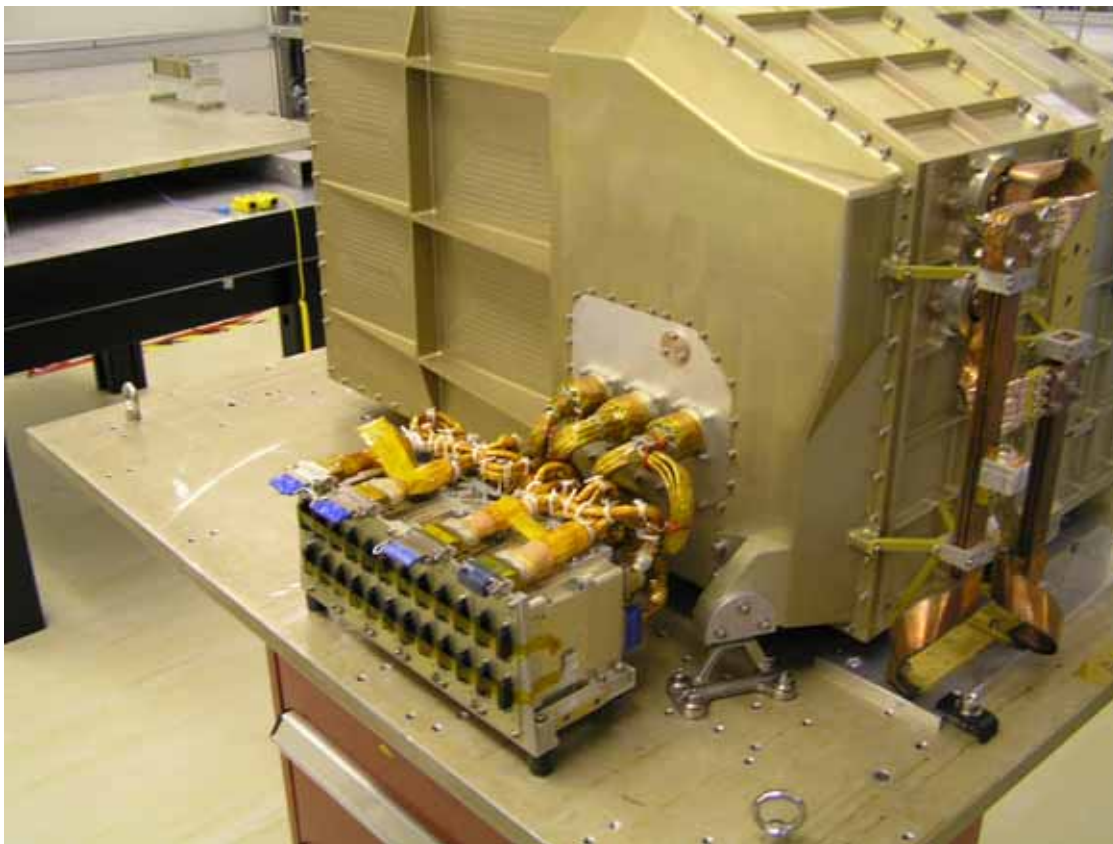
Side view showing Thermal straps & JFET's with ESD connector covers fitted

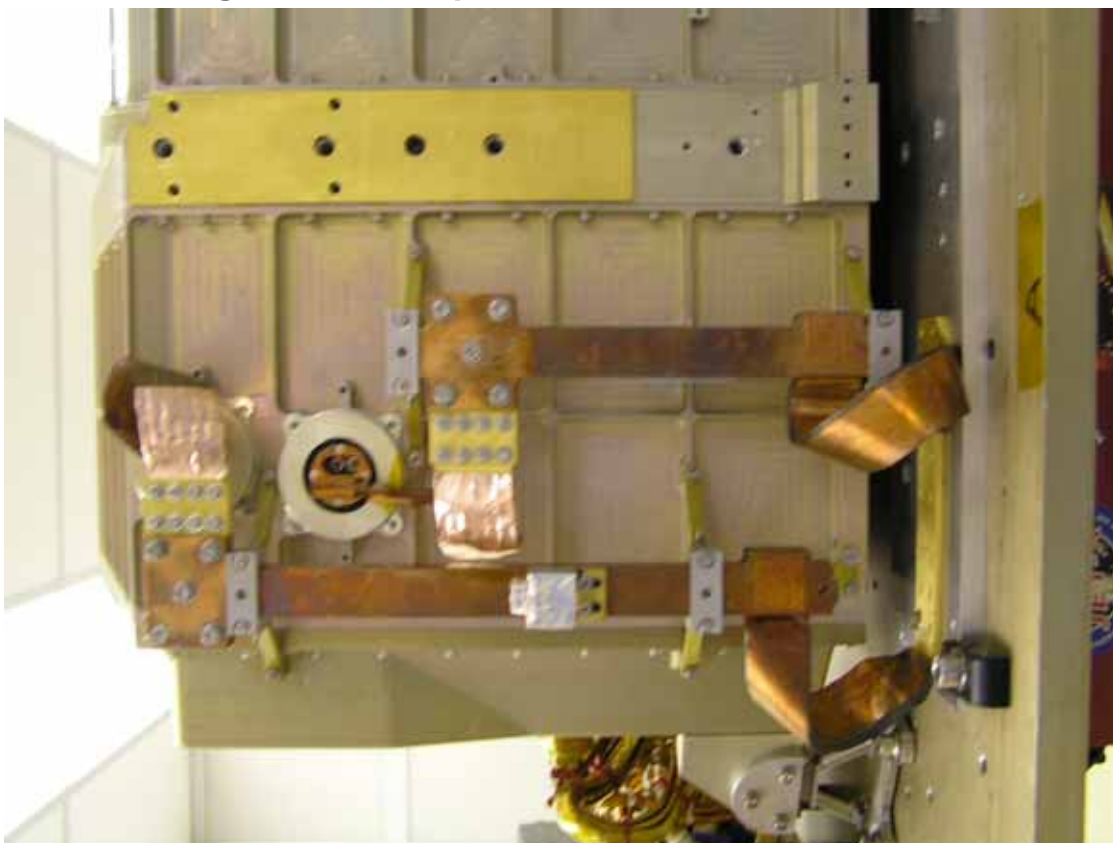
End view showing Thermal straps

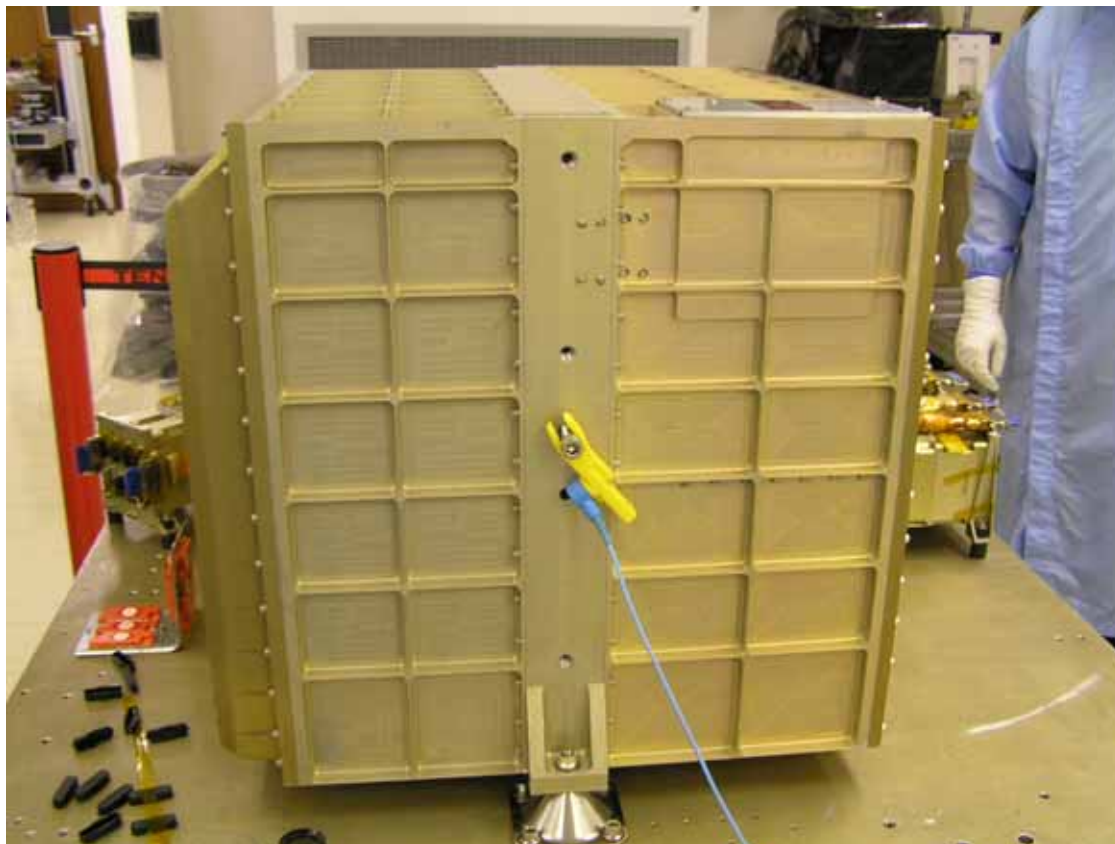
Opposite End Showing ESD strap fitted and Red Tag item Top Right

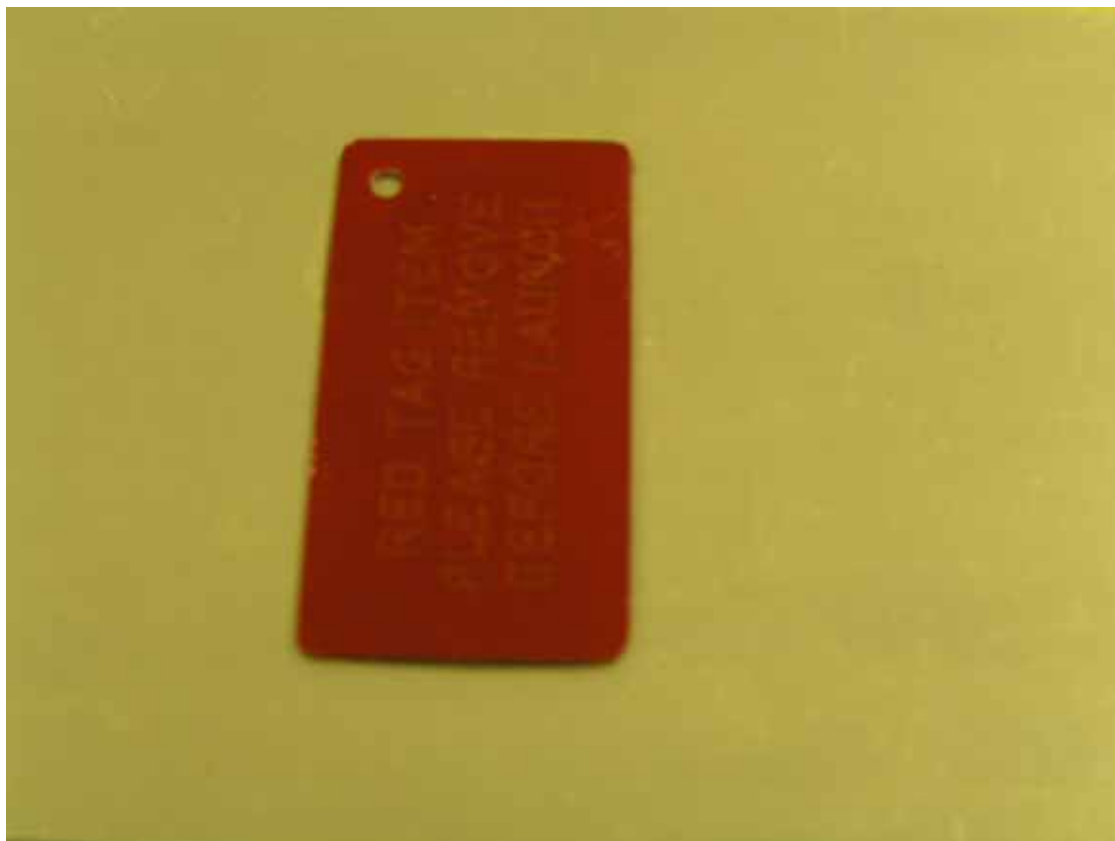
RED TAG Label on aperture cover

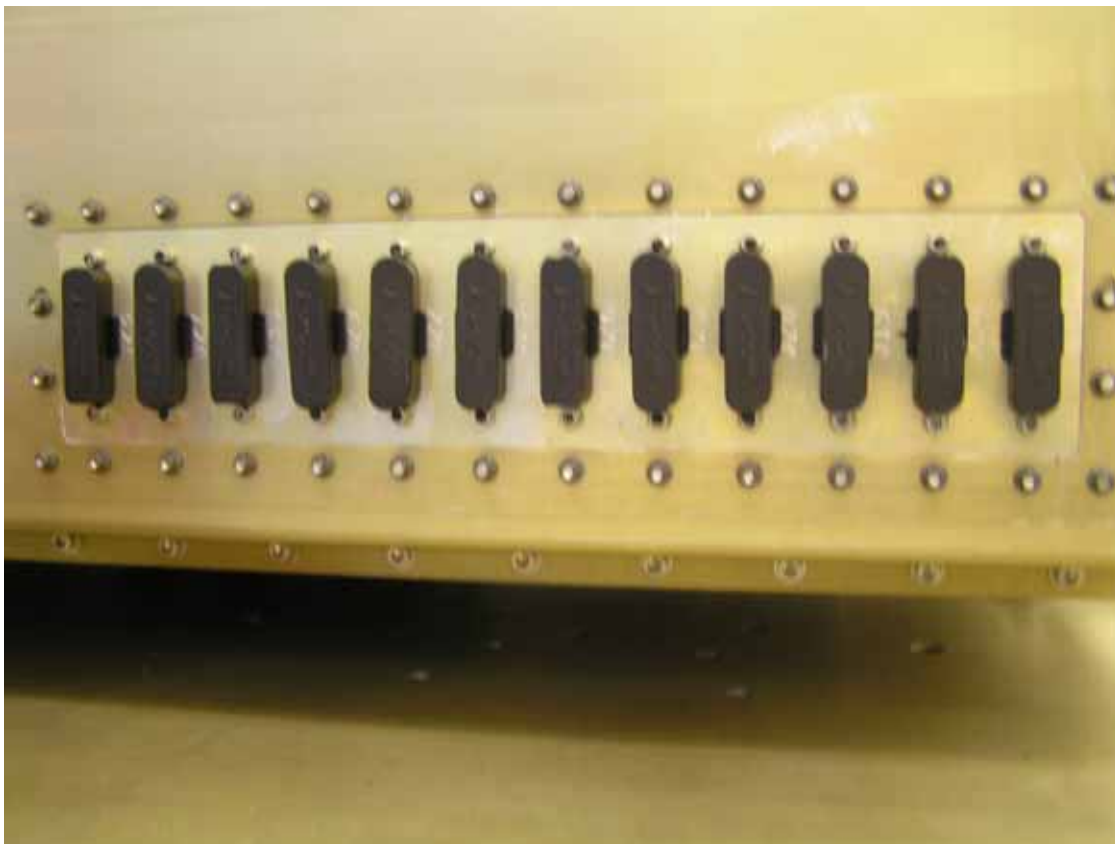
ESD Connector Covers in Place

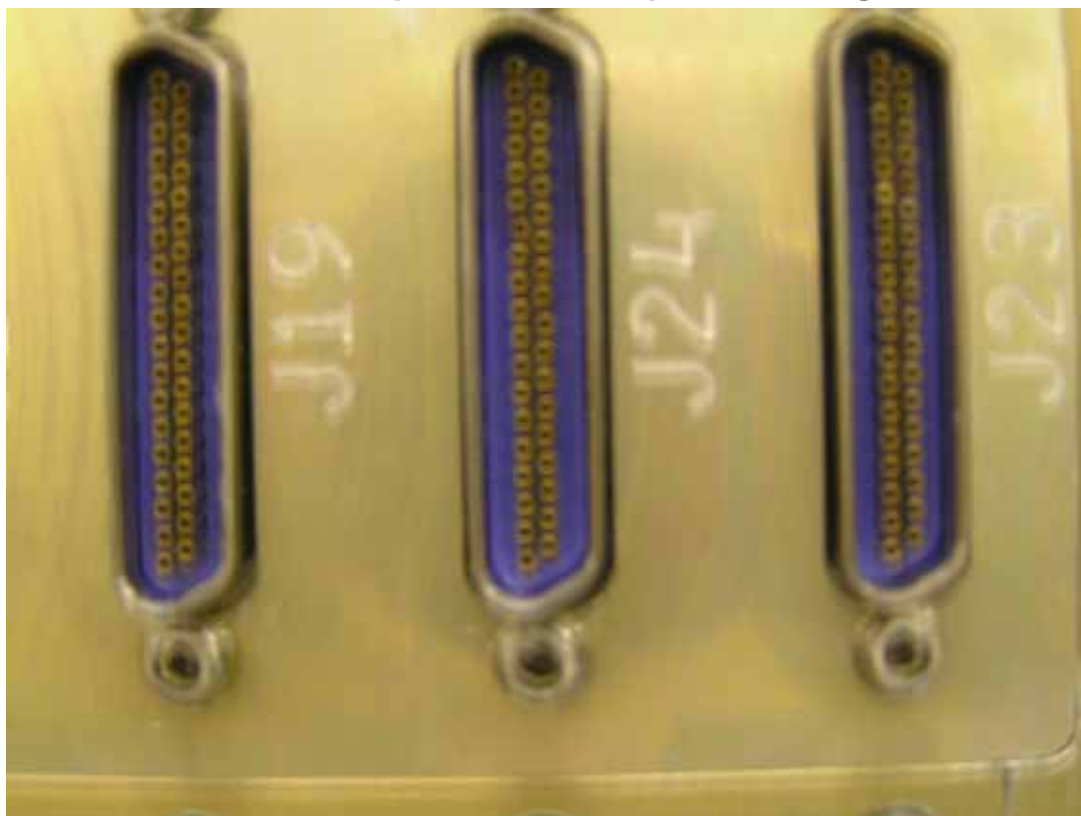
Pins out of alignment in connectors J24 and J30.

**J24- 7th pin down on left hand side has pin out of optimum alignment
J30 Not shown has a similar problem with a pin out of alignment**
