Spacecraft/Project HERSCHEL / SPIRE Document Number SPIRE-RAL-REP- 002957 Issue 1 Sub System 9th August 2007 FS **Dichroics** Date Model **INCOMING INSPECTION REPORT FROM** TO **UCF Project** Department of Physics and Astronomy, Rutherford Appleton Laboratory University of Wales, Cardiff, Space Science and Technology Department Chilton DIDCOT OXON OX11 0QX **Drawings / Documents Attached Applicable sections** Photos Attached Containers Yes **External Visual Inspection** Yes **External Connector** Yes **Documentation** Yes **Verification of Interfacess** No **Extra Comments Sheets** Yes **INSPECTION CONDUCTED BY WITNESS BY** DATE NAME DATE NAME 9th August 2007 9th August 2007 Eric Clark (PA) Eric Clark (PA)

SPIRE-RAL-REP-002957 Dichroics Photos

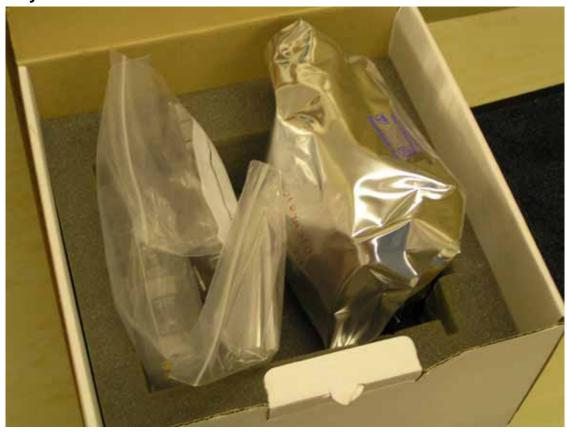
Delivery Box

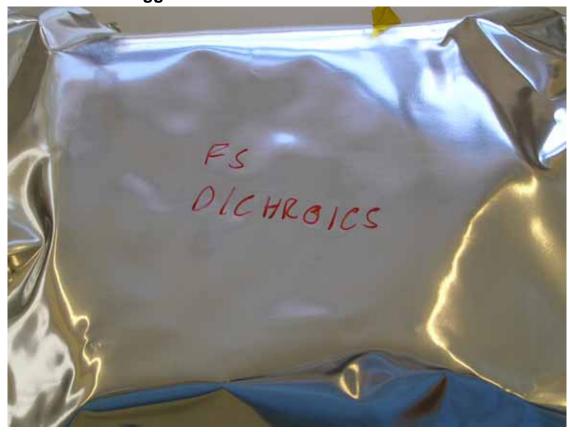
Dichroics Double Bagged

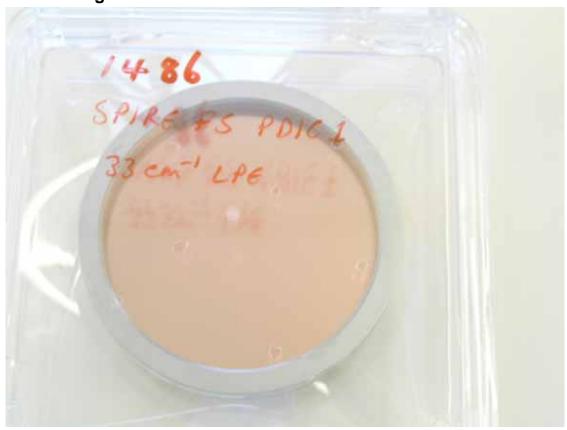
PDIC 1 in storage Container

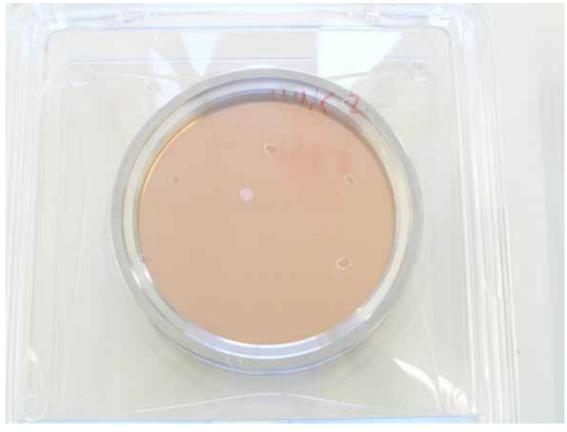
PDIC 2 in storage Container
