Minutes of SPIRE CQM BDA Kevlar Failure Non-Conformance Review Board

1 October 2007

CQM BDA Kevlar Failure Report

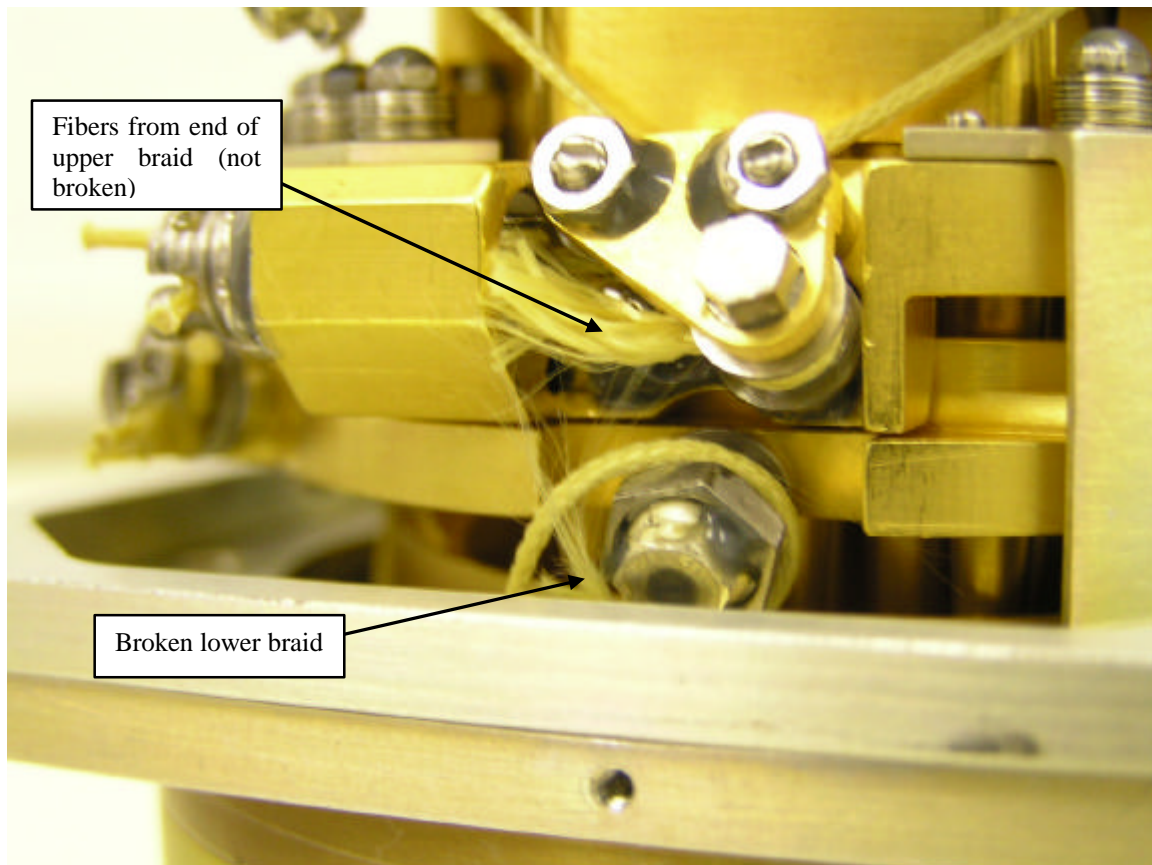
Figure 1: Picture of broken Kevlar on CQM PLW taken shortly after discovery (29/05/2007). The Upper frayed bundle of fibers is one of the terminations of the upper braid. The broken lower braid is seen still partially wrapped around the pulley.

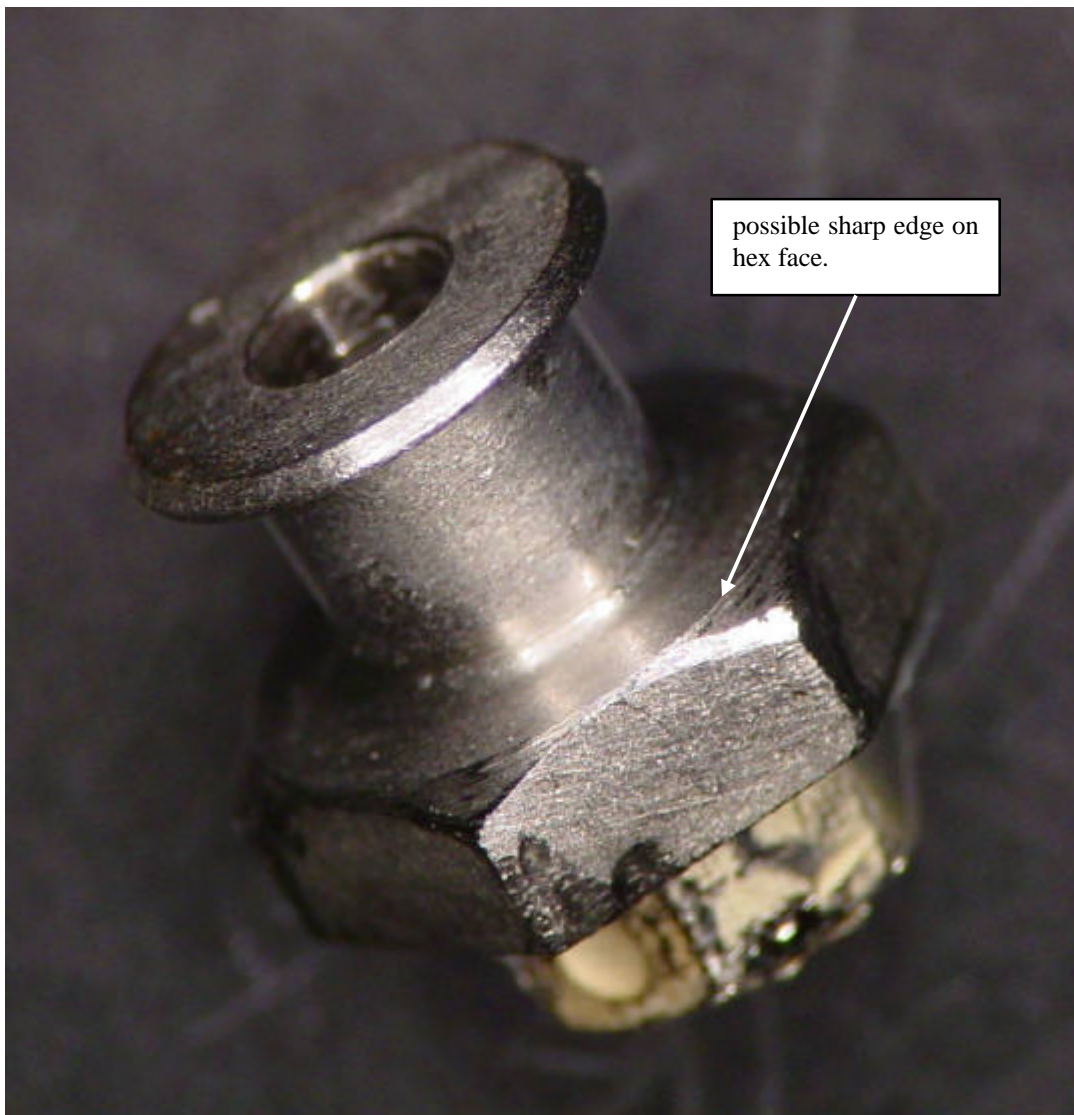
The changes to the pulleys were implemented in part due to the CQM fraying and also due to abrasion of the Kevlar against the pulley barrel discovered during attempts to string the Qual BDA. Photographs of a CQM-type pulley and a polished pulley typical of all the other BDAs are shown in Figure 2 and Figure 3, respectively. The CQM pulley design incorporated a chamfer on the hex face as an early attempt to prevent damage to the Kevlar by the points of the pulley hex. Unfortunately this chamfer left a sharp edge on the pulley face. It was likely this edge that caused the pre-existing fraying discovered on the CQM. In the final design, the entire pulley end face and barrel is rounded off and polished. This final design was used on BDAs from the Qual onward, including all the FM and FS units.

Figure 2: Unpolished pulley as used on CQM BDA. Note possible sharp edge on hexagonal face.

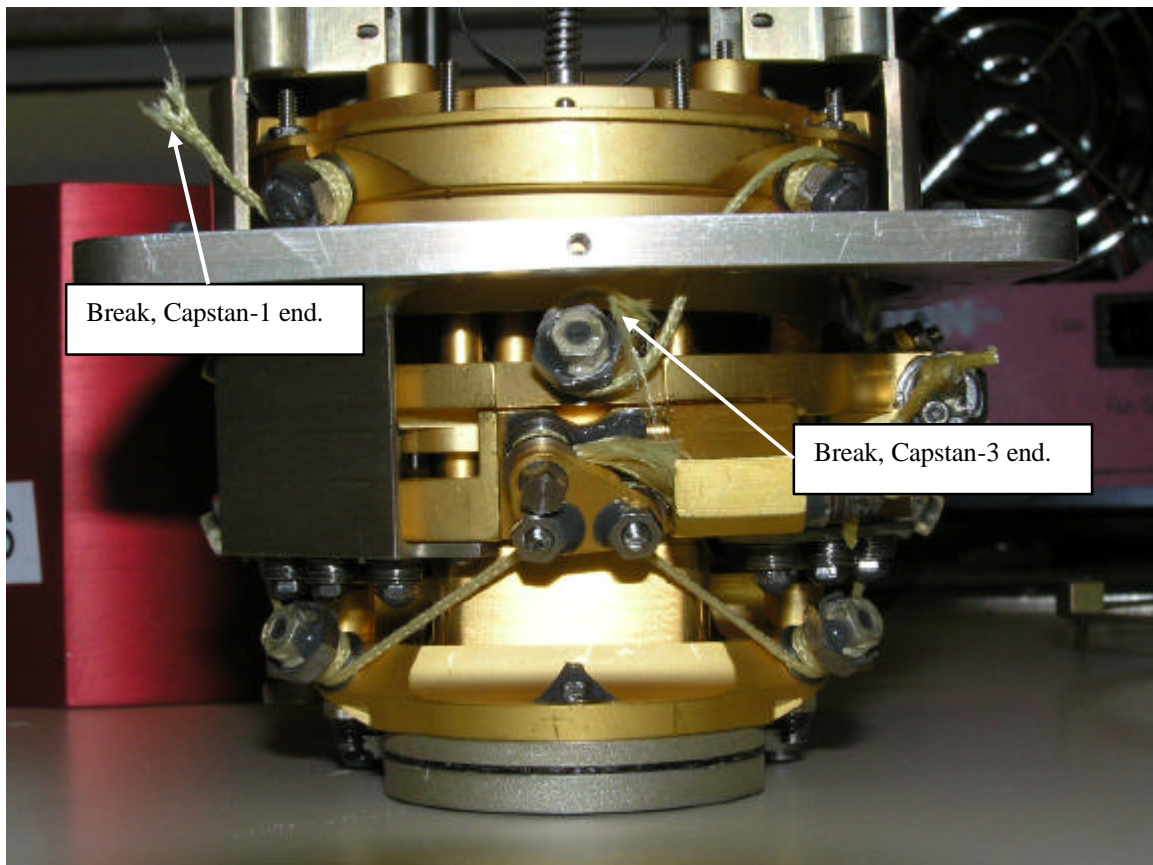
Figure 4: CQM PLW at RAL with light can removed, showing the both ends of the broken lower braid.

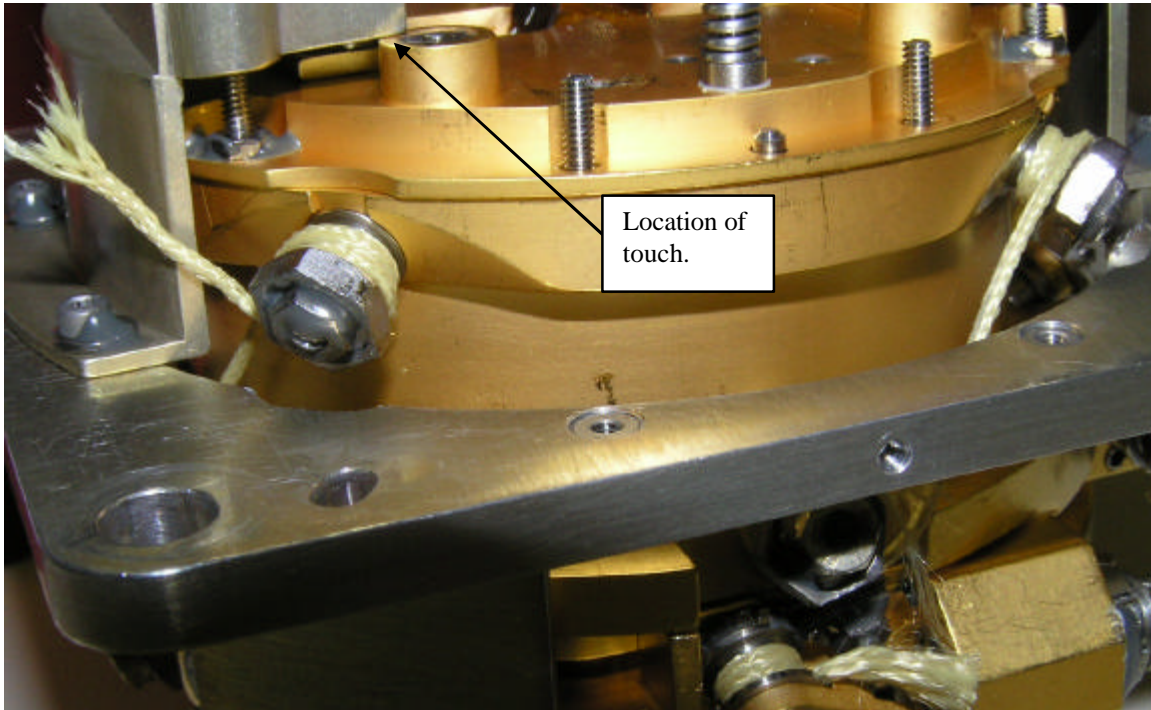
Figure 5: CQM PLW inspection at RAL, showing location of 300mK to connector bracket touch. Note slack in Kevlar on pulleys adjacent to the one near the break.

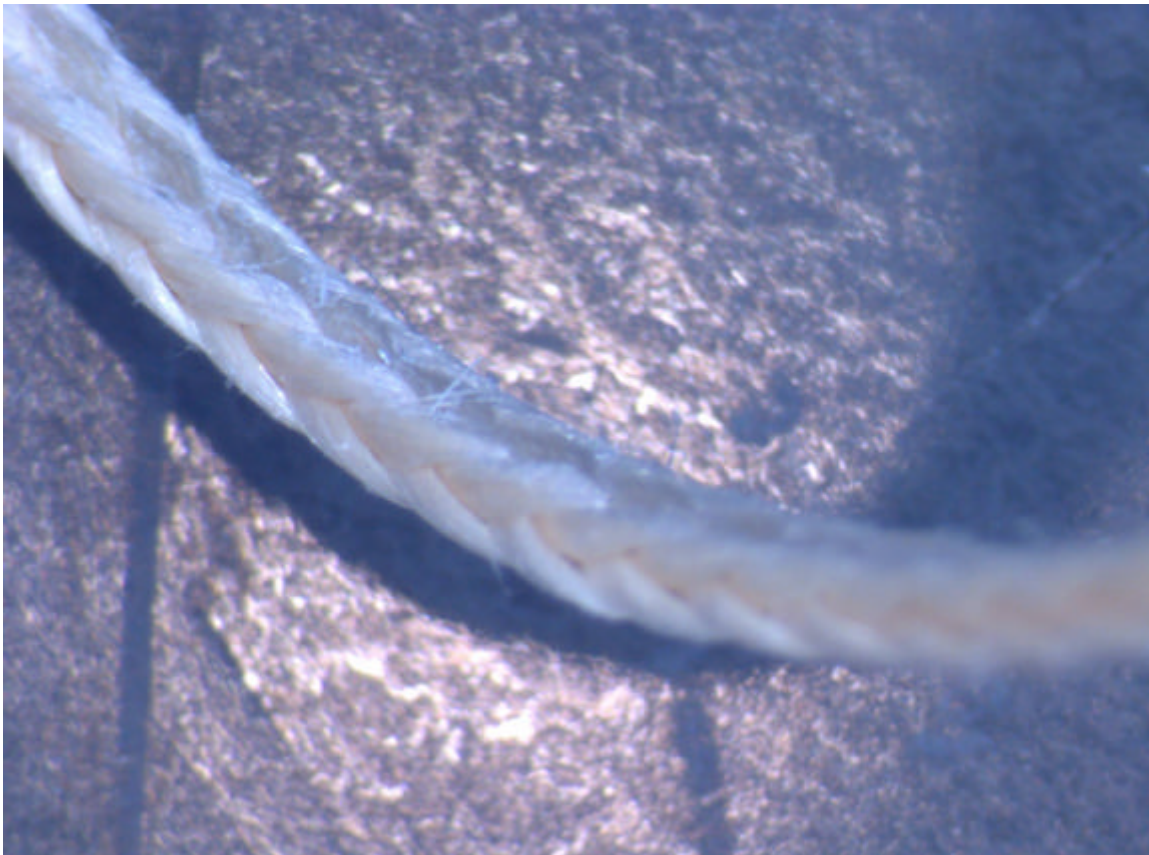
Figure 7: Microscopic view of abraded Kevlar from pulley #2 area.

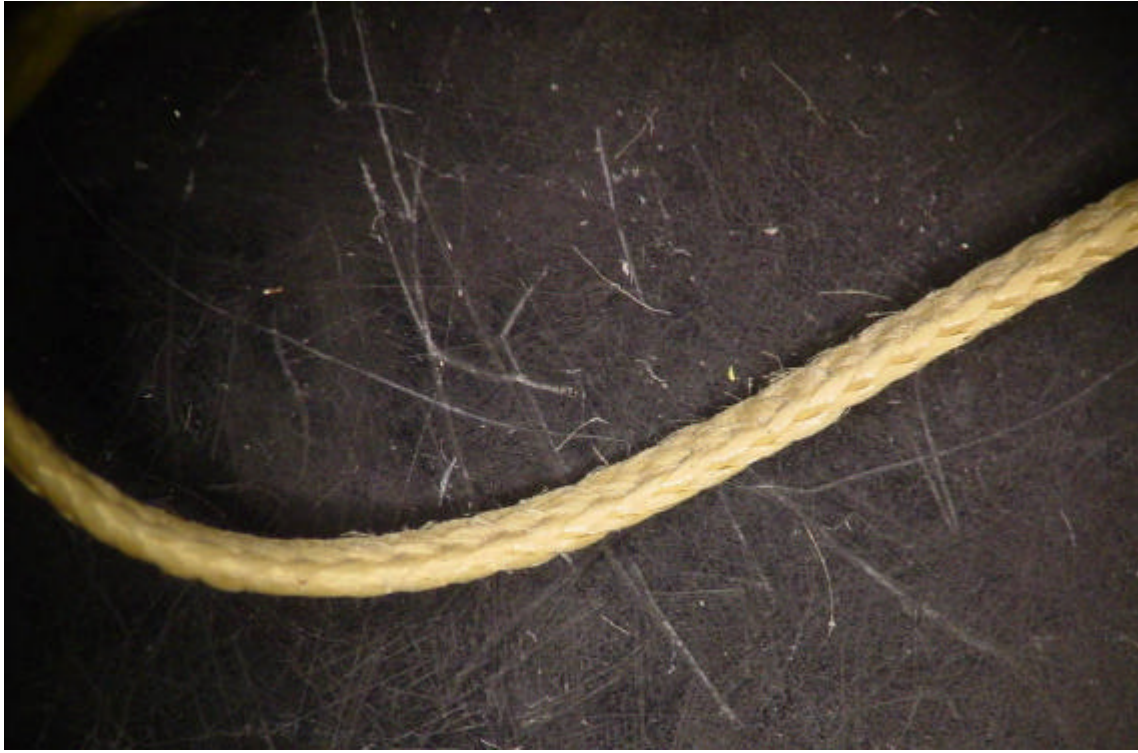
Figure 9: CQM lower braid Kevlar from pulley #2 area, showing abrasion where the Kevlar was against the pulley barrel.

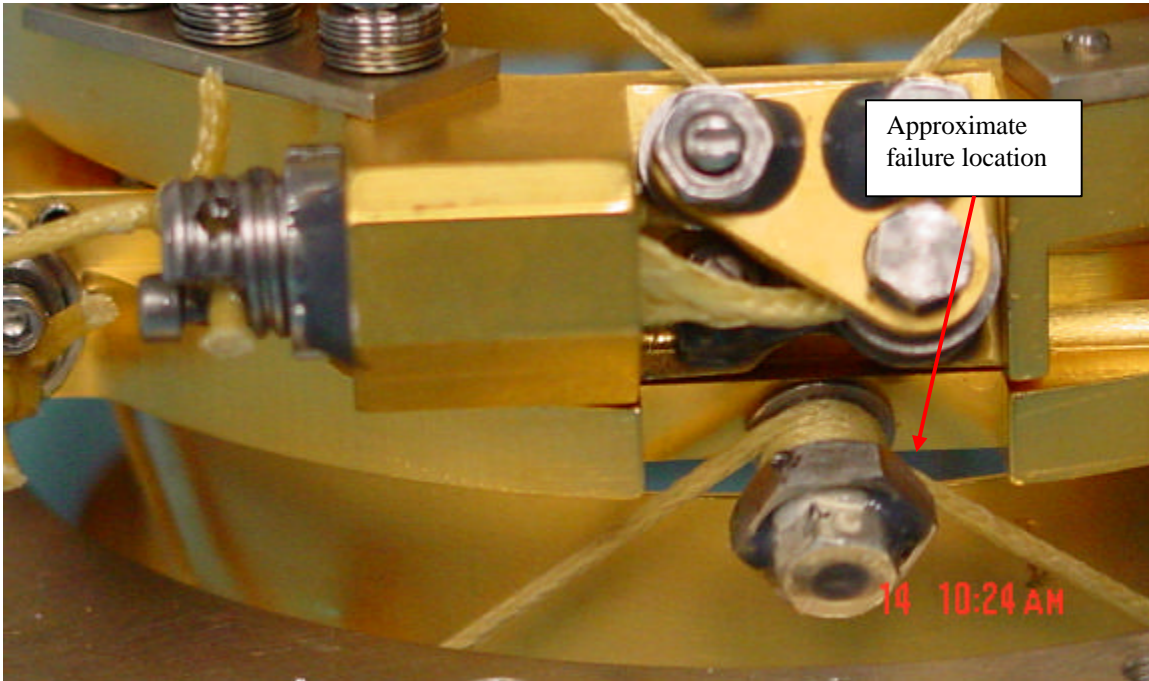
Figure 10 View of the ultimate failure location on the CQM BDA from the period of suspension stringing, May 2003

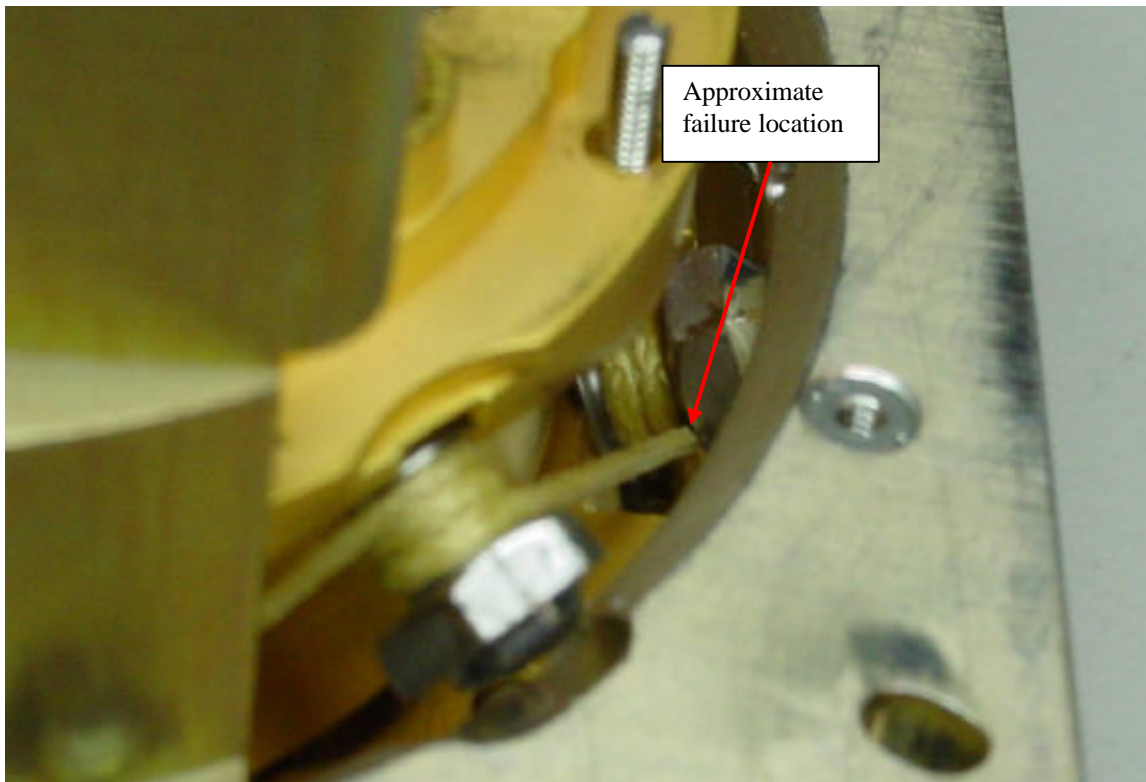
Figure 11 View down the Kevlar braid to the failure location taken during post-vibe inspection at JPL.

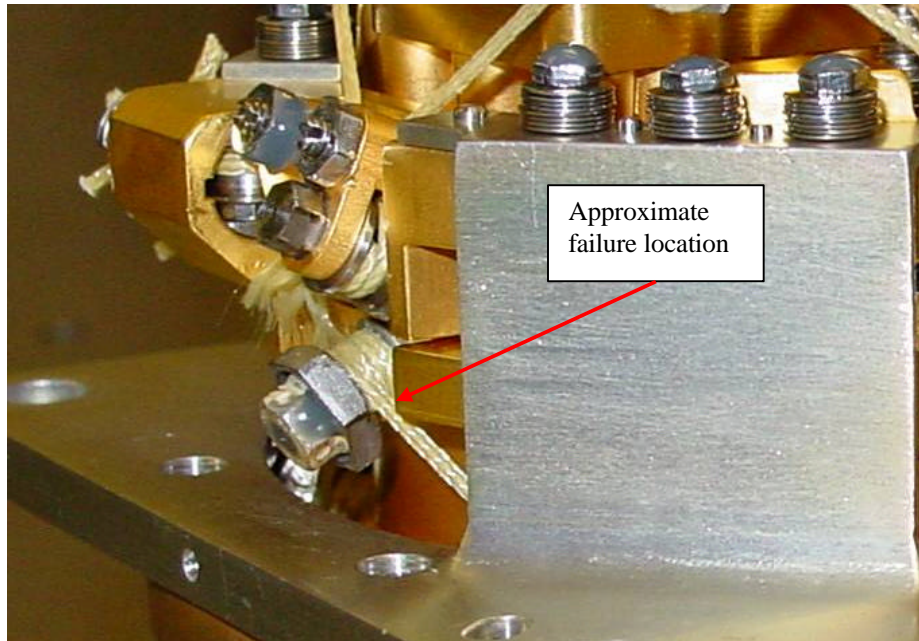
Figure 12 View of failure location taken at RAL before installation into the CQM instrument, Sept. 2003.

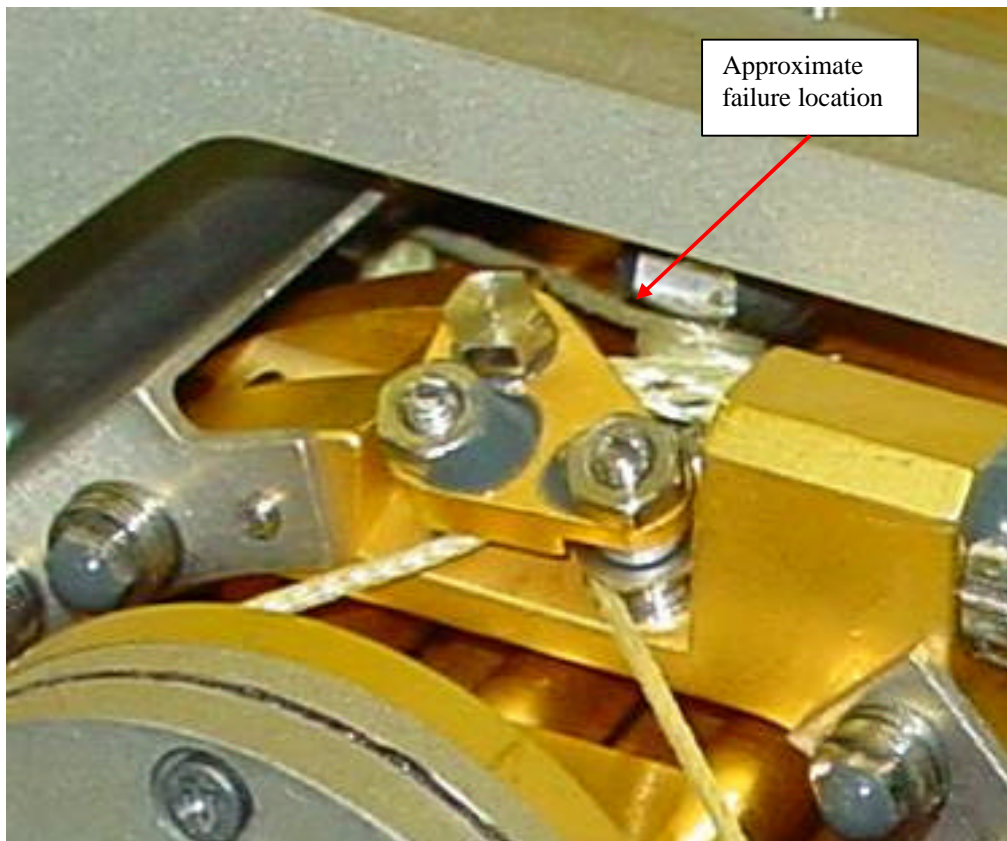
Figure 13 View of failure location after installation into CQM instrument, Sept. 2003.

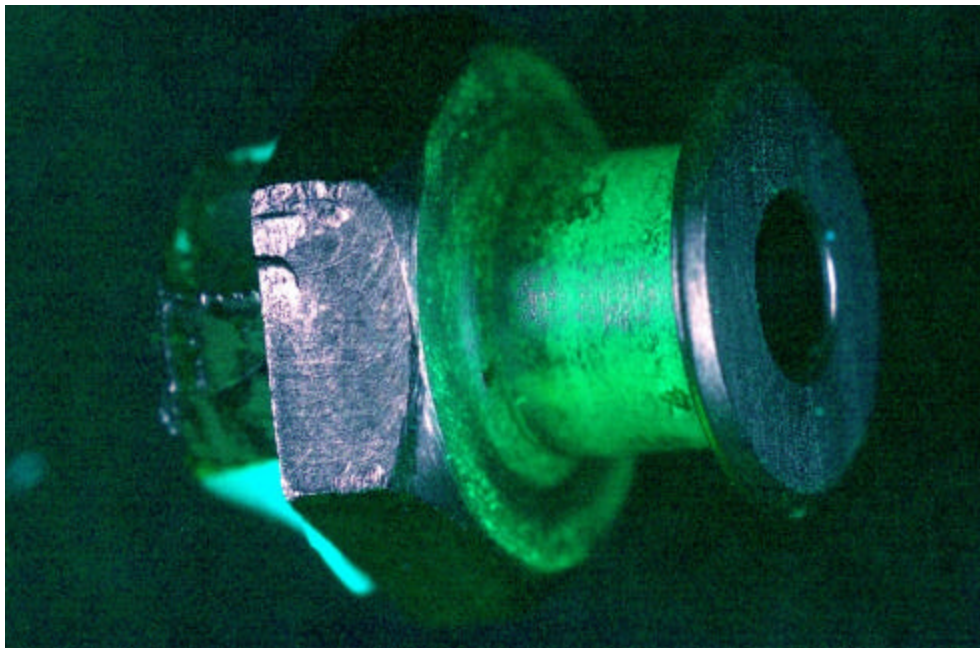
Figure 14: CQM BDA pulley #2 (pulley near failure) under UV light. Green fluorescence is Kevlar residue. Blue fluorescence on the left is from pulley staking epoxy. Note the Kevlar debris on the hex face up to the sharp edge.

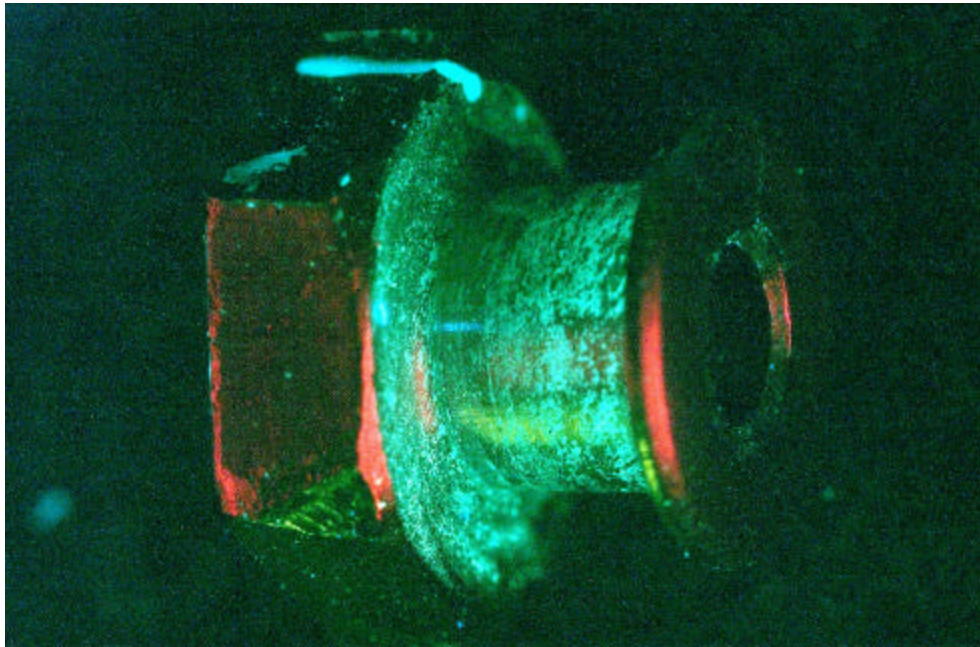
Figure 15: CQM BDA pulley #1 under UV lighting. Red areas are stray reflections from light source. Other fluorescent colors are as in the previous figure.

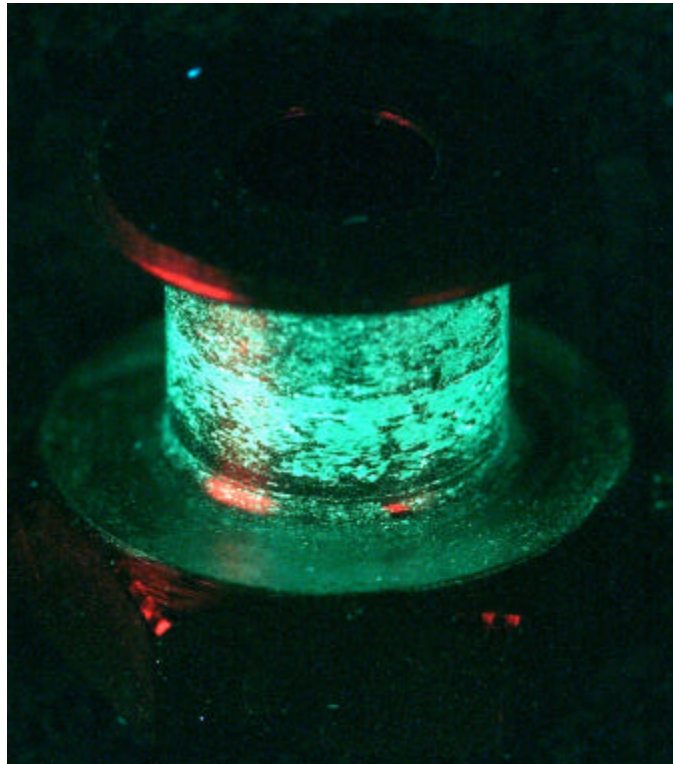
Figure 18: Unpolished pulley after initial (no failure) abrasion shake test. Viewed under UV light, showing green fluorescence from Kevlar debris.

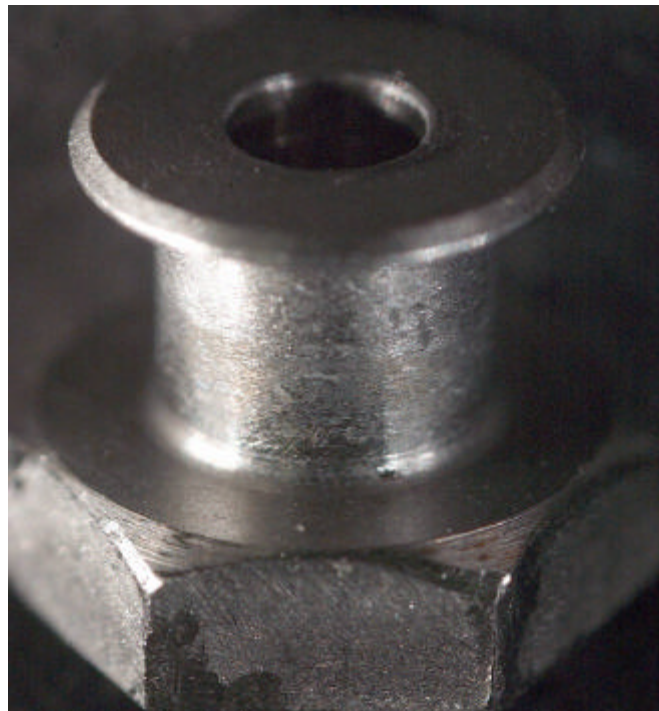
Figure 19: Unpolished pulley from Figure 18 under ordinary illumination. Kevlar debris is barely visible.

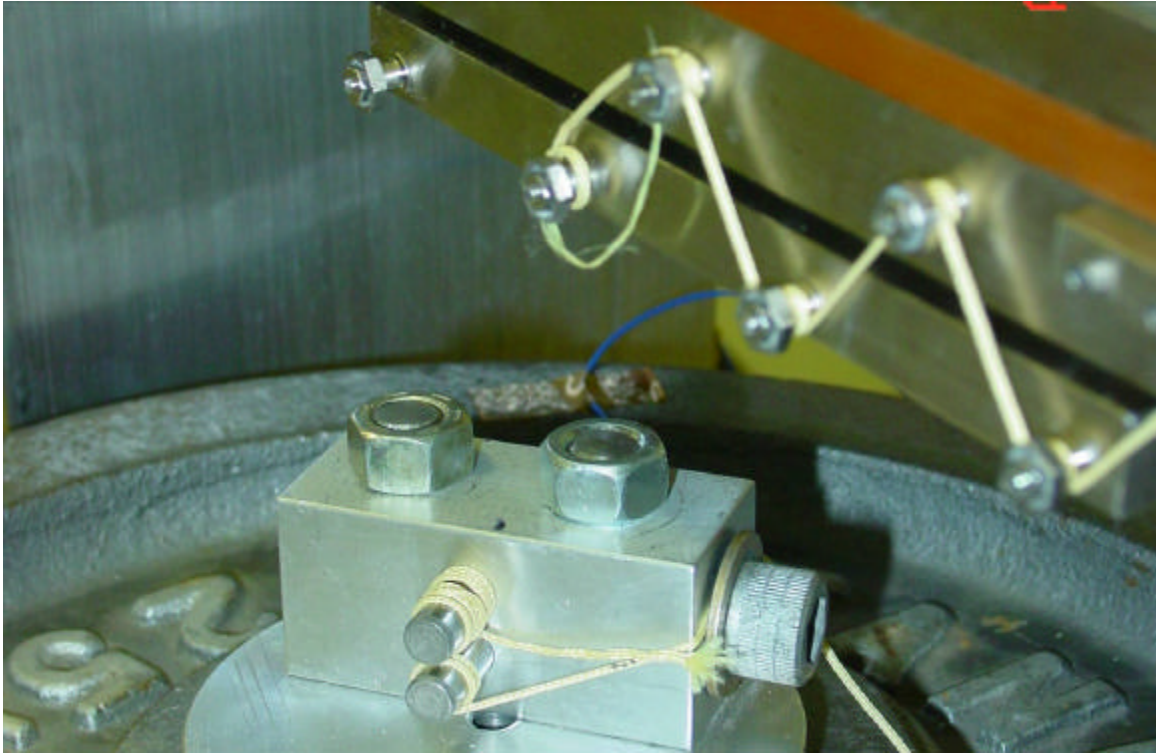
- Failure at the pulley after 7.7 minutes at max level
 - Qualitatively looks like the broken Kevlar on the CQM
- Slide 16: Shake to failure of unpolished pulley

Figure 22: failure from shake with unpolished pulley.

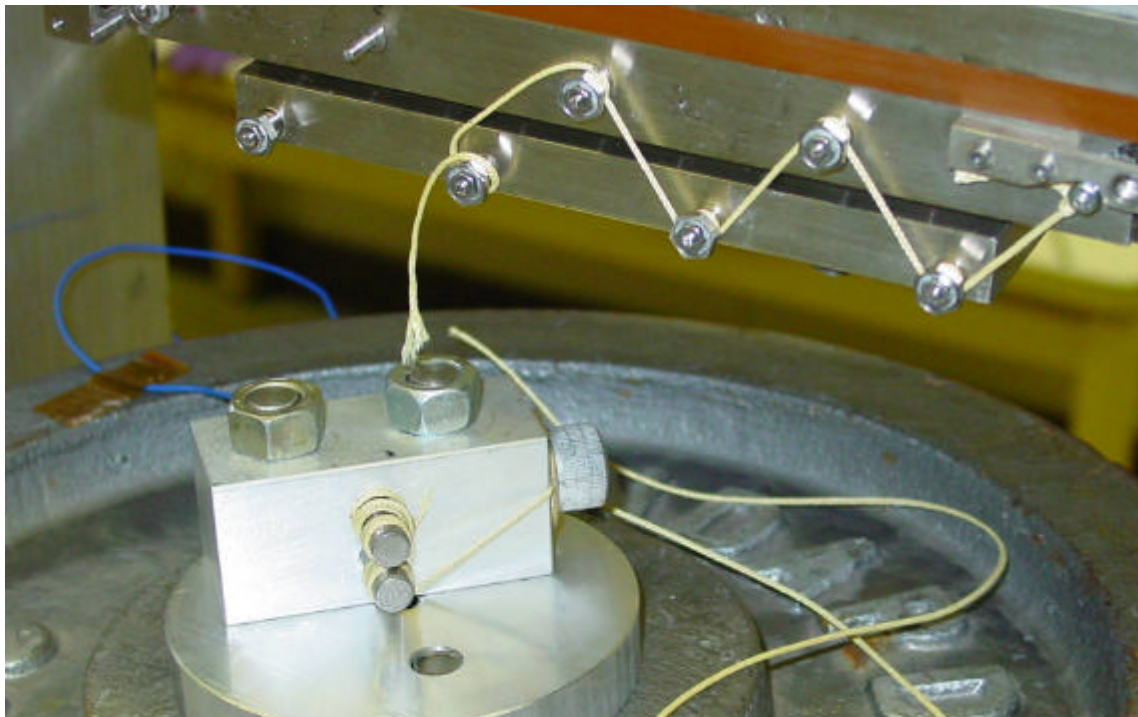
- Failure at highest level after 36 minutes
 - Broke not at pulley but at bottom tie-off – looks like a more localised break than the distributed fraying seen on the CQM and on the 300-mK strap support system

Figure 23: failure from shake with polished pulley.

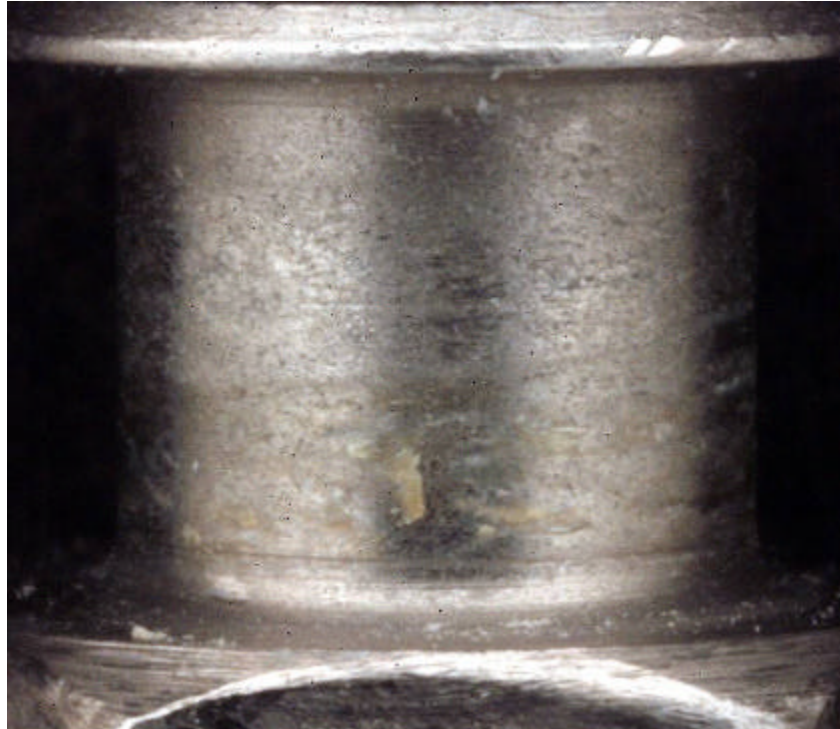
Figure 24: Unpolished pulley under visible illumination after shake-to-failure test.

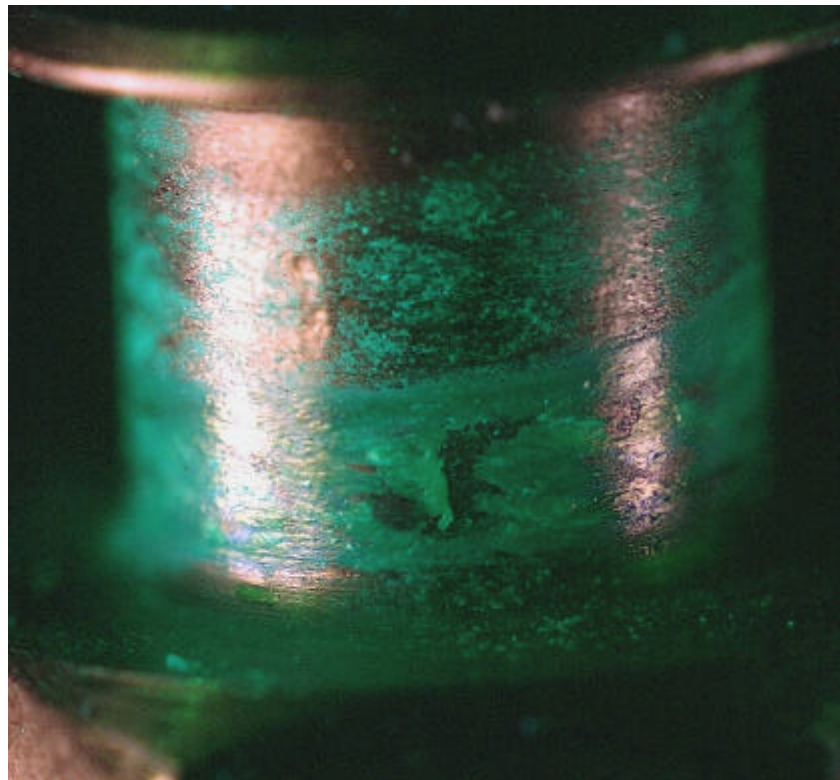
Figure 25: Unpolished pulley from previous figure under UV illumination.

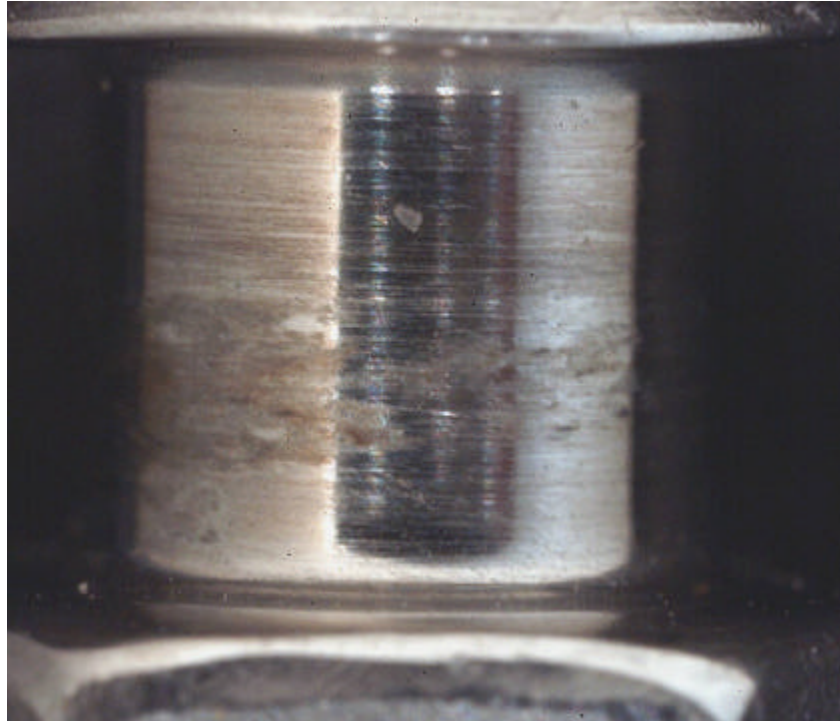
Figure 26: Polished pulley under visible illumination after shake-to-failure test.

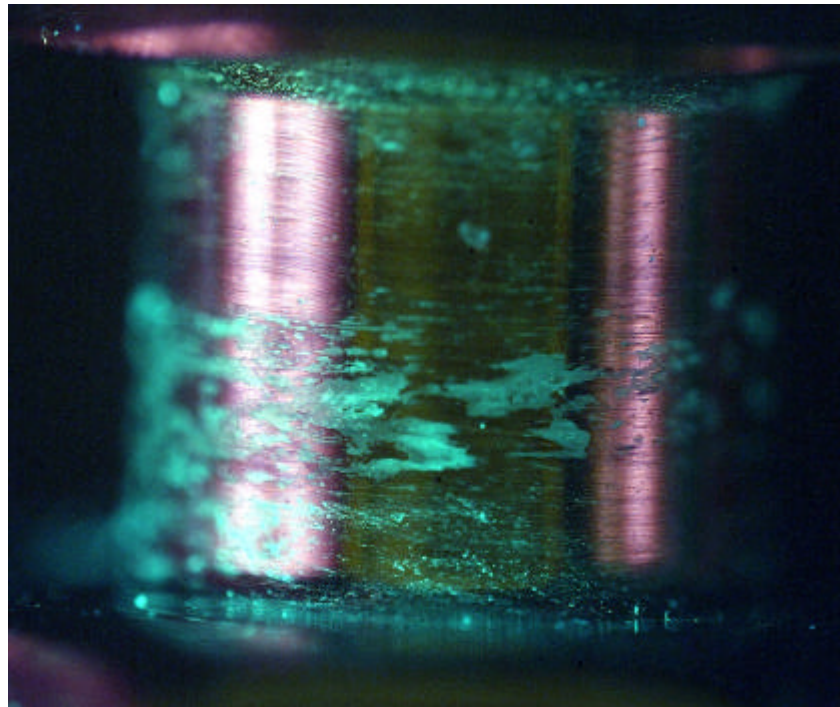
Figure 27: Polished pulley from previous figure under UV illumination.

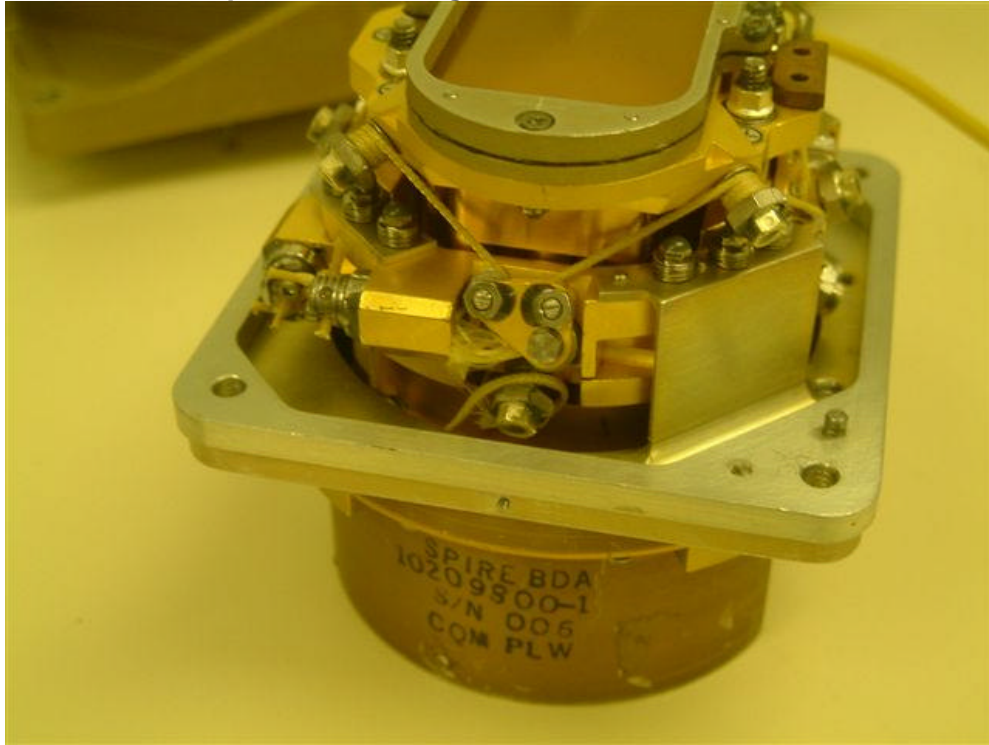
Close up: Note it is the lower cord that's broken the end is just visible

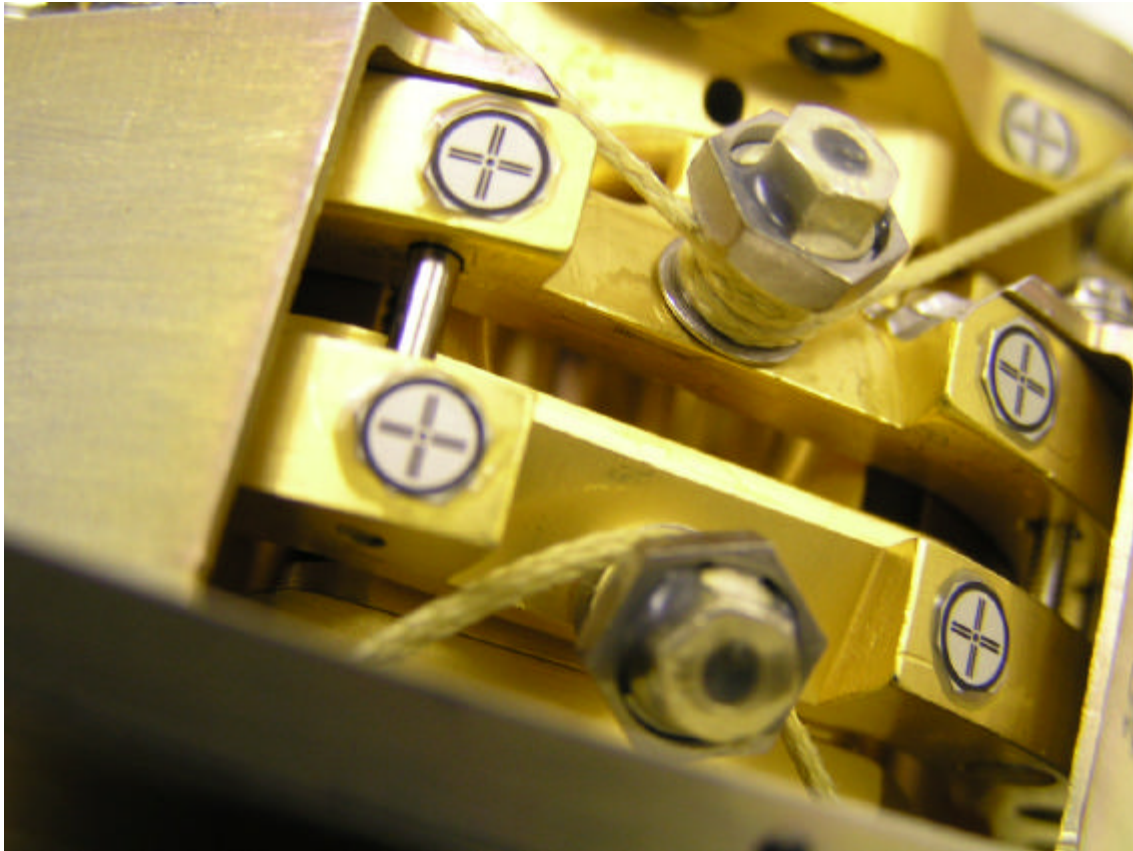
View Opposite side to the Break when viewed under x15 magnification the upper cord is starting to fray

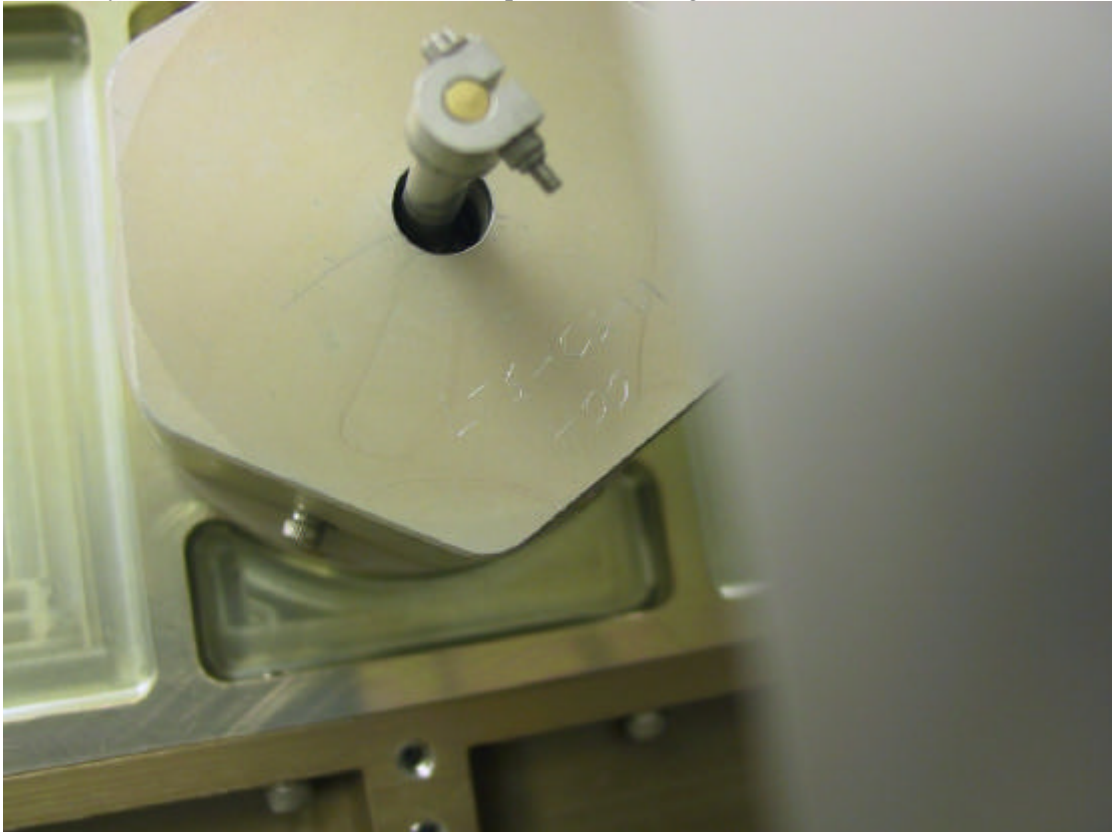
The bus-bar section was non-concentric with the hole in the baffle, as shown in Figure 1. The displacement is in a plane perpendicular to the SPIRE optical bench. Using a multimeter, 15 Ω continuity was measured from the 300mK portion to the light baffle cover & SPIRE structure.

Figure 1 View of photometer light baffle post-STM warm vibration.

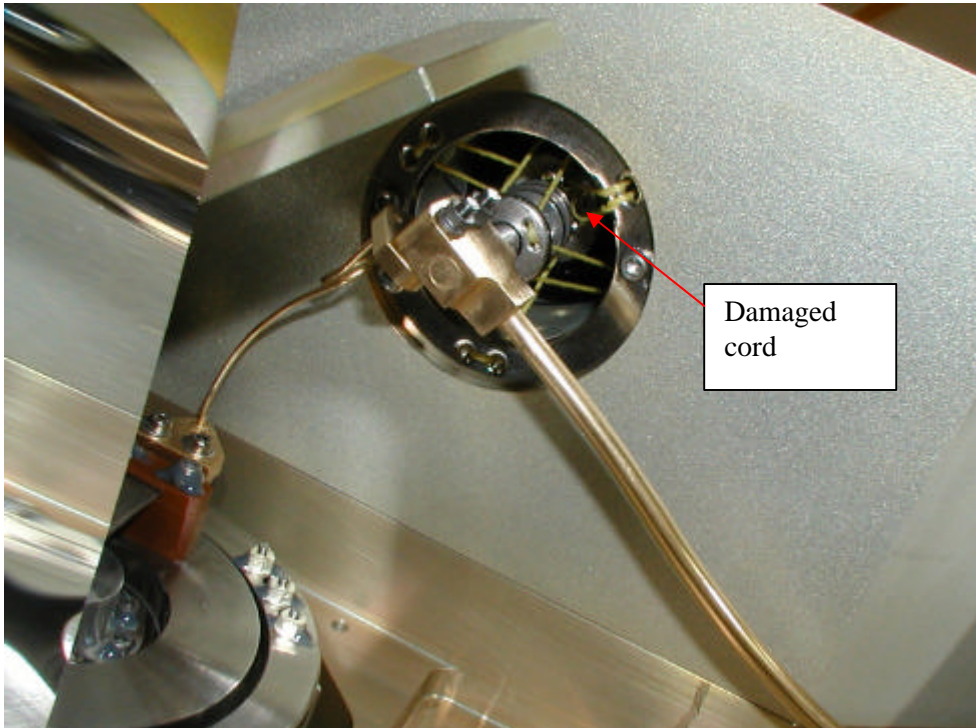
The photometer 2-K box was de-mounted from the SOB, and the base removed to allow access to the box interior. Figure 2 shows a damaged Kevlar cord. Partial failure of this cord will result in an extension of this section, with a resulting misalignment of the central hub.

Figure 2 View from inside 2K box showing damaged cord.

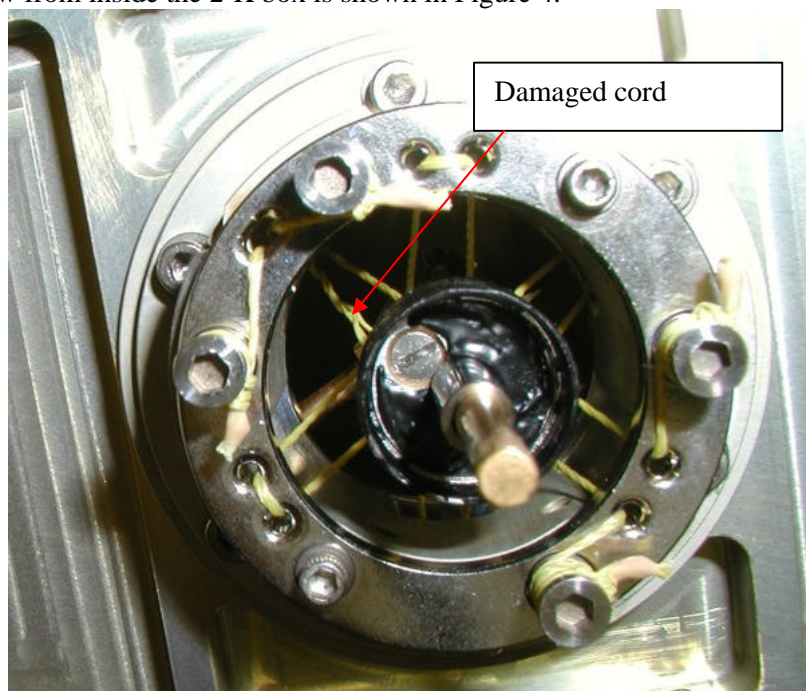
Figure 3 Light baffle on 2-K photometer box, after removal of baffle cover.

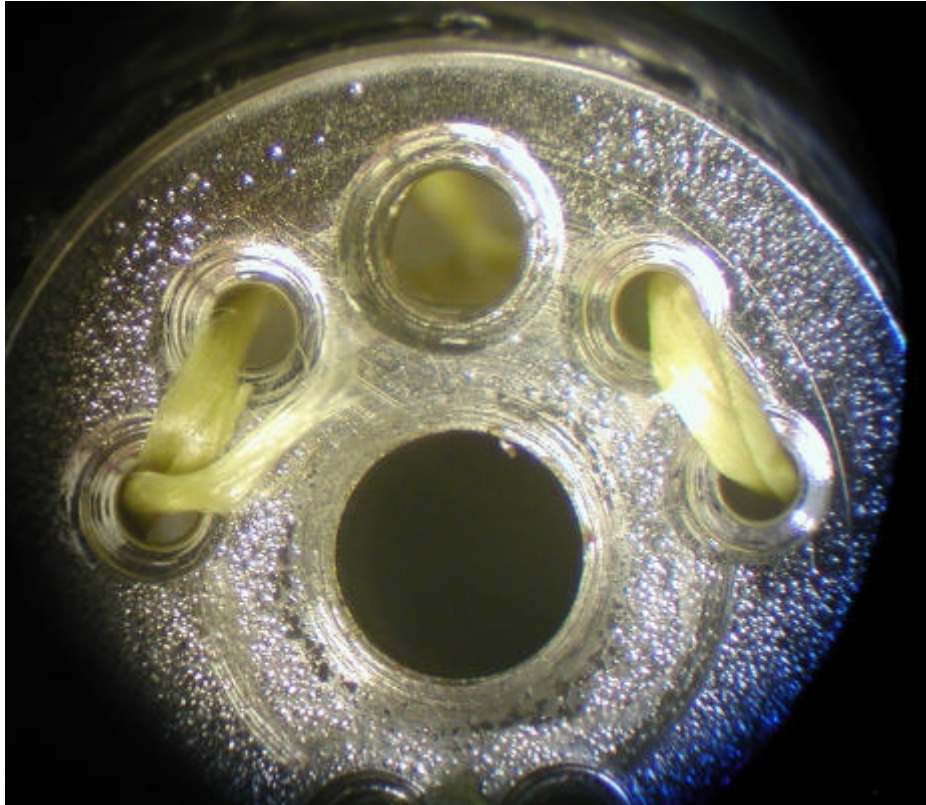
- Inspection report
 - Partial failure of a Kevlar cord – led to overall extension of the Kevlar suspension and loss of alignment
 - Page 7, Figure 8:
 - Shows poor machining quality on the guide holes

Figure 8 Close-up of light-baffle end of central hub, showing failed Kevlar section

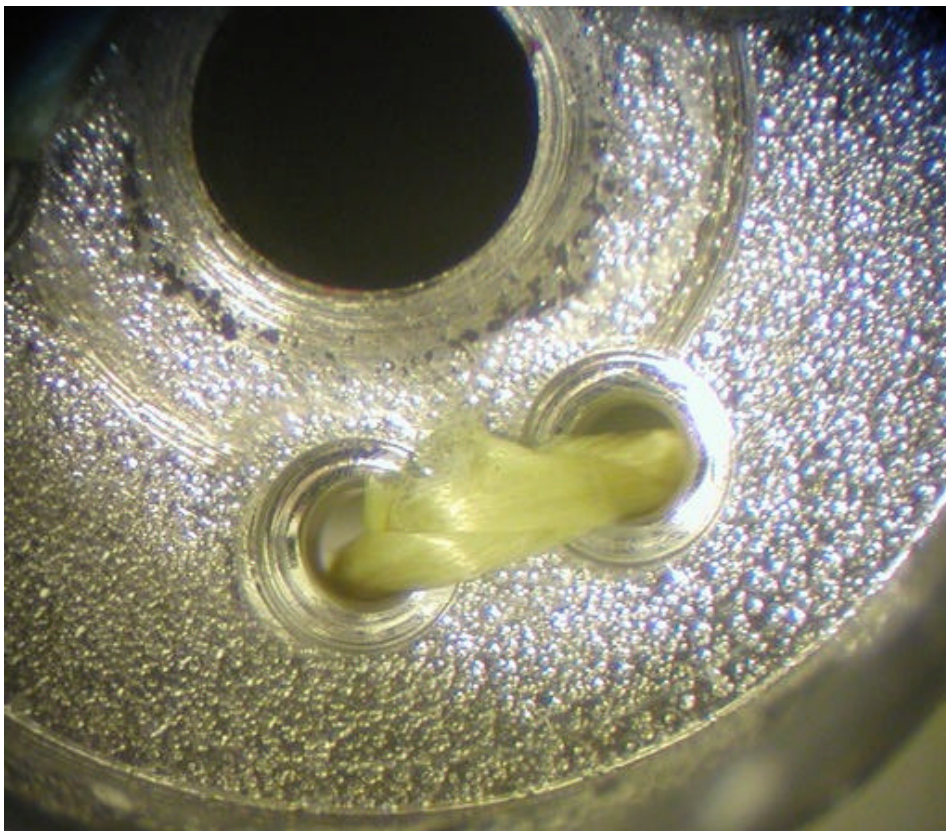
- One and a half of the three bundles broken
 - Figure 9 shows a similar phenomenon happening to another braid at the machining edge
 - Marty question: What was pre-tension?

Figure 9 Another view of the light baffle end of the central hub, showing Kevlar distress at another guide-hole pair.

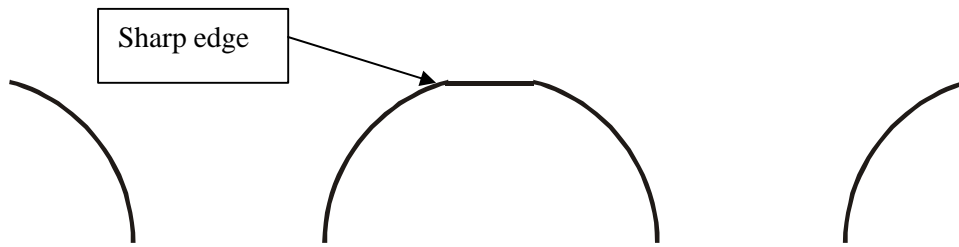
Figure 12 Appearance of radiused holes on light baffle end of central hub as inferred from figure 9. Note the flattened tops due to incorrect machining. This will be confirmed using the 3-D coordinate measuring machine at Cardiff.

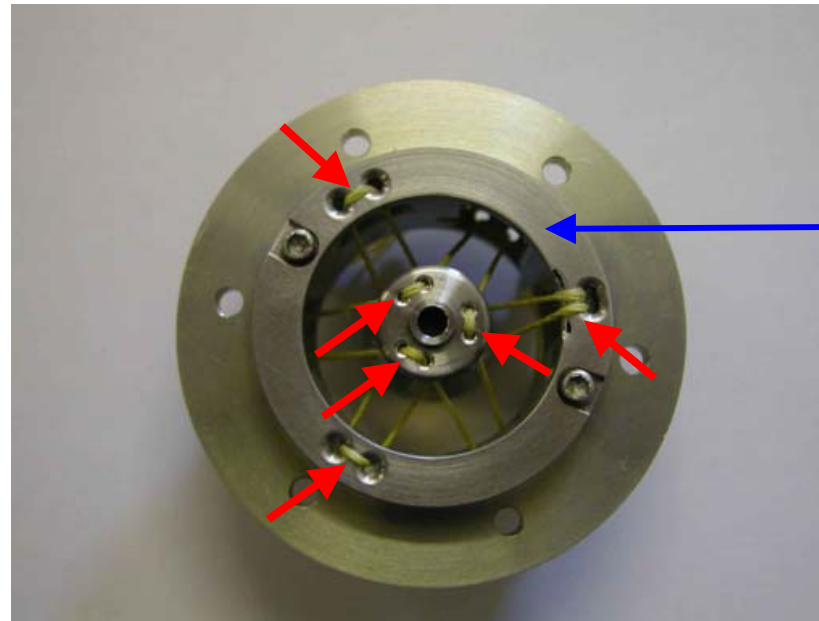
This face must NEVER be placed in contact with a bench, or similar, otherwise the Kevlar cords may be damaged at the points indicated by the red arrows.
