Minutes of SPIRE CQM BDA Kevlar Failure Non-Conformance Review Board

1 October 2007

CQM BDA Kevlar Failure Report

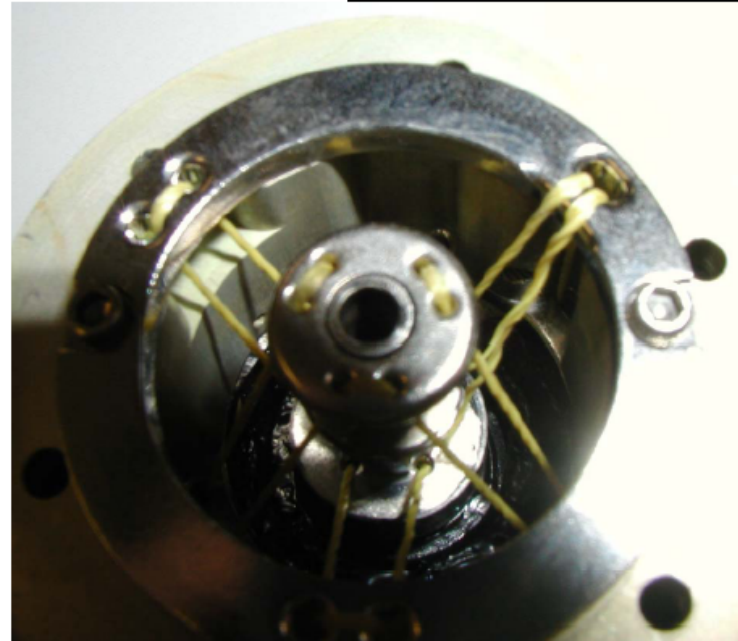
Figure 3 - View of the partially failed Kevlar cord

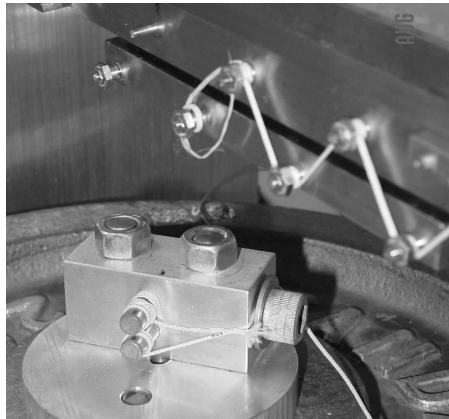
- Failed after 7.7 min at highest shake level
- Failed at pulley

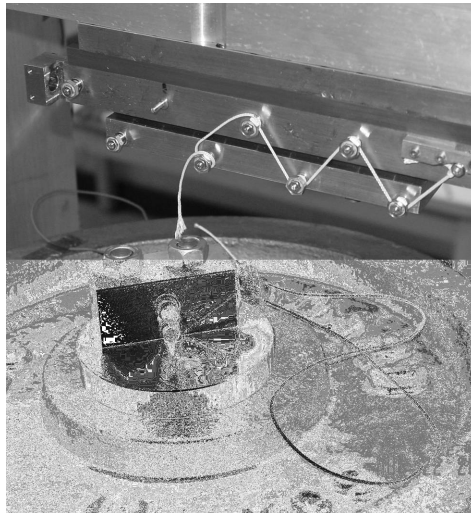
- Failure after 36 minutes at max shake level
- Failed at lower tie-off
