SSTD Incoming Inspection Report

Spacecraft/Project **HERSCHEL / SPIRE**

Document Number **SPIRE-RAL-REP-003017**

Sub System **DPU**

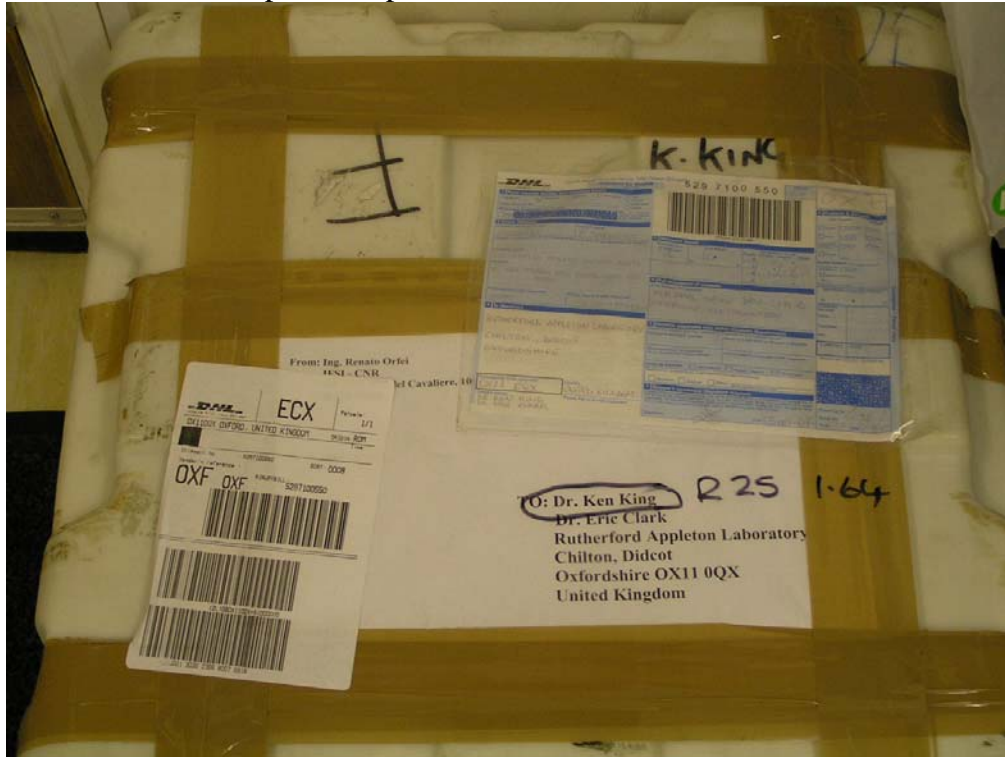
SPIRE DPU Incoming Inspection 5 Dec 07
Top of transportation container as delivered

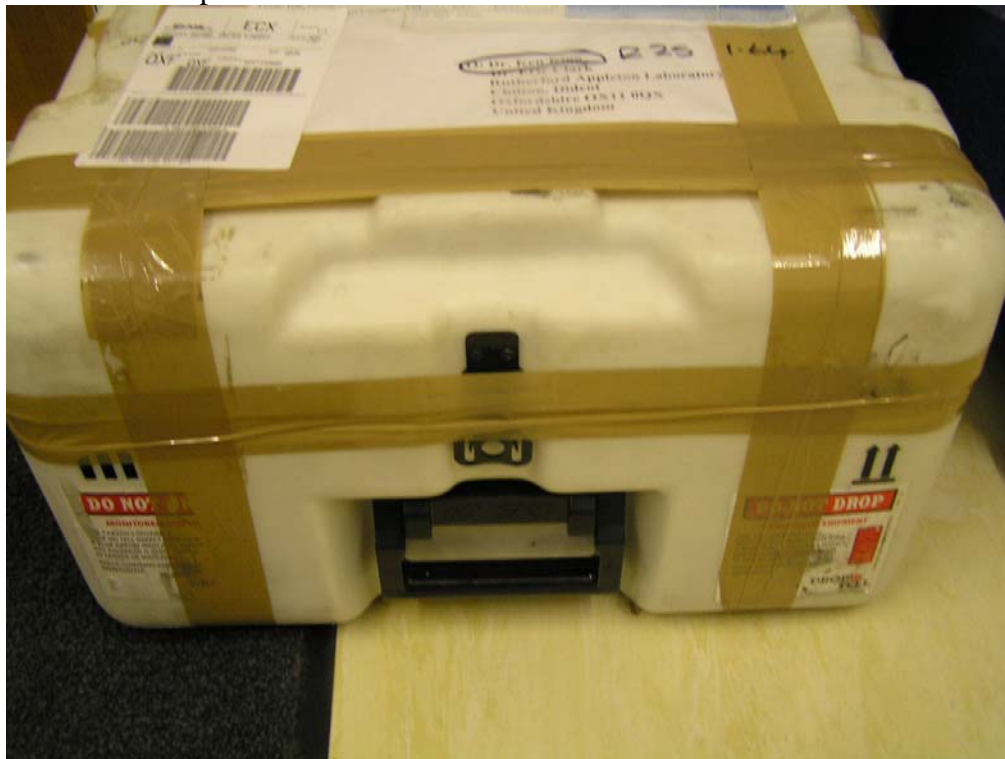
The DPU CFM 2 was supplied packaged inside the transportation box with gray foam that left particles on the outer wrapping on the unit. There were no shock indicators, temperature or humidity detectors inside the package.

Transportation container as delivered – no shock indicators.

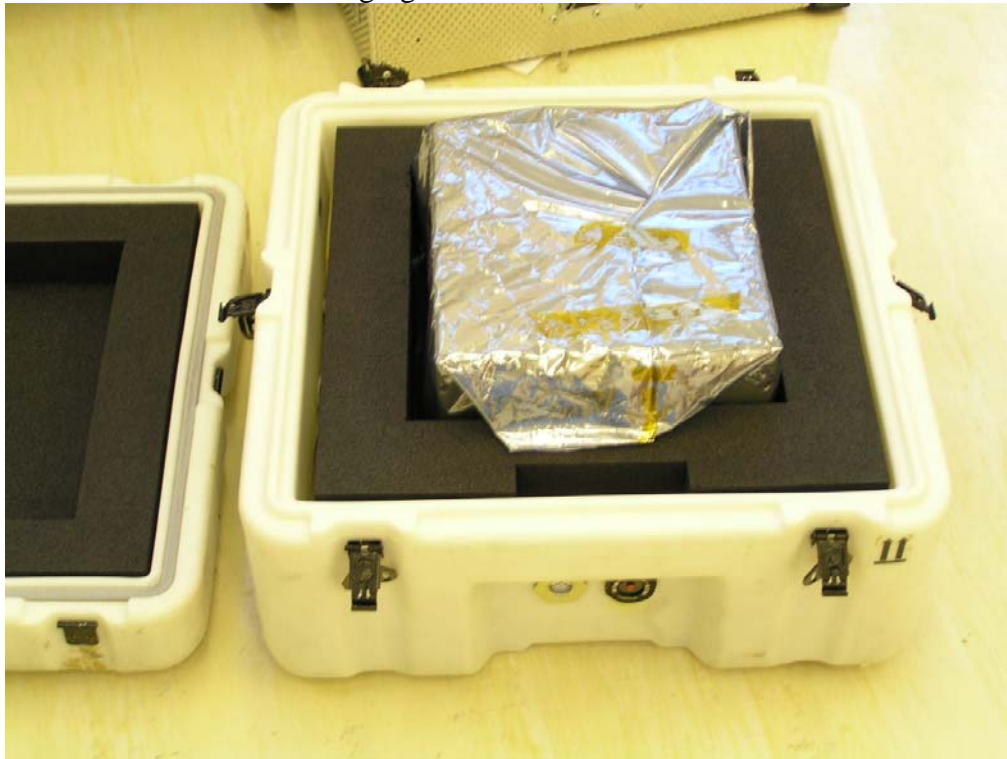
Packaging of DPU inside container

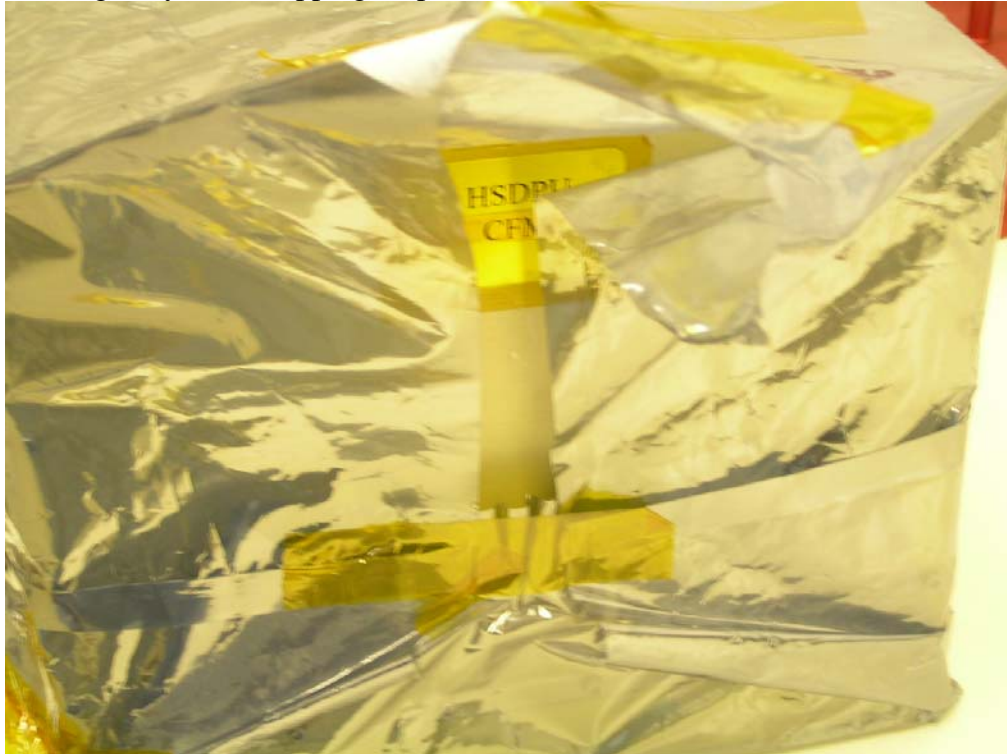
The DPU was supplied with a single layer of ESD wrap, which contained two tears and one end was left open. The unenclosed state had led to particulate contamination of the DPU. There were no ESD covers on any of the connectors, so particles were also present inside the connectors.

Single layer of wrapping – open end allows dust contamination to enter

The DPU will need vacuum cleaning and black light inspection before use in RAL clean rooms.

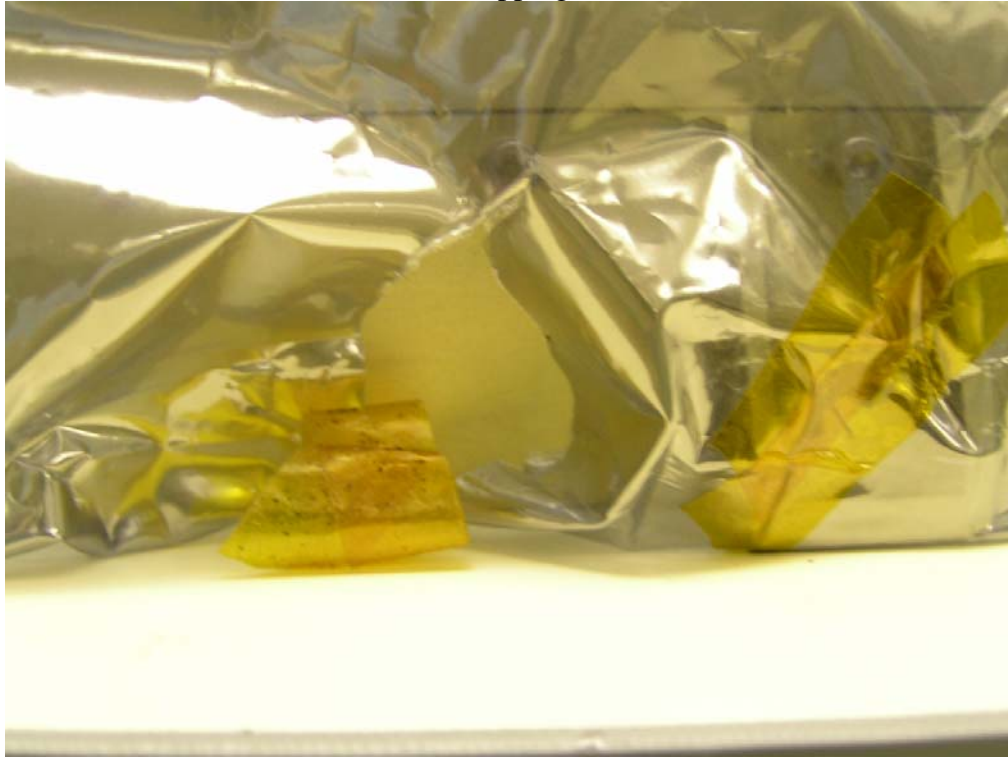
Tare in the wrapping at the base

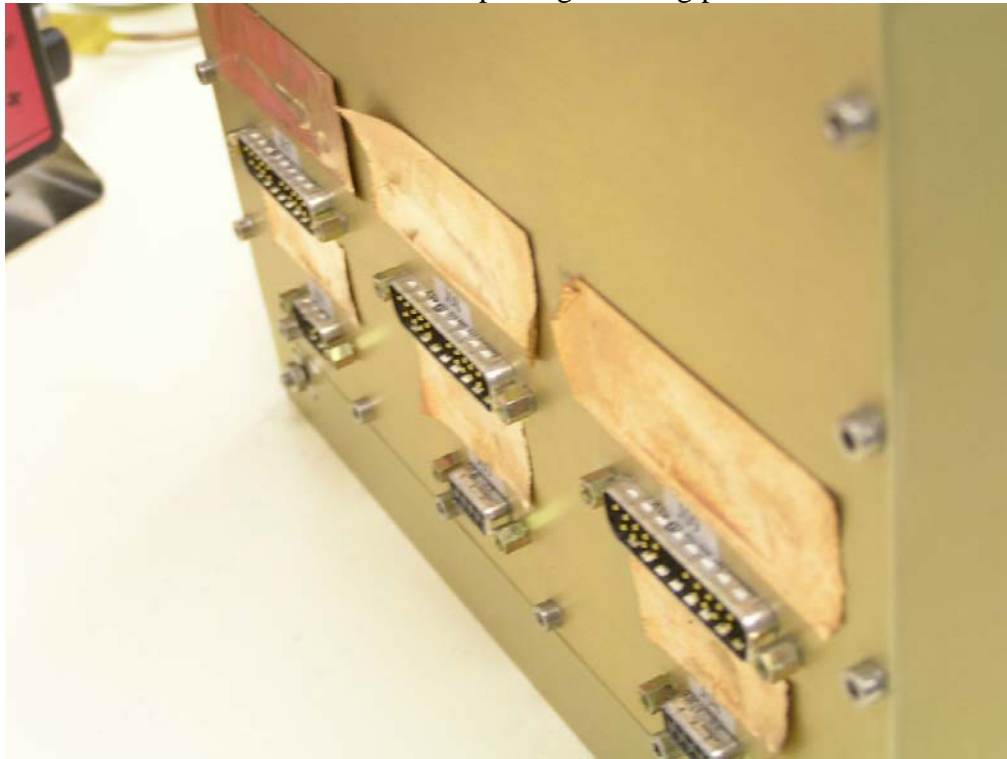
Uncovered connectors and peeling blanking plates on DPU

ESD protective covers were placed on the connectors in the RAL clean room prep-area with ESD precautions in place.

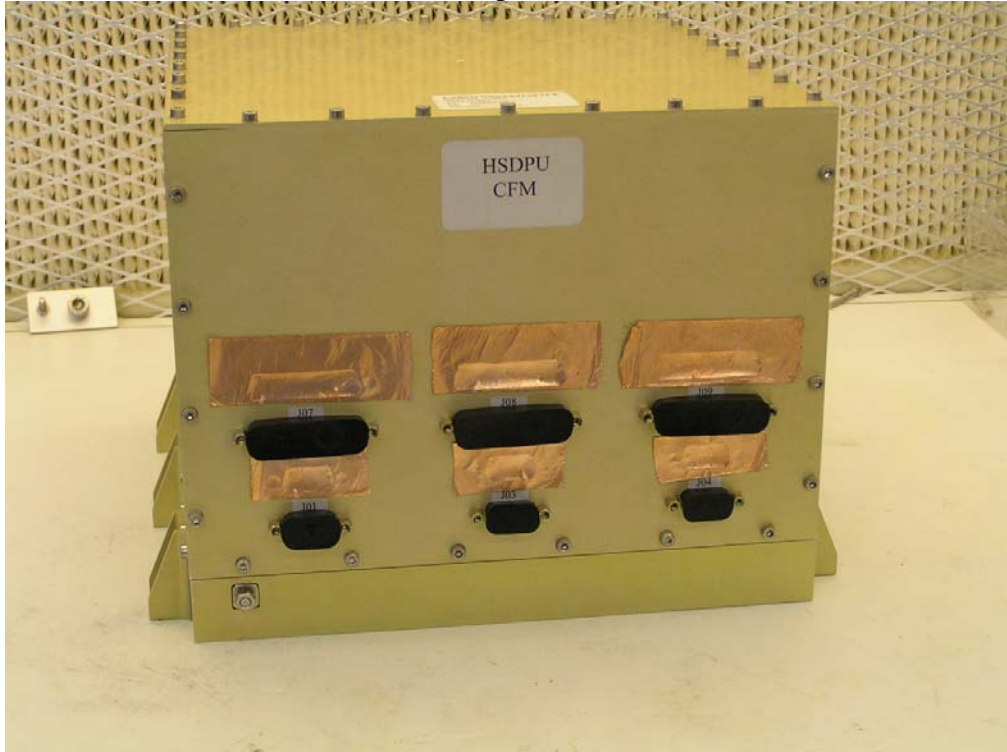
ESD covers put on at RAL

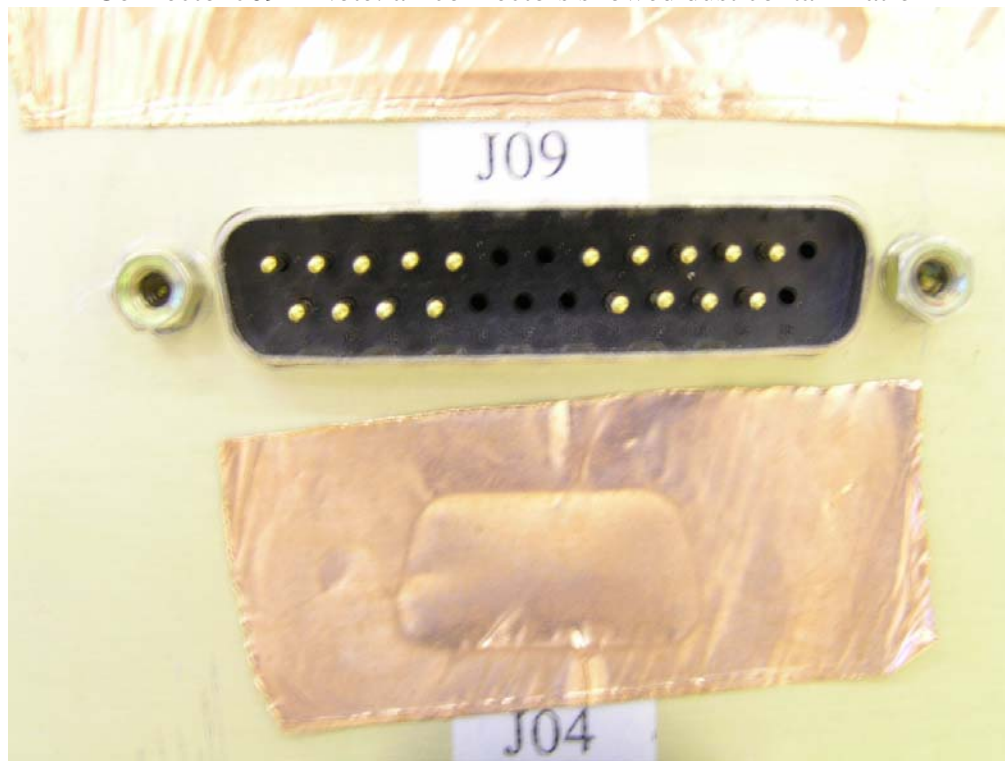
Connector J09 – Note: all connectors showed dust contamination

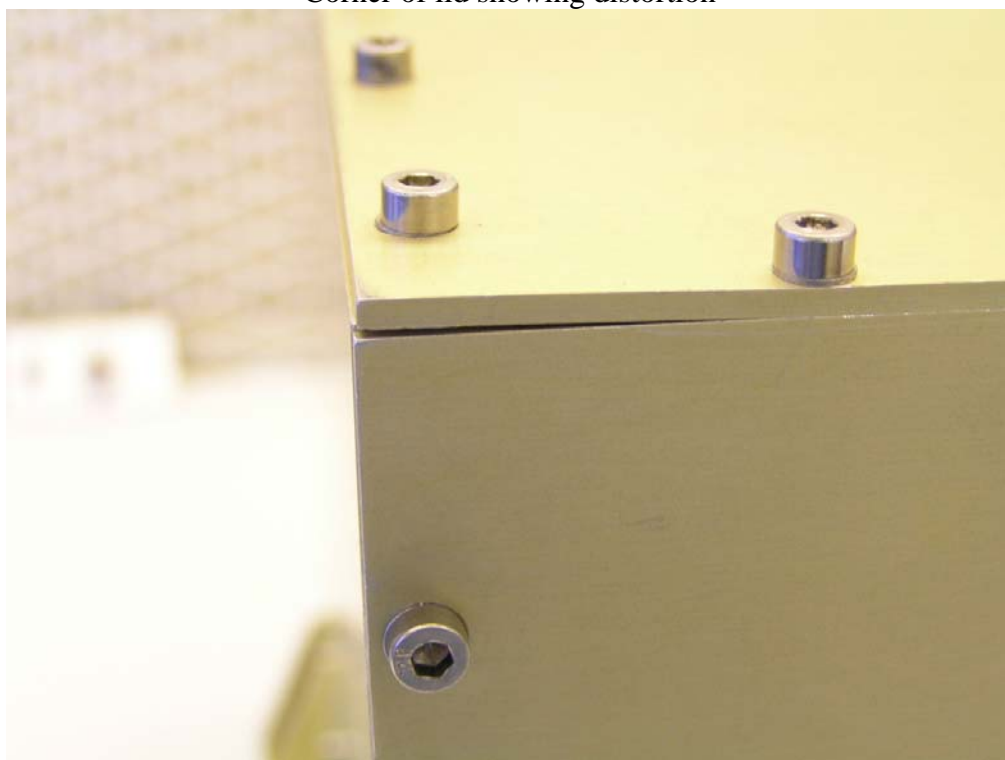
Corner of lid showing distortion

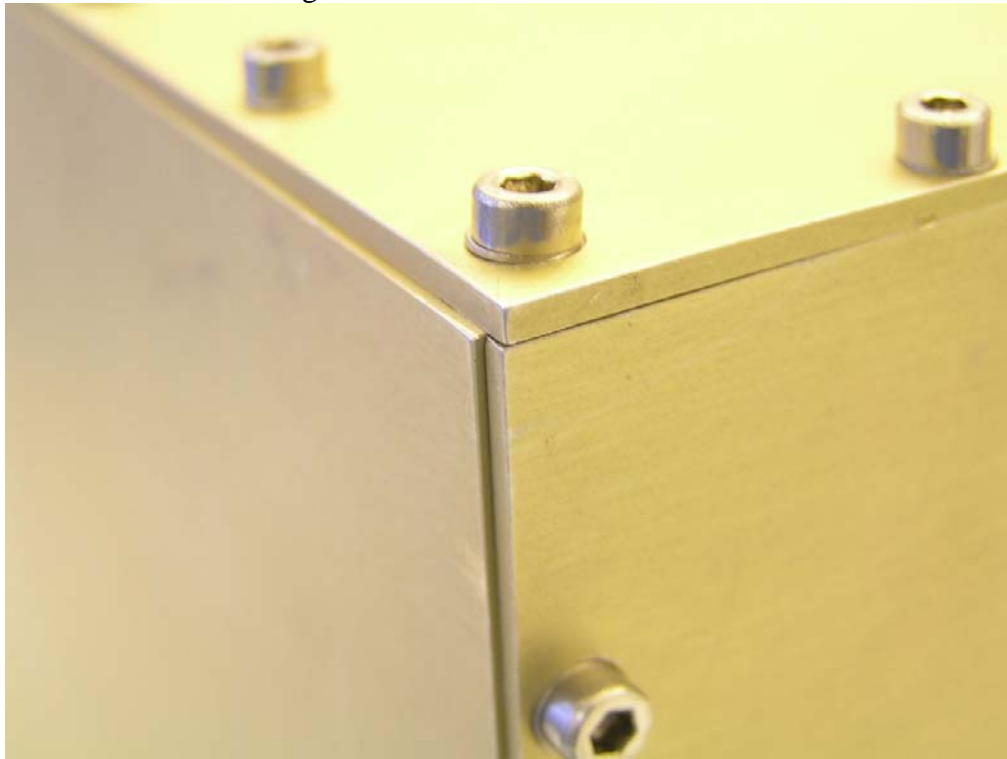
Misalignment of the side of the box at the lid
