**Venus Monitoring Camera on Venus Express**

## **Commissioning Report**

VMC-MPAE-TN-MCRB-001

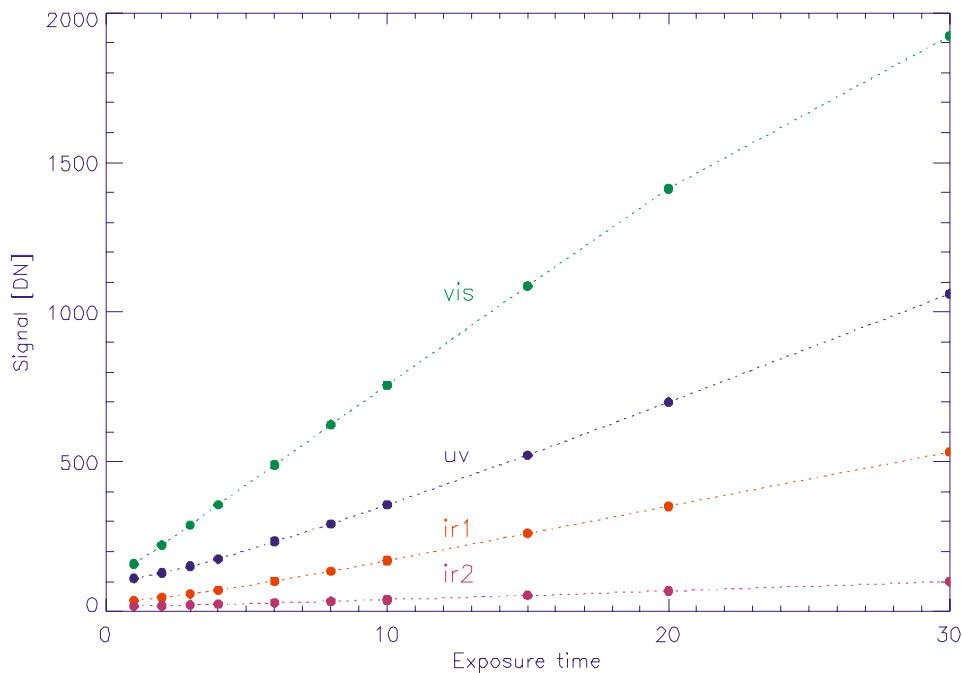
The first switch on of VMC was on 21.11.2005. Ten full frame images were commanded and received. VMC operated nominally. The data obtained proved useful to supplement stray light data obtained later. Figure below shows the signal strength (DN) as a function of exposure time in seconds for all four VMC channels. Linear fit confirms the expected linear response of the VMC CCD.

**Figure 2-1 Stray light during the first switch on sequence confirms the expected linear response of the VMC CCD detector. Exposure time is in seconds.**

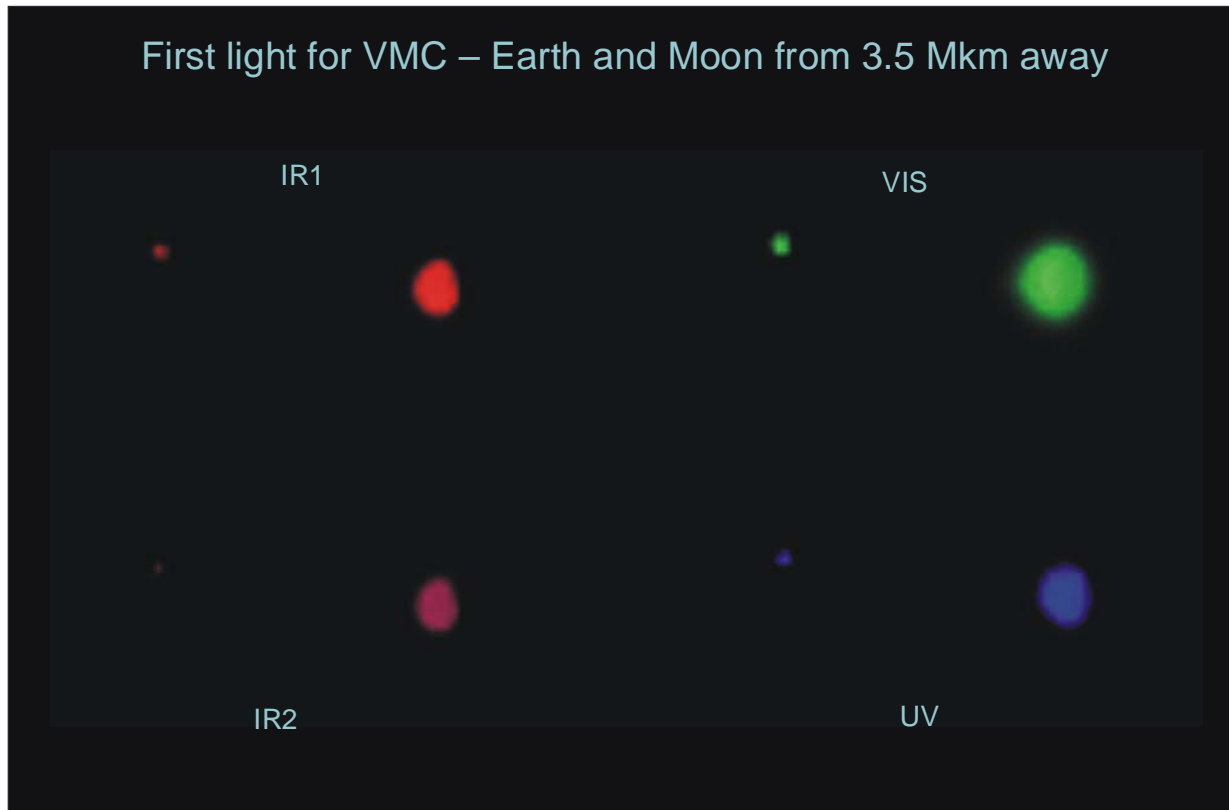
**Figure 2-2 Earth – Moon images obtained in the four channels of VMC. False colour. Earth is overexposed to enable seeing moon in all channels at the same time.**

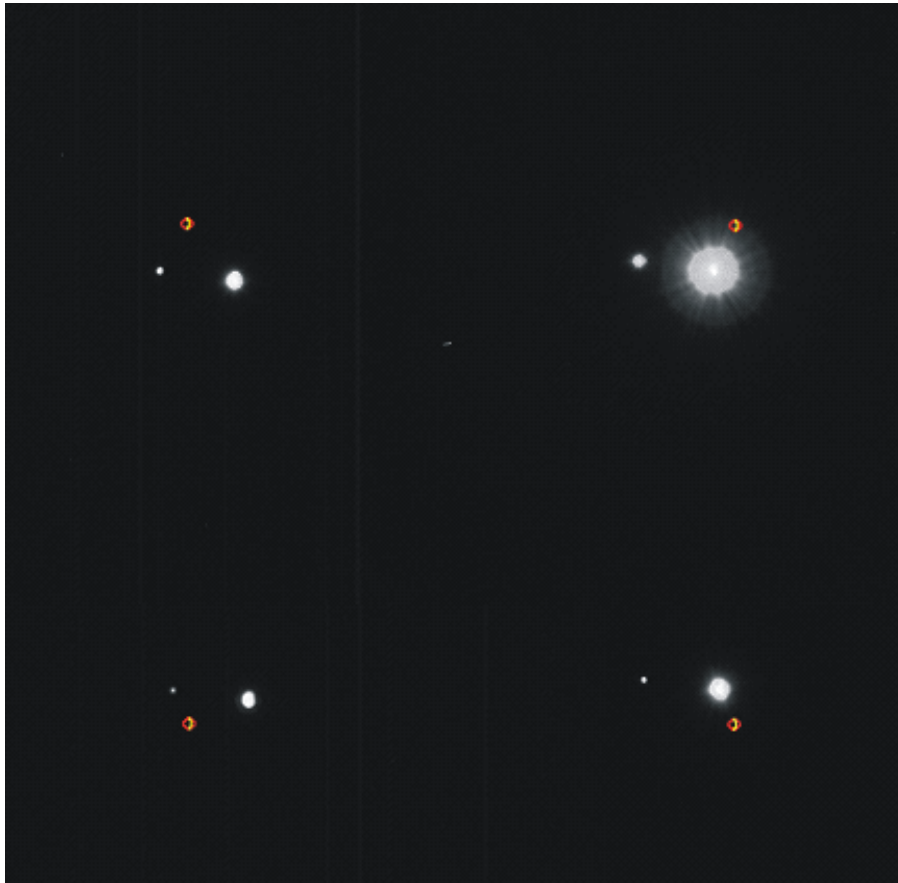
The Earth-Moon images were used for checking the alignment of the optics. Figure below shows the expected position of the Earth in comparison the position in the image. Alignment error is less then 1.5 degree in all channels and this is acceptable.

**Figure 2-3 Red dots show the expected position of the Earth. The alignment error is less than 1.5 degrees in all channels and is acceptable.**

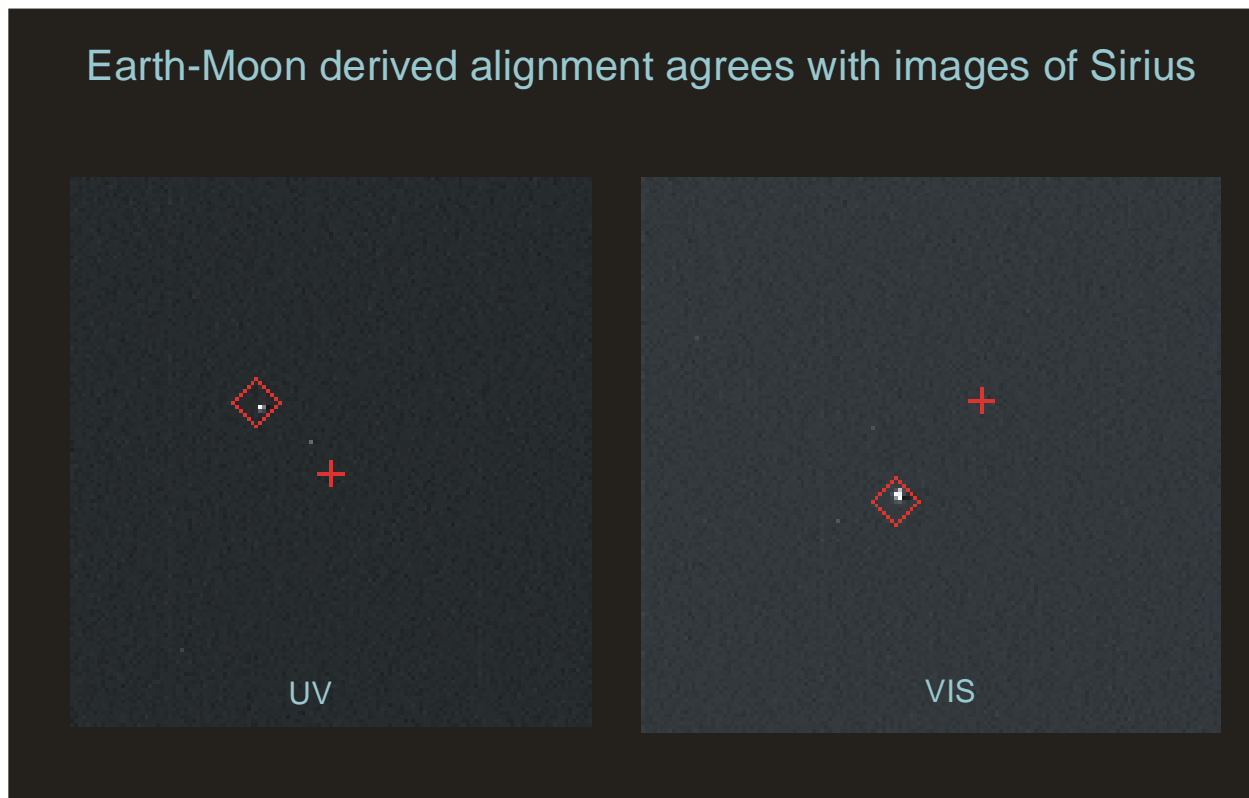
The optical alignment was confirmed with images of star Sirius. The figure below shows the images of Sirius in two of the VMC channels together with the expected position of the star. The alignment error is the same as that derived from the Earth – Moon images.

**Figure 2-4 VMC images of Sirius in uv and visible together with the expected position of the star (red cross). Optical alignment error is the same as that obtained from Earth – Moon images.**

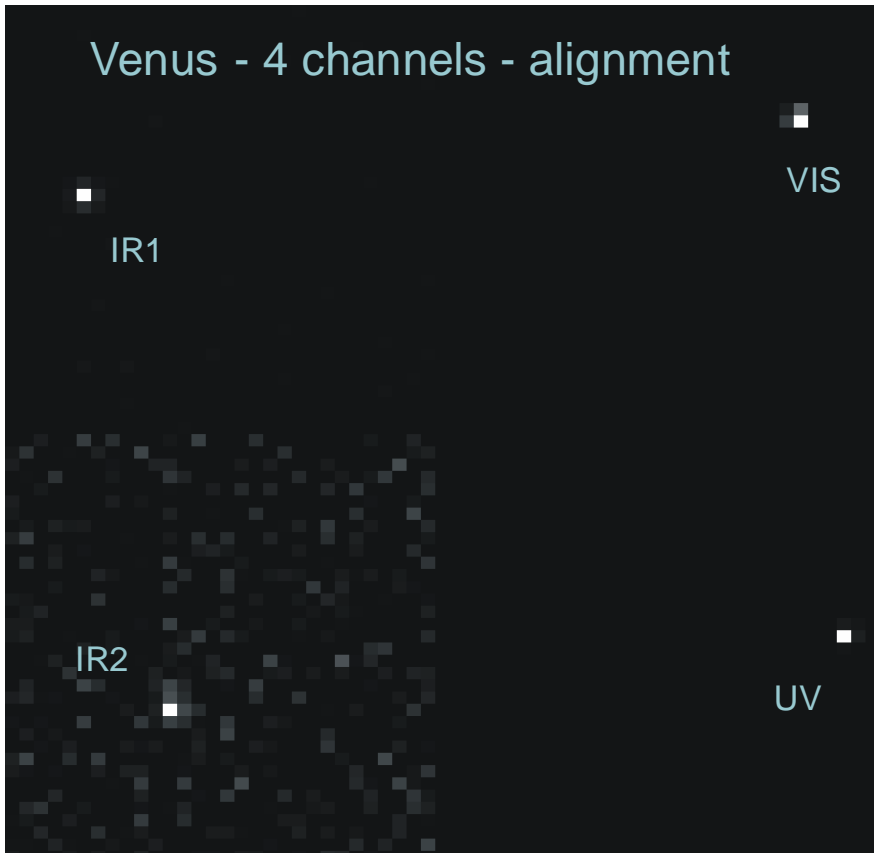
Figure 2-5 First VMC images of Venus – showing alignment and point spread function. The VMC is in expected good focus.

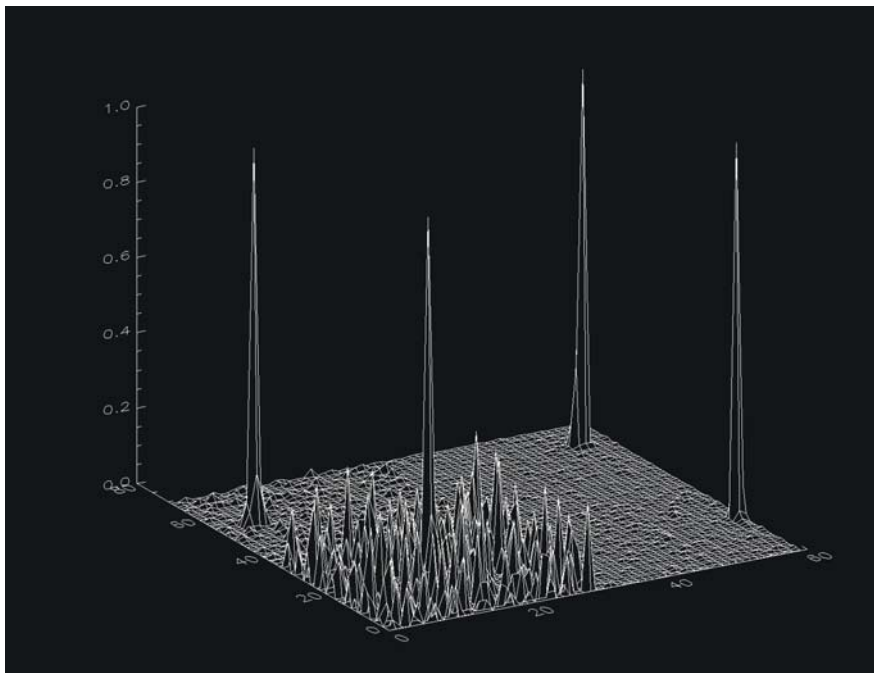
Figure 2-6 First images of Venus. Signal in all channels is normalized to unity. Venus is here a point source and covers as expected less than one pixel. This proves that focus of VMC is good and has not changed since before launch.

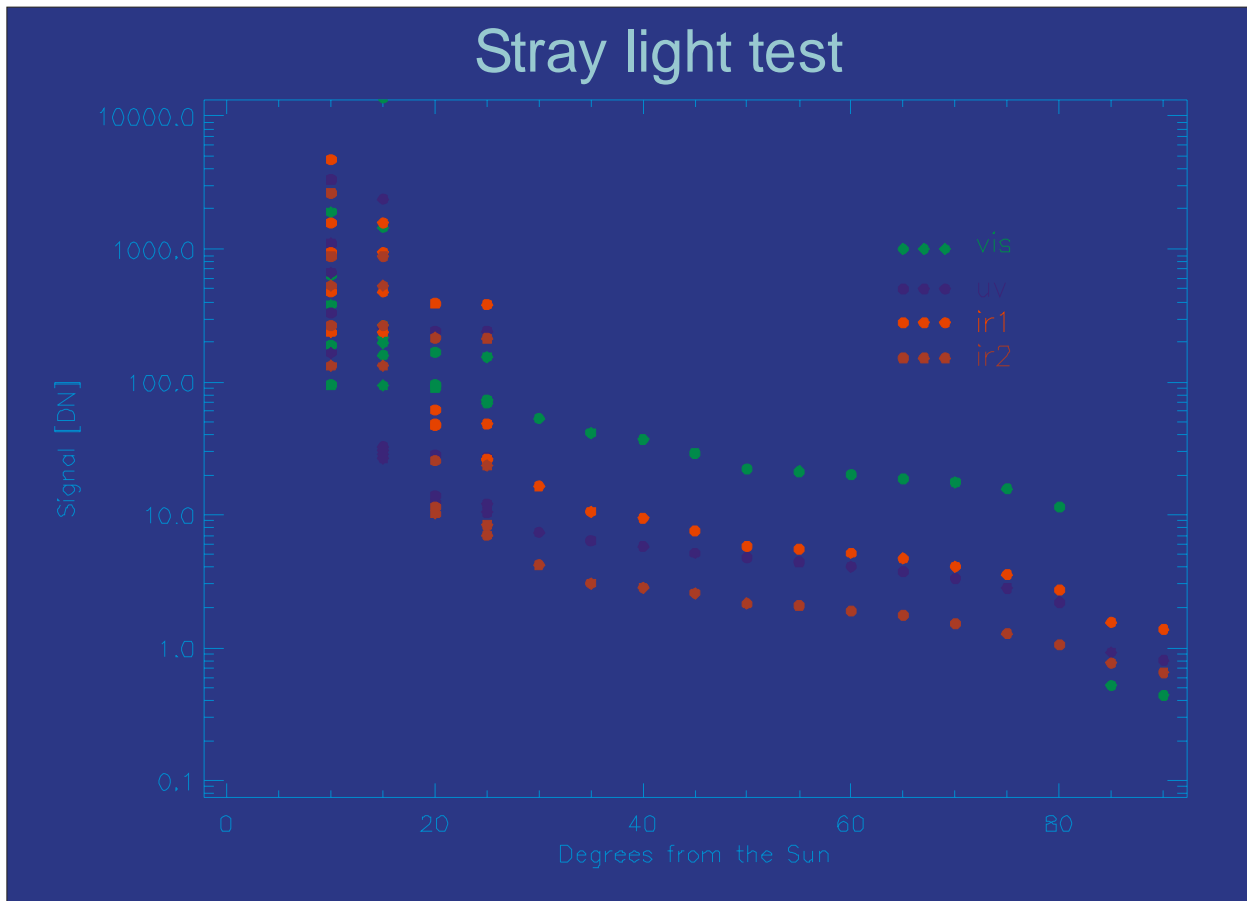
Stray light test was performed on 02.12.05. 36 full frames were commanded and received. The S/C axis was pointed between 90 and 10 degrees from the Sun with 5 degrees intervals. The obtained data is summarized in figures below. Most of the data with angle to the Sun < 20 degrees is saturated. This test was repeated in February 2006 with different exposure times, but analysis of these data has not been completed to date.

**Figure 2-7 First stray light test. Stray light is minimal for data with Sun angle > 30 degrees. Data for smaller angles is mostly saturated and can not be analyzed.**

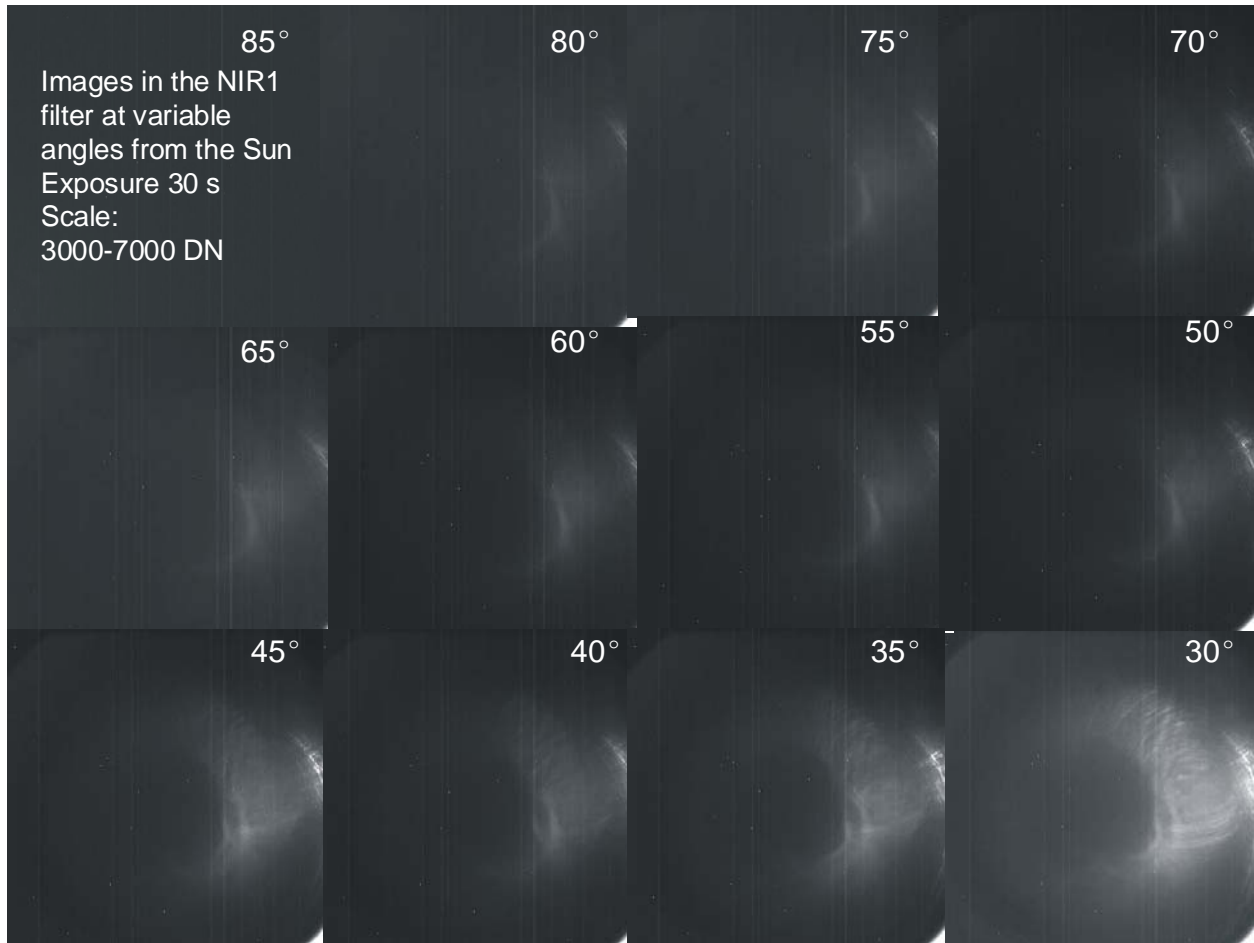
Figure 2-8 Examples of stray light patterns obtained.

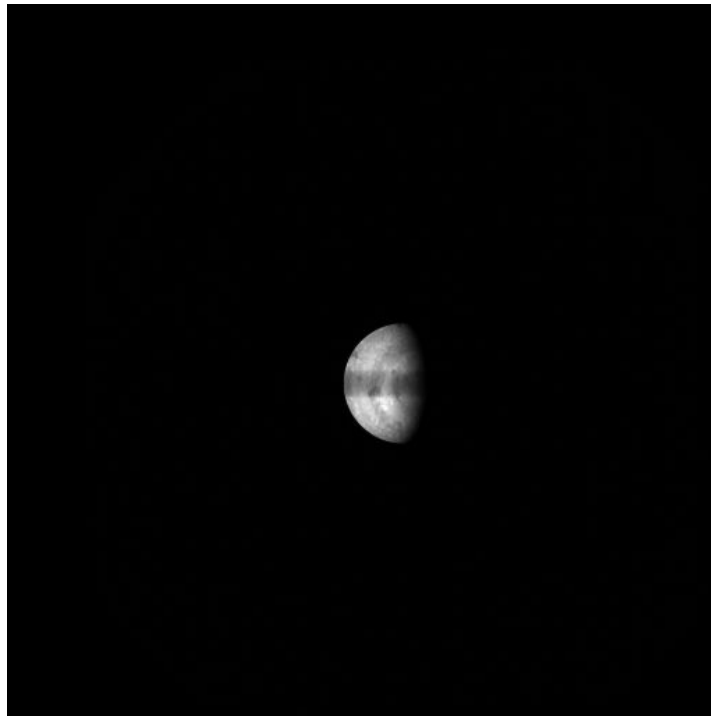
The horizontal dark stripe was discovered in all UV images. Example is shown in figure 2-9.

**Figure 3-1 UV image of Venus v0001\_0076.uv2 taken in Capture orbit.**

The dark stripe crosses the image horizontally (almost perpendicular to the CCD columns) and has width of ~18 pixels at half-minimum (figure 2.2).

After discussing the problem with the project, ASTRIUM and ESOC, sun avoidance of 10 degrees was recommended and was found to be possible.

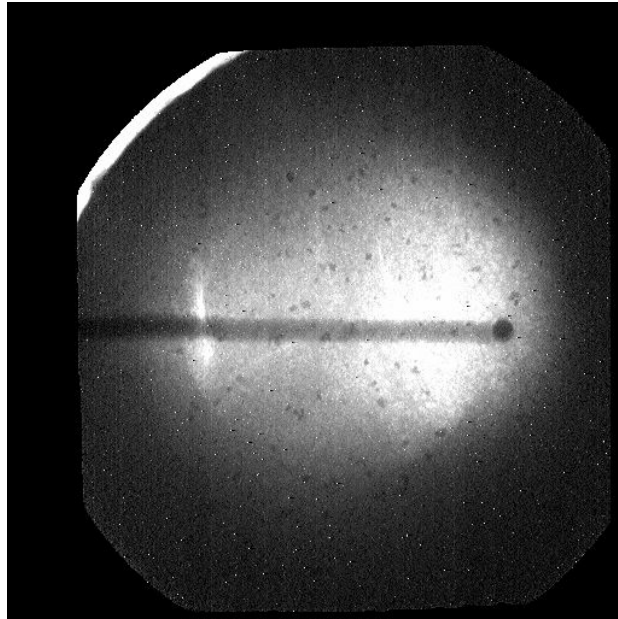
**Figure 3-2** UV image v0002\_0010.uv2 taken during in-orbit stray light characterization on April 24, 2006.

show an irregular pattern which is obviously not part of the Venus. It is now almost certainly known that this pattern comes from CCD and most likely from the micro-lens layer. To date it is not known how this pattern originated and whether it will evolve with time.

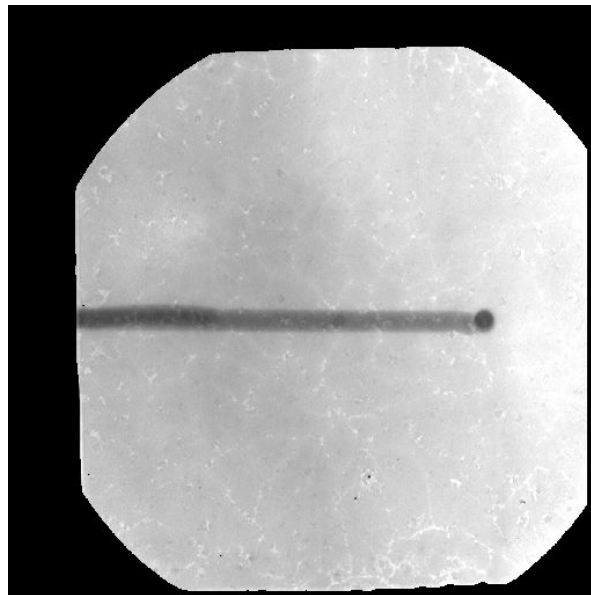
**Figure 3-3** UV image v0004\_0033.uv2 taken during the first pericentre pass.

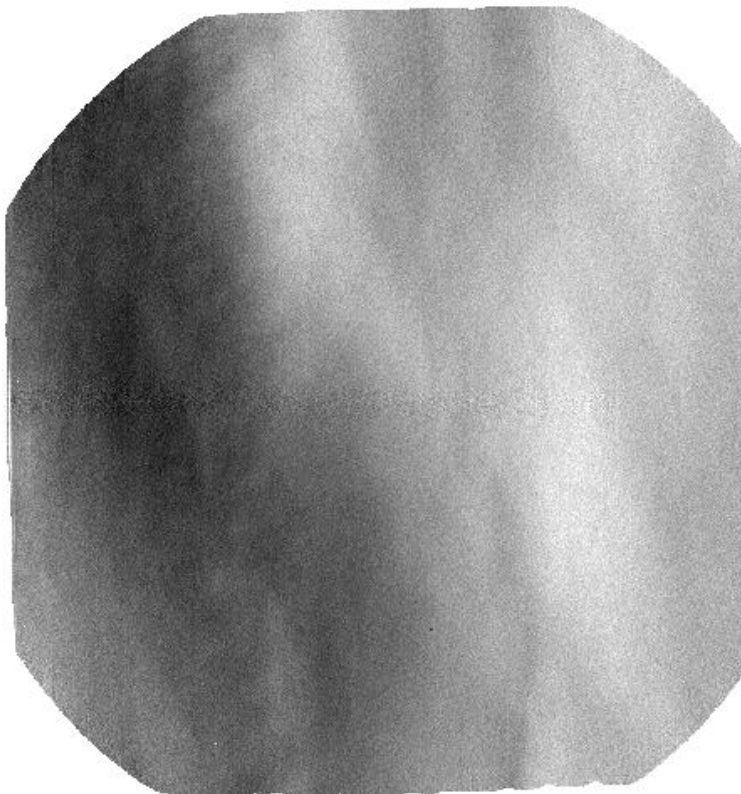
**Figure 3-4 Corrected image (original Figure 3-2). Although the sun strip is still visible, most of the artifacts are removed. It is hoped that averaging many images in the future will produce a significantly better flat field and hence a better correction.**

If we can assume that the pattern will not evolve it should be possible to correct images by constructing new flat fields by averaging many close up Venus images. This has been already attempted with a few available images and the result is promising. An example of a corrected image is shown in the figure below.
