**GIADA FS MODEL  
IN-FLIGHT COMMISSIONING  
REPORT**

This document reports the in-flight commissioning activities performed on GIADA experiment in the night between 3 and 4 April 2004 @ ESOC.

This report is applicable to GIADA FS model on board the Rosetta S/C now flying @ about 11000Km from earth. The Rosetta S/C has been launched from Kourou on 2 March 2004. The data have been retrieved from DDS by means of the PI Workstation located @ PISA in ESOC.

**Doc : GIA-GAL-RP-517**

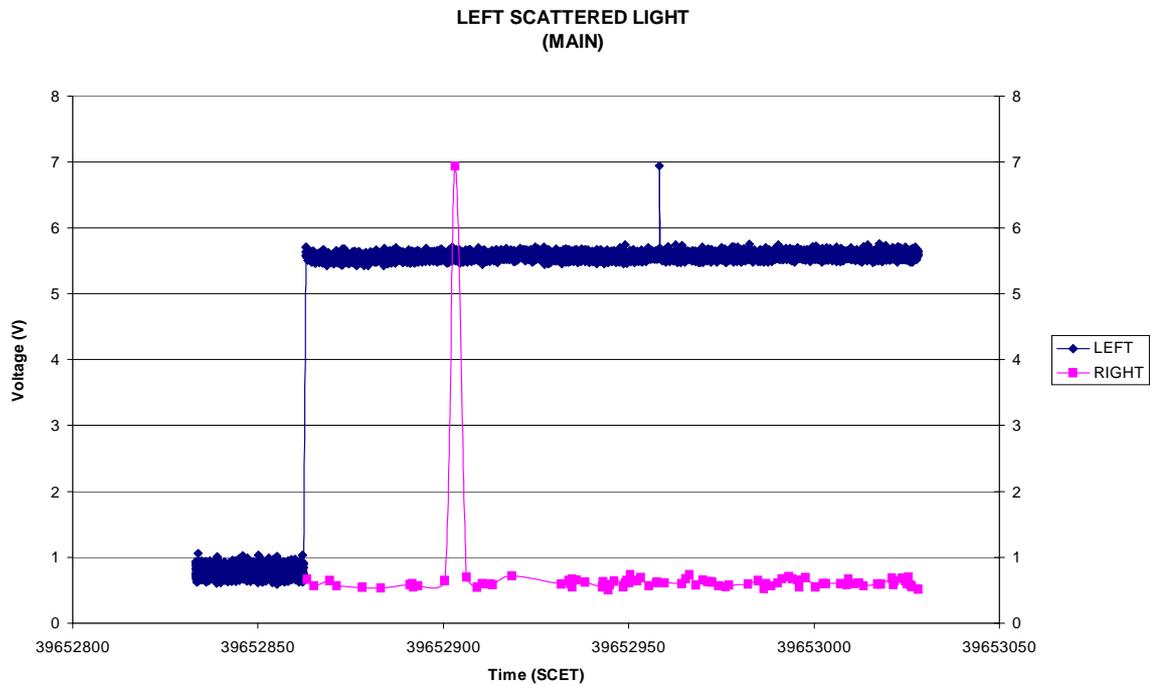
The detection thresholds of each channel are set to about 0.8V (Context file updated via memory load command). After the 2<sup>nd</sup> GDS power-on (when the Science TM was enabled), the Calibration data have been successfully received. The left and right channels show an average noise of 0.1÷0.2V and a standard deviation below 50mV. As soon as the Lasers have reached medium power, a flood of GDS events (especially on Left channel) have been received due to internal stray-light, as the cover is closed. As we can see in the following picture, the left channel receives a higher internal stray-light.

**Figure 10 GDS Detection (Left and Right Receivers) - MAIN**

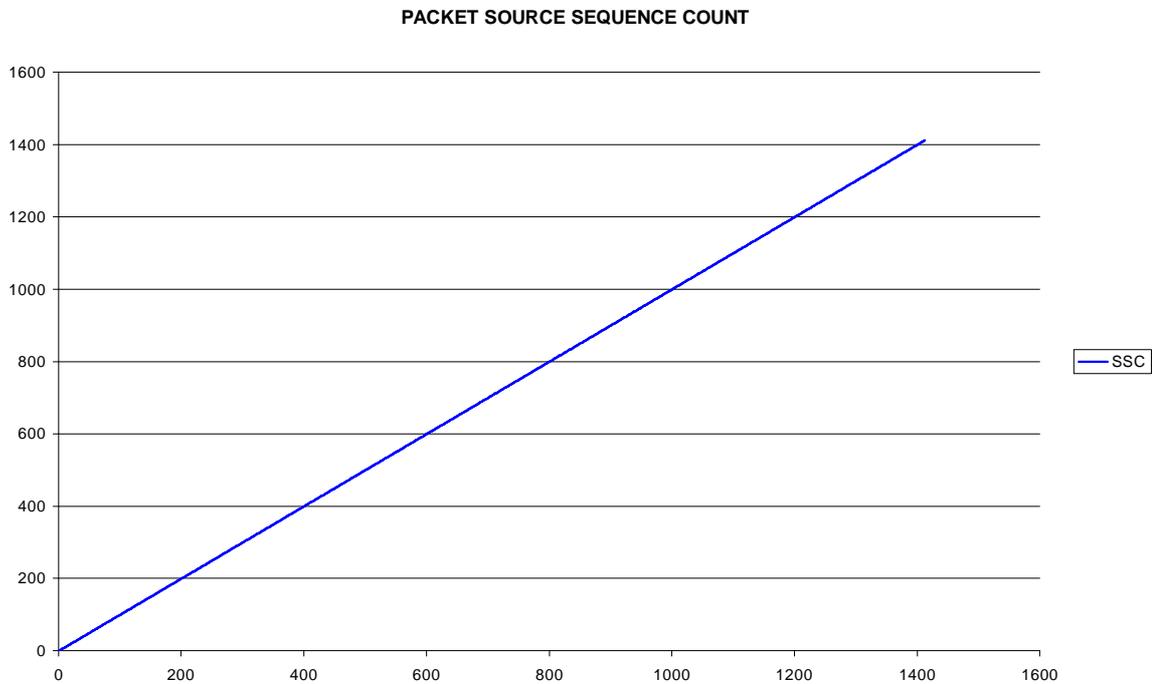
During the test, no missing packets have been found in the reception of HK TM (refer to Figure 19, in which the source sequence count of HK packet is monotonically increasing from  $0$  to  $1412$ ). Figure 20 reports the Dust Flux number when GIADA is in Normal mode and the IS sub-system is switched-on. The dust flux is different from  $0$  (which is the expected value when dust is not present, as now foreseen) only for few minutes after the switch-on or off of the MBS, or GDS or Laser power relays. This behaviour is quite similar to the one found during on-ground testing (refer to the User Manual): at the time of the sub-system power relay on or off, the IS performs a 'ghost detection' and thus Dust Flux becomes different from the expected value (i.e.  $0$ ). Figure 21 shows the status of the two reed-switches from the GIADA power on until the power-off, as extracted from the HK TM packet, which are sampled with repetition time of  $10s$ . As we can see, when GIADA was in Normal mode, the cover remained open leaving the GIADA sub-systems looking at the deep space. Taking into account the Spacecraft orientation, practically the sun did not illuminate the

Figure 19 Source Sequence Count for HK TM packets (REDUNDANT)

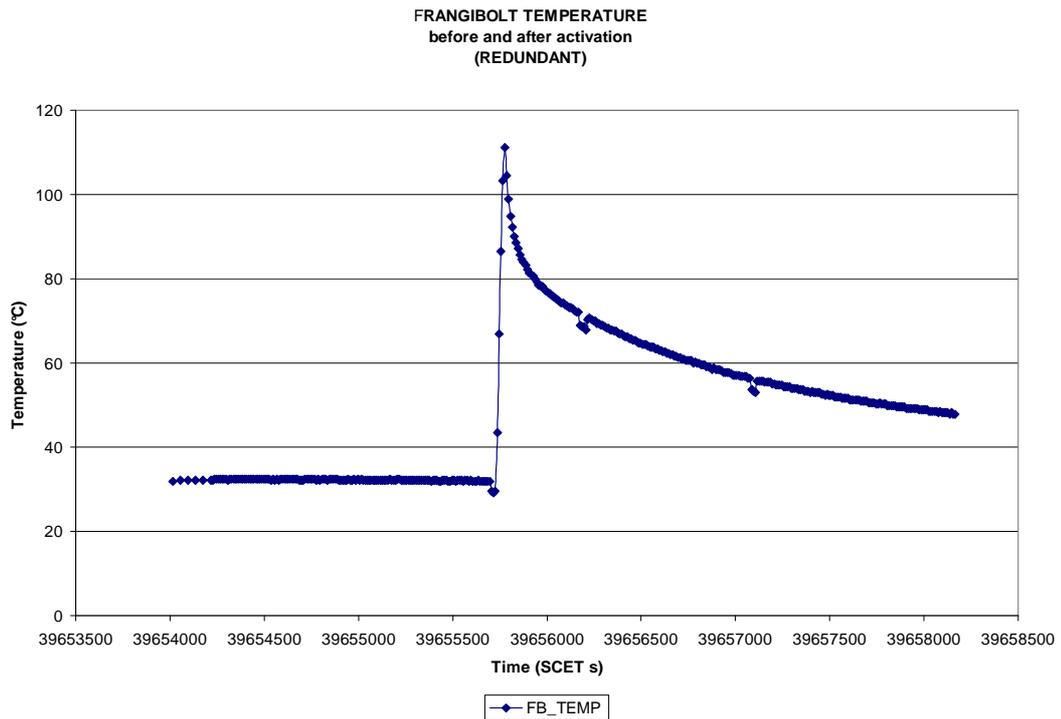
During the Frangibolt heating the temperature increases above 100°C, which is the temperature limit at which the Frangibolt can be activated. After that, the Frangibolt power is automatically switched-off by the on-board software and the temperature slowly decreases.

**Figure 22 Frangibolt temperature during Activation (REDUNDANT)**

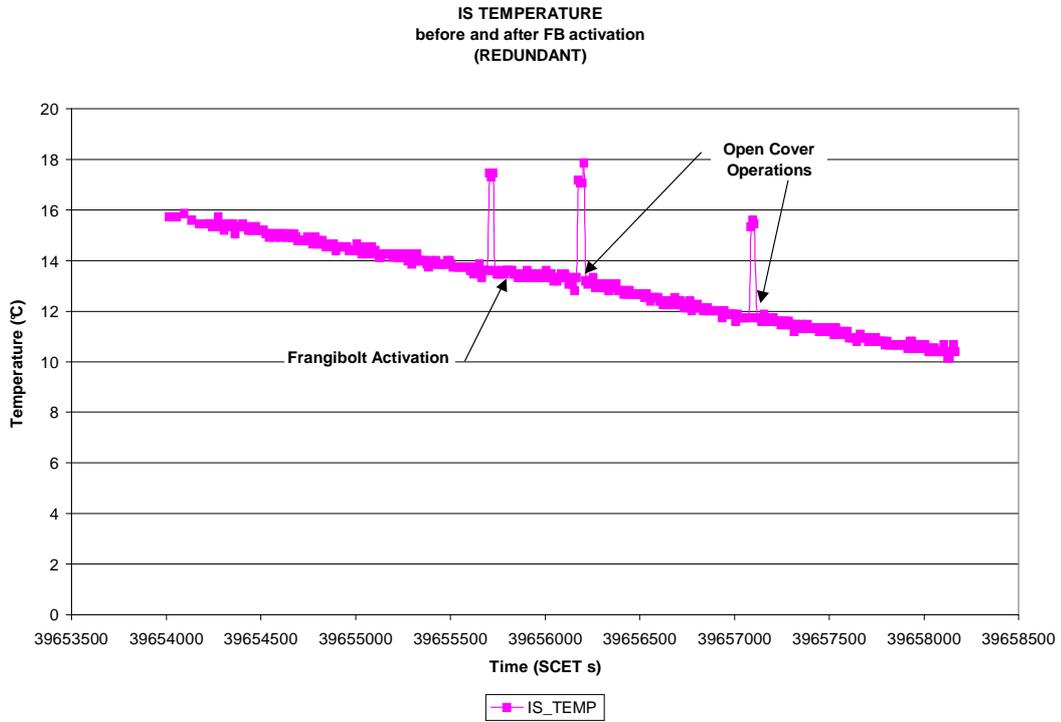
The IS temperature is shown in Figure 23, before and after the cover was opened. The temperature decreases, being the IS sensor now radiatively coupled with the deep space.

**Figure 23 IS temperature before and after FB activation, but IS Off (REDUNDANT)**

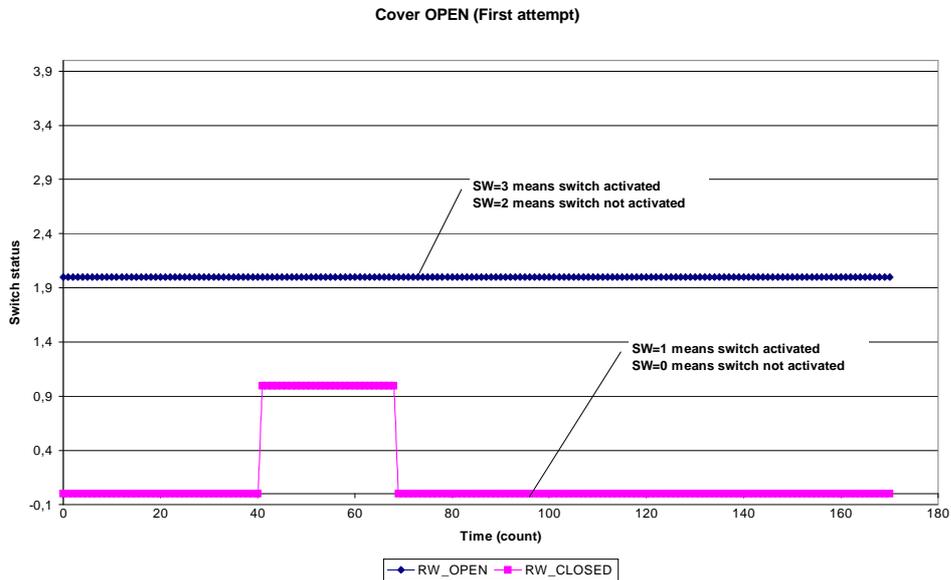
After the first cover open attempt, the cover resulted not completely open, as shown in the Figure 25, in which the status of the two reed-switches is reported. The figure is extracted from the cover report, which is received on-ground at the completion of the operation. The correct behaviour is when in the same figure it shall appear the sequence of the following conditions:

In the Figure 25, only the first condition is reached, while the second does not appear. This means that the cover was not completely open: it moved from its closed position but it did not reach its final open position. In the first part of the movement, it seems that the cover needs more steps to reach the activation of the RW\_CLOSE: 40 steps with respect to the < 10 expected. This could be due to the possibility that the cover was unlikely ‘stuck’ to the GIADA support (refer to GIADA close configuration in Figure 24). Then the cover moved and the ‘close reed switch’ activated, as expected, for 29 steps. Unfortunately the cover seems not reaching the final open position, even after 100 steps.

**Figure 25 Reed switches Status during the 1<sup>st</sup> Cover Open operation (REDUNDANT)**

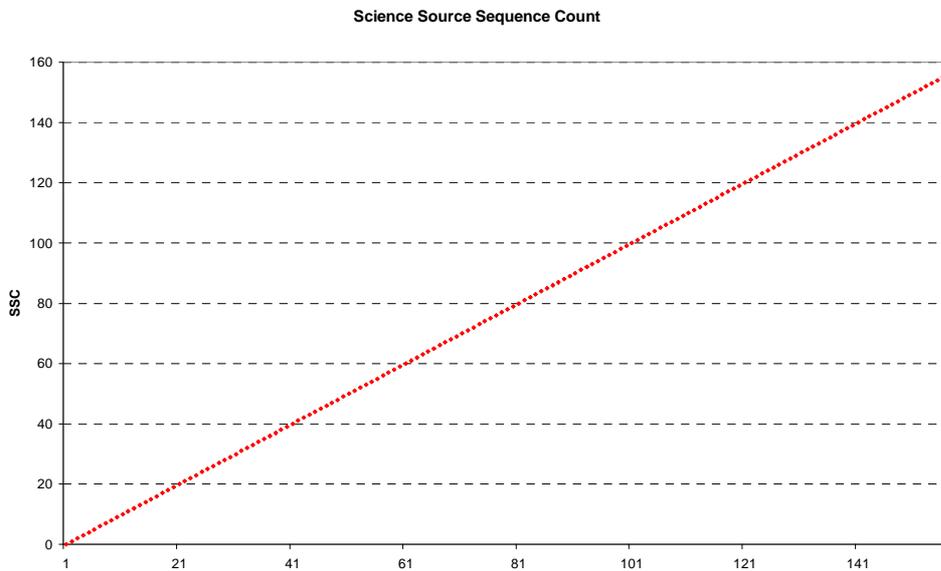
The science TM has been correctly received and no missing packets have been observed. Figure 29 shows the SSC of TM packets when GIADA is in Normal mode and science TM is enabled. The maximum flood of TM packets (typically 1 packet every 30s) was after the lasers were switched on. In this condition, several GDS 'ghost detections' on Left receiver were found with a rate of 1 detection every second. This is due to the level of the internal stray-light (background noise), which is caused by a contamination problem on the internal optics parts. The problem was found during the storage and pre-launch test campaign in Kourou. In this condition, the internal stray-light results in the order of the Left receiver detection threshold. Remark: the internal stray-light level remained the same even after a cleaning procedure was applied on the optics parts.

**Figure 29 Science TM packet Source Sequence Count (REDUNDANT)**

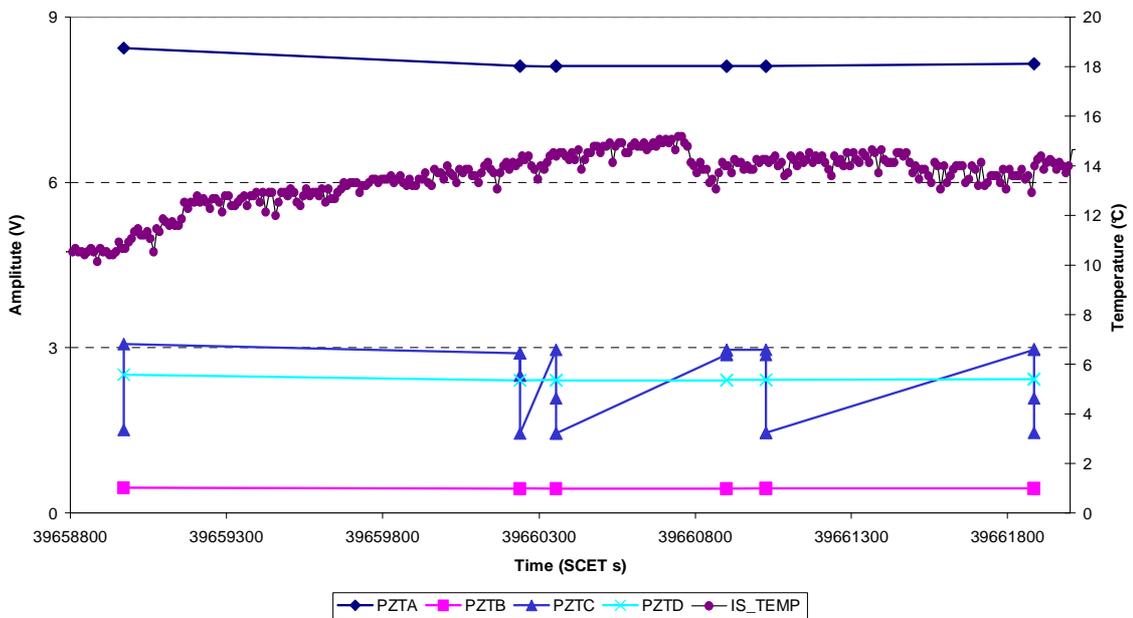
Figure 38 IS Calibration – A, B, C and D Amplitude when stimuli fall to 0V (REDUNDANT)

Figure 38 compares the measured amplitude of the IS channels (except the E channel) during the six internal calibrations. Only the channels output when the stimuli falls to 0V are reported in this figure. As we can see, Channel-C is confirmed not stable during the six calibrations (the amplitude varies from 1.5V to 3V), while the other channels are quite stable even if the amplitudes depend slightly on the IS temperature (e.g., Channel A decreases of 0.33V when temperature increases of about 3.5°C). This most probably is due to a combination of several causes: the stimuli amplitude, the channel peak detector error, the mechanical behaviour of the IS plate, etc.

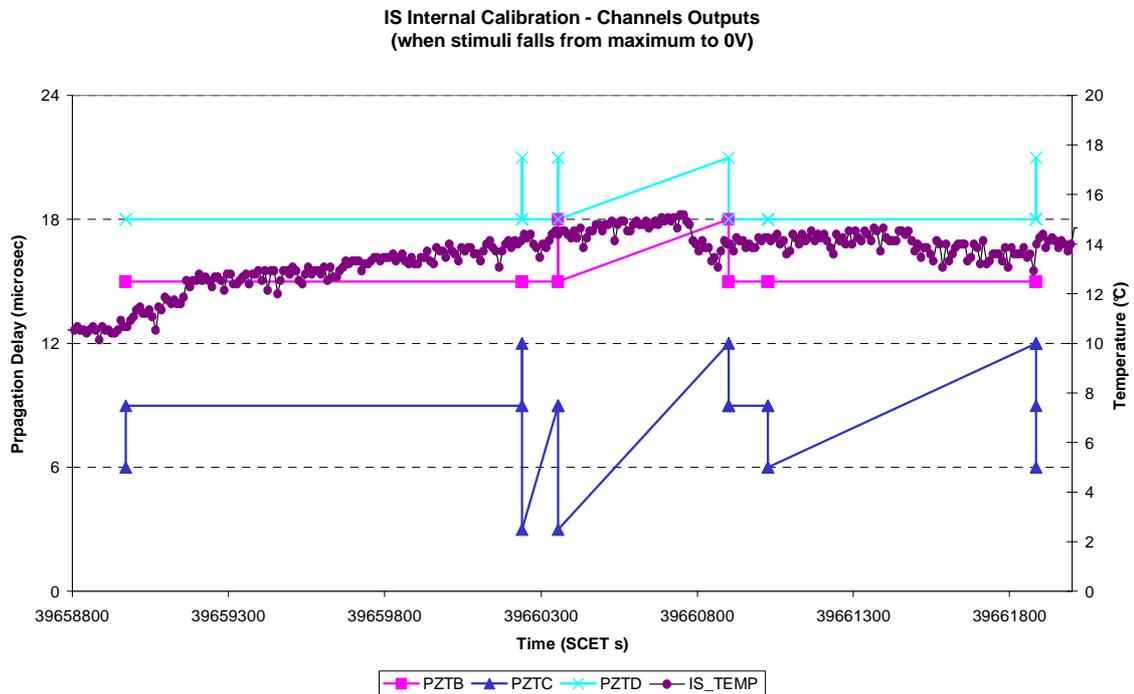
**Figure 39 IS Calibration – A, B, C & D delay time when stimuli falls to 0V (REDUNDANT)**

Figure 39 shows the measured delay time of the IS channels (except channel A, for which the delay time is always 0). This variation (except for Channel-C) is in the order of the time resolution (1 bit = 3  $\mu$ s). The Channel-C should be observed during the next GIADA operations and in case its behaviour is confirmed, it is suggested to increase its detection threshold to improve the reproducibility and stability of its detection.

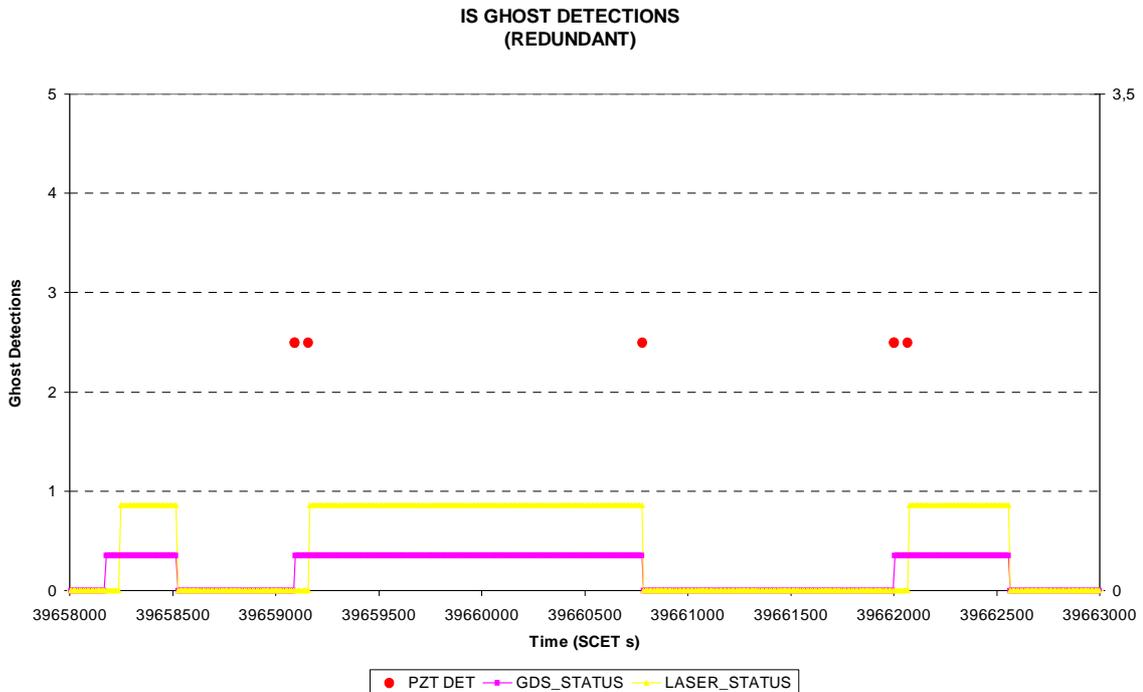
Only eight unexpected detections (ghost events) are observed during the test. Seven are normal IS detection, while the last one is a combined IS+GDS detection. They are observed when the GDS and Laser power relays have been switch-on or off (refer to Figure 40). This behaviour was expected, since already observed during on ground testing (refer to UM). The Table 4 shows the output voltage and delay time of the five channels. As we can see the voltage measured after the detections is below the detection thresholds (50mV); this means that the noise levels (induced by power relays on or off) are very low and in any case below those observed during the on-ground testing.

**Figure 40 IS Ghost detection wrt GDS/Laser switch-on/off (REDUNDANT)**

In conclusion the IS sensor behaviour does not depend on the other sub-systems (in particular GDS and Laser), except at their power-on/off (i.e., when the power relays are turned on or off). In this condition some ‘ghost detections’ can be observed. As expected, the performance of the sensor depends slightly on the temperature, which is measured just after the detection so that output can be corrected.

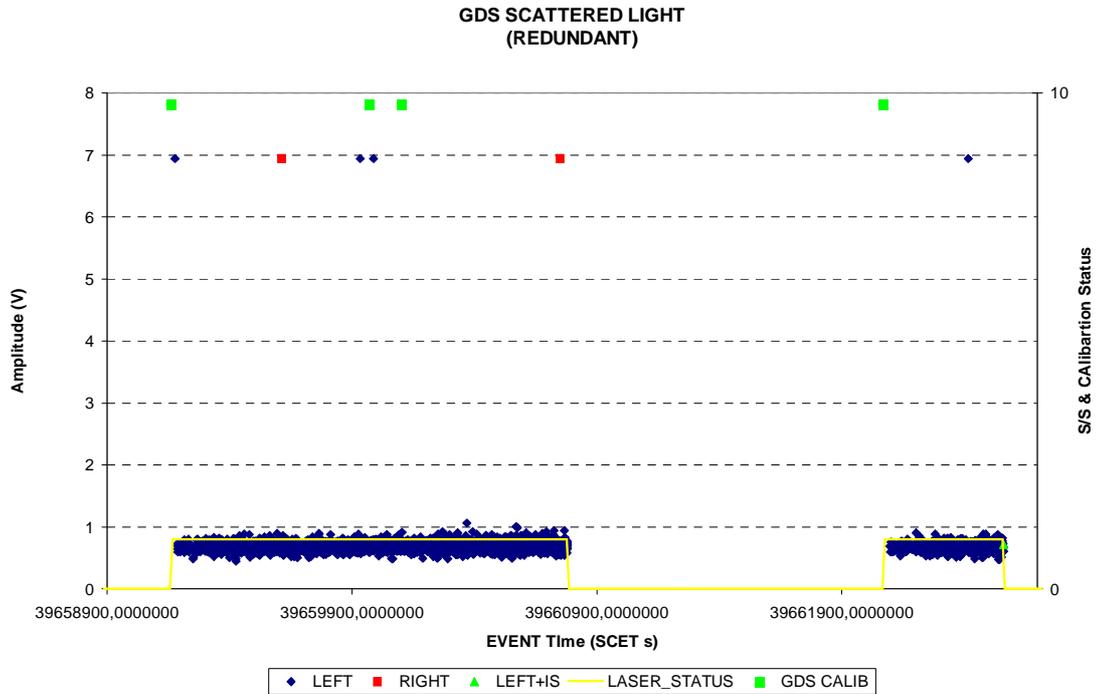
In summary, as soon as the Lasers have reached nominal power, the internal stray-light, due to contamination problem, has produced several ‘ghost detections’ on Left channel. The next two figures show the detections on Left and Right receivers and their relevant amplitudes.

**Figure 45 GDS Scattered Light (Left and Right Receivers) (REDUNDANT)**

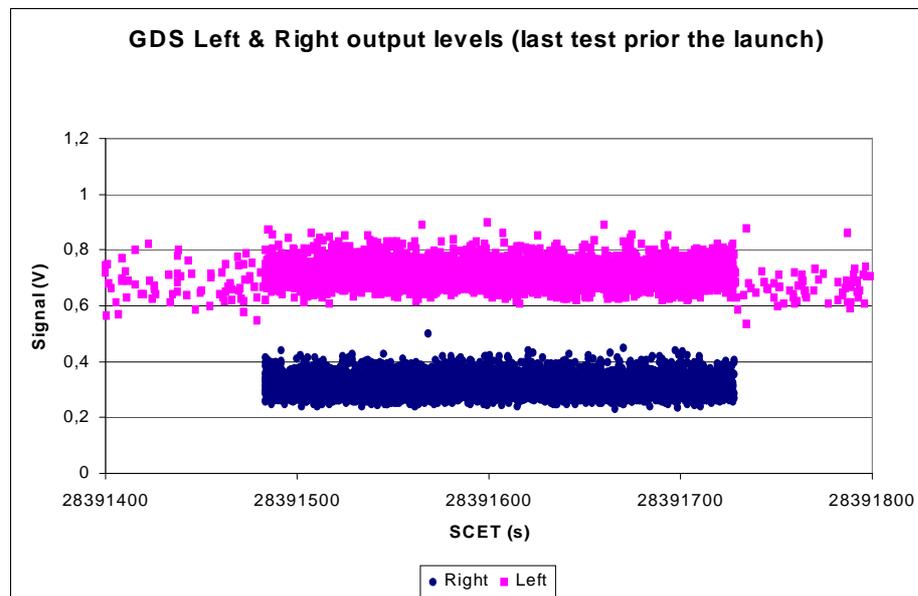
- The first, in which the detections amplitude is of the order of 0.8V (Left channel); these are ‘ghost detections’ due to the high level of the internal stray-light (contamination problem). The noise level is confirmed of the same order than that found before launch (refer to Figure 47). In order to minimise these numbers of detections (and thus the data rate and production), the detection threshold of Left channel should be increased at least at 1V. It is suggested to keep under control this situation and only after a consolidated behaviour, update the value in the context file.

**Figure 47 GDS Left & Right output levels measured prior the launch**

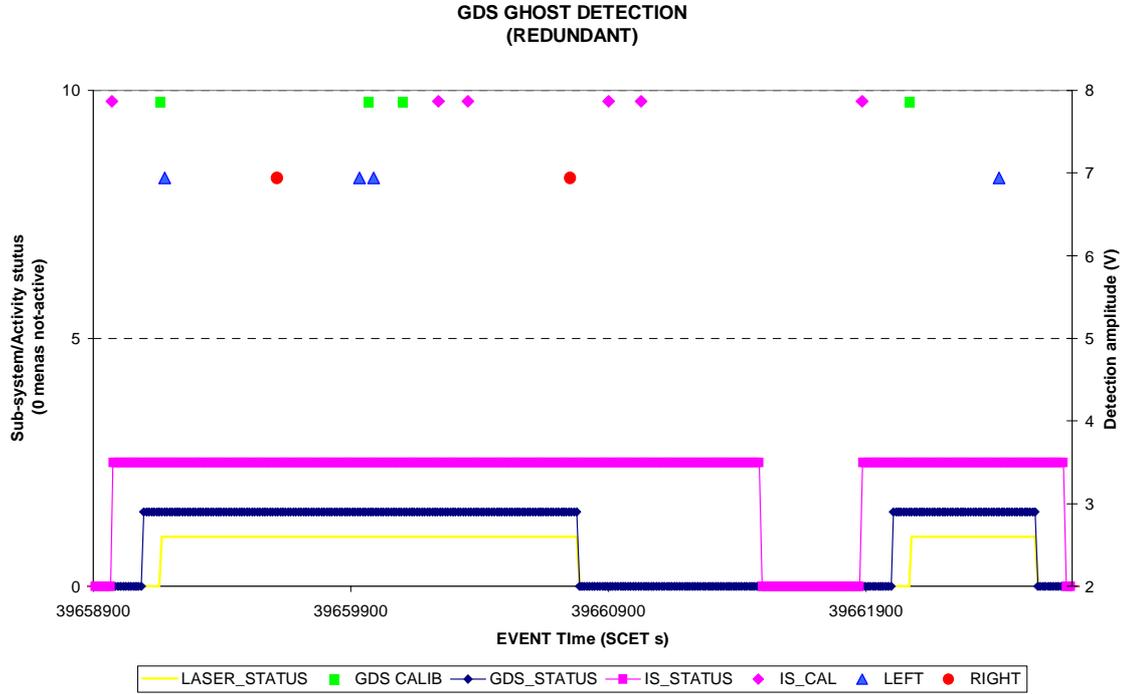
- The second type, in which the detections amplitude is 6,9375V on Left and Right receivers. These detections were sporadic and they are seven. The amplitude of 6,9375V, means saturation. The first and fifth detections happened when laser power relay was switched-on and off: they are ‘ghost detections’. The remaining detections seem not related to a particular GIADA internal activity (e.g., an internal calibration, a relay switch-on/off, etc.) and therefore can be supposed ‘real’ detections. Unfortunately this conclusion cannot be practically demonstrated. The science team, if needed, will perform further analysis.

**Figure 48 GDS Left & Right detections with amplitude above 7V (REDUNDANT)**

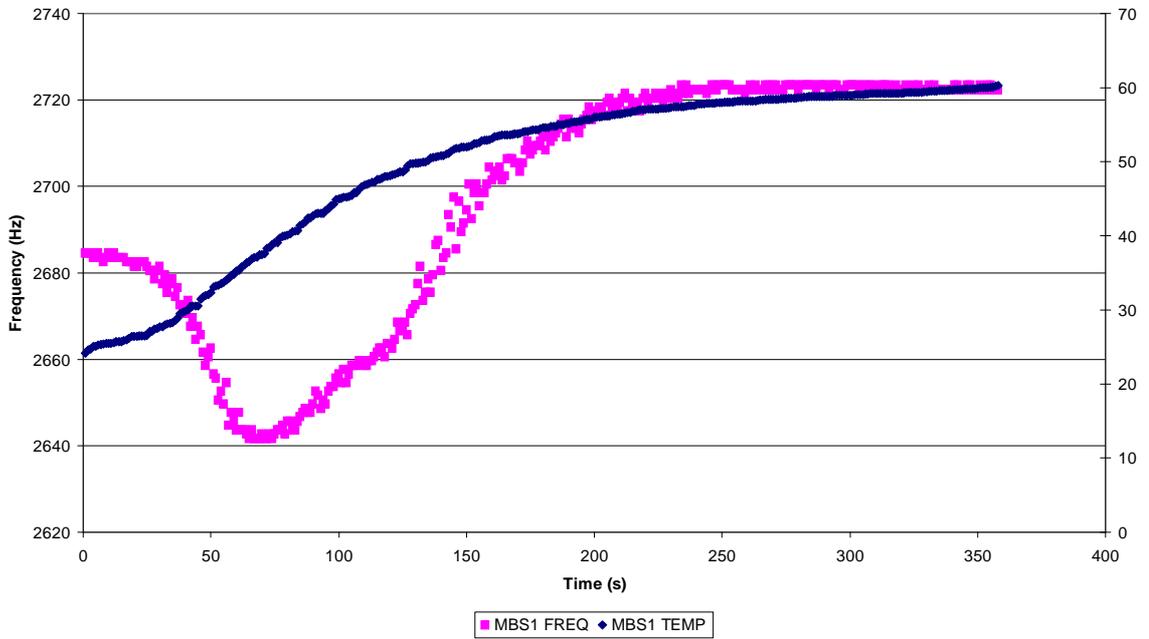
**Remarks:** This discrepancy is a known behaviour of the MBS unit, which was already detected during on-ground test campaign, when the MBS temperature changes too fast (temperature gradient  $> 1^\circ\text{C}/\text{minute}$ ), as during heating process. On MBS1, a  $\Delta t$  of  $30^\circ\text{C}$  is reached after 200s; this means a thermal gradient of about  $9^\circ\text{C}/\text{minute}$ , as we can see in Figure 53.

Figure 53 Frequency and Temperature during MBS1 heating (REDUNDANT)

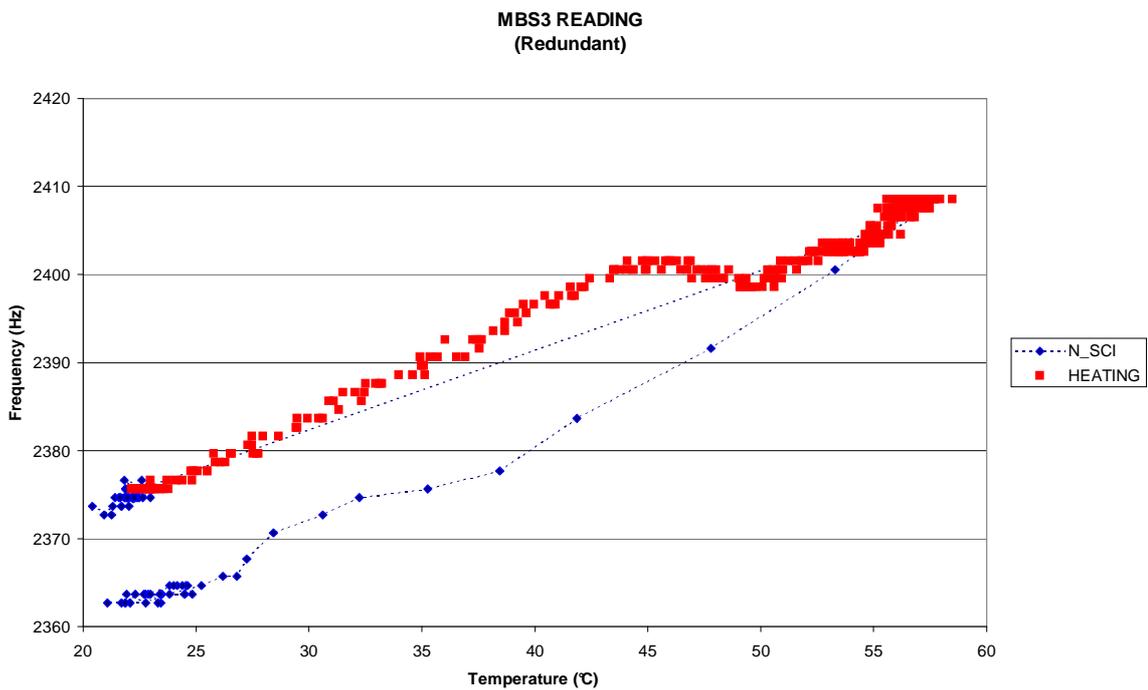
As reported in Figure 58, the frequency value after the completion of the heating, when the temperature is returned to its initial condition, is different from the value before the start of the heating (measured  $\Delta$ Frequency is about 11Hz). For MBS3, the frequency shift results inside the expected range ( $\pm 3$  Hz/ $^{\circ}$ C).

**Figure 58 MBS3 Frequency wrt temperature in Normal Acquisition and heating  
(REDUNDANT)**
