Title: **GIADA FS MODEL REPORT OF IN-FLIGHT INTERFERENCE SCENARIO PART 1A (20 - 21 SEPT '04)**

## GIADA FS MODEL

This document reports the II part of the in-flight commissioning activities performed on GIADA experiment in the period from 20 and 21 September 2004 (Interference scenario 1A).

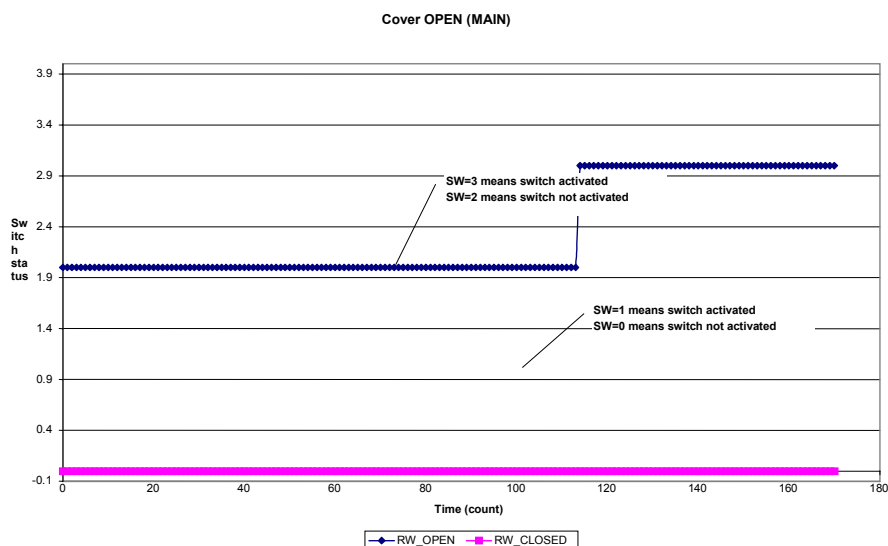
**Figure 8 Reed switches Status during the Cover Open operation (MAIN)**

Only the second condition is shown in Figure 8, while the first does not appear. This means that the starting position was with the cover not completely closed, most probably due to the last closing operation at commissioning, when the cover bounced due to repeated closing procedure.

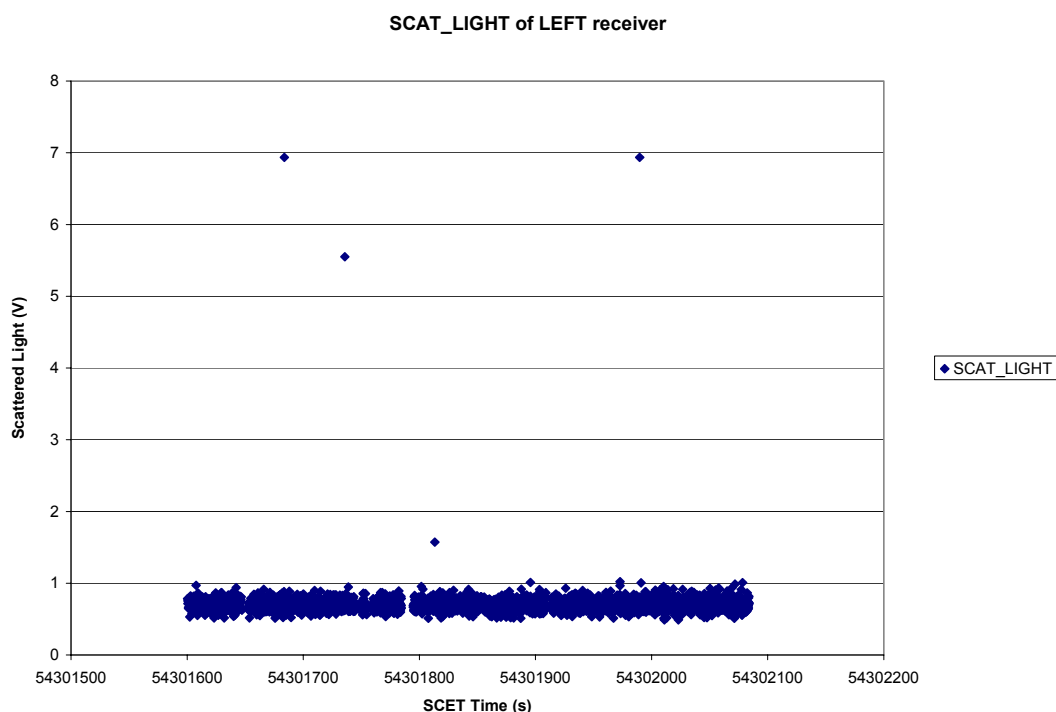
***Figure 11 GDS Detection (Left Receiver) – MAIN***

The scattered light on the left channel shows an average value of 0.707 V and a standard deviation of 0.175 V. The absolute value is slightly larger than that measured during the first commissioning (0.67 V), while the standard deviation has increased (it was < 50 mV).

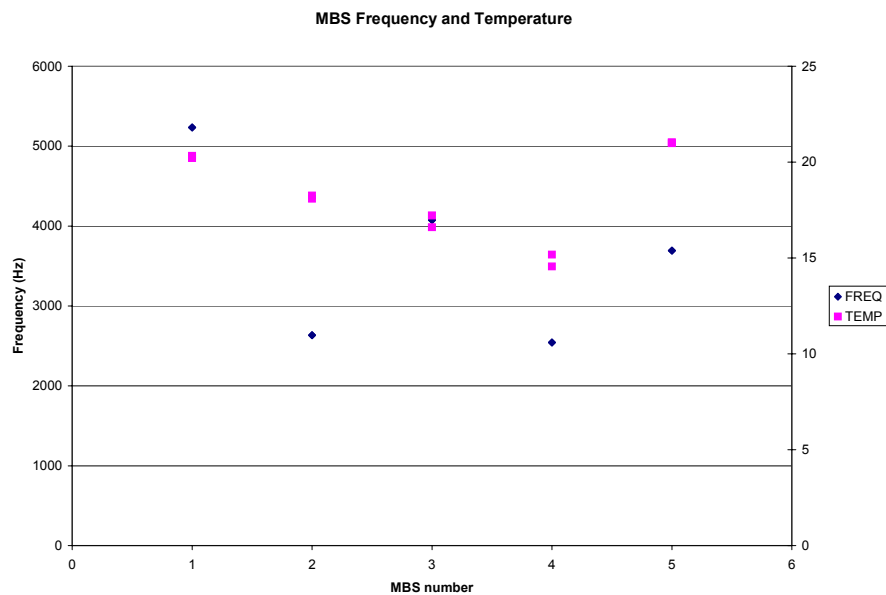
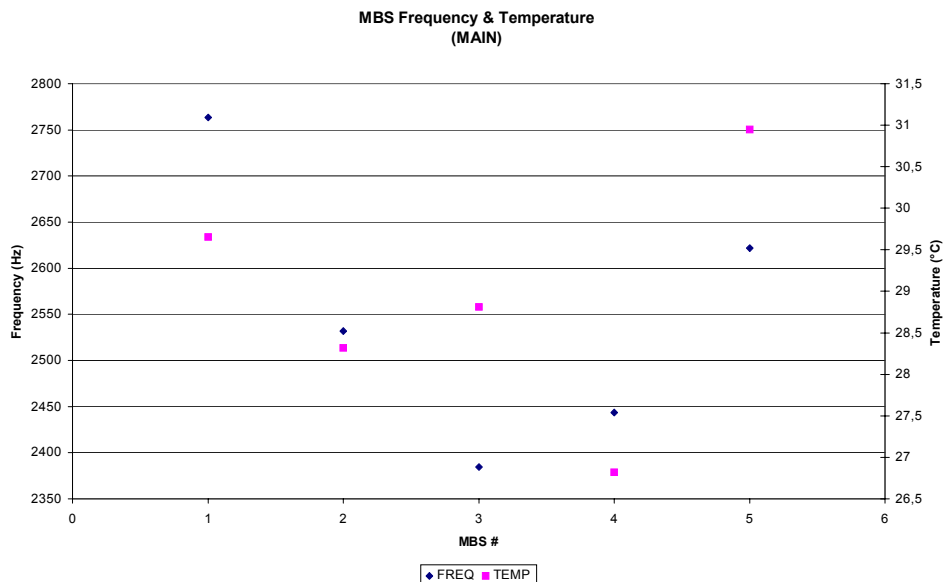
**Figure 13 MBS Frequencies and Temperature (MAIN)**

Comparing the frequency acquisition during this test with those at the first commissioning, a significant increase of frequency of the MBS1, MBS3 and MBS5 is observed (see the two figures below). This point has to be investigated for the future tests.

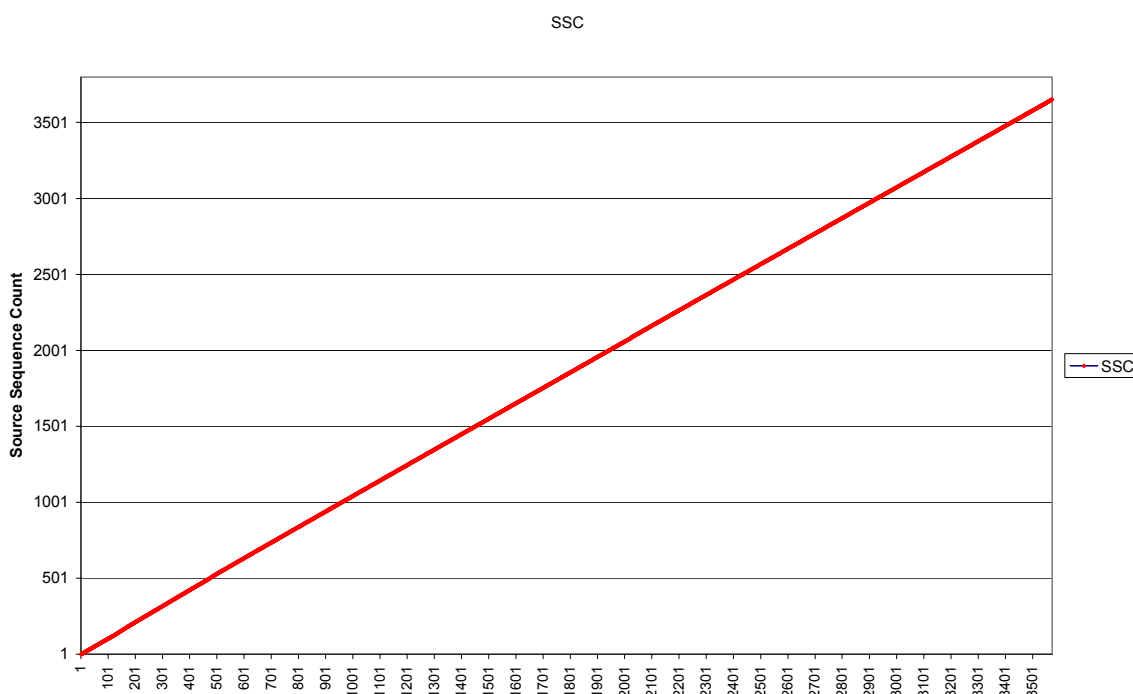
***Figure 26 Science TM packet Source Sequence Count***

Figure 26 shows the SSC of TM packets when GIADA is in Normal mode and science TM is enabled. The flood of TM packets (from a range of one packet every 7.5 s, at the begin of test, to one packet every 1.3 s, at the end of the test) was observed after the lasers were switched on. In this condition, several GDS ‘ghost detections’ on the Left receiver were found (GDS production rate is discussed in Section 5.2.3.2) due to the level of the internal stray-light (background noise) in combination with the electronic noise. N.B.: at the last test before launch and as confirmed at GIADA Commissioning in April '04, the internal stray-light was in the order of the Left receiver detection threshold.

**To avoid future flood of events, the detection threshold of GDS Left channel should be changed in the Context File.**

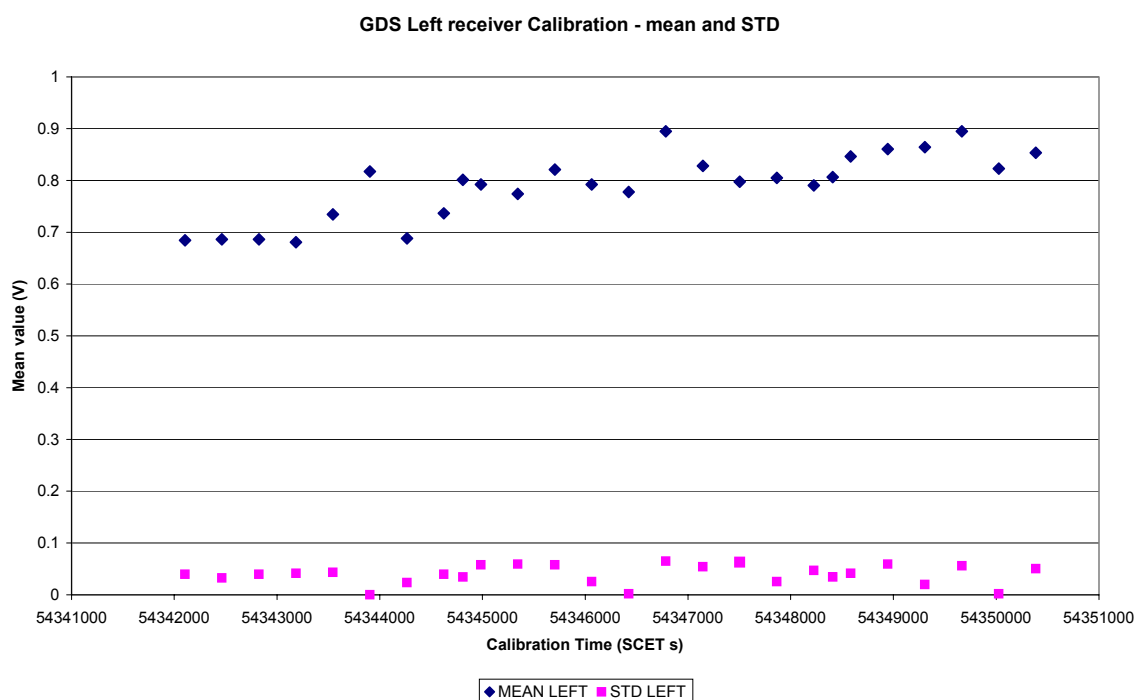
**Figure 35 GDS Calibration (Left & Right mean value and STD deviation)**

- At the begin of the test sequence, the mean value is approx. the same as the one measured during the GIADA Commissioning: it was 0.67 V with standard deviation ( $3\sigma$ ) < 50 mV, while now it is 0.685 V and  $3\sigma$  < 40 mV.
- Then, the mean value increases of about 0.2 V reaching at the end of the test 0.85 V and  $3\sigma$  < 65 mV.

The internal stray-light (in combination with the electronics noise) is above the Left receiver detection threshold and increases from the begin to the end of the test. This is also confirmed by the production rate of GDS ghost events, that is shown in Figure 41: it results lower at begin (about 1 packet every 7.5 s, i.e. 0.133 packet/s) and maximum at the end (about 1 packet every 1.3 s, i.e. 0.766 packet/s). Finally, Figure 36 and Figure 37 shows the laser light monitor and the laser temperature at the time of the GDS calibration.

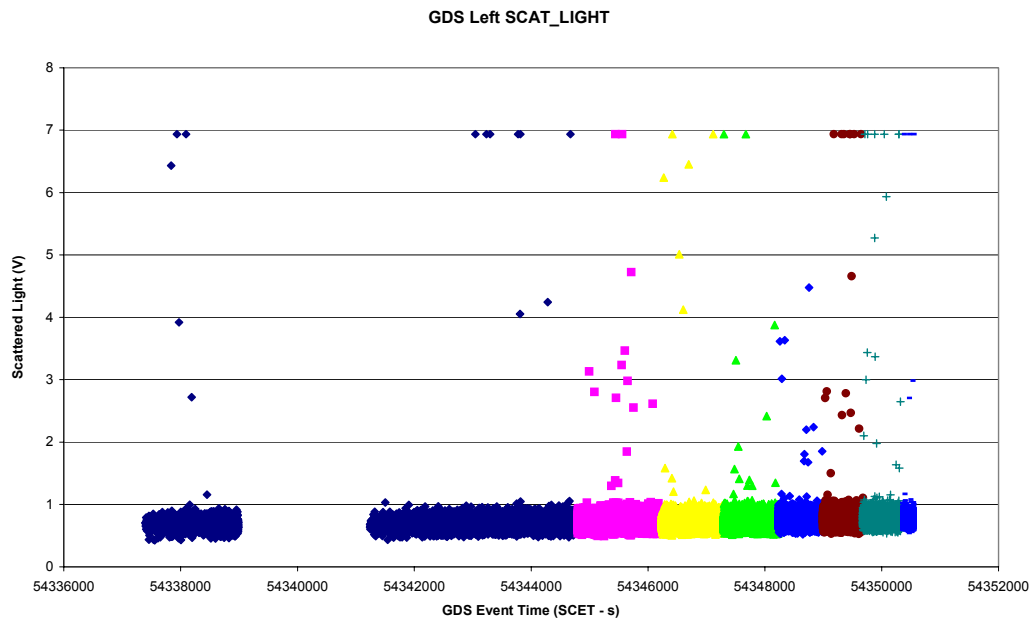
*Figure 38 Amplitude of 'ghost detections' on Left receiver*

Figure 38 shows the Left Receiver 'Ghost detections'. As in the 1<sup>st</sup> Commissioning (April '04) two 'detection' types can be distinguished:

- The first type in which the detections amplitude is of the order or little above of detection threshold (0.8 V); these are 'ghost detections' due to the high level of the internal stray-light, now in combination with the electronics noise. The noise level is confirmed of the same order than the one found during the 1<sup>st</sup> Commissioning in April '04 (see Figure 39) only at the beginning of the test. Then, when all the other experiment were operative and the GIADA internal temperature increased, the noise increased and went little above the detection threshold. Due to this high production rate (which is shown in Figure 41), it can be possible to saturate the SSMM Memory, but since the downloading rate was sufficiently high, the SSMM memory allocated for GIADA was not saturated during the test.

- The second type, in which the detection amplitude on the left receiver is well above the detection threshold or in saturation (6.9375 V). These detections have happened more often than in the 1<sup>st</sup> Commissioning and seem not correlated to any specific GIADA internal events (such as calibration or relay on-off switching). **An explanation could be the interference (conducted on the power line) of the other experiments.** Further dedicated analyses are needed to understand if they are correlated to specific operations of other payloads.

However, in order to minimise these numbers of detections (and thus the GDS data rate and production), the detection threshold of Left canal should be increased at least at 1-1.2V.

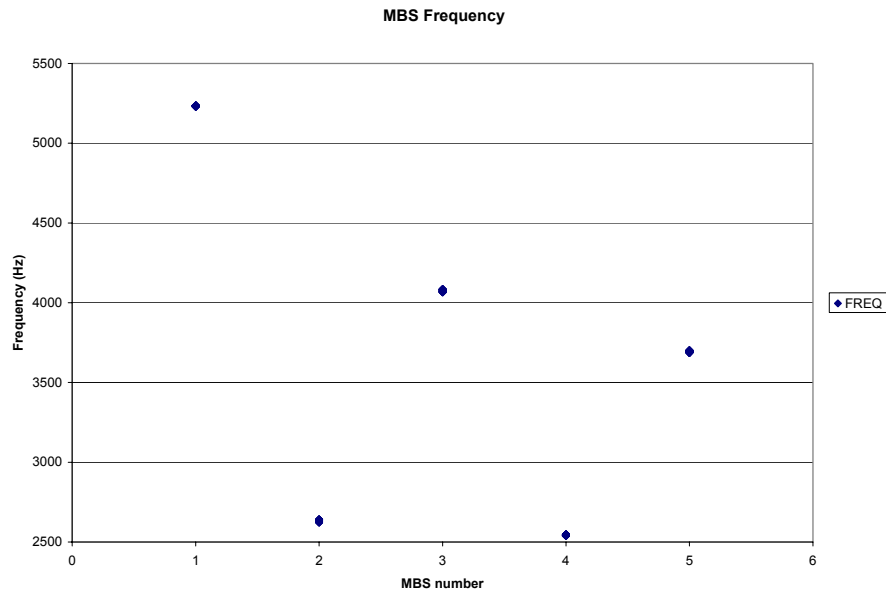
**Figure 43 MBS Frequency**

The MBS frequency for three of the MBS (1, 3 & 5) is confirmed to be significantly higher then in the 1<sup>st</sup> Commissioning.

This seems possible because of MBS in-flight contamination due to offgassing-volatilised material. **Reasons of this change must be investigated together with other experiments/payloads that have observed similar situation and may require MBS heating at the next GIADA-on opportunity.** From operational point of view, all MBS's work as expected and the frequency dependence vs. temperature (frequency shift due to temperature change) is consistent with the commissioning data.

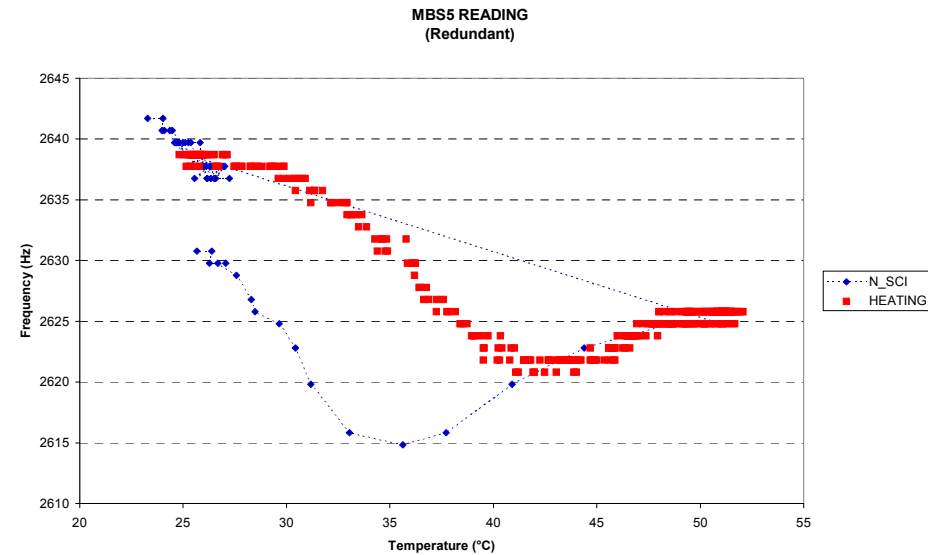
**Figure 56 MBS5 Frequency wrt temperature in Normal Acquisition and heating @ Commissioning (April '04**

- The MBS5 frequency (which points to the +Zu direction) is increased of about 1000Hz, from 2430Hz (data taken during the GIADA Commissioning, refer to Figure 56) to about 3686Hz @ 25°C.
