Title: **GIADA FS MODEL REPORT OF IN-FLIGHT POINTING SCENARIO (23 & 30 SEPTEMBER '04)****GIADA FS MODEL**

This document reports the activities performed on GIADA experiment on the 23 and 30 September '04 (Pointing scenario).

This report is applicable to GIADA FS model on board the Rosetta S/C now flying @ about 74.2×10^6 km from the Earth (about 4 minutes of delay between the S/C and Earth in the radio link communication). The data have been retrieved from DDS by means of the PI Workstation located @ INAF - Osservatorio Astronomico di Capodimonte in Naples.

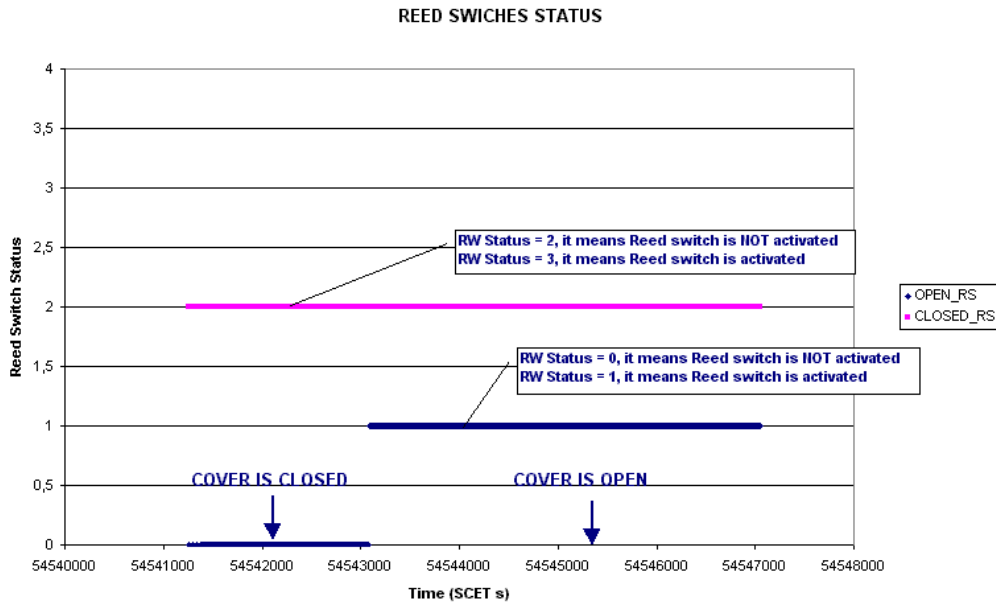
Figure 3 Cover Reed Switch Status (Cover open & close operations)

The instrument cover was successfully opened and closed by command sequences at the expected time. **Unfortunately the second cover close attempt, which was run during the Power Off OBCP, failed and at the end of the procedure the cover resulted unexpectedly open.** In Figure 3, it is shown the status of the two reed-switches that indicate the open position of the cover. The status of the 'open' reed switch remained active also at the end of power off: **this shows that the cover remained open** (details are reported in Section 5.1.2.1, in which the status of the two reed switches as decoded from the Cover Reports are reported).

The status of the 'closed' reed switch remained always not-activated: this is nominal, because when the cover reaches its closed position, the reed switch is still not active (the switch is active only for few steps before the close position is reached) and the transit in front of the 'closed' reed switch is performed in a time shorter than the sampling rate of HK telemetry, i.e. 10s (thus the described transition cannot be seen in the HK TM report!).

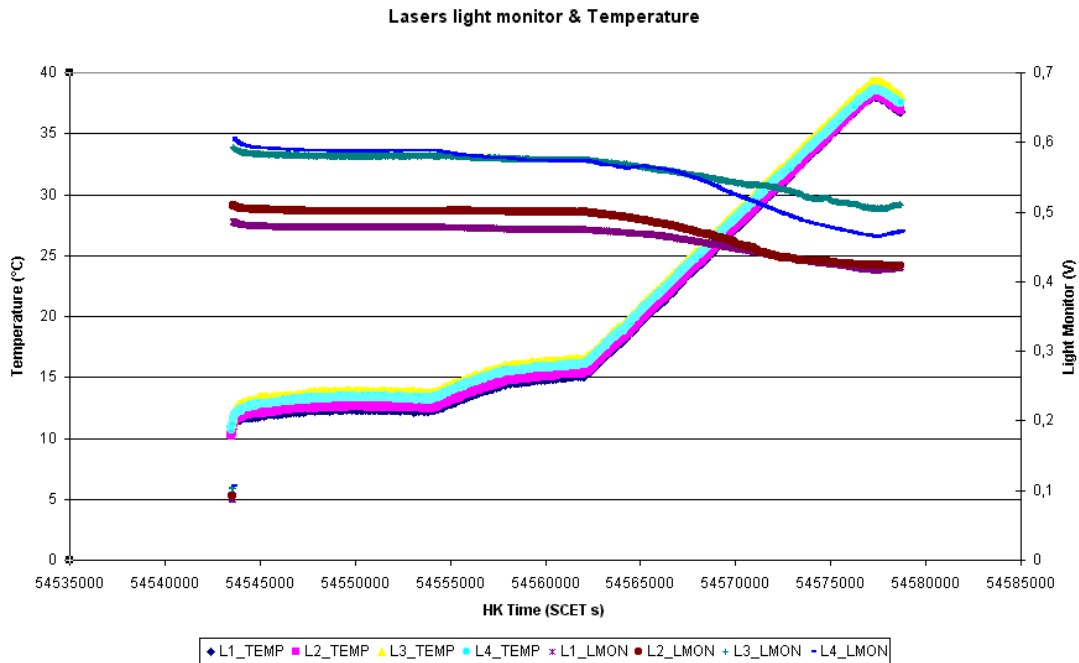
Figure 7 Laser light monitor and temperatures

The laser light temperatures (Figure 7) increase from 8°C to about 40°C. As expected, the light of each lasers decreases when the temperature rises up.

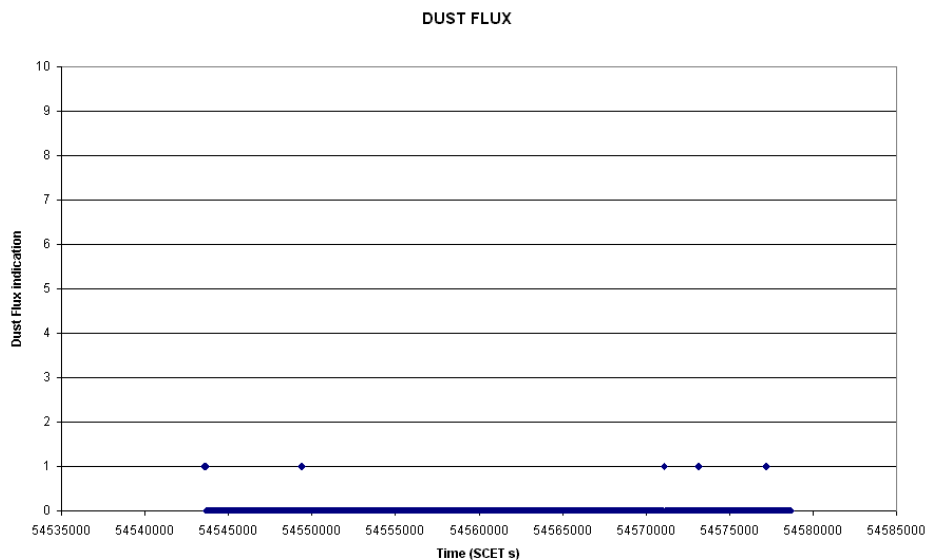
Figure 9 Dust-Flux Monitor (valid only when the IS sub-system is ON)

The Dust Flux indication is > 0 (Figure 9) four times: the first 1 minute after the sensor switch-on (in which - as understood on ground - few IS ghost events can be observed) and the other 3 sporadic during the test. The reason is that channels A and C have detected few 'Ghost events', due to internal noise level when Gain is High.

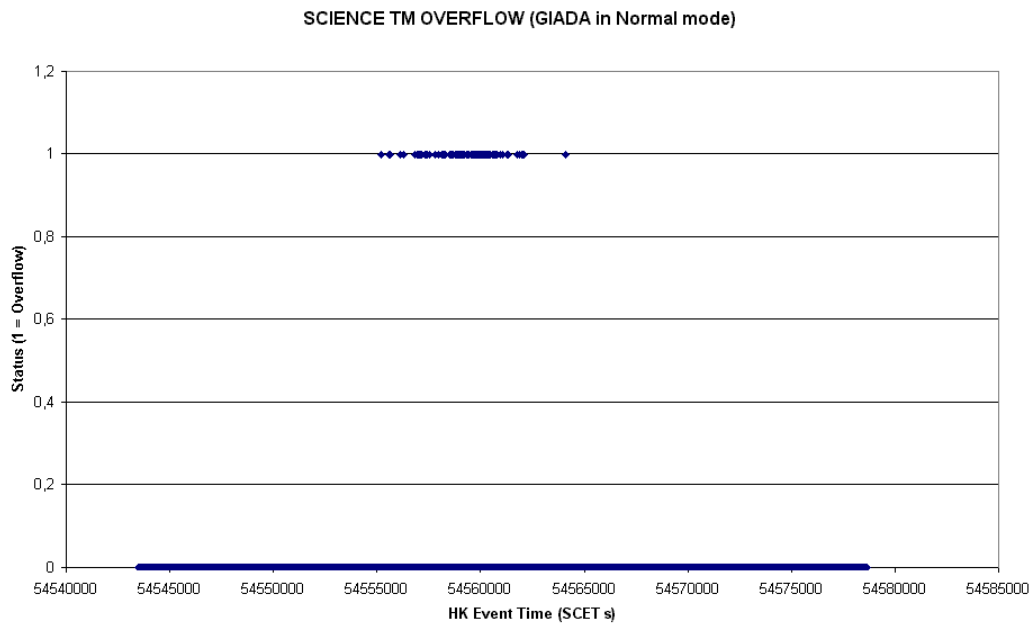
Figure 11 TM overflow monitor

Figure 10 and Figure 11 show the Source Sequence Count of HK Telemetry and the science TM overflow flag versus time, respectively. **No missing HK packets have been found in the TM, while the science TM has been overflow due to a flood of the GDS ghost detections**, in the period when the GDS receiver was not saturated due to the stray-light induced by sun illumination. This, consequently, has provided an SSMM memory overflow and, thus, a loss of the science packets.

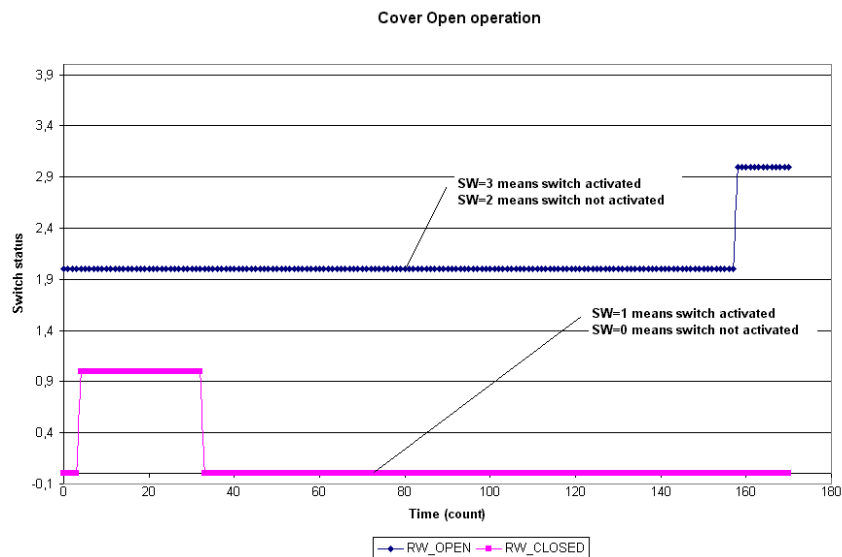
Figure 12 Reed switches Status during the Cover Open operation

After the cover open operation, the cover resulted completely open, as shown in Figure 12, in which the status of the two reed-switches is reported. The figure is extracted from the cover report, which is received on-ground at the completion of the operation (@SCET time 54543084s, corresponding to about 06:51:40 UTC Time of 23 Sept 2004). The correct behaviour of the operation is when the sequence of the following conditions appears:

- The reed switch that indicates the Cover-Close position (named RW_CLOSE) starts not activated, and then it is temporarily activated after the start of opening operation for a short number of steps (expected value: 29-30 steps).
- The reed switch that indicates the Cover-Open position (named RW_OPEN) is activated after 124-125 steps and remains permanently in this status.

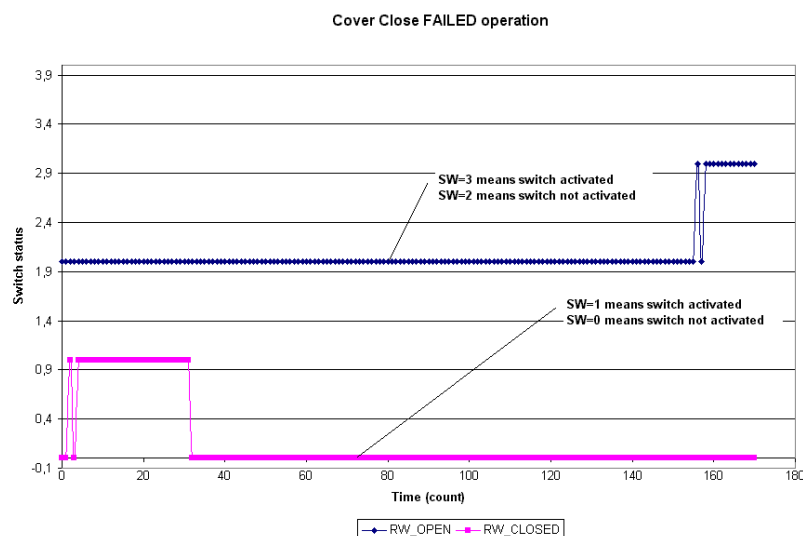
Figure 14 Reed switches Status during Cover Close FAILED operation

During the power-off, the GIADA cover is automatically closed by the OBCP (Close Cover) despite its actual position (operation happened @ 17:04:15 UTC time of the 23 Sept. 2004). Since the cover was already closed (by the previous Close Cover operation), the new close cover operation resulted unexpected: at the beginning the cover bunched over the cover support, then it reversed its movement and it came to the open position. This is in line with the status of the two reed-switches in Figure 14, in which the reed switch indicating the Cover-Open position is active at the end of the movement (in nominal operation it should be not active at all) and the other is activated only few times (while in nominal operation it should be activated several times).

During the successive data post-processing, which was performed in real time by PI team, a not expected cover final position was found: cover remained in the open position after the second close operation. Therefore a recovery procedure was suddenly initiated by asking to ESOC RMOC to run in-real time the following:

- Switch-on GIADA by the nominal Power-on FCP
- Wait few minutes and check the HK telemetry to control the status of the two Reed-switches indicating the open/close cover position
- Switch-off GIADA by means of the embedded Power-off OBCP: the cover was automatically closed.
- Verify the Cover close by means of the received cover report and HK telemetry report. In case of correct status, the procedure is stop here otherwise it should be run again.

Having ESOC RMOC agreed on the proposed procedure, GIADA was switched-on again @ 20:18:58 UTC Time of the 23 Sept. (SCET = 54591522s). The power-on was successfully completed at 20:30:18 UTC time. After about 40 minutes, the GIADA power-off procedure was initiated and successfully completed @ 20:57:58 UTC Time (SCET = 54593861s) after having received the Cover Report Event. **At this time the cover resulted successfully closed.**

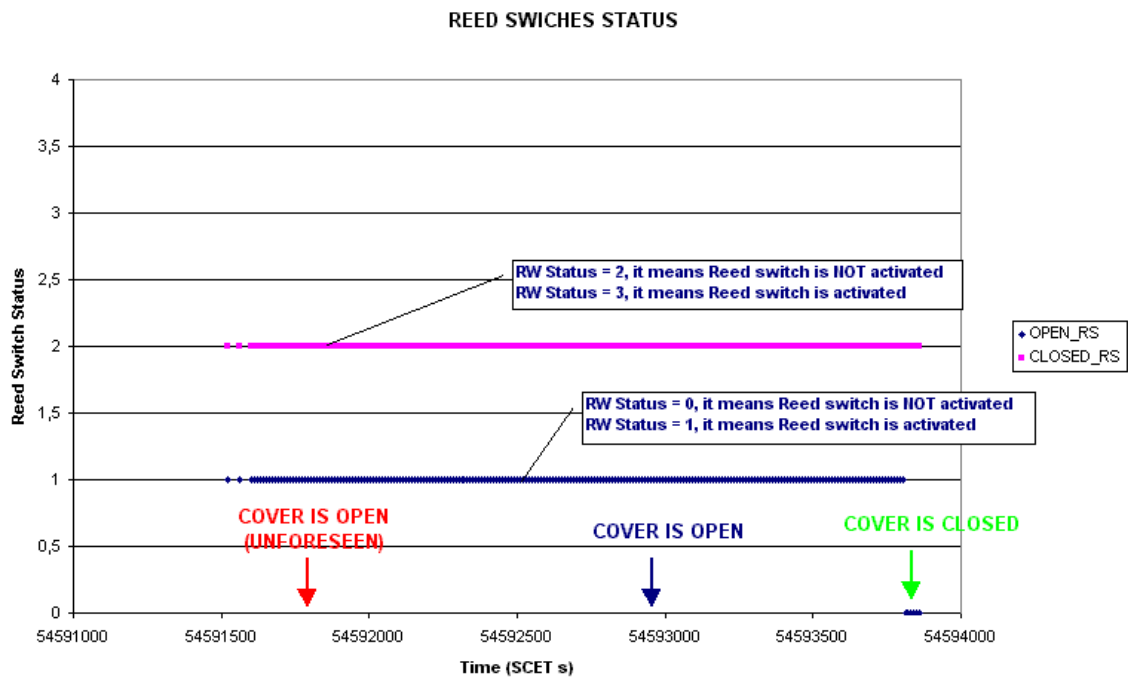
Figure 15 HK Reed switches status (during the recovery procedure)

In Figure 15, the two reed switches confirm that the cover was in open position (red coloured text) at the first power-off and then was successfully closed after the new power-off. These conditions are also confirmed by the Cover Report (refer to Figure 16) which was received @ 20:57:07 UTC Time of the 23 Sept. 2004.

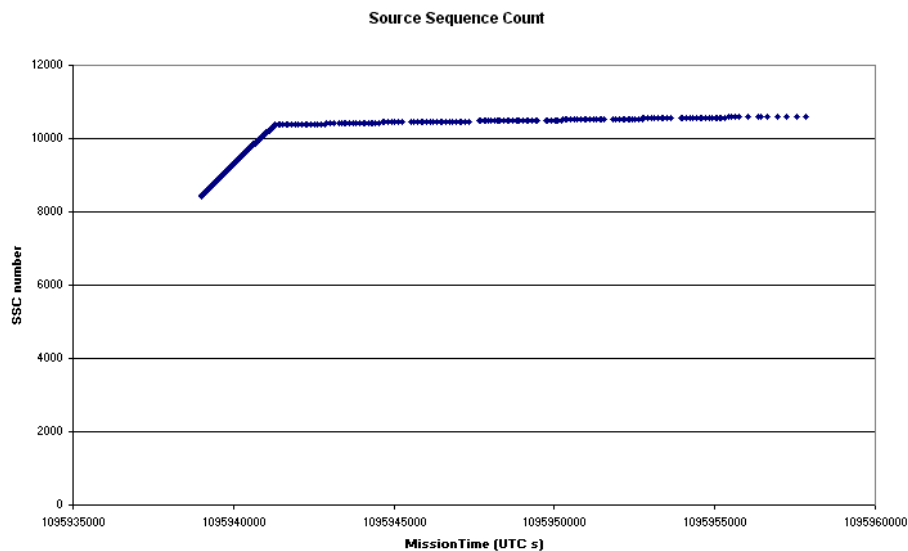
Figure 20 Science TM packet Source Sequence Count versus time

Many science TM packets were lost due to the **saturation of the SSMM memory allocated to GIADA (1 Mbytes)**. Figure 20 shows the Source Sequence Count of science TM packets when GIADA is in Normal mode and the science TM is enabled. The first 8437 science packets were completely lost. The flood of TM packets was observed after the lasers were switched on and until the sun illumination saturated the GDS receiver output (sun stray-light). In fact, due to the level of the internal stray-light (background noise) in combination with the electronic noise (as already seen in the previous Interference tests performed on 20-22 September), the GDS Left receiver provided several GDS ‘ghost detections’ (GDS production rate is discussed in Section 5.1.3.2). As the sunlight entered inside the GIADA aperture (sun angle < 70 deg), the GDS left and right receivers became saturated and no more GDS ghost events were produced. Consequently the SSMM started to empty by the downlink data rate and no more science packets were lost (Figure 21).

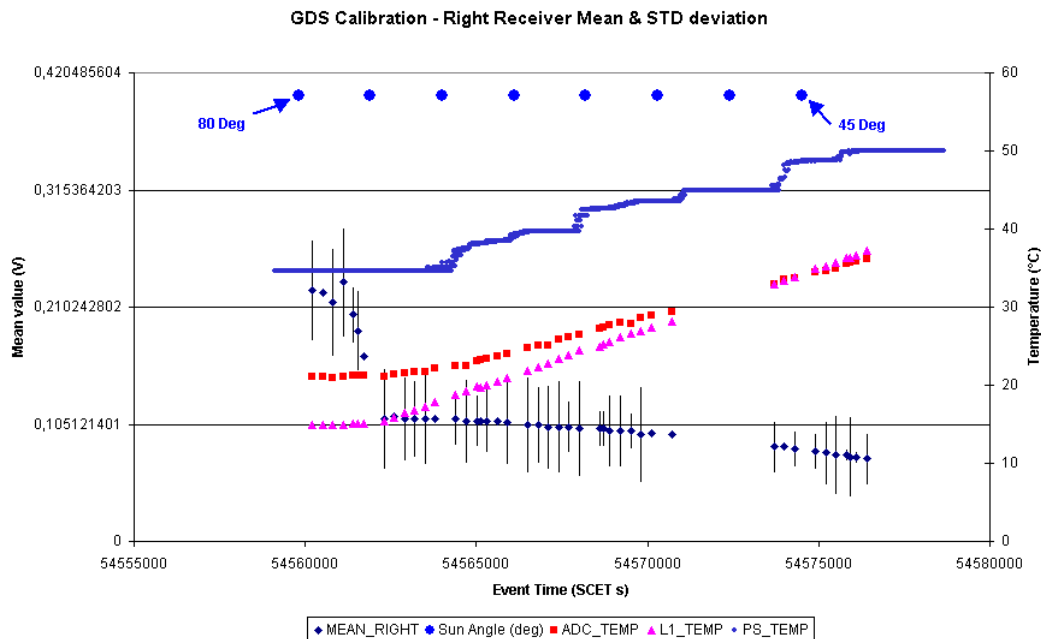
Figure 36 GDS Right Receiver Calibration (mean value and STD deviation)

As we can see, the mean value of the Right receiver is always below the detection threshold (only few ghost detections were observed on the Right channel). In particular three phases can be distinguished depending on the sun angle with respect to the S/C Z axis:

- From the beginning of the test (i.e. from the on-ground availability of the data) until the Sun angle has reached about 70 deg from S/C Z axis (Figure 6), in which the mean value is almost constant and it is about 0.22V. The standard deviation is below 50 mV.
- When the sun angle has reached about 70 deg (@ about 12:12:00 UTC), the mean value decreases from 0.22V to 0.11V and the GDS receiver becomes to be saturated. The standard deviation is below 30 mV.
- After this time up to the end of the test (Sun angle reached 45 deg), in which the mean value slowly decreases from 0.1V to 0.06V (possibly due to increasing of the lasers temperature). The GDS right receiver is saturated. The standard deviation is below 50 mV.

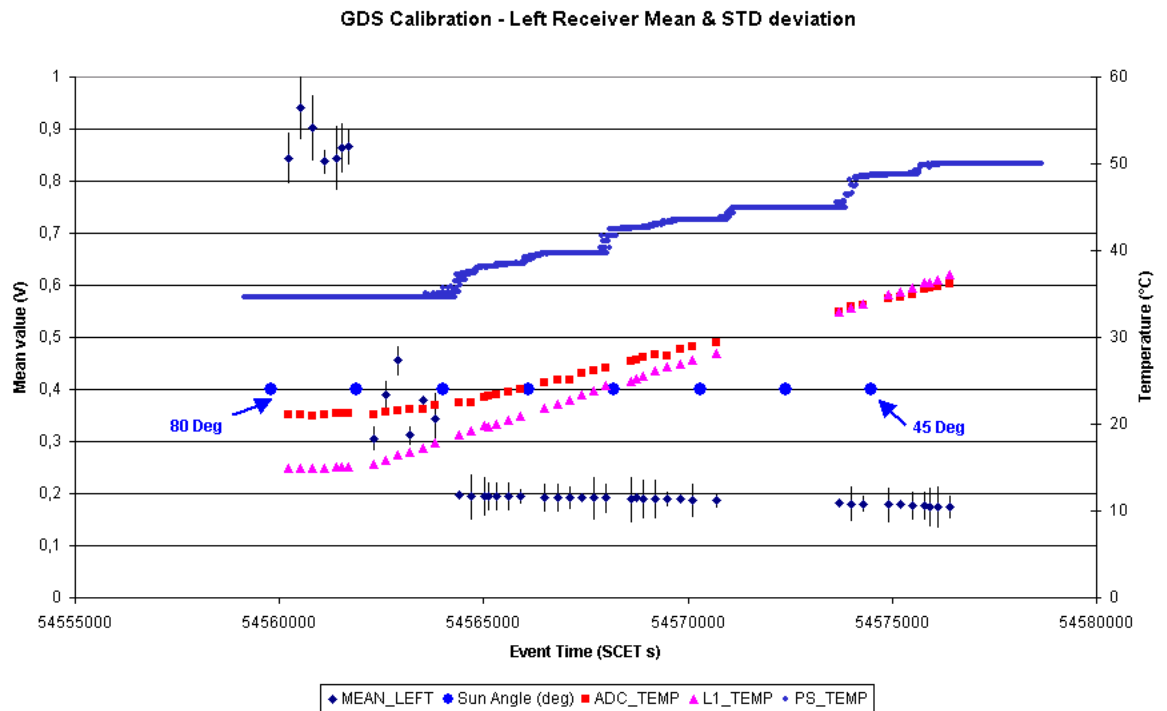
Figure 37 GDS Left Receiver Calibration (mean value and STD deviation)

When GDS is not in saturation, the average is about 0.87 V (minimum and maximum are within 0.86V and 0.94V), while its standard deviation is always below 70mV. The saturation occurs almost at the same time (i.e. with the same sun angle) of Right receiver. The mean level at saturation is 0.2-0.18V, which is slightly higher then for the Right receiver. The mean value slightly decreases when the temperature increases.

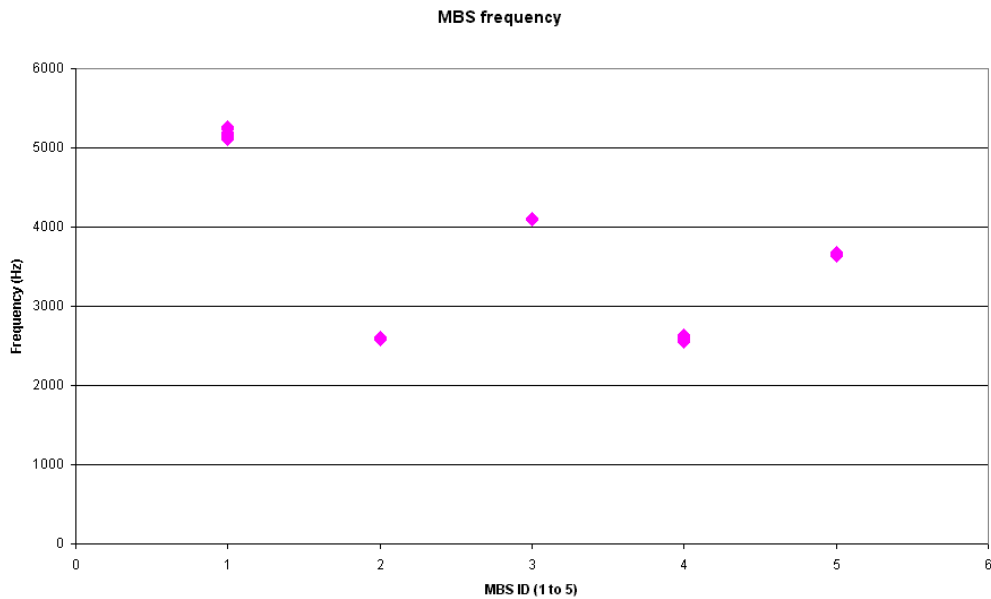
Figure 44 MBS Frequency

The MBS frequency for three of the MBS (1, 3 & 5) is confirmed to be significantly higher than in the 1st Commissioning. However, no significant deviations have been observed from the measurements taken during the Interference test, even if the MBS were heated up to 60°C due to the sun illumination.

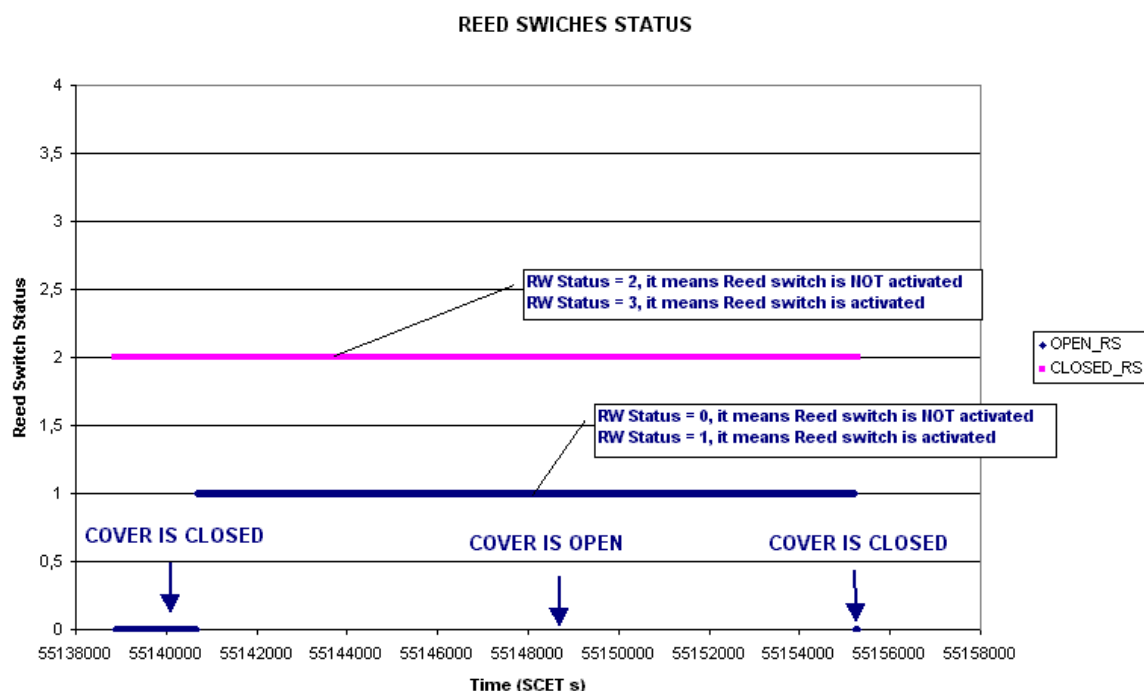
Figure 61 Cover Reed Switch Status (Cover open & close operations)

The Instrument cover has been successfully opened by command and closed by **Power Off OBCP** (the on-board FCP was changed after the previous experience of 23rd of September removing the command to close the cover before the Power-off OBCP). In Figure 61, it is shown the status of the two reed-switches that indicate the close and open position of the cover. The details are reported in Section 5.2.2.1, in which the status of the two reed switches as decoded from the Cover Reports is reported.

The status of the 'closed position' reed switch remains always not-active: this is nominal, because when the cover reaches its closed position, the reed switch is still not active (the switch is active only for few steps before the closed position is reached) and the cover closure is performed in a time shorter than the sampling rate of HK telemetry, i.e. 10s (thus the described transition cannot be seen in the HK TM report!).

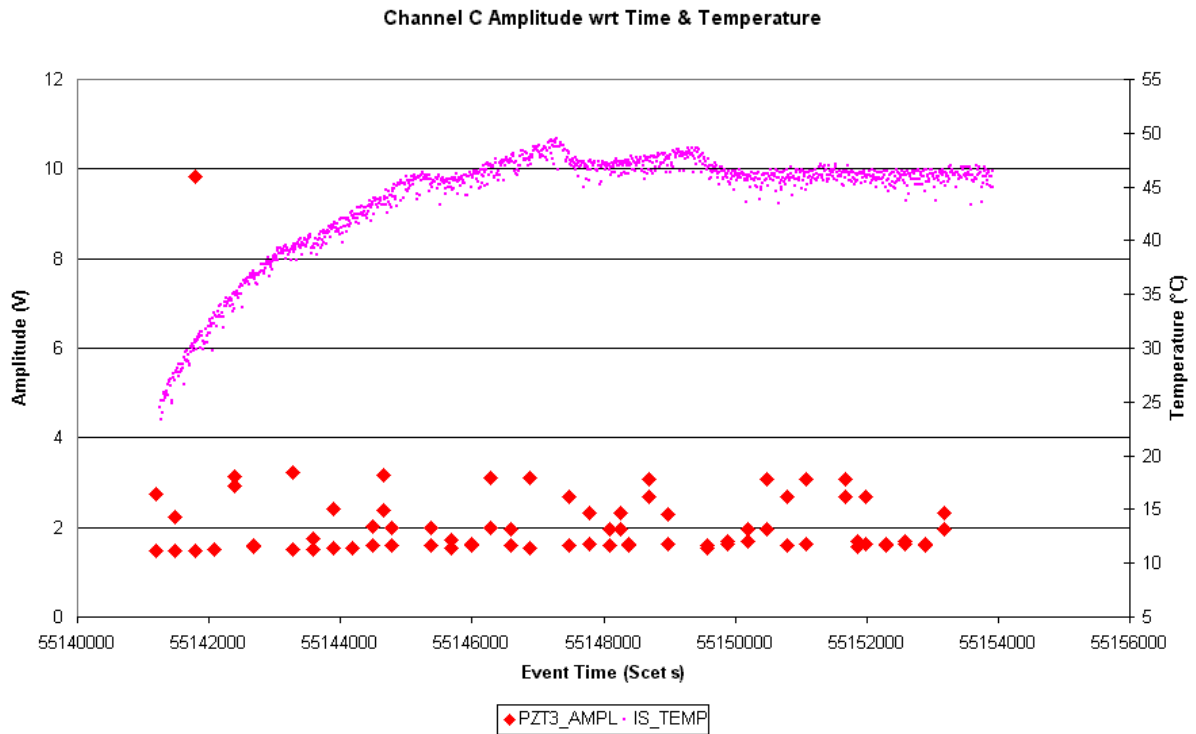
Figure 85 Channel C response wrt IS temperature

- Channel-C response is confirmed not stable along the test (refer to the voltage/delay time measurements of 2nd and 4th stimuli) and wrt. the temperature change (Figure 85 and Figure 86). The same behaviour is observed for the delay time, for which the variations are within 20-60 μsec . It is suggested to increase channel C detection threshold to 100-150mV for the next in-flight tests and compare the obtained results.

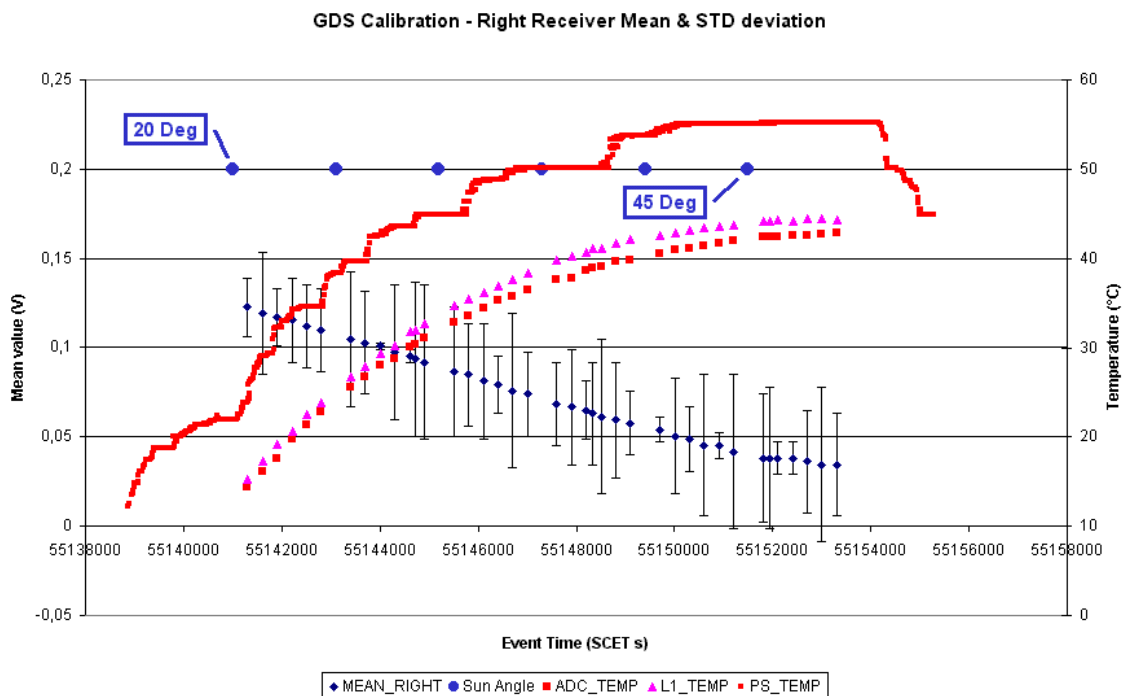
Figure 89 GDS Right Receiver Calibration (mean value and STD deviation)

In Figure 89, the mean value of the Right receiver is always saturated and below the detection threshold (no ghost detections observed on the Right channel). From the beginning of the test (sun angle 20 deg wrt. S/C Z axis) up to the end of the test (sun angle 45 deg wrt. S/C Z axis - Figure 6), the mean value is slowly decreasing from 0.12V to 0.03V, probably due to the increase of the GIADA internal temperature (the laser temperature is in the range 14 - 44°C). When the internal thermal equilibrium is reached, the calibration output becomes constant (variation is less than 5mV). The GDS Right receiver is always saturated. The standard deviation is below 50 mV.

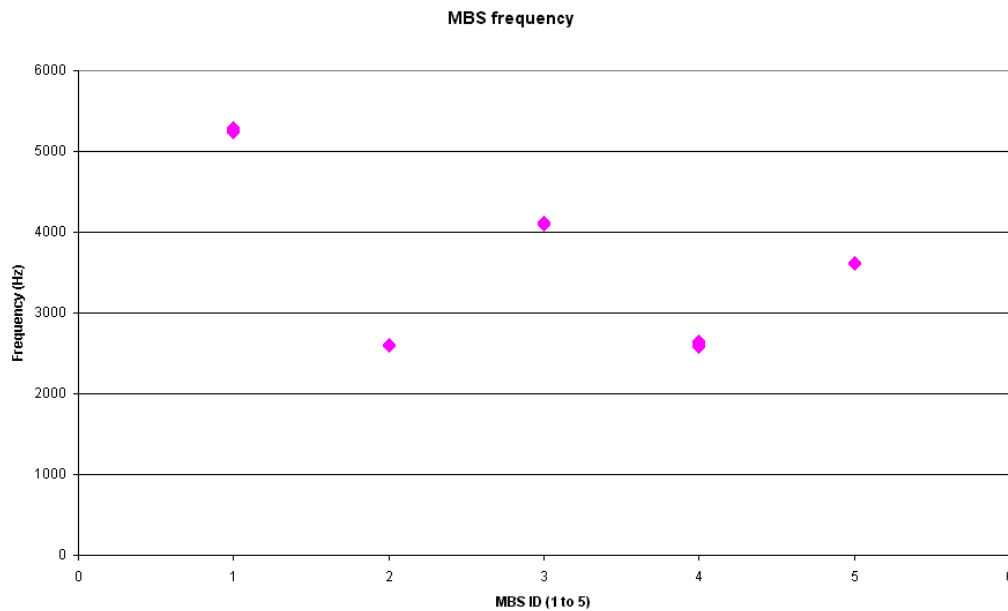
Figure 97 MBS Frequency

The MBS frequency for three of the MBS (1, 3 & 5) is confirmed to be significantly higher then in the 1st Commissioning. However, no significant deviations was observed wrt. to Pointing - I part (23 Sept. 2004), even if the MBS were heated up to 65°C due to the sun illumination.
