R O S E T T A
FLIGHT REPORTS
of RPC-MAG

RO-IGEP-TR-0015

Anomaly Report & Analysis

MAG-OB Failure in June 2005

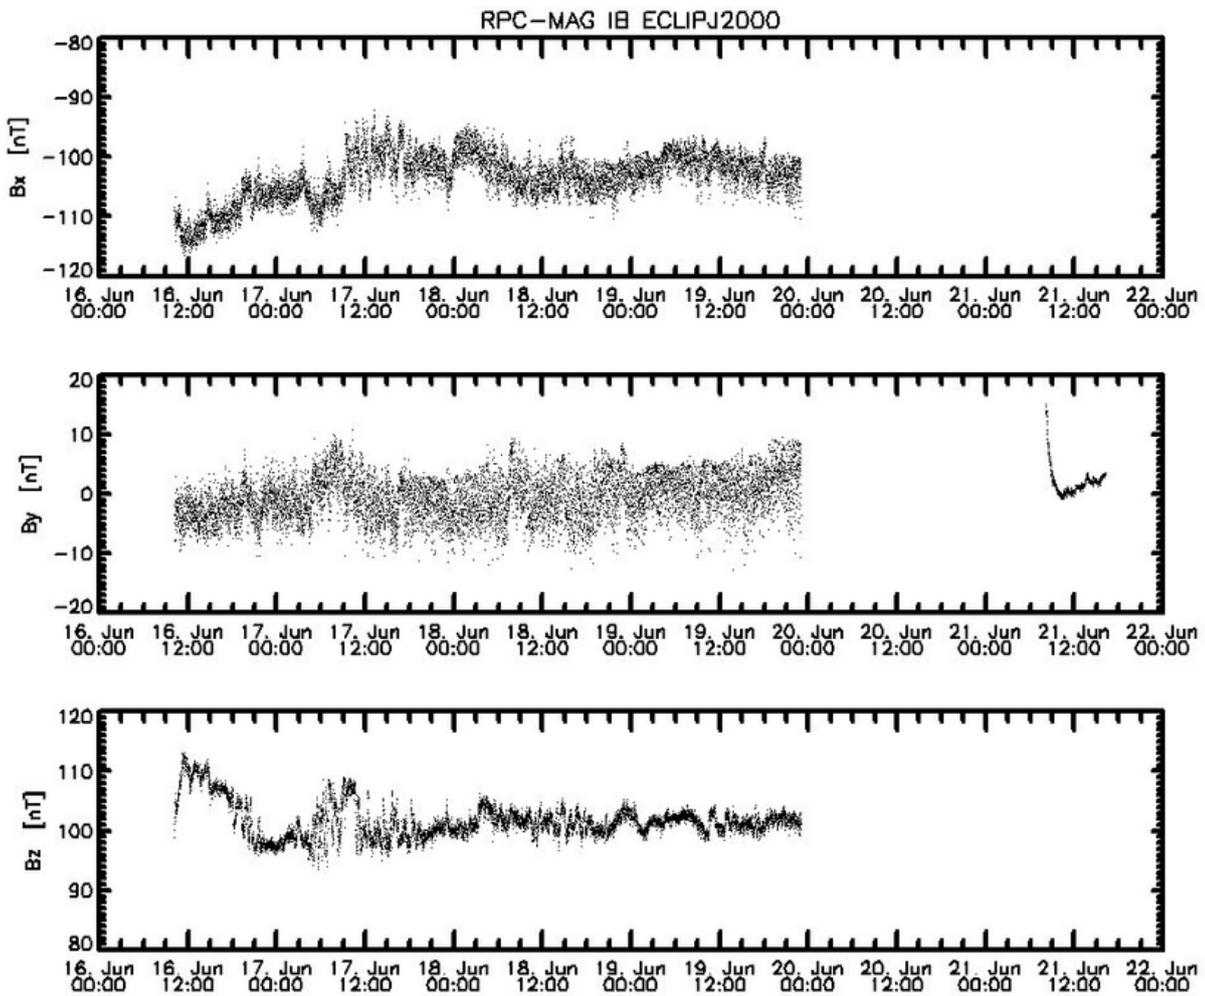
Figure 2: RPCMAG: Magnetic field measured with the IB Sensor

On the first view everything looked nominal. According to our HK data all necessary voltages had the right values (refer to the plots in Appendix B) and the RPC-MAG IB sensor transmitted reasonable data in the usual manner (refer to Figure 2). The OB sensor, however, sent a faulty signal (refer to Figure 3):

The increased noise level of the IB sensor is caused by the variations of the OB-Y sensor with an amplitude of some thousand Nanotesla. Both sensors are only 15 cm apart. Therefore, the huge OB-Y variations have a magnetic influence to the IB sensor in the order of some Nanotesla.

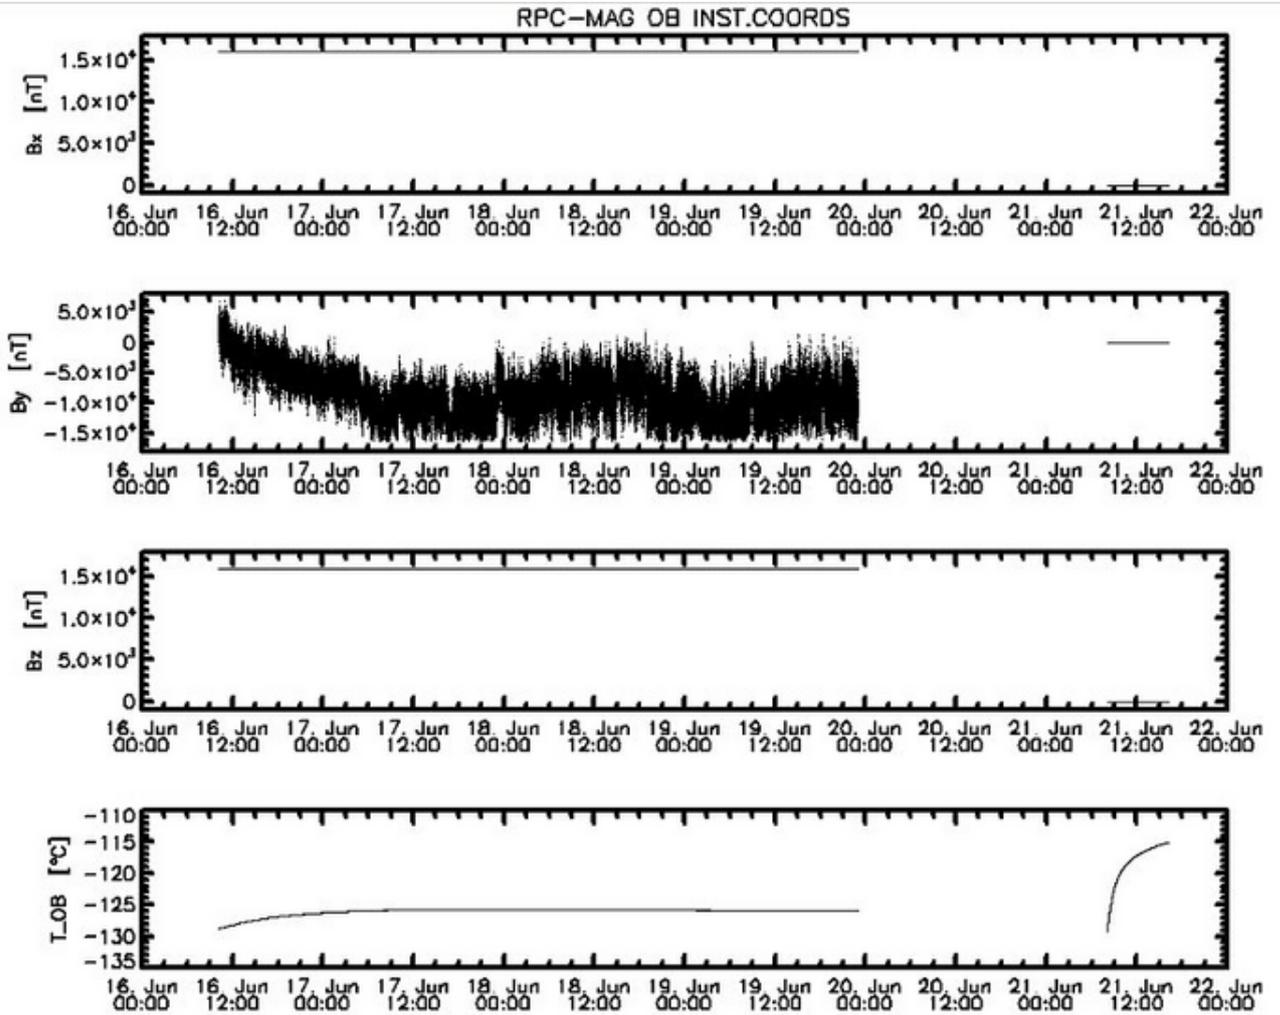
Figure 3: RPCMAG: Magnetic field measured with the OB Sensor

- the B_x component was permanently saturated.
- the B_y component showed erratic variations of a few thousand Nanotesla.
- the B_z component was permanently saturated.

This behavior did not change over the whole operation period until the switch off on June 19. The OB data looked erroneous in the science packets (sampled by 3 individual 20 bit ADCs) and the housekeeping packets (sampled by a different 16 bit ADC) as well (refer to Appendix C). The temperature of the IB and OB sensor (thermistors inside the magnetic field sensors) was, however, measured in the right way (refer to Figure 17).

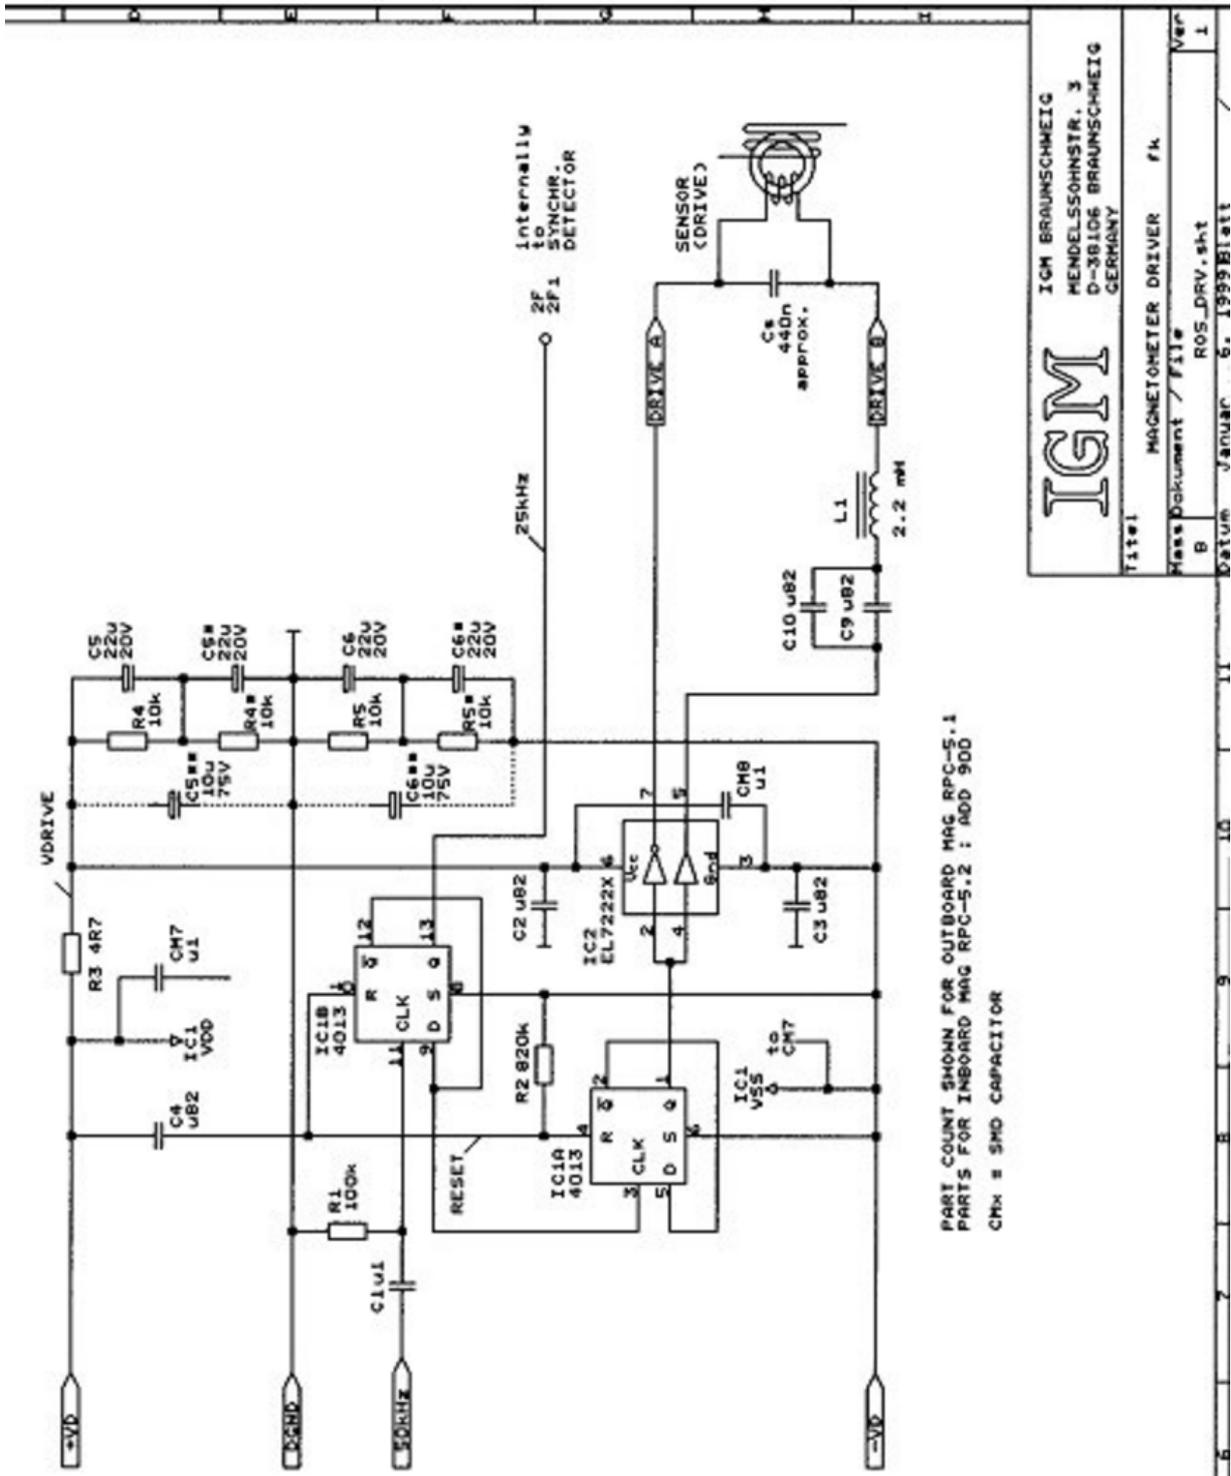
E The RPCMAG FGM Driver Electronics

- The master clock f_0 is divided by 84 to generate an input frequency of $f_1 = 50$ kHz for the FGM drive electronics (refer to circuit diagram in Appendix E). Furthermore this frequency is divided by 2 times 2 to provide the needed $f_2 = 25$ kHz and $f_3 = 12.5$ kHz. Thus, up to this point the failure probability is extremely low.
- The most likely failure source is the complex behavior of the resonant circuit consisting of L_1 , C_s and the sensor excitation coil (refer to the right side of Figure 16) during the power on phase.

The described resonant circuit has to oscillate exactly on his resonance frequency of 12.5 KHz. This can only be guaranteed, if during the RPCMAG activation phase enough power is provided via the s/c or RPC PIU power supply. It is absolutely necessary that the supply voltage rises "immediately" with a steep flank. If the flank is to flat, respective the slew rate is to slow, the resonant circuit is not able to draw the high initial current needed to fall into the right oscillation state (the resonant circuit is not excited with a simple sinusoidal signal but with steep needle pulses to minimize power consumption. Therefore, sufficient power has to be provided to generate even the first needle pulse in the right height). It might happen that the circuit will not start oscillating which will of course cause a failure behavior.

The failure source can not be located definitely, but with the utmost probability, a catenation of unfortunate circumstances lead through a faulty oscillation of the resonant circuit in the sensor excitation drive. This is an absolutely uncritical error which can be corrected by a repeated Power off/on cycle.

The best modus operandi for RPCMAG would of course be to switch the instrument on, ensure that it works nominally, and leave it in the powered state to minimize the power on cycles.
