#### SSTD Incoming Inspection Report

Spacecraft/Project	HERSCHEL / SPIRE	Document Number	SPIRE-UCF-REP-002203	]	Issue 1
Sub System	Spectrometer Cal Source	Date	8th November 2004	]	Model PFM
		 CONTAINER INSP	ECTION	t

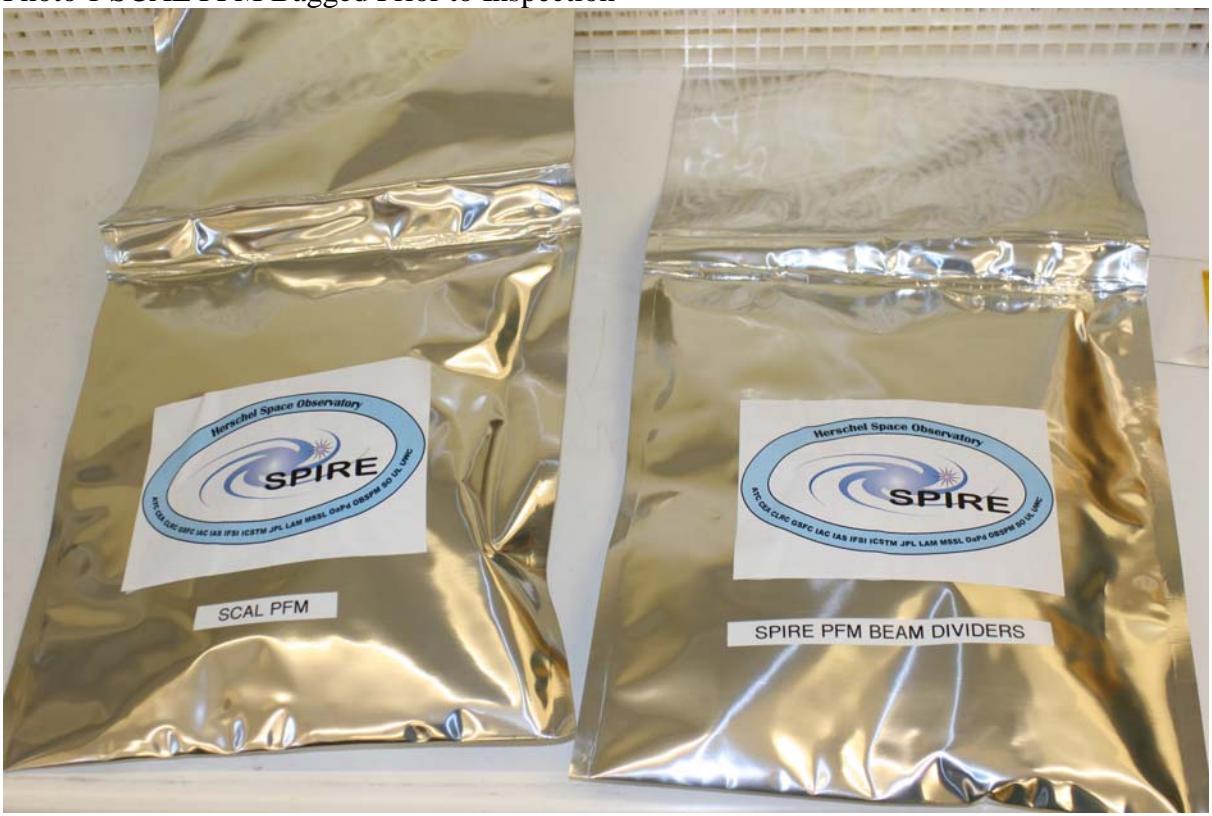
Photo 1 SCAL PFM Bagged Prior to Inspection

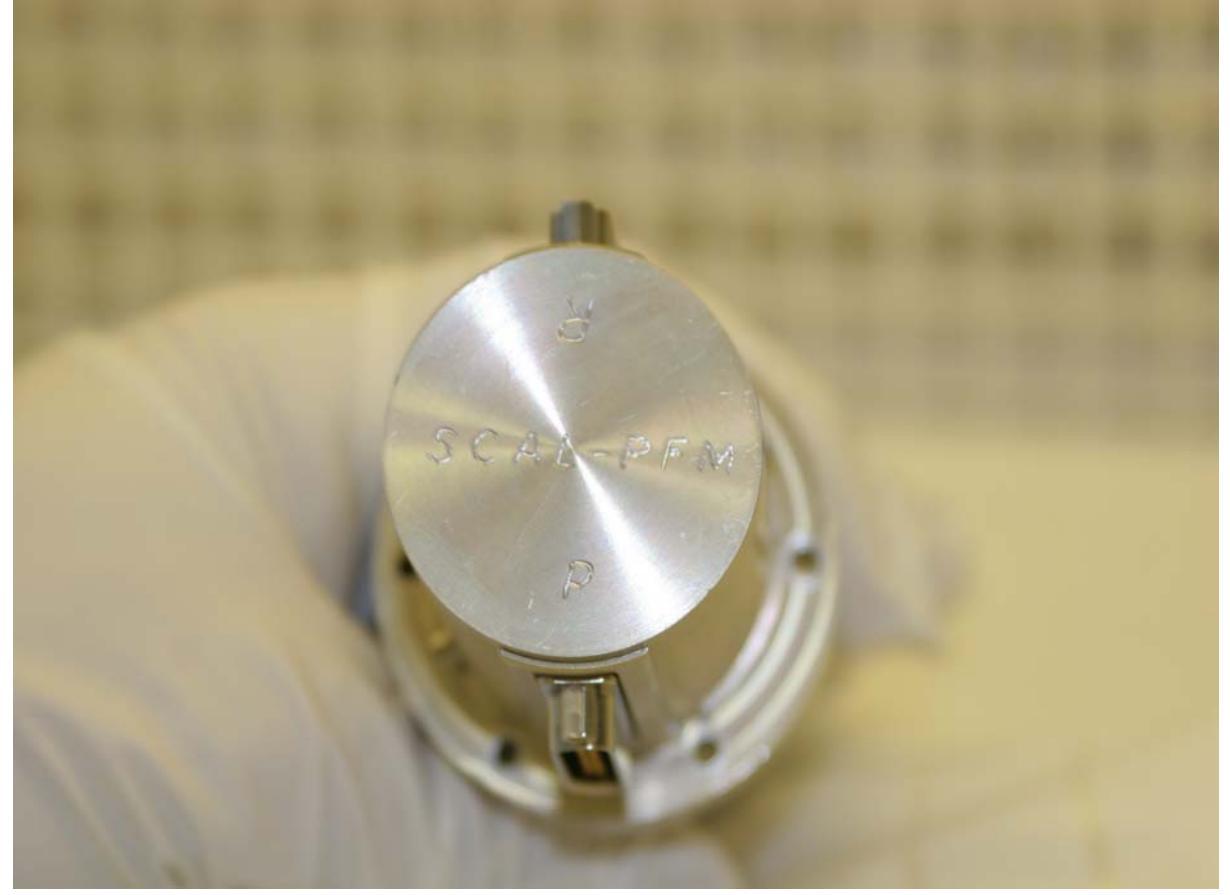
Photo 2 SCAL Showing Prime & Redundant clearly Marked

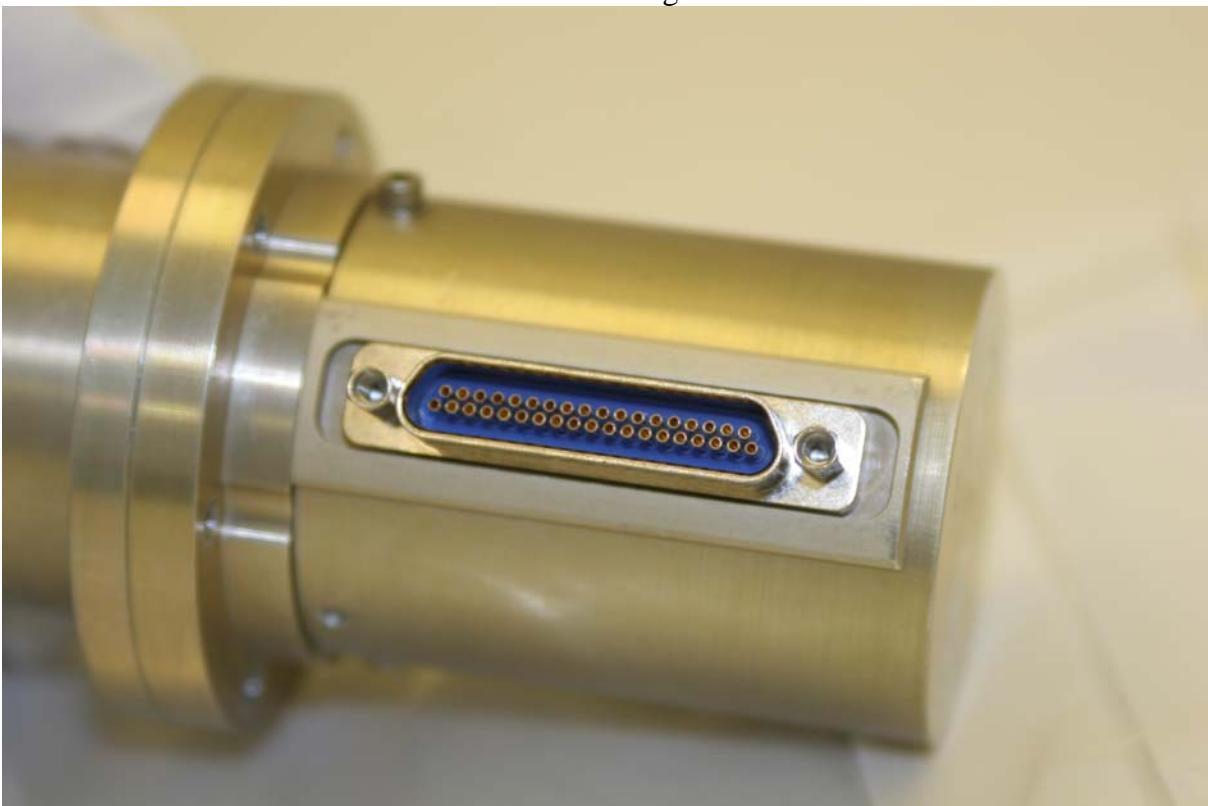
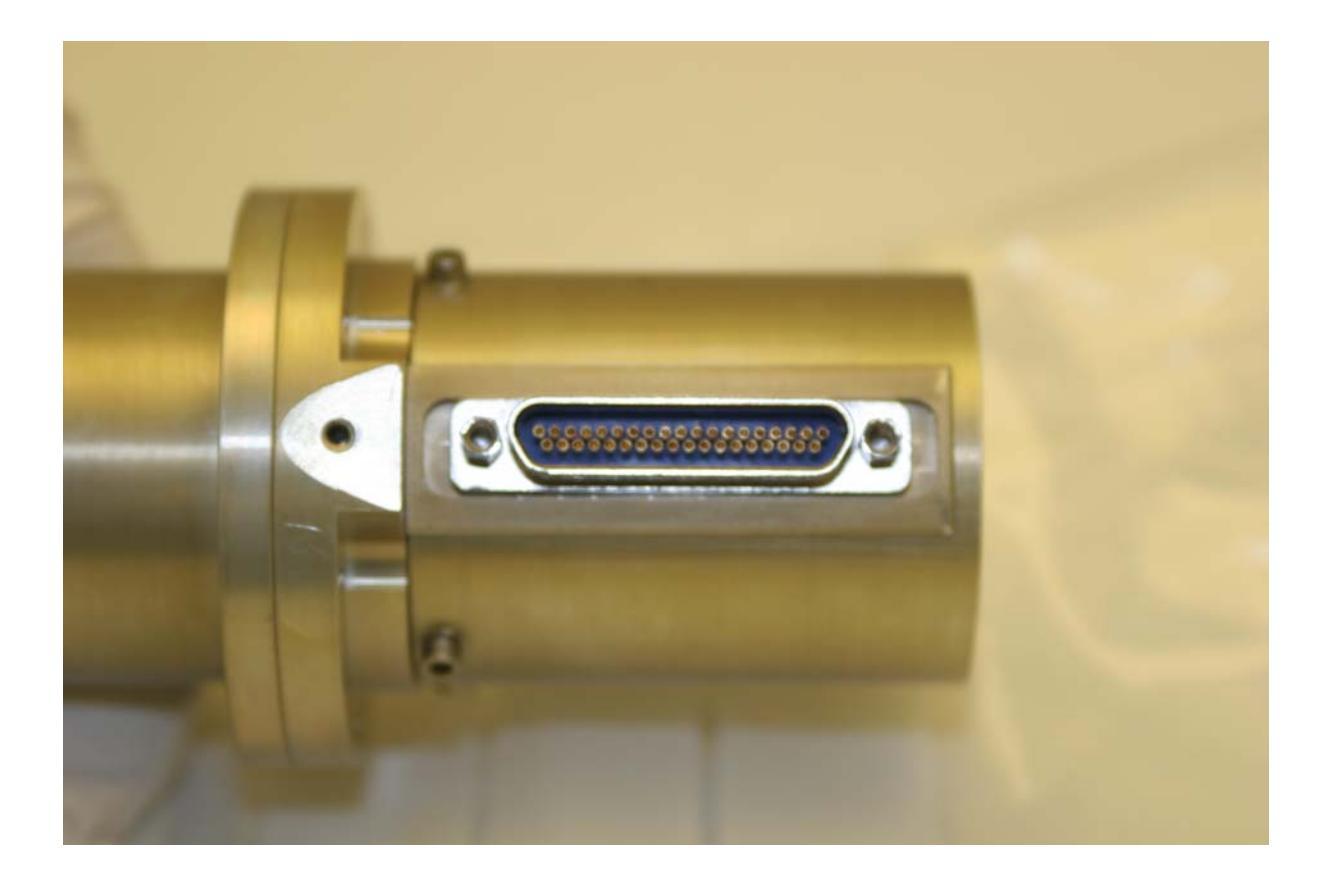
Photo 3 & 4 Prime & Redundant Connector Pin Alignment OK

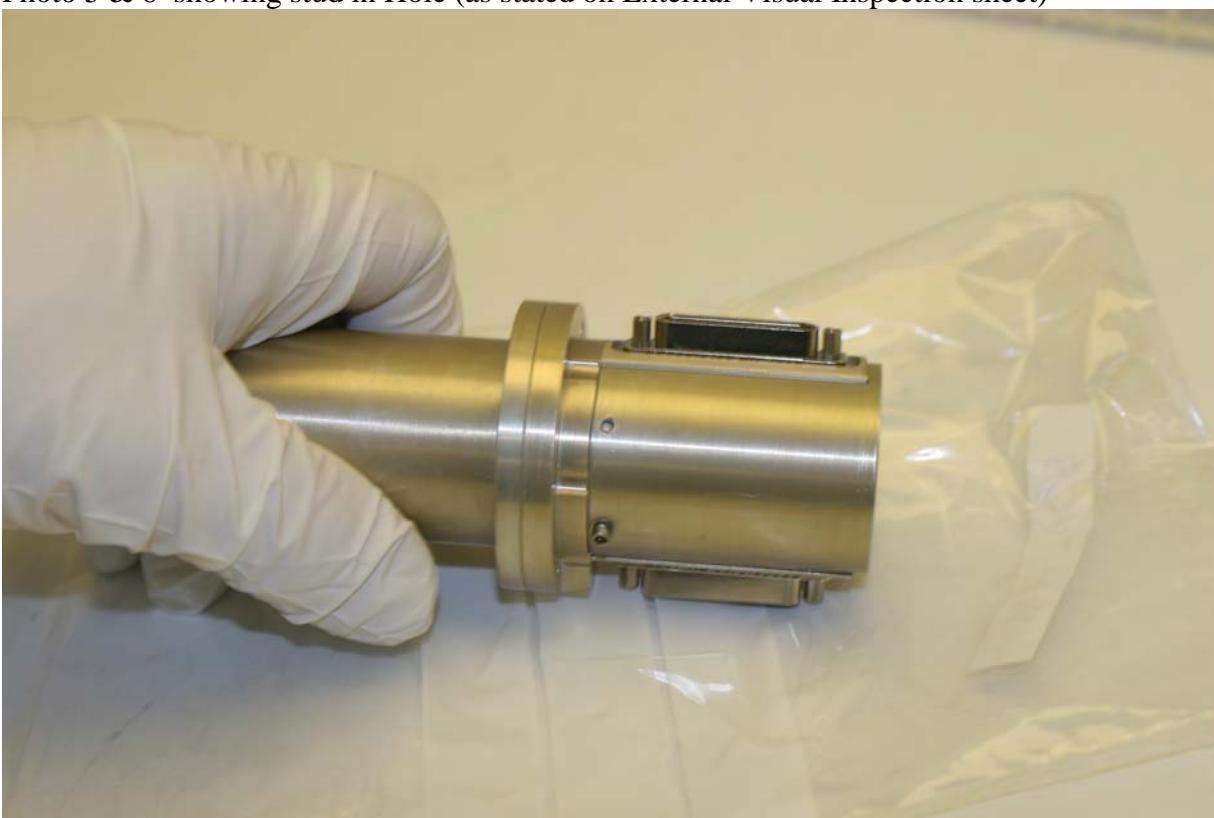
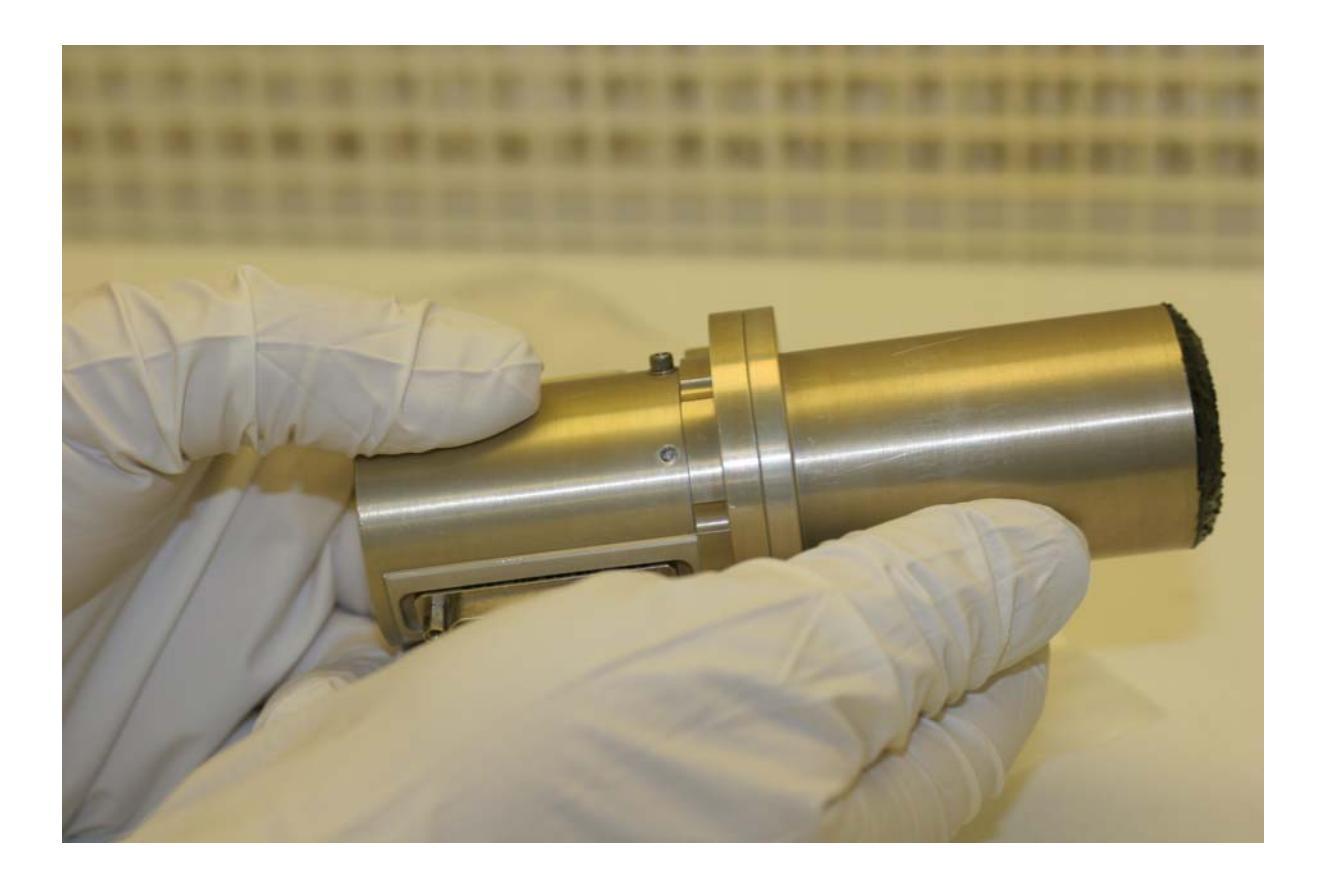
CHECK LIST	REMARKS	RESULTS
Contents against shipping list		CORRECT
Instrument label		CORRECT
Note status of external		
contamination		ACCEPTABLE
Degradation of paintwork		
or Coating?		ACCEPTABLE
Fasteners correctly locked?	None	SEE REMARKS
Check protective covers are		
correctly labelled and fitted?		CORRECT
	Peter Hargrave mentioned that one of the rear cover retaining screws had had its head sheared off	
Additional Comments	during assembly, leaving the stud behind, it was agreed that we could use as is. PH to raise NCR. See	
	Photo attached.	SEE REMARKS

Photo 5 & 6 showing stud in Hole (as stated on External Visual Inspection sheet)

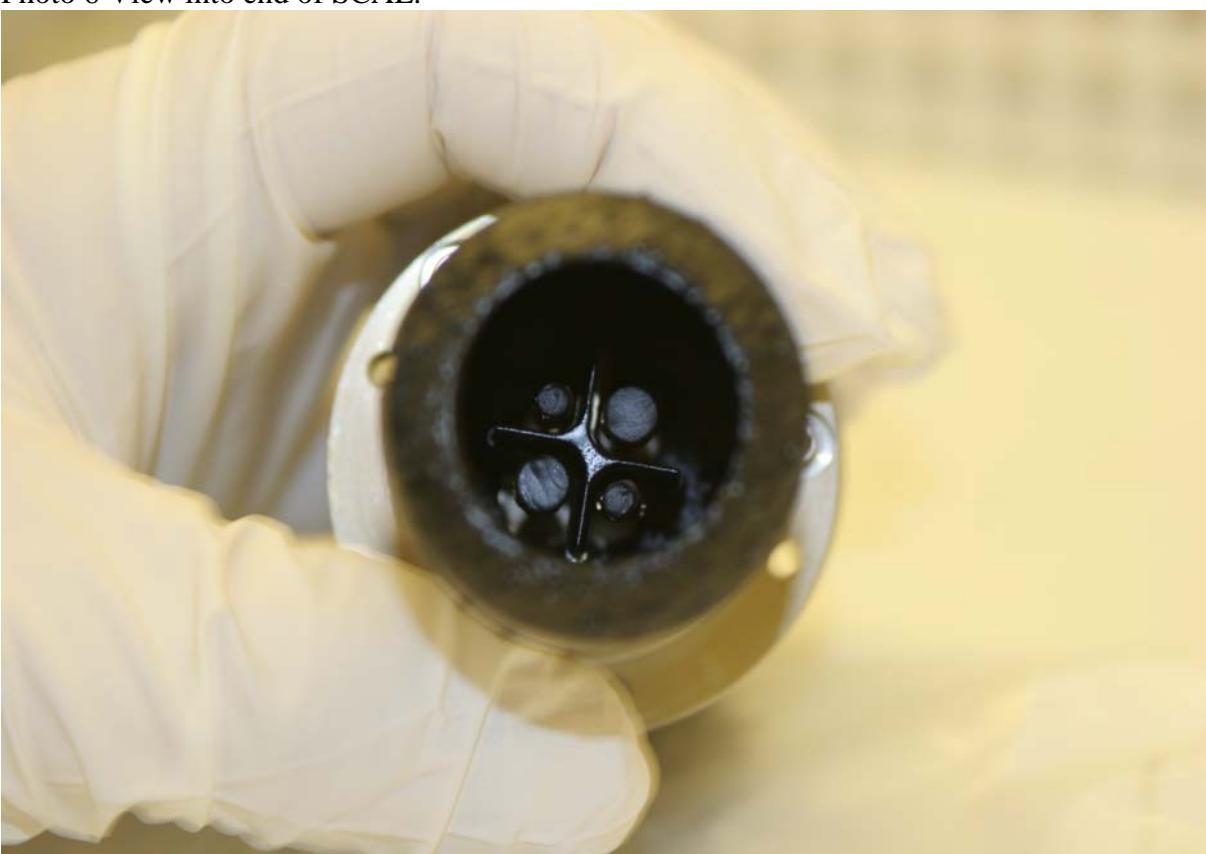
Photo 6 View into end of SCAL.
