SPIRE STM Optics Integration & Optical Alignment Verification

Summary of Activity

- RAL, May 2003 -

SPIRE-RAL-REP-001721

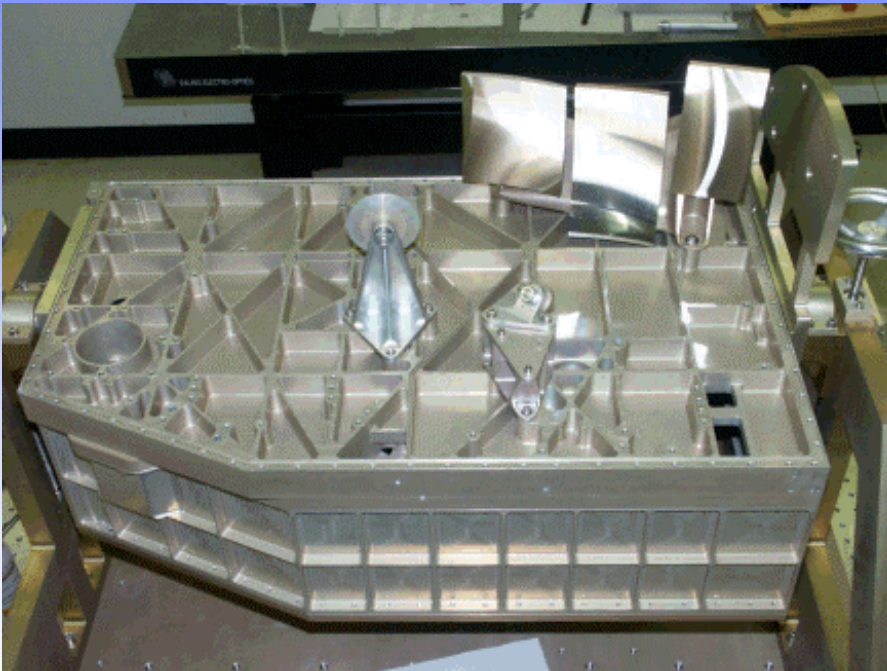
**Common optics and
Photometer optics on SOB**

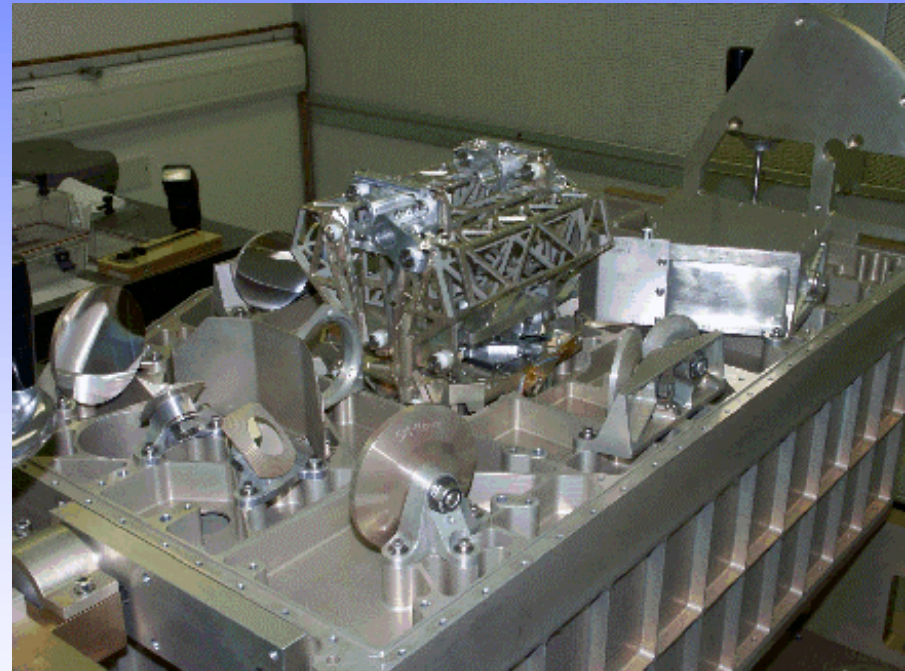
Spectrometer optics and SMEC

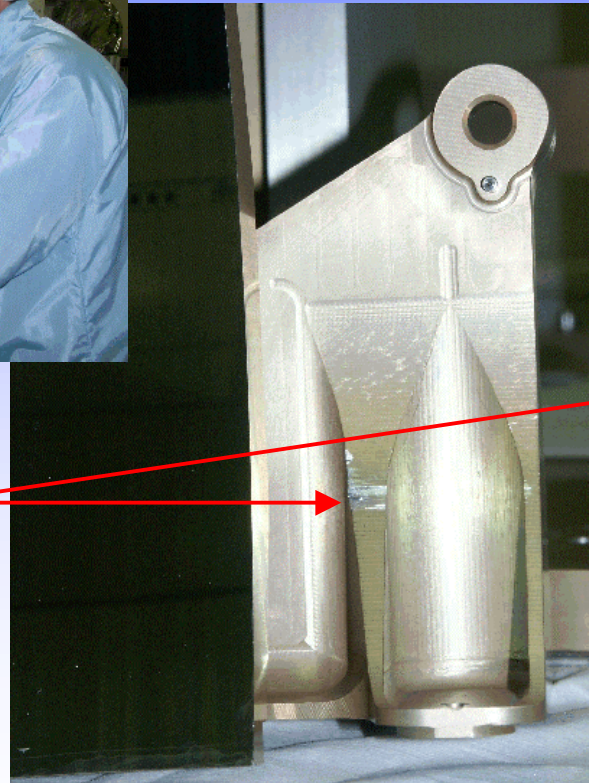
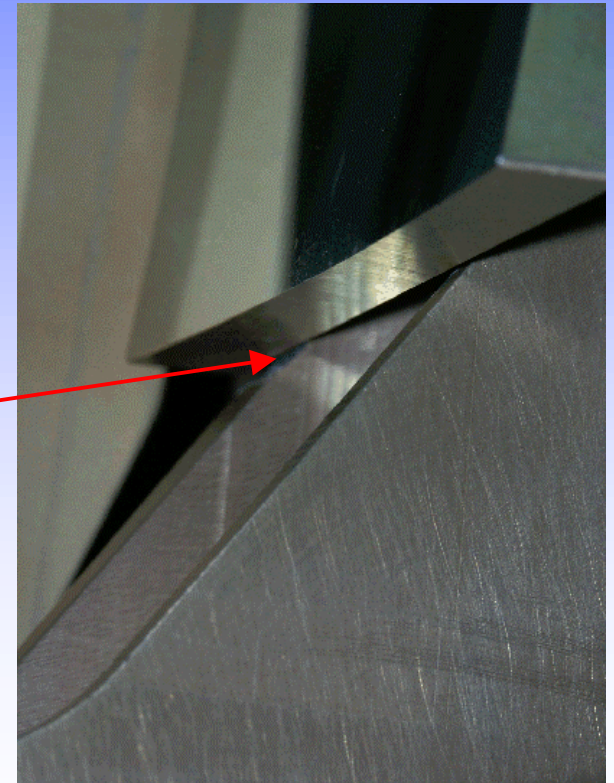
CM3 “extraction” to allow local cut in bracket (because of mirror/bracket clash)

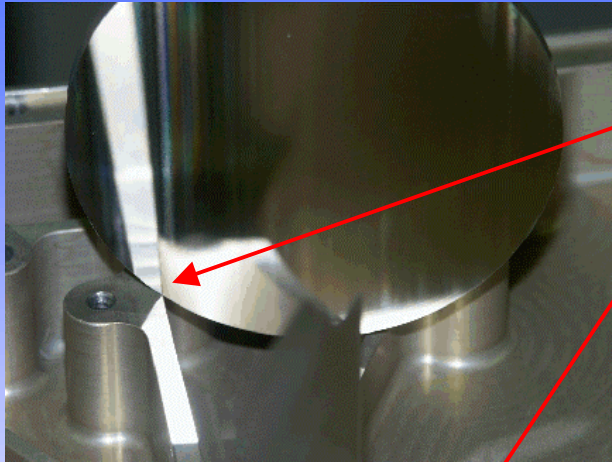
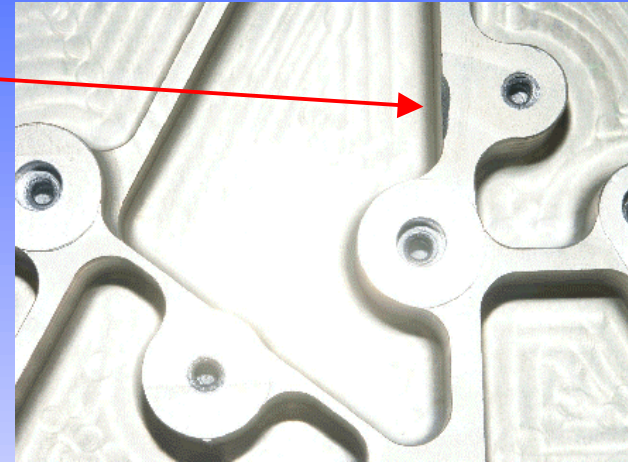
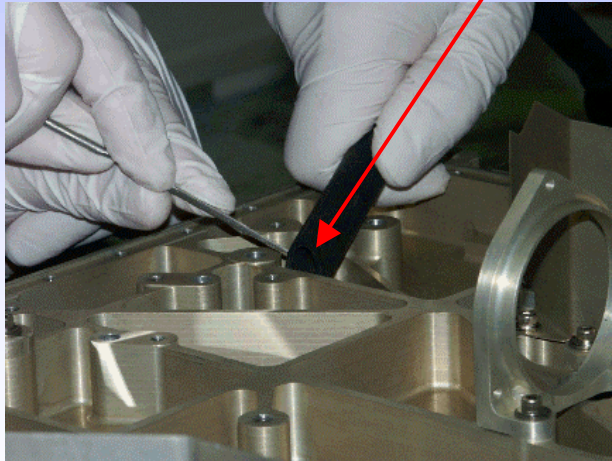
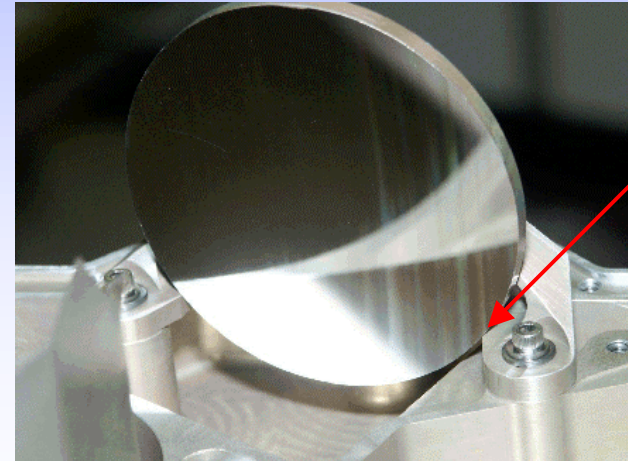
SM11b issue with local
SOB rib

SM11a
bracket
issue

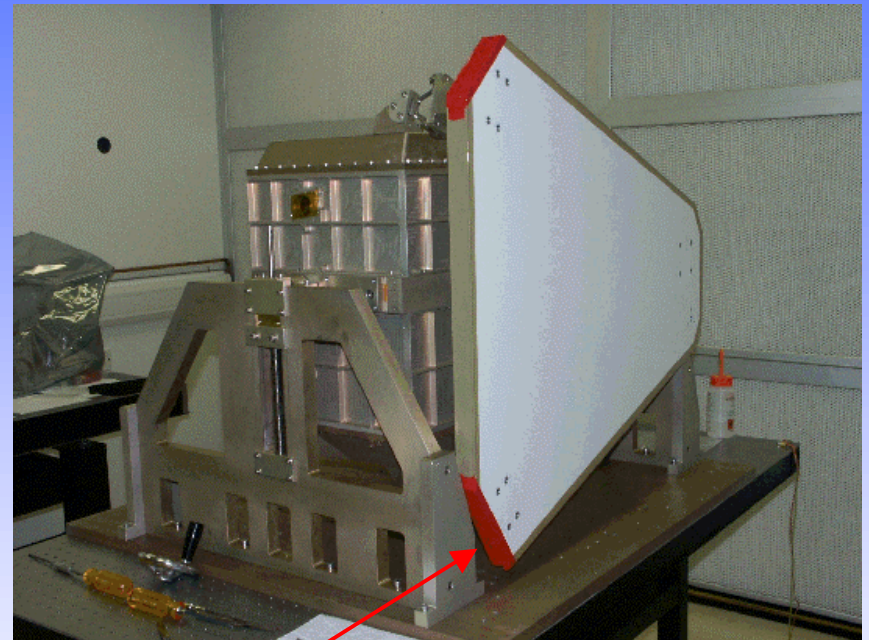
**Cuts of LAM lightweight HOB plate
to fit with instrument and MGSE**

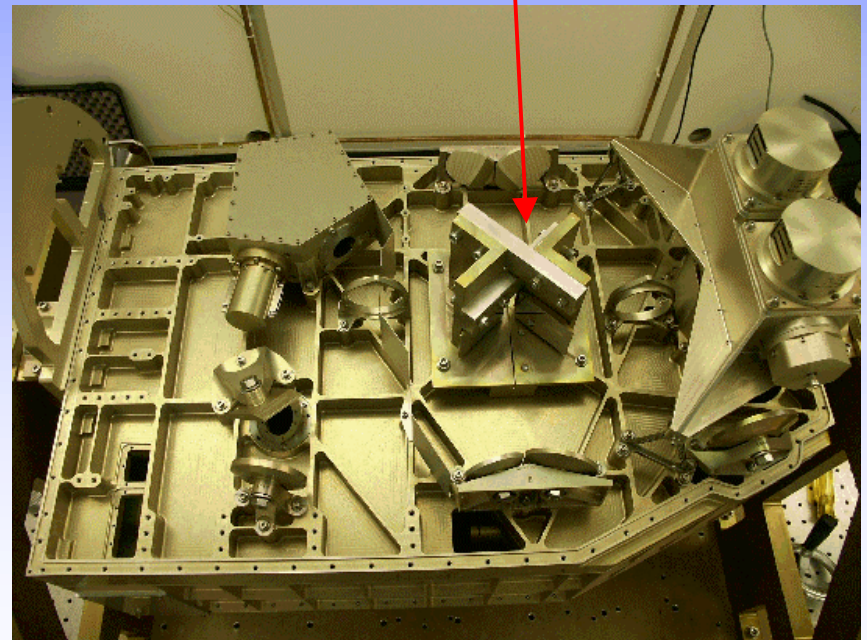
SMEC replaced by SMEC simulator
(with non-moving mirrors for alignment)

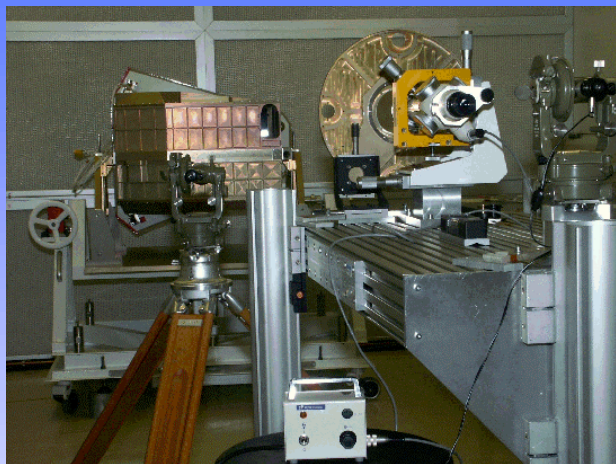
CS-tool (P) and Apex
tool in place of PM8

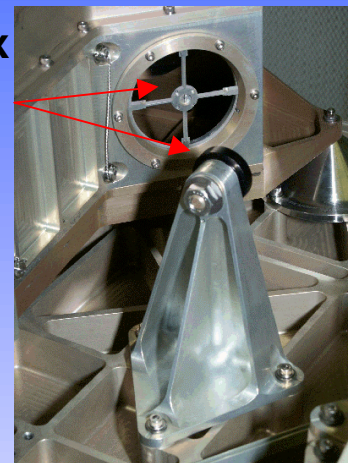
External OGSE: MAT,
Theodolites, M2-tool

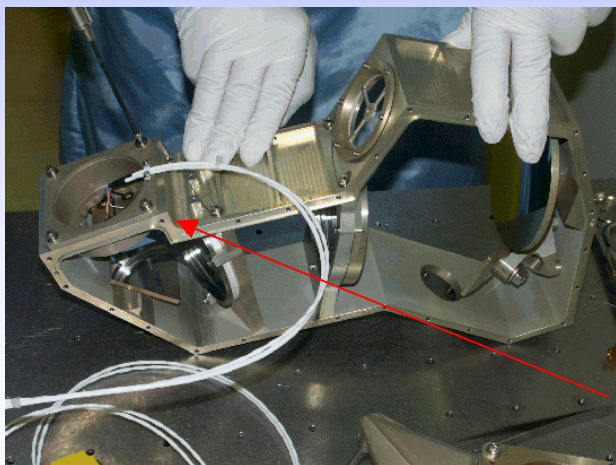
Projection of lighted
BSM (CM4) hole onto
M2-tool

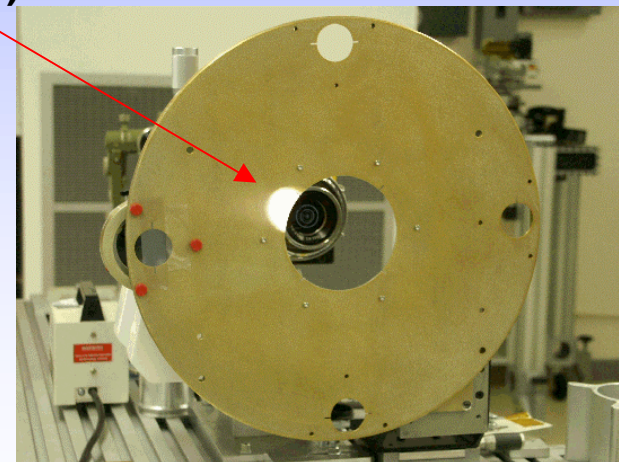
Vis. D-Tool (P)
in PLW

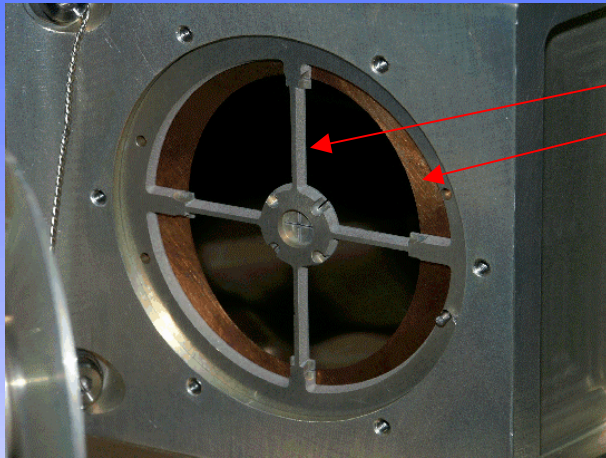
CS-tool (P) &
Cold Stop

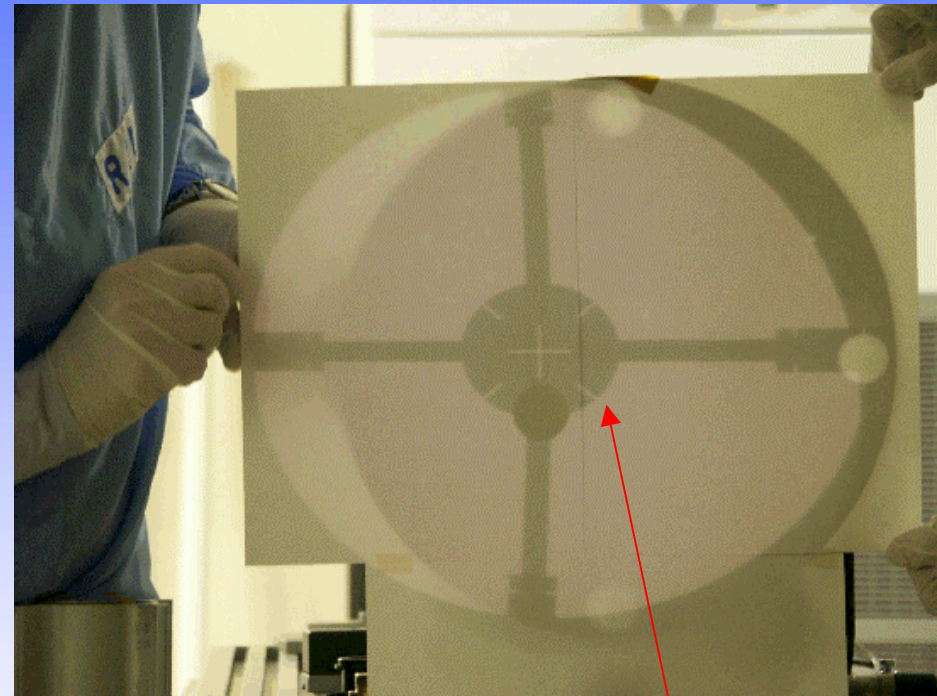
Projection/Image of CS-tool
on M2 (after BSM shimming)

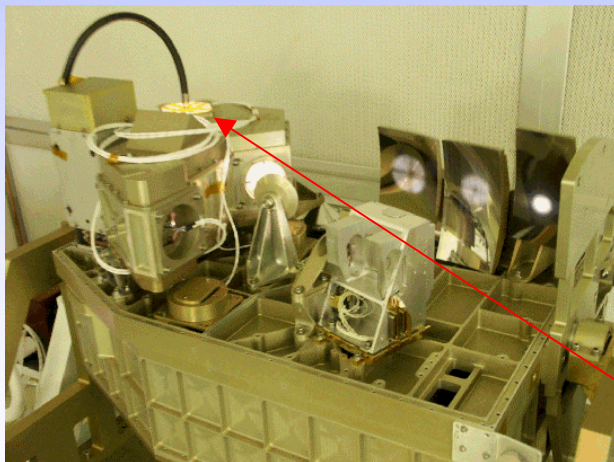
"Systeme D"-tool with
white light fibre in PSW

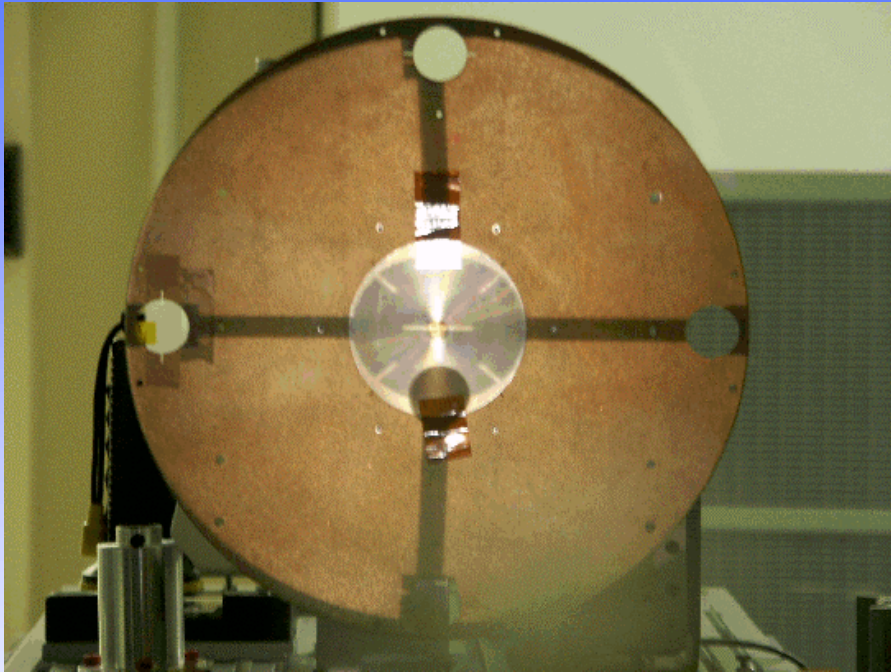
Projection of CS-tool on M2-tool after re-alignment on Phot. LOS (inc. CM3 tilt)

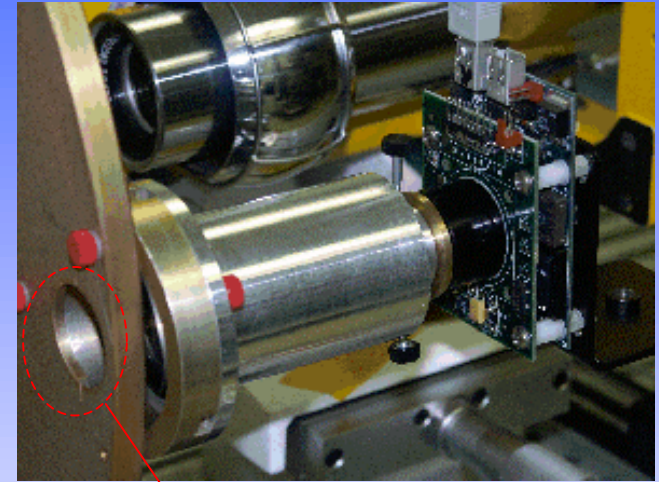
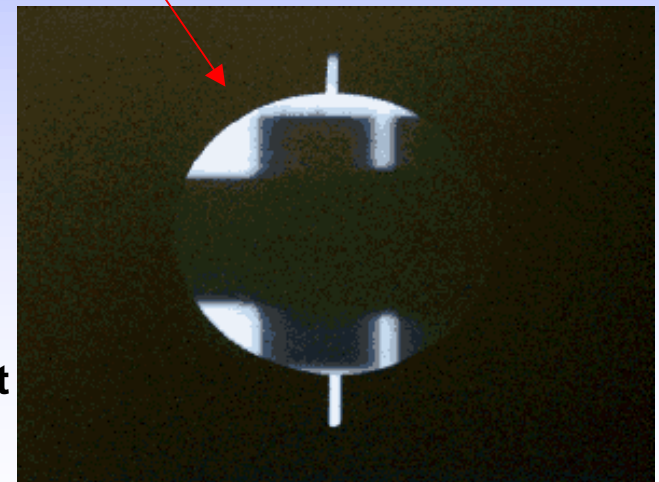
**CCD acquisition of pupil edge shift
between cold stop and M2**

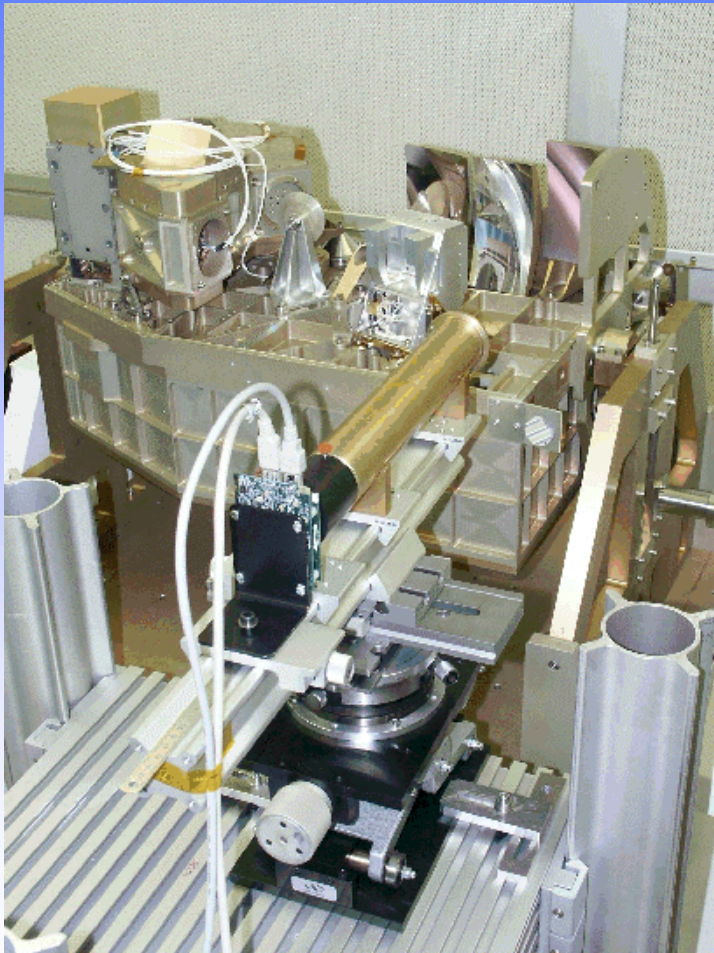
**Hartmann bench
with CCD camera**

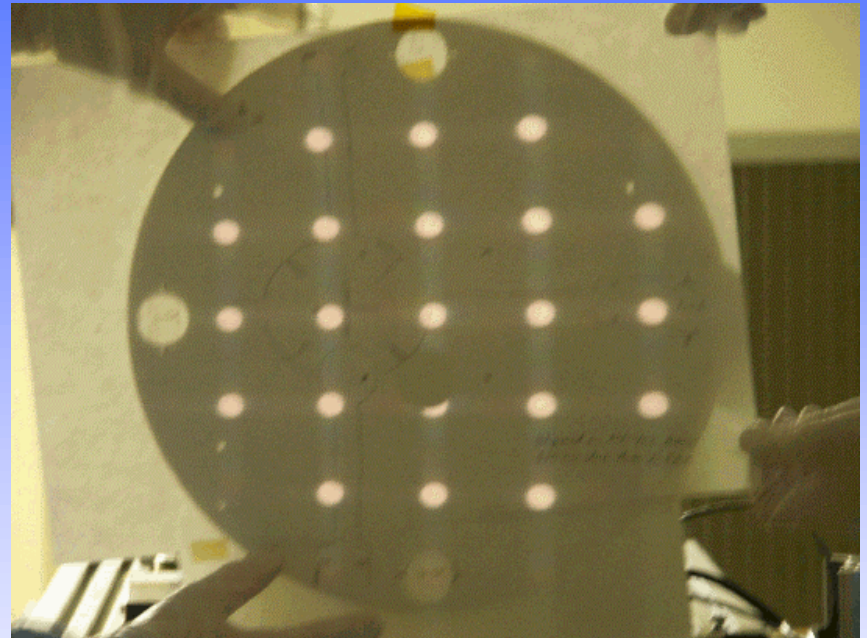
**Image of Hartmann tool
(at cold stop) on M2**

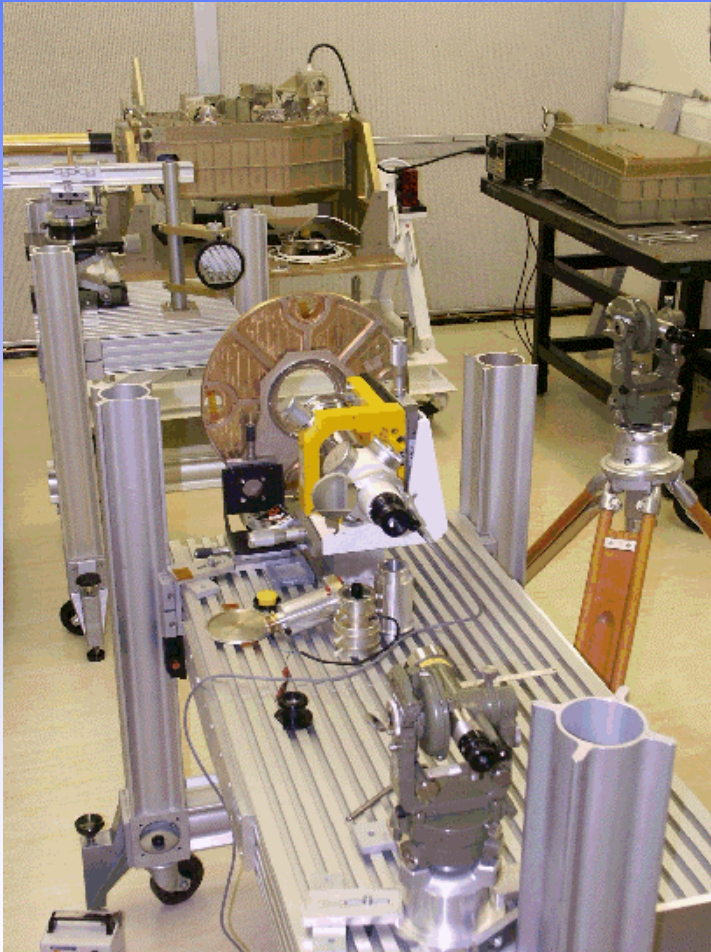
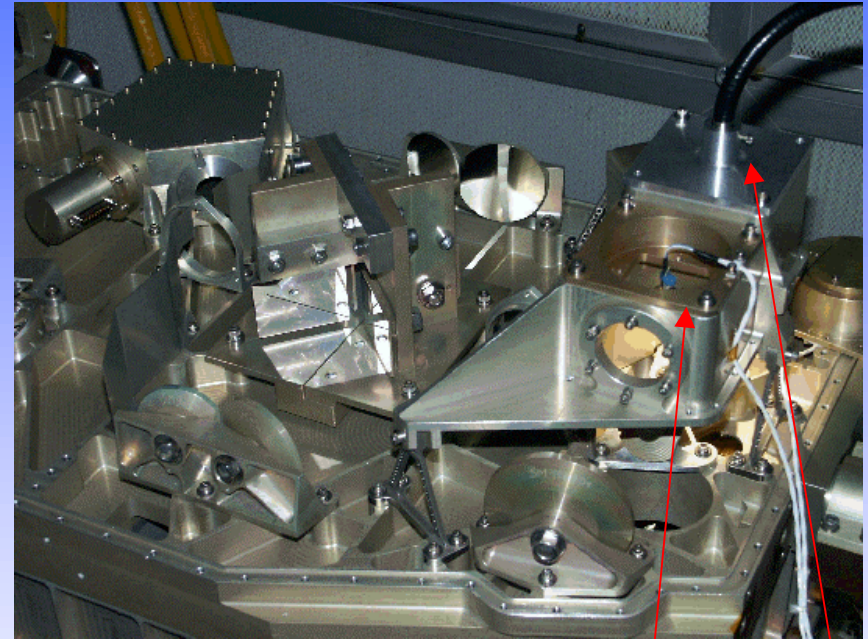
Variant of the vis. D-tools in SSW and SLW

**External OGSE re-setup after rotating
instrument on spectrometer side**

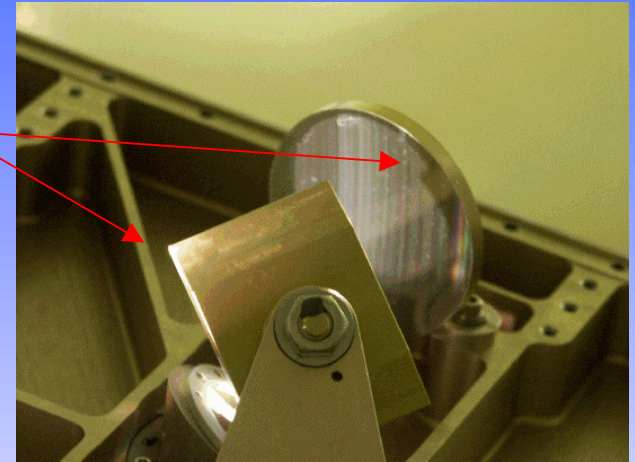
Vignetting
by SM7

(SM7 = flat mirror)

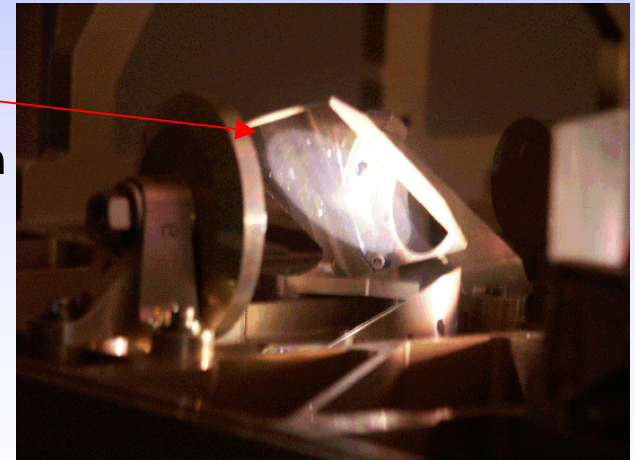
Beam footprint
on SM7 after
optimal rotation

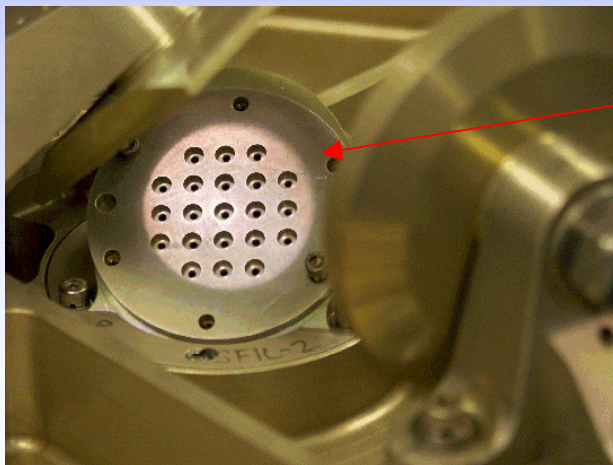
16 deg. rotation

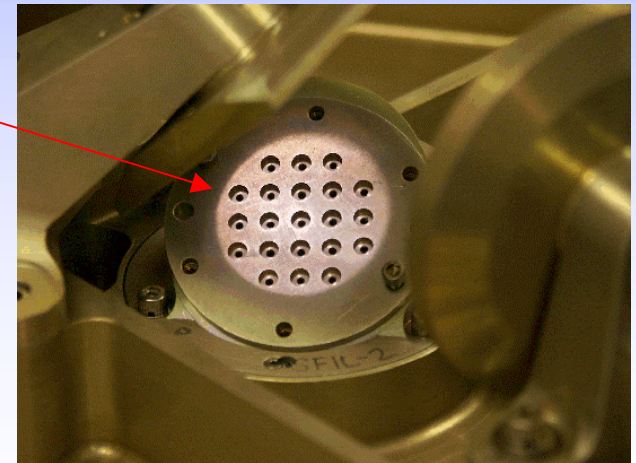
Pupil “wandering”
at cold stop
(Hartmann tool) due
to SM8 rotation

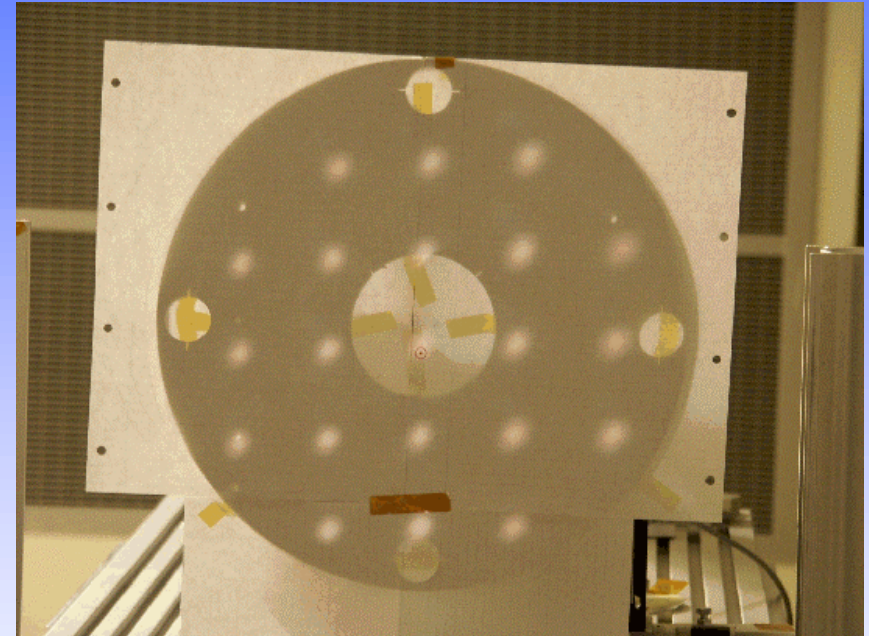
Image of Hartmann tool
(at cold stop) on M2 tool

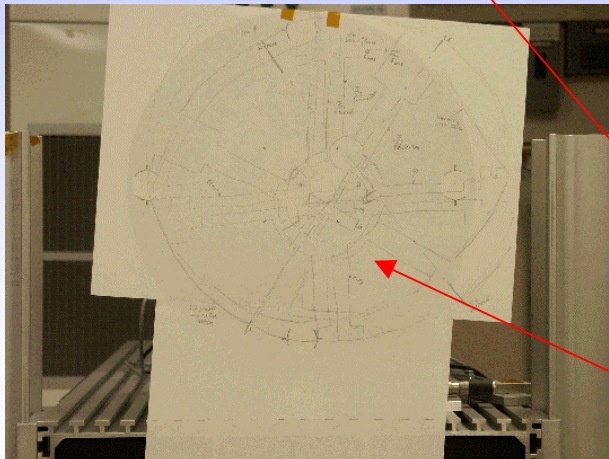
CS-tool (S) projected on
M2-tool, and after several
rotation of the CS-tool (S)

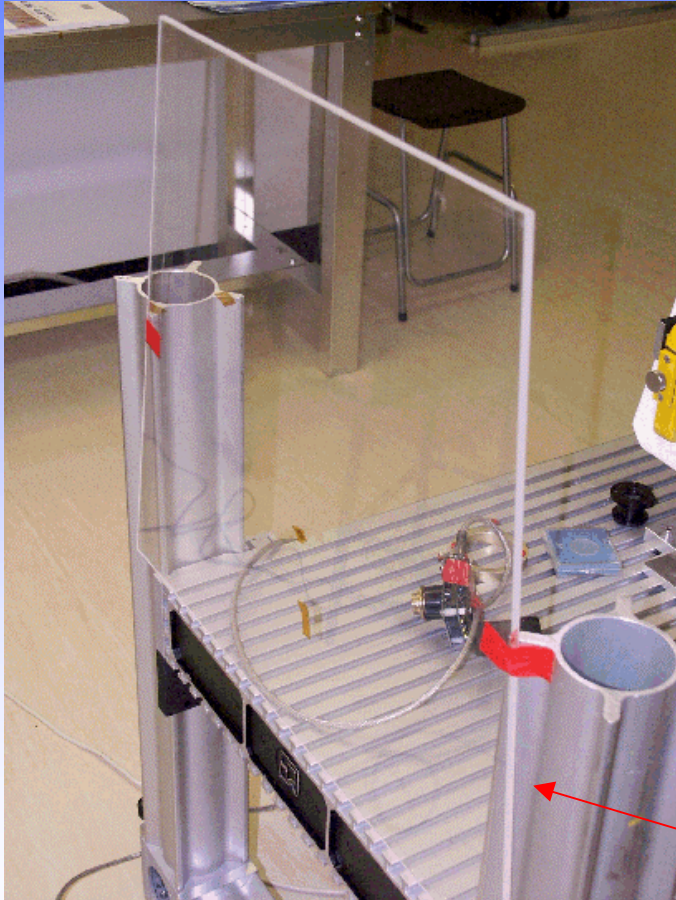
New M2-tool screen

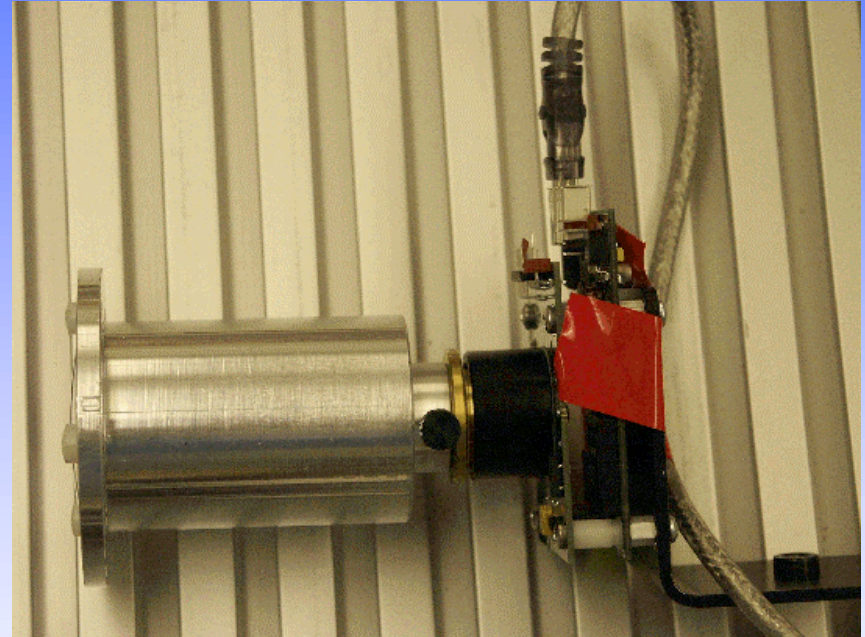
**Camera system for search of
IR D-tool signals at M2**
