**SUBJECT:           Instrument Vibration Test Report  
                      STM Qualification**

MSSL-technote-SPIRE-21	Instrument Vibration Test Report STM	Issue 1.0, October 2003
------------------------	---	-------------------------

This document lists the main results of the qualification vibration test of the Herschel SPIRE instrument structural thermal model (STM). This model is structural representative with a few exceptions as listed in section 5. The STM model was tested in April 2003 with the stainless steel supports for the instrument itself and the detector boxes.

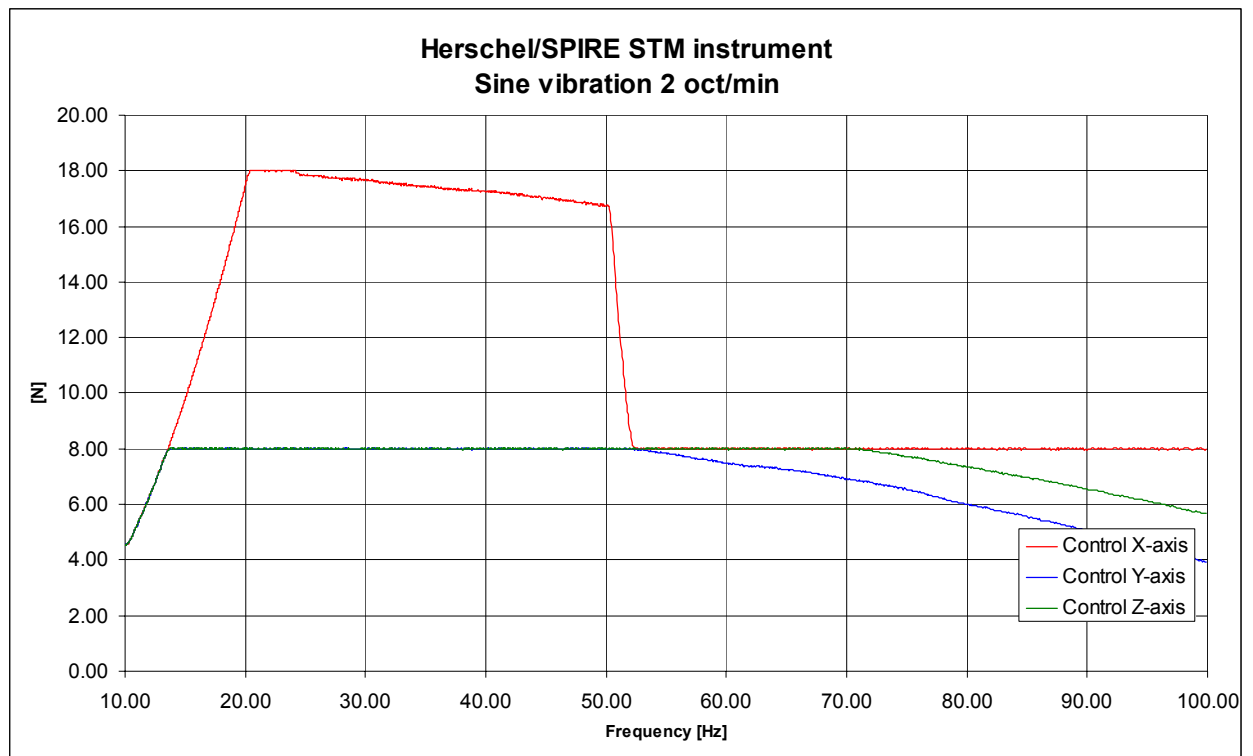
Figure 8.4-1 Achieved inputs for the 3 directions

As can be seen from figure 8.4-1 the force notch kicked in for the X direction at 24 Hz, for the Y direction at 52.5 Hz and for the Z direction at 71 Hz. For the X direction the input above 50 Hz was limited to 8 g. This to prevent fatigue damage to the main cone of the instrument. See log in appendix B. The cone at maximum load is stressed up to 85% of its allowable stress. Therefore it was decided to limit the amount of maximum load cycles to 1000. Hence the reduction after 50 Hz.

After discussions with Thijs van der Laan and Eric Sawyer decided to lower the sine input above 50 Hz down to 8 g. This based on the stressing of the main cone during this run. There is little margin left and we need to minimise the fatigue damage. The cone is stressed up to 85% of its allowable stress. The number of full load cycles was reduced to 1000.

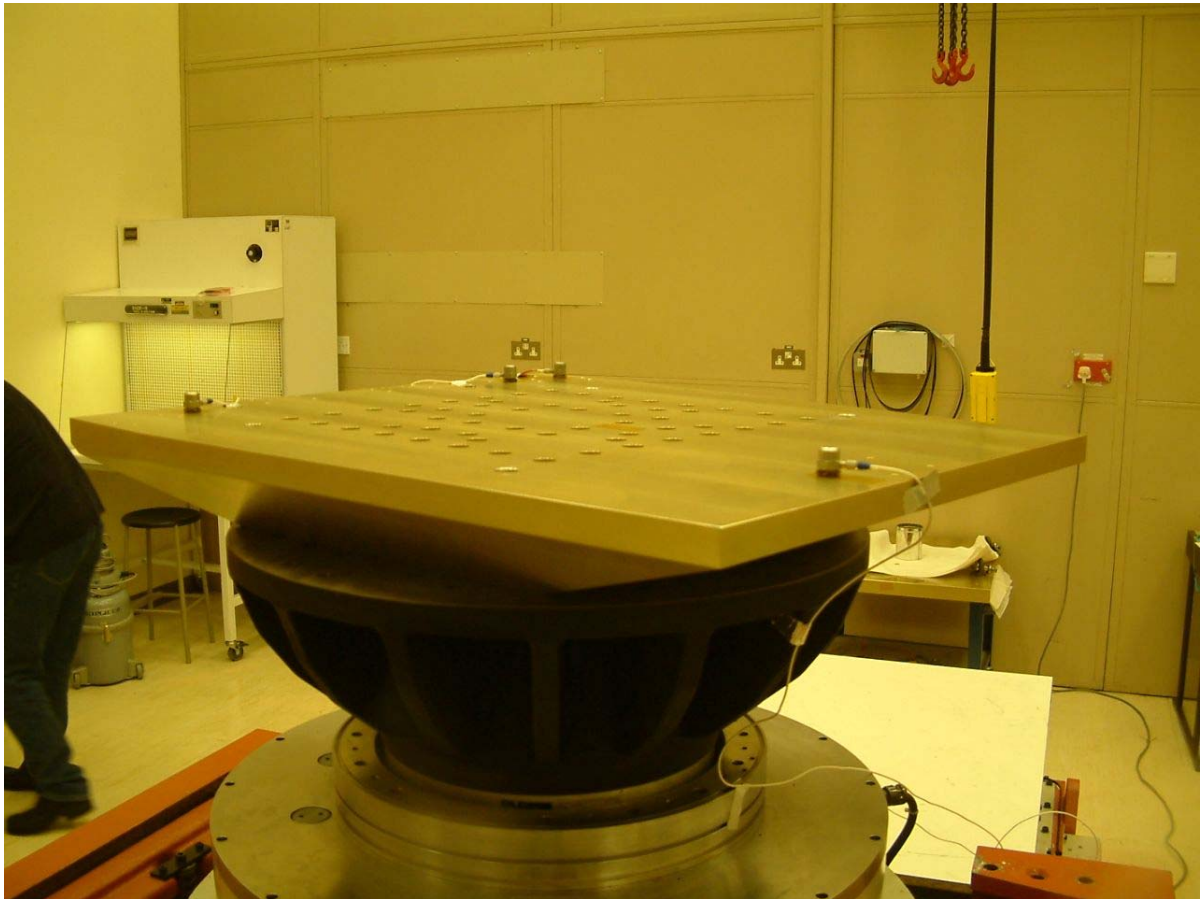
A-1:Control accelerometers

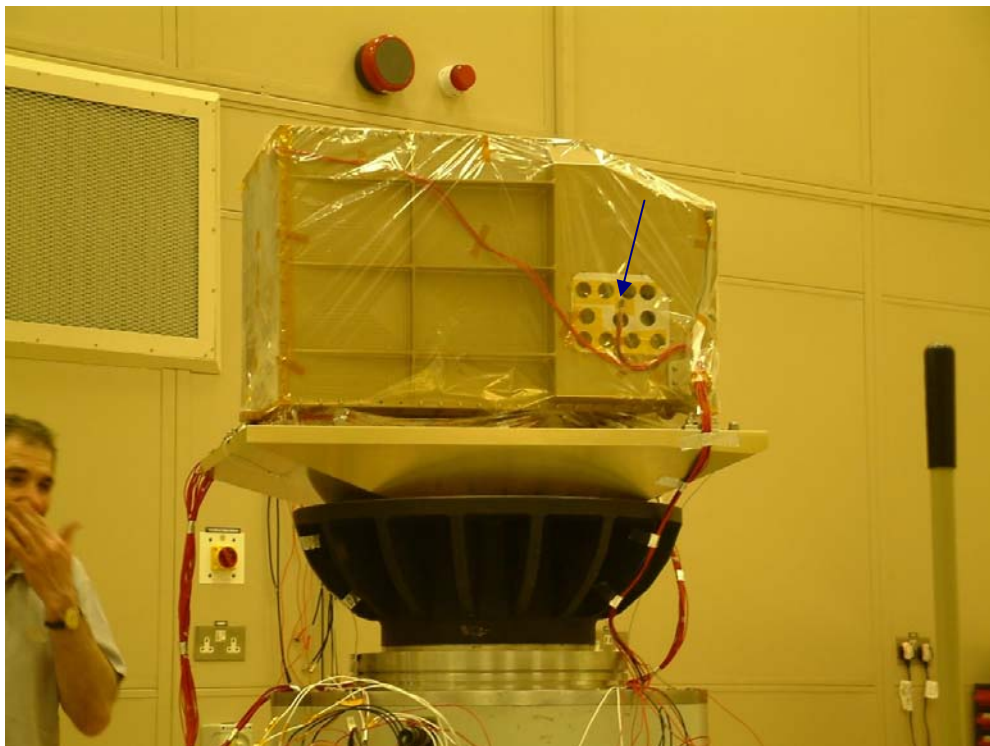
A-9: Cover plate (Y)

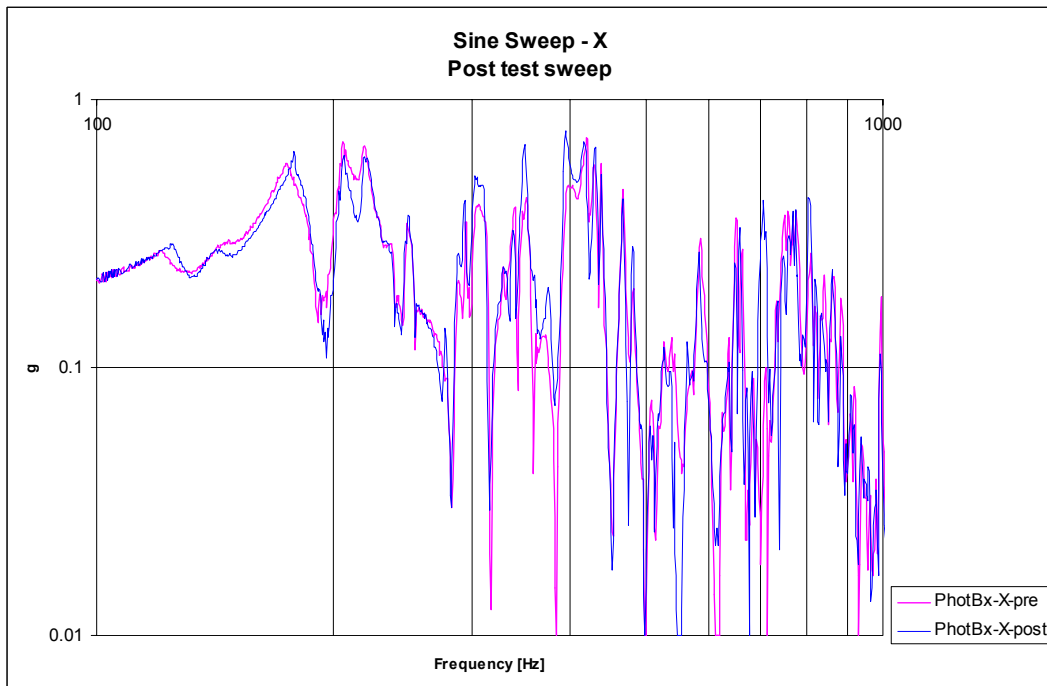
Figure B-2: Photometer det. box in excitation direction (position shown in figure A3, appendix A)

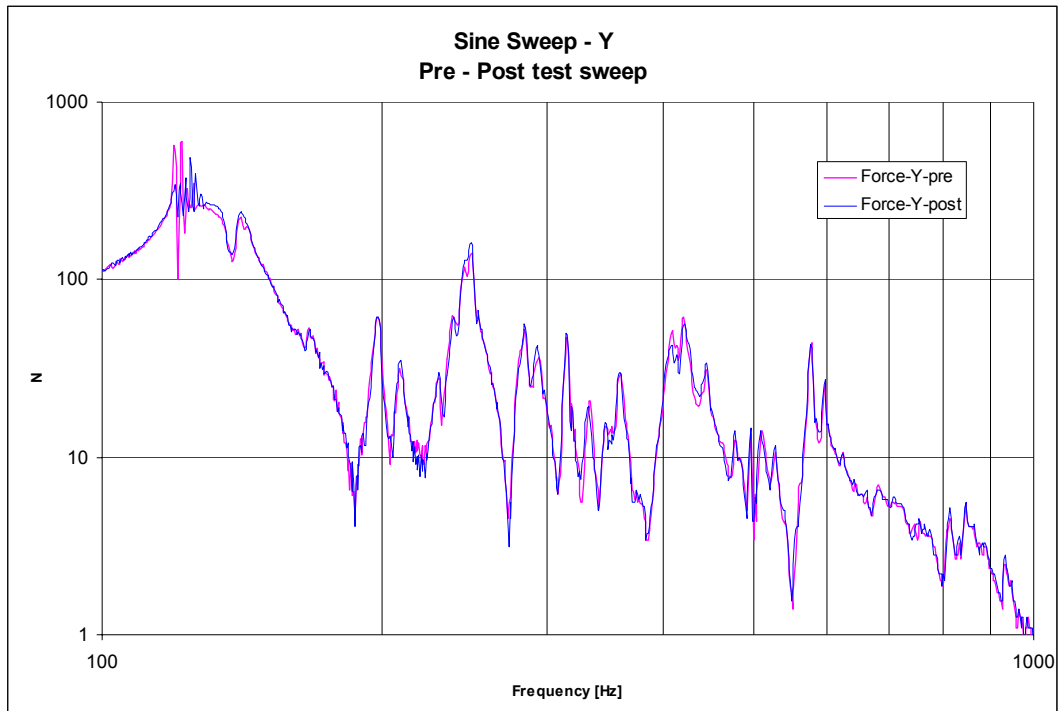
Figure B-6: Interface force in excitation direction

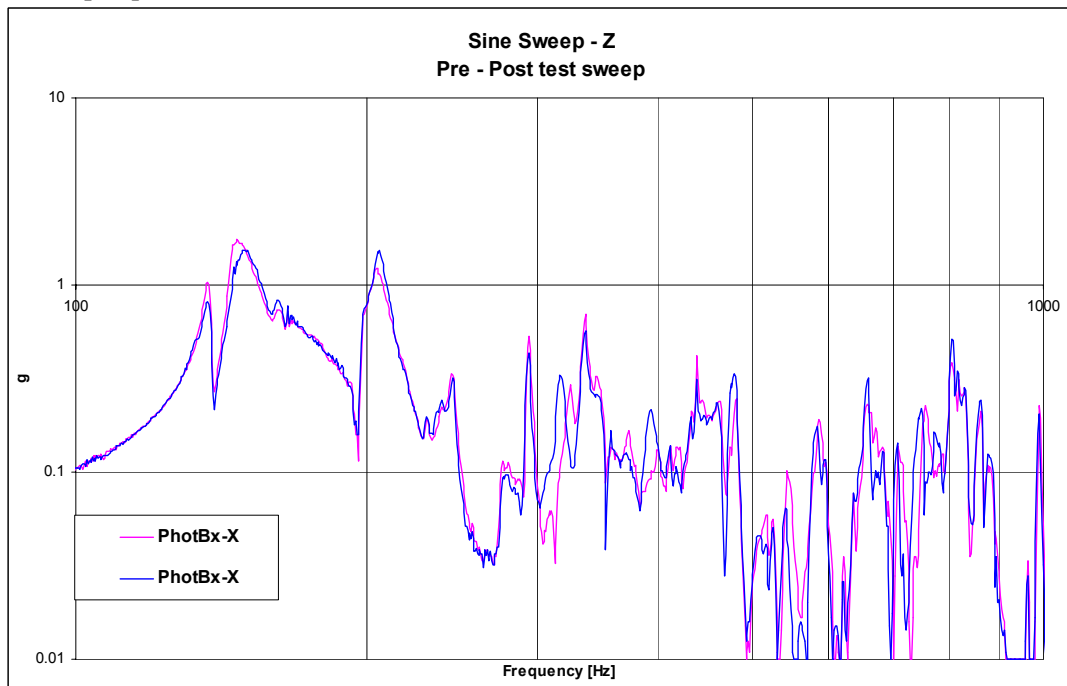
Figure B-8: Photometer det. box in excitation direction (position shown in figure A3, appendix A)

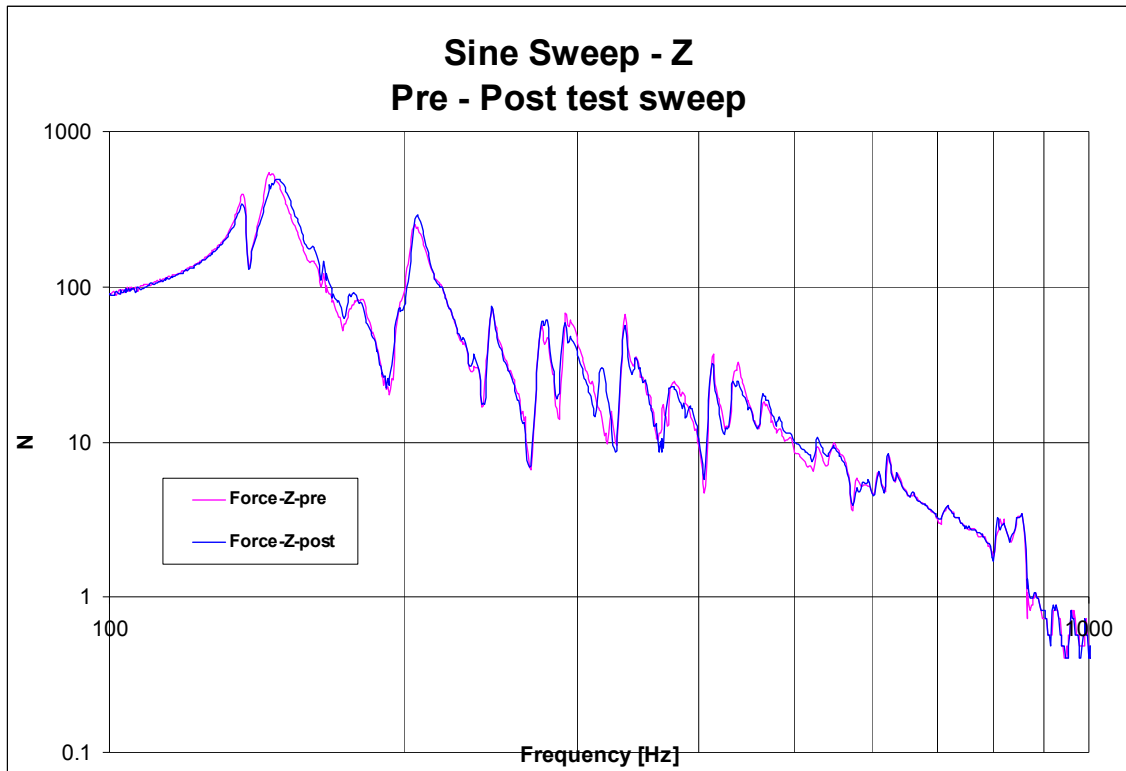
Figure B-9: Interface force in excitation direction

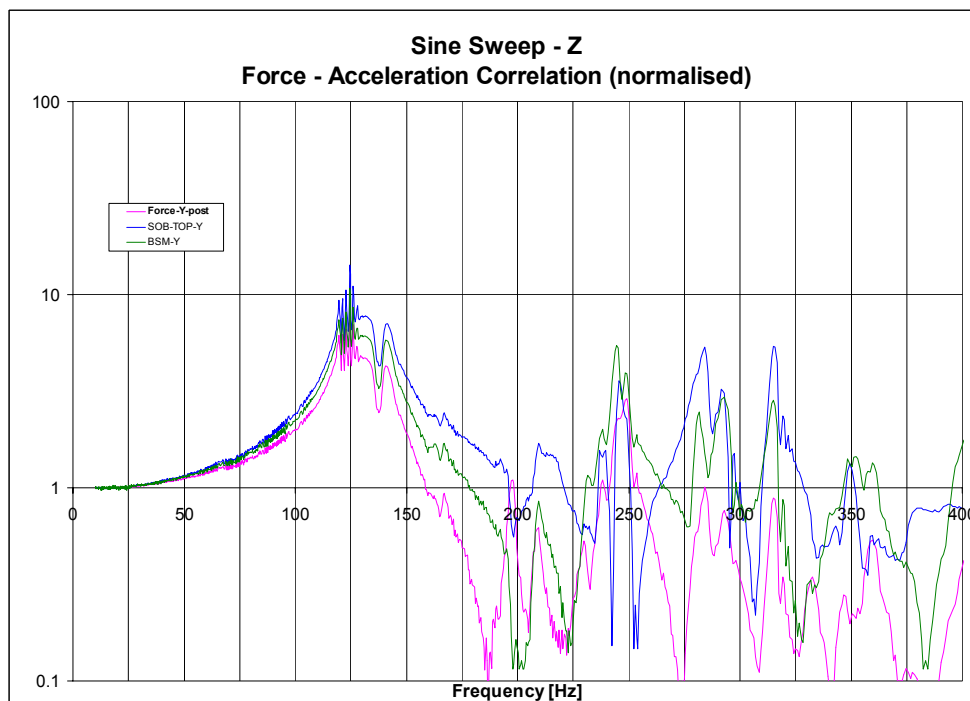
D-2: Interface force and SOB acceleration in Y

In this appendix the measured interface force is compared with the acceleration measured on top of the Spire optical bench (SOB). The correlation is limited to below 400 Hz. Both the force as well as the acceleration have been normalised to 1 at 10 Hz.
