**SPIRE PFM CLEANLINESS REPORT**

Document Number: MSSL/SPIRE/TR/007.01 – 08 June 2004

**MULLARD SPACE SCIENCE LABORATORY  
UNIVERSITY COLLEGE LONDON**

This report documents the cleanliness control and cleanliness level obtained on the SPIRE PFM structure from the manufacturing stage at MSSL to the optical bench, photometer and spectrometer cover assembly at RAL. This document is not a contamination control plan but is meant to show that MSSL observed correct contamination control procedures. It also documents tests such as vacuum bake out, Residual Gas Analysis (RGA), visual inspection and airborne particulate monitoring results.

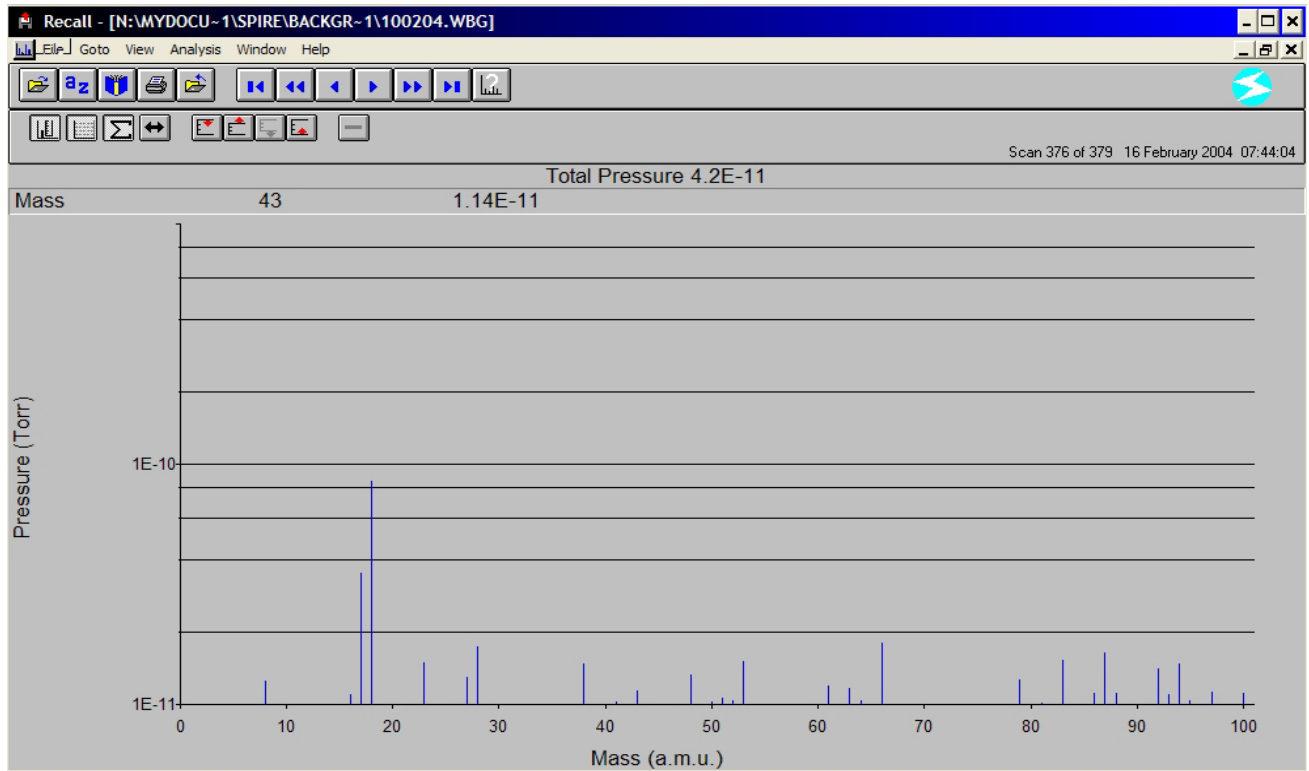
### Vacuum bake out – Chamber certification – RGA data

**Comment:** Prior to certification chamber was inspected to VC-HS+UV and cleaned as defined in MSSL/SPIRE/PA006.01 "Structure – Cleanliness control plan". Some particles were observed. The chamber was cleaned down using Spectro grade Acetone and IPA and then re-inspected. Re-inspection showed no fluorescing. RGA data was taken during chamber certification while at 125°C. RGA Spectra is shown on next page. Spectra shows very low levels (e-10 torr), with the dominant peaks at AMU 18 and AMU 17 indicating N<sub>2</sub>. This is expected as the chamber was exposed to cleanroom environment (water vapour/O<sub>2</sub>) and is purged with N<sub>2</sub>. All other spectra are at the limits of the faraday cup detection (2E-11).

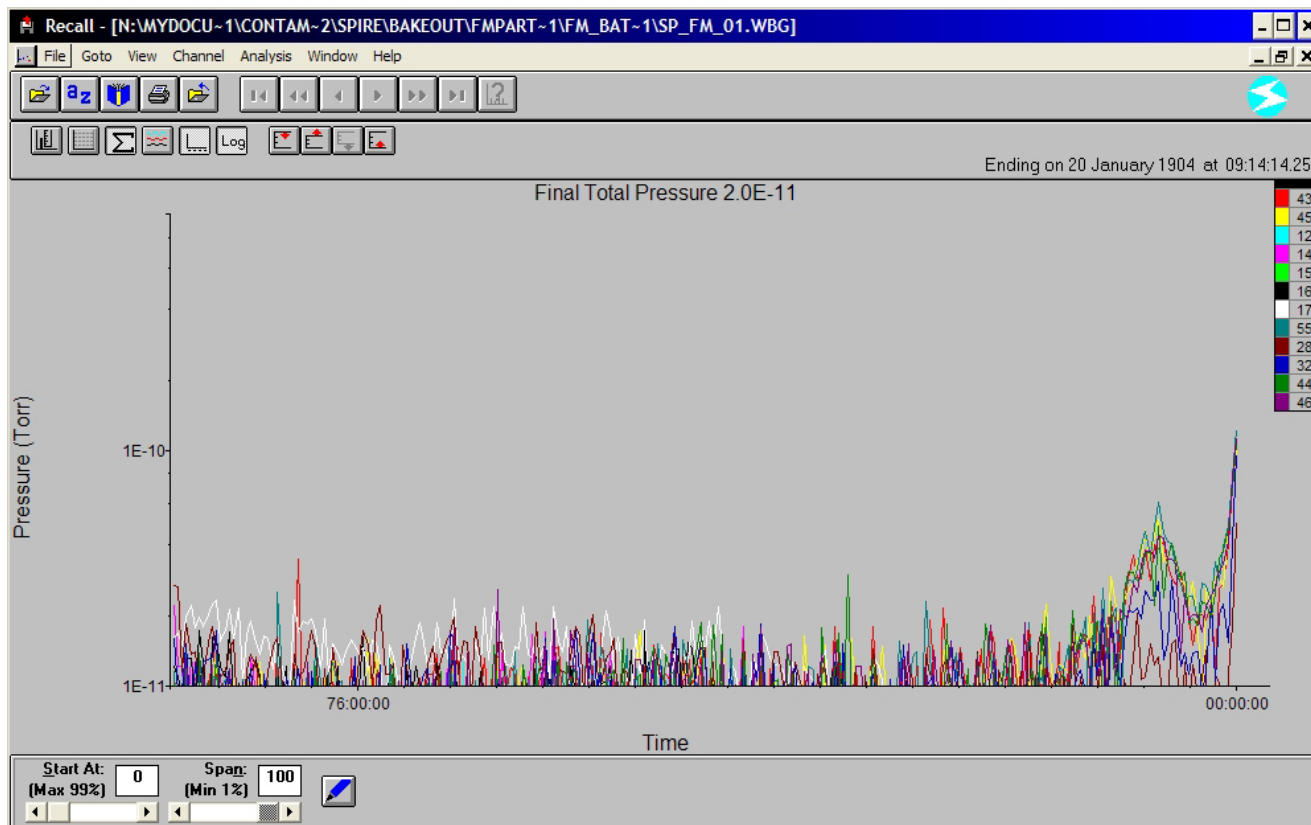
### TEST CONDITIONS: RGA spectra – Bar & trend chart

| TIME | OPERATION/COMMENT | RESPONSIBLE |
|---|--|---|
| 08:59 | P = 1.0E-7 mbar, T = 100°C, Heaters off, RGA show good decay<br>(see attached RGA report), end of bake out | ADR |

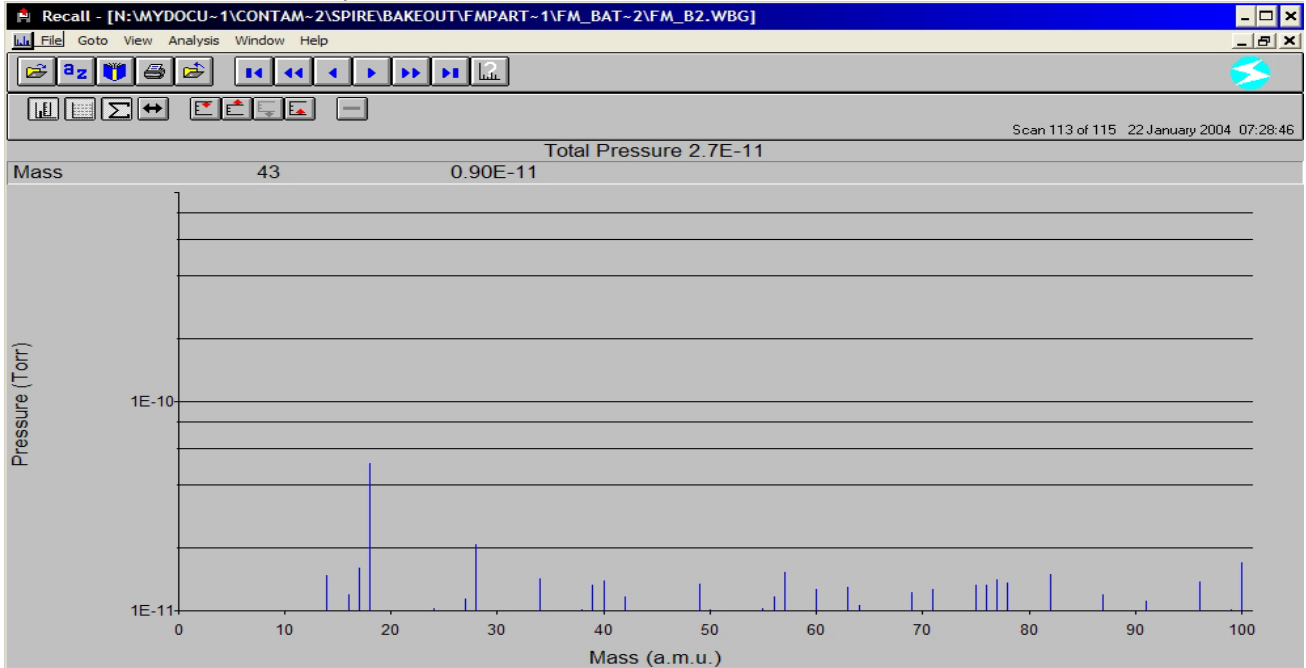
### TEST CONDITIONS: RGA spectra – Bar & trend chart

| TIME | OPERATION/COMMENT | RESPONSIBLE |
|---|---|---|
| 08:20 | P = 2.0E-7 mbar, T = 100°C, heaters off, RGA shows good decay<br>End of bakeout | |
