SSTD Incoming Inspection Report

Spacecraft/Project **HERSCHEL / SPIRE**

Document Number **SPIRE-RAL-REP- 002455**

Sub System **Detector Harness**

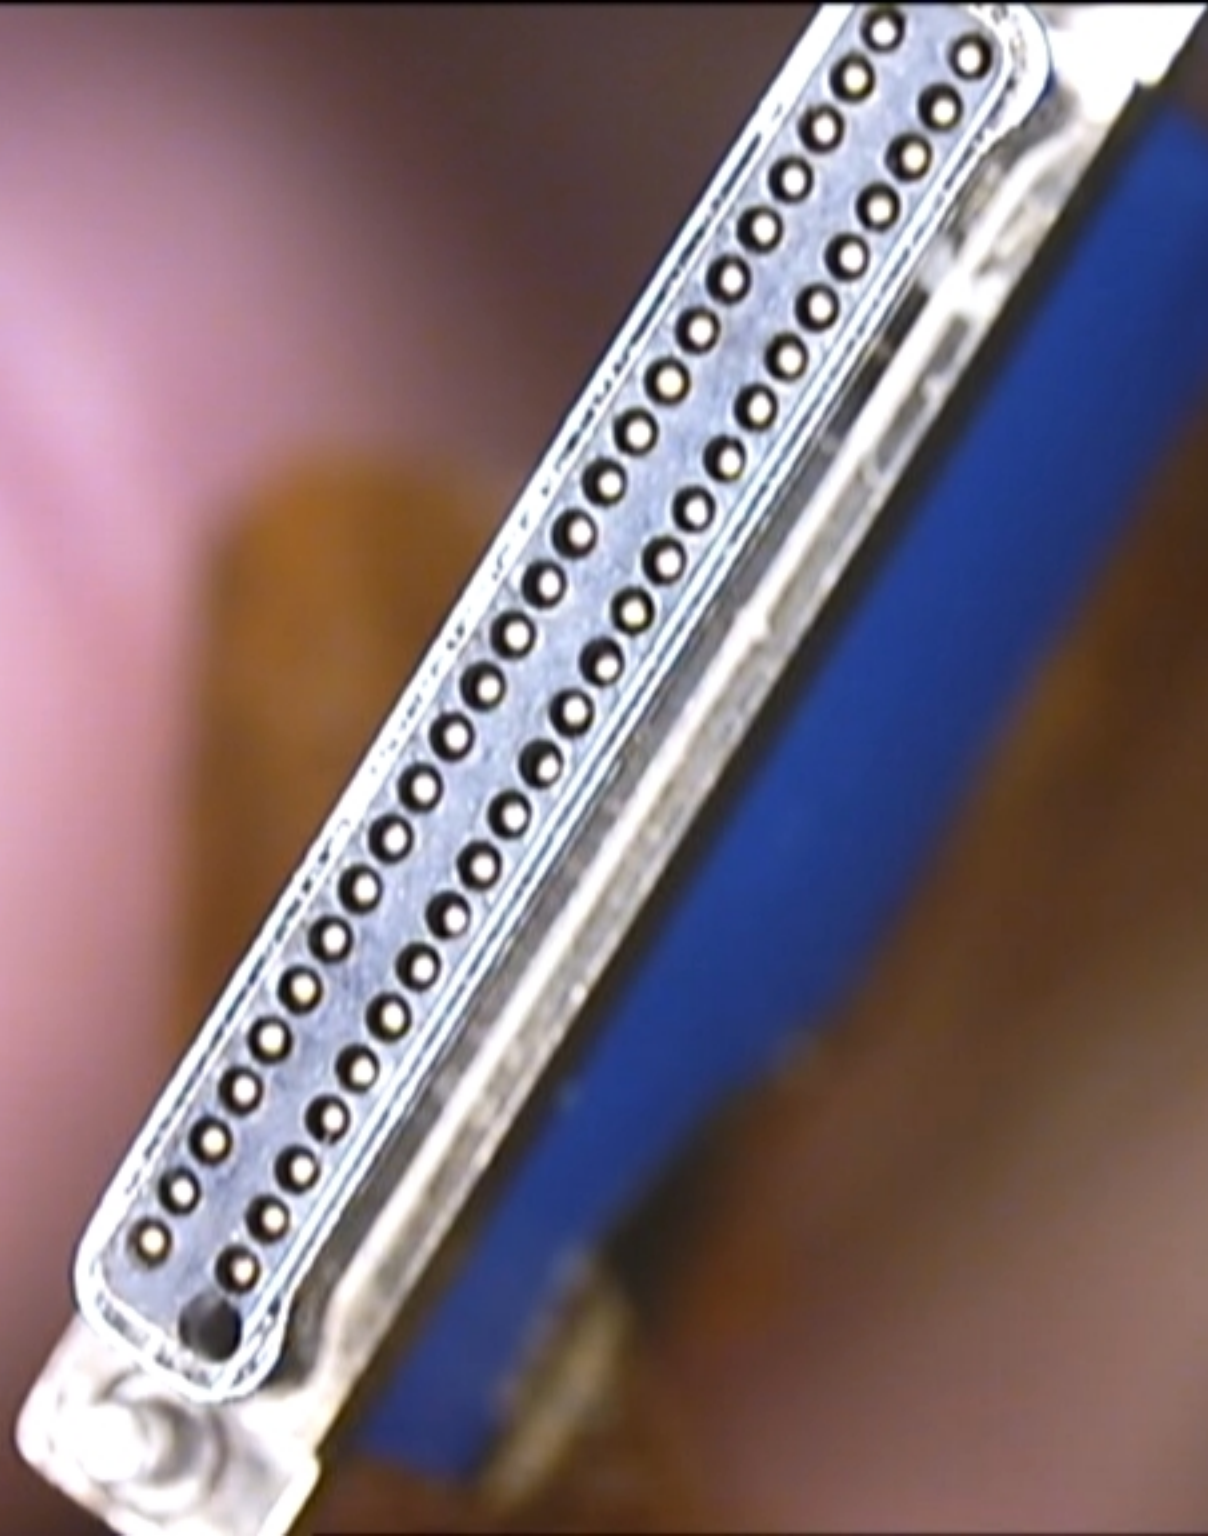
Drawings / Documents Attached
Photo of Connector with missing pin

Connector ID	Comments
P06- 035	Pin missing Hole enlarged, Link to P05-033 and earth Tag Otherwise all other pins OK See Photo attached
P05- 033	Link to P06-035 and earth Tag all pins OK
P11- 033	all Sockets OK, Conector Cover fitted
P12- 035	all Sockets OK, Conector Cover fitted
