SST DEPARTMENT
VIBRATION TEST FACILITY
REPORT REF: AIV-2003-091-VIB
HERSCHEL : CARDIFF COMPONENTS

RUTHERFORD APPLETON LABORATORY
Vibration Facility
Chilton, Didcot,
Oxfordshire OX11 0QX

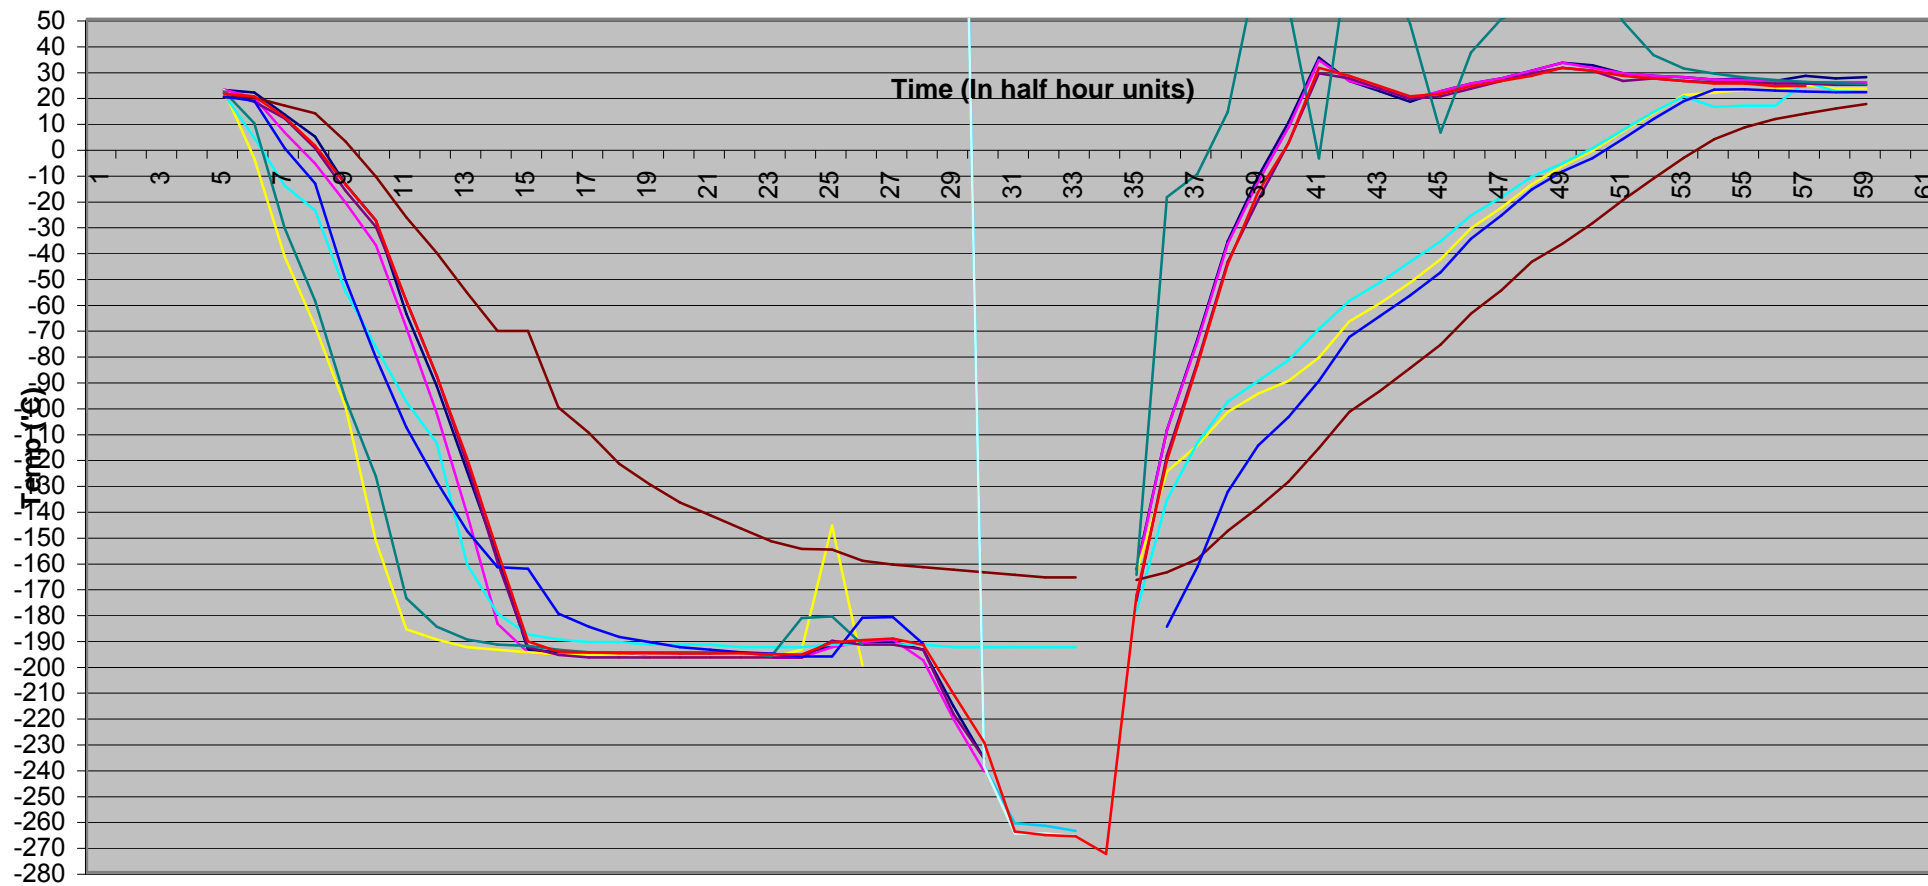
BSM 300mK Components Cooldown/Warmup Data

ACTION	DATE	TIME
Pumpdown Started	23/03/04	16:45
Cooldown Started	23/03/04	21:30
Cold Vib. Testing	24/03/04	11:30
Start Warm Up	24/03/04	12:00
Ambient Testing	25/03/04	08:40
Test Item Removed	25/03/04	11:00
