SSTD Outgoing Inspection Report

Spacecraft/Project **HERSCHELL/SPIRE**

Document Number **SPIRE-RAL-REP- 002862**

Sub System **FPU**

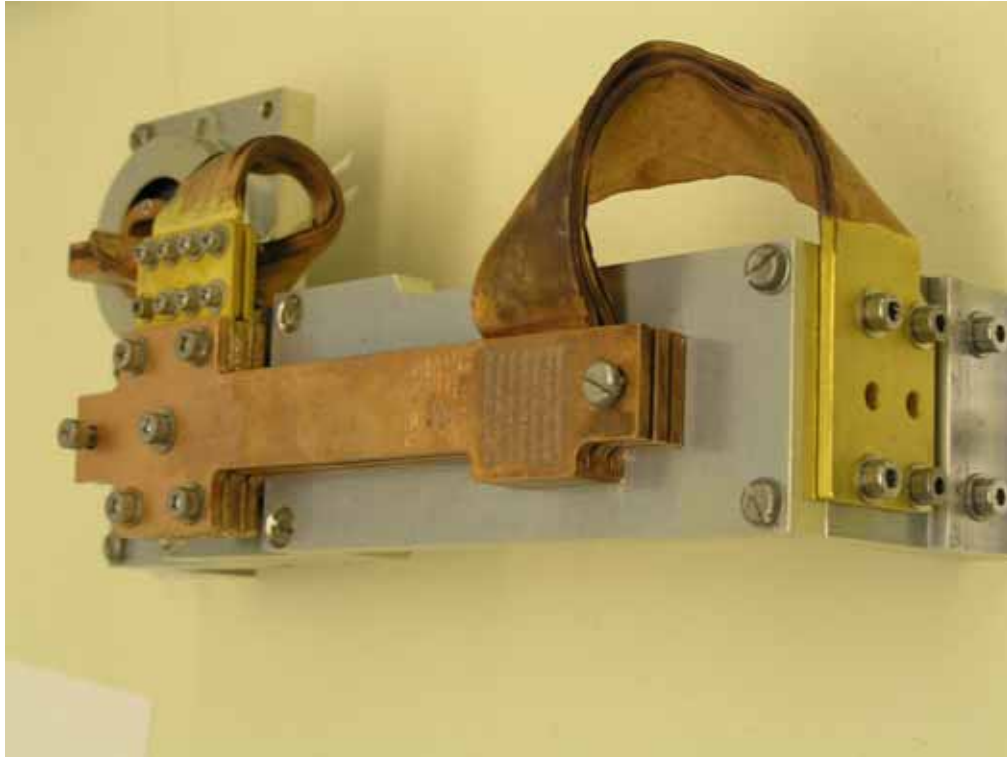
View of level 0 copper strap with gold plated interface plates to be fitted at integration

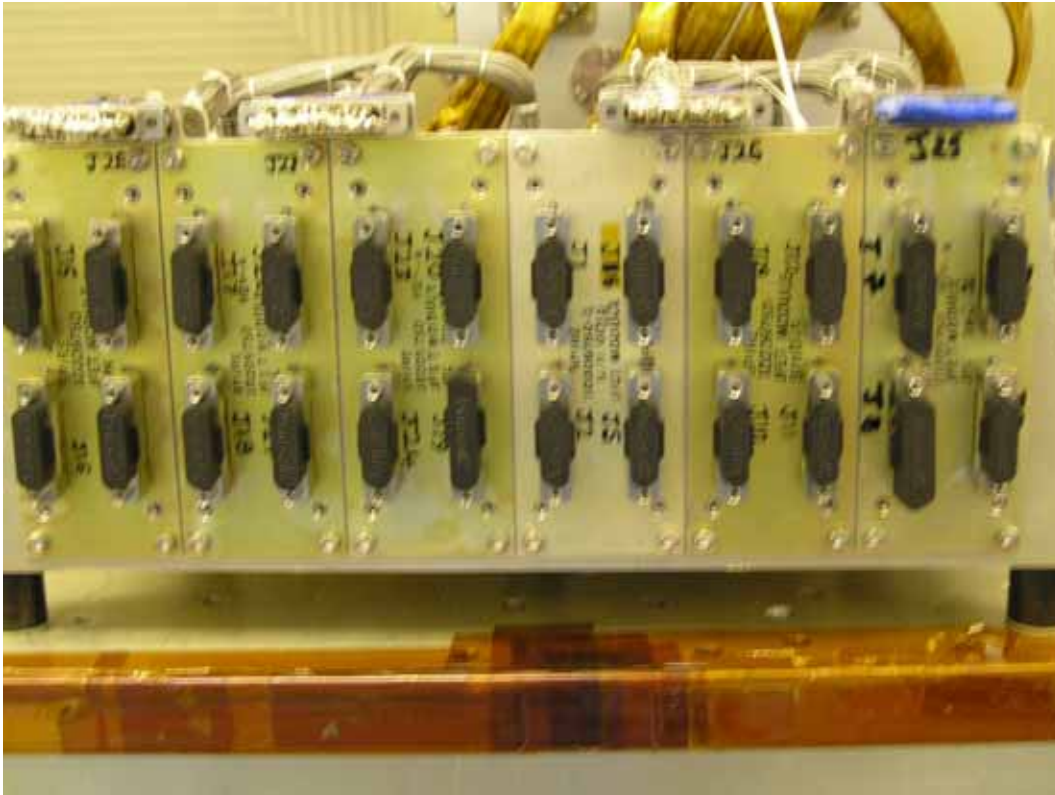
**JFET Connectors with covers and savers
(not removed during this inspection)**

Connector covers on the other connectors were not removed because of savers. Inspection of these areas will be required at a later date.

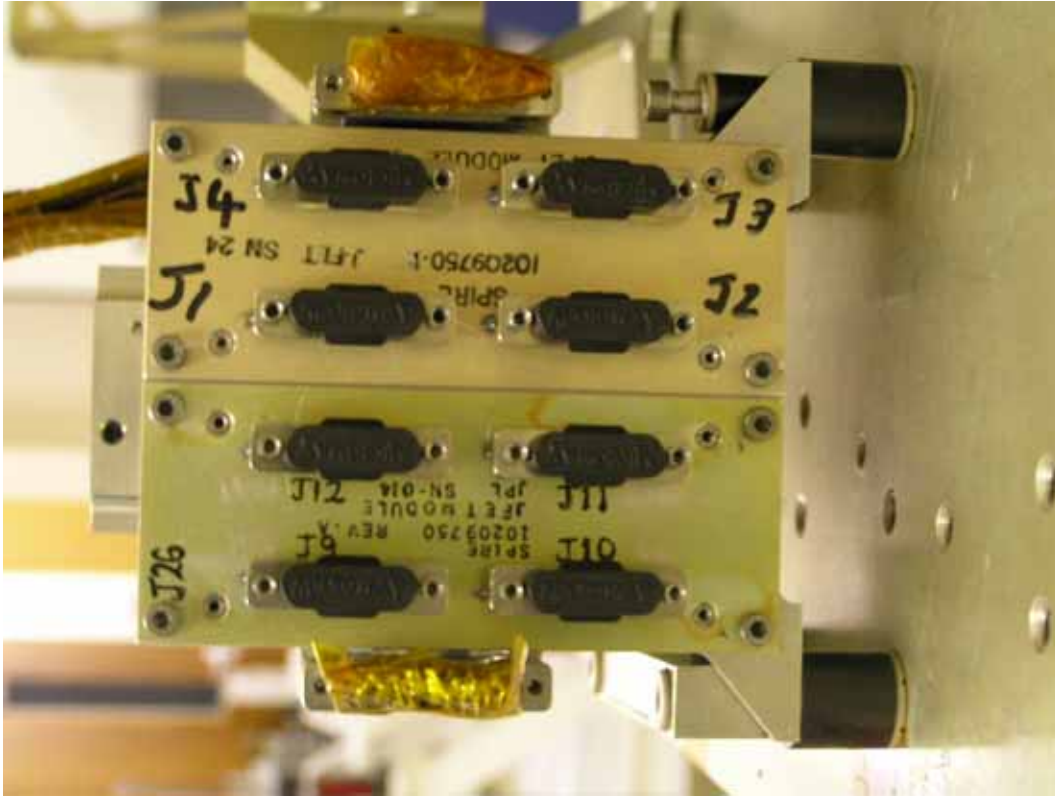
Connectors with savers and covers (not removed)

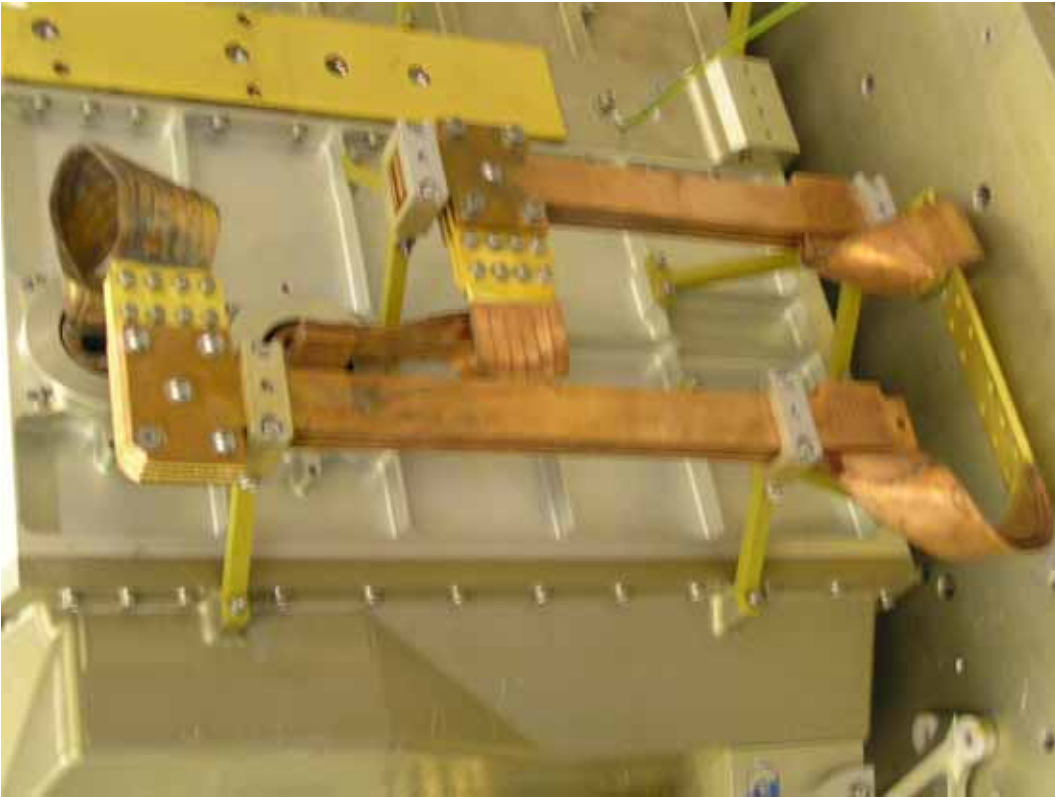
Oxidation seen on copper strap surfaces. The interface plate are gold plated. Harnesses and cables are OK.

Tarnishing of the copper on L0 straps can be seen, interface plates are gold plated

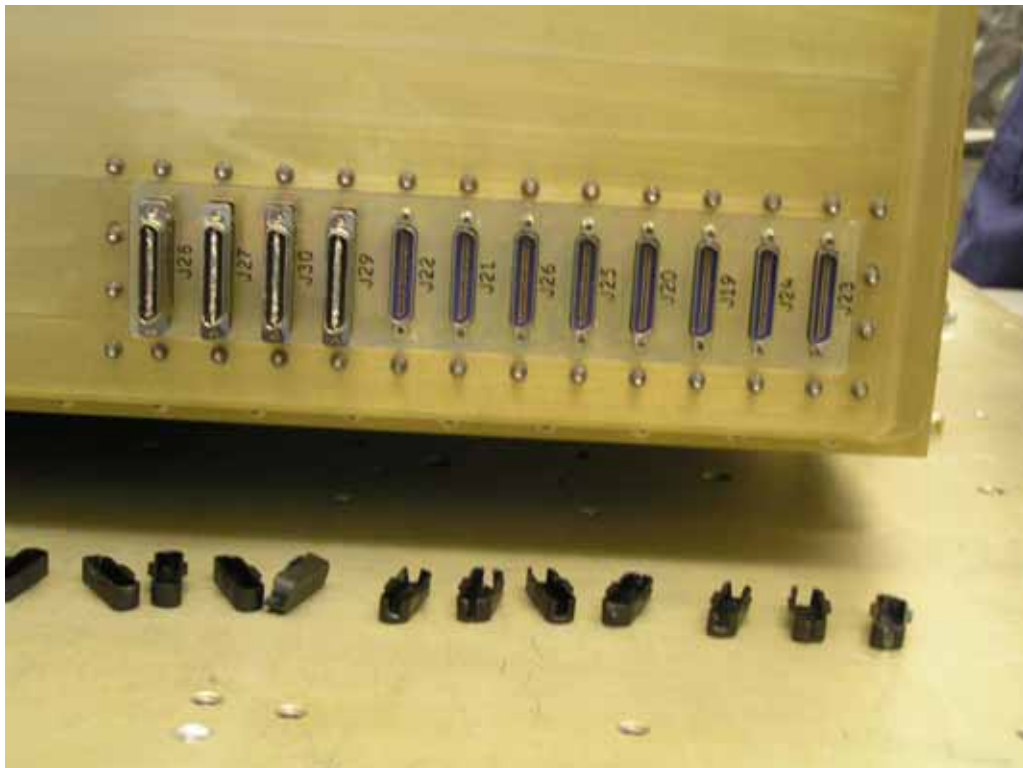
Covers removed for inspection of connectors,
(J27 to J30 – savers not removed)

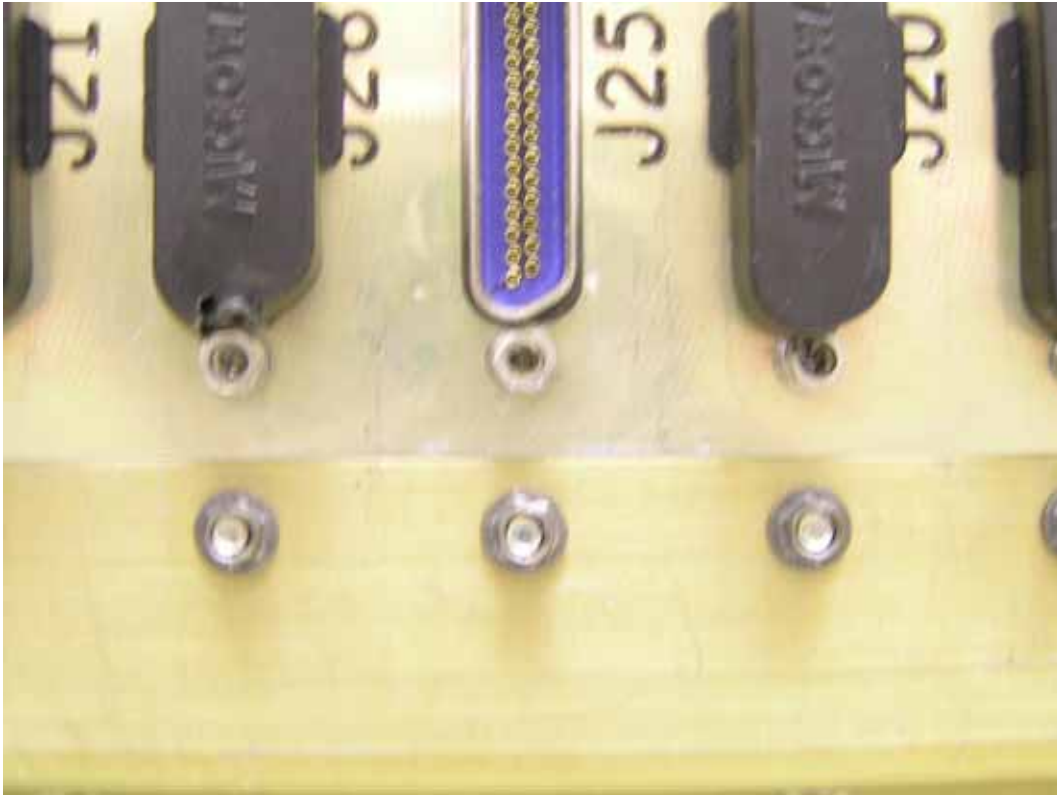
J24,J22,J25, J20-crack seen on blue area inside connectors, alignment of pins OK.

Connector with crack in the blue gasket between bottom pin and case
Ref HR-SP-RAL-NCR-171

NCR raised to cover cracking number HR-SP-RAL-NCR-171

NCR Description	
<p>Cracking was seen in the pin support between pins on FPU flight unit. Connectors numbers J24,J22, J25, J20-cracks seen on blue area inside connectors, alignment of pins OK. Not all connectors were checked as savers were in place. The gasket is not critical to connector operation and not part of the structure of the connector. Therefore the integrity of the connector is not compromised. Mating and de-mating is not expected to cause further degradation as this problem occurs at cryogenic temperatures.</p>	
Cause of NCR	
<p>Probable caused by multiple low temperature cycling during testing. This type of connector is now known to have cracking issues, but this was not known at time of fitting. The cracking was not observed at previous inspection,(two cryocycles ago).</p>	
Disposition / Corrective Action	
<p>Actions discussed at NRB and recorded on this NCR</p> <p>1) As there are two more planned mating for these connectors, one for electrical testing and one for final mating Further inspection is required before and after each mating. 2) Connectors with savers should be checked when savers are removed after delivery. 3) As it is now recommended to use as is - subject to no further degradation of connectors before final mating.</p>

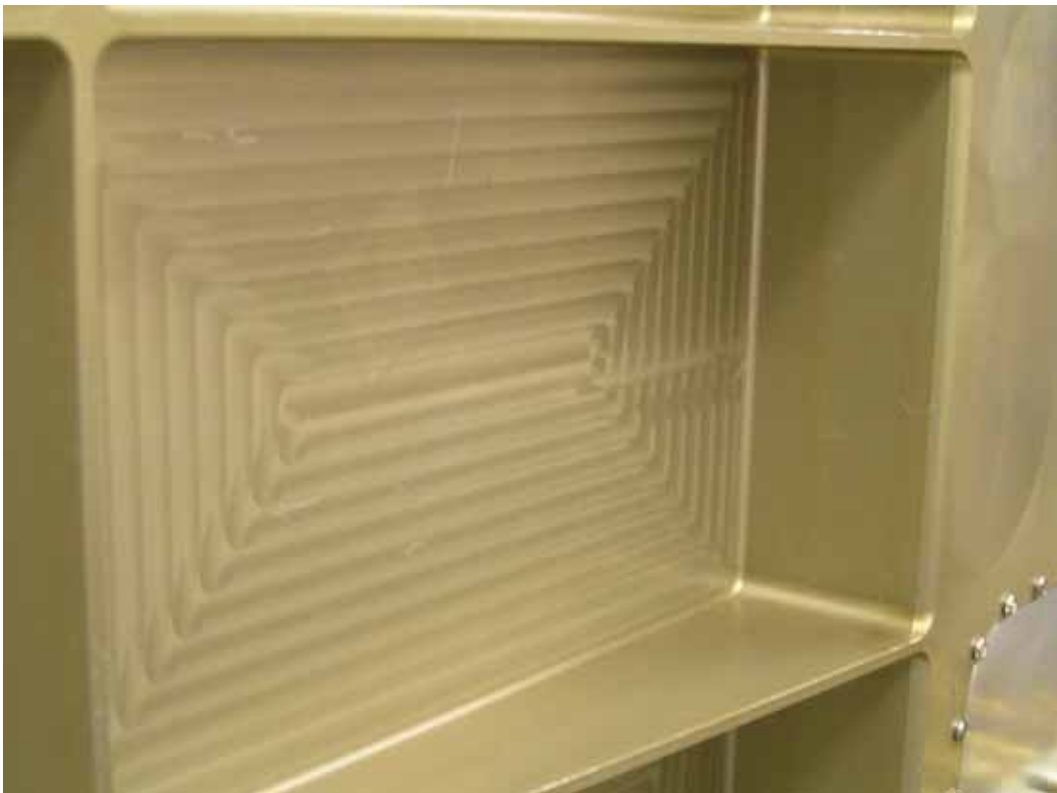
Many small scratches observed on the side of the case, Caused during insertion and extraction from the cryostat for cold tests.

Side of FPU to show scratch marks on the case

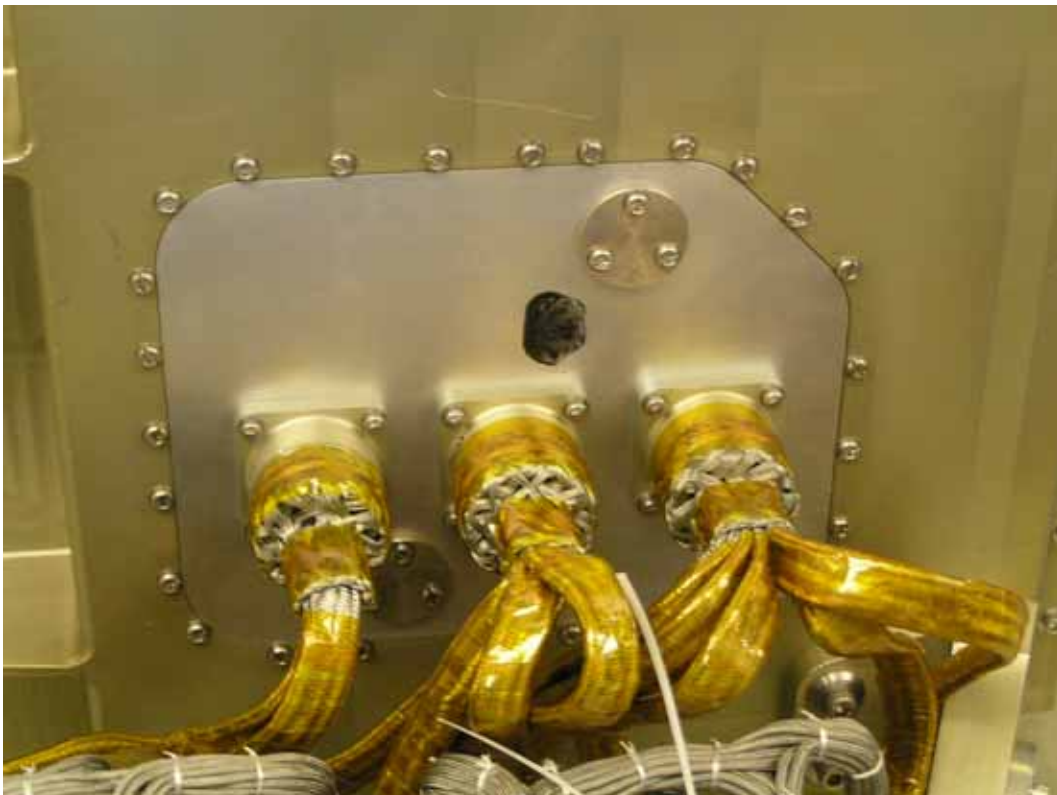
View of cable, black mark from removal of temperature sensor and scratch on case

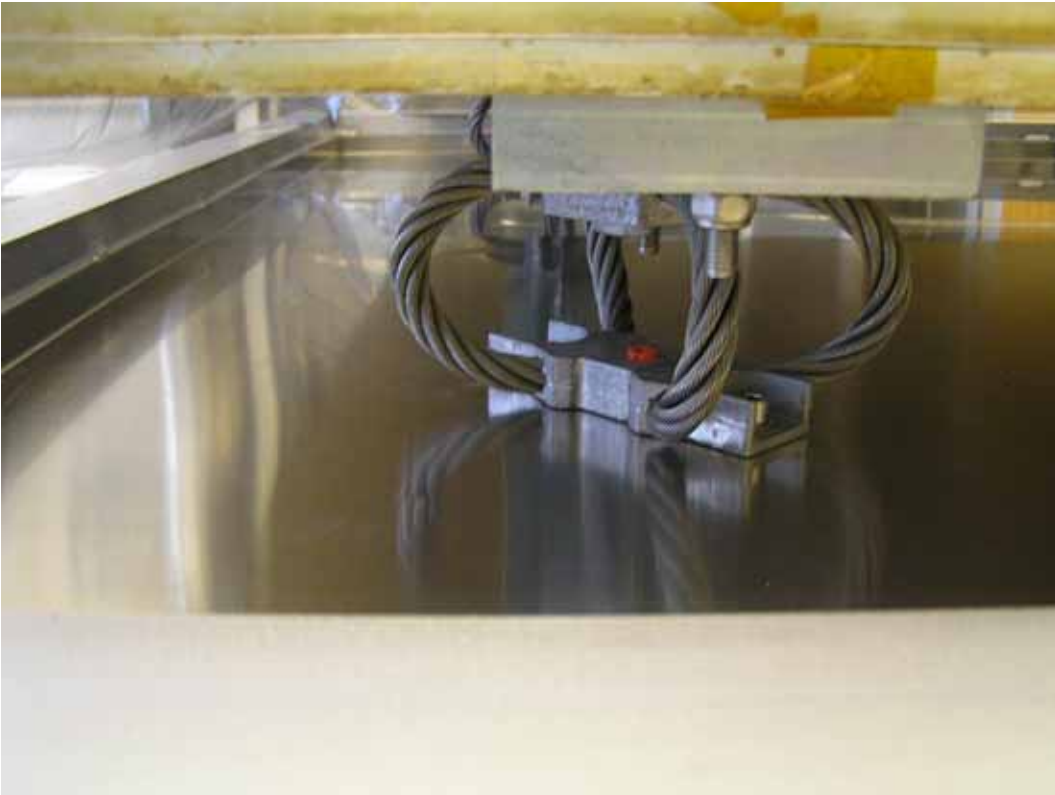
Sock absorbing springs under platform inside transportation case base

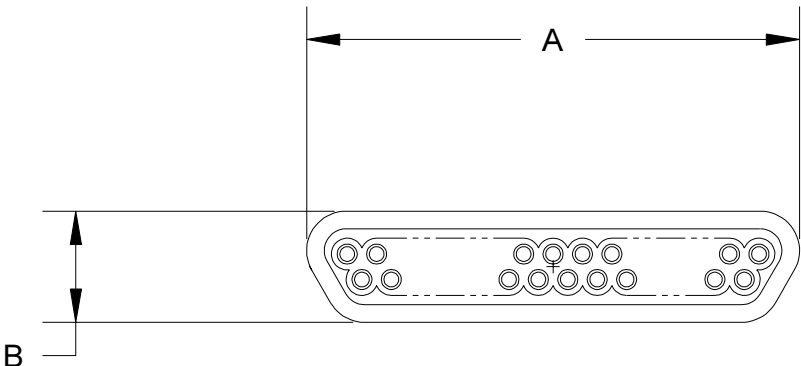
1. MATERIAL:
35-45 SHORE FLUROSILICONE PER MIL-R-25988.

2 ALL MICRO-D METAL SHELL RECEPTACLE CONNECTORS ARE SHIPPED WITH THIS ITEM INSTALLED. INFORMATION PROVIDED HERE IS ONLY FOR PURCHASING THIS ITEM SEPARATELY.
