Venus Monitoring Camera on Venus Express

Anomalous features in the VMC images

VMC-MPAE-TN-SS010-001

Issue 3/1

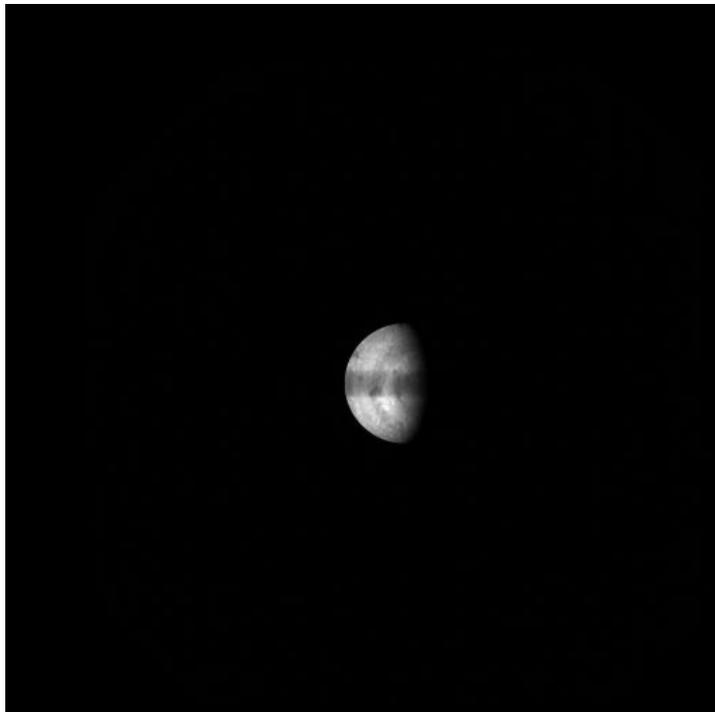
The horizontal dark stripe appears in all UV images. Example is shown in figure 2.1.

Figure 2.1 UV image of Venus v0001_0076.uv2 taken in Capture orbit.

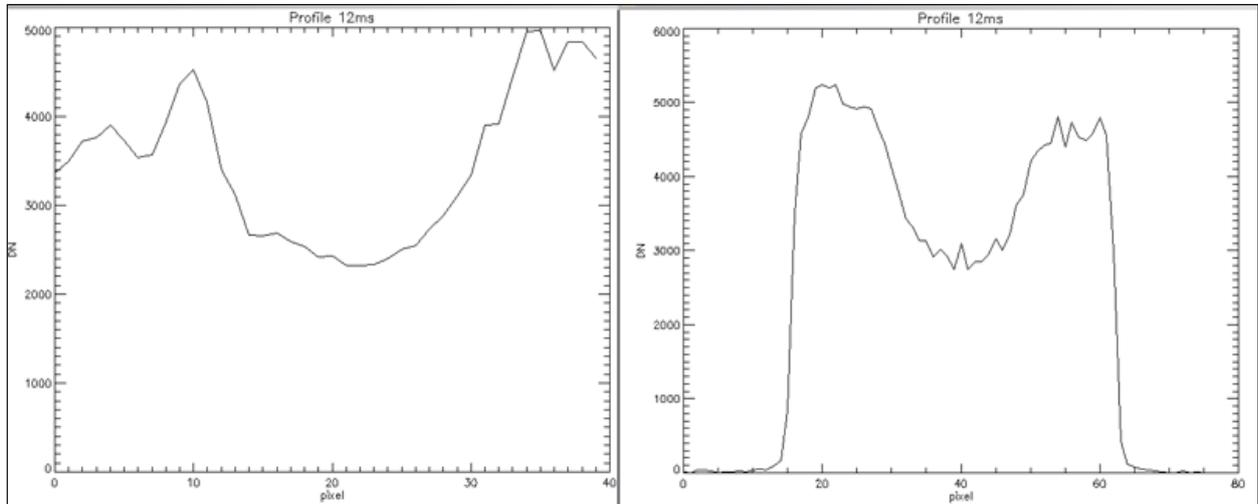
The dark stripe crosses the image horizontally (almost perpendicular to the CCD columns) and has width of ~18 pixels at half-minimum (figure 2.2).

Figure 2.2 Brightness profiles across the CCD perpendicular to the dark stripe (right).

Angular dimensions of the sun as seen from Venus is ~ 13 mrad that corresponds to ~ 17 pixels of the CCD. This is almost exactly the width of the dip in the dark stripe brightness profile (figures 2.2, 2.3).

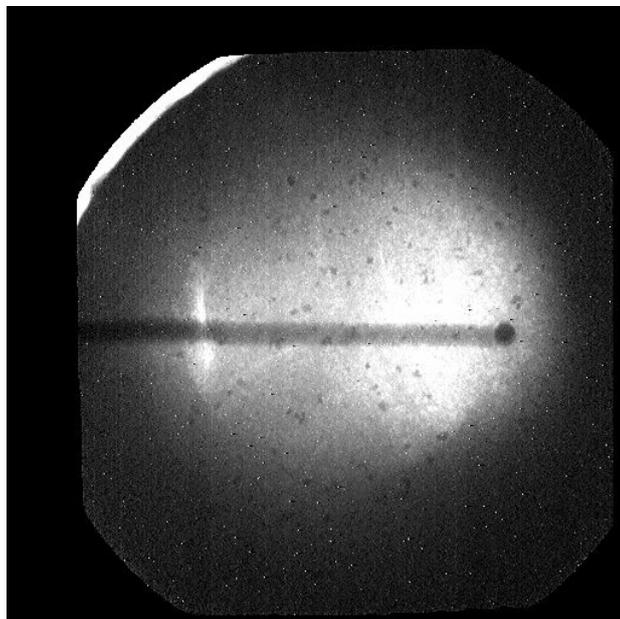
Although inside the dark stripe the features on the Venus disc are visible and recognizable its centre is characterized by about a factor of 2 lower sensitivity as compared to the rest of the image. Figure 2.3 shows the appearance of the dark stripe when the entire field of view was illuminated during the stray light tests on April 24, 2006.

Figure 2.3 UV image v0002_0010.uv2 taken during in-orbit stray light characterization on April 24, 2006.

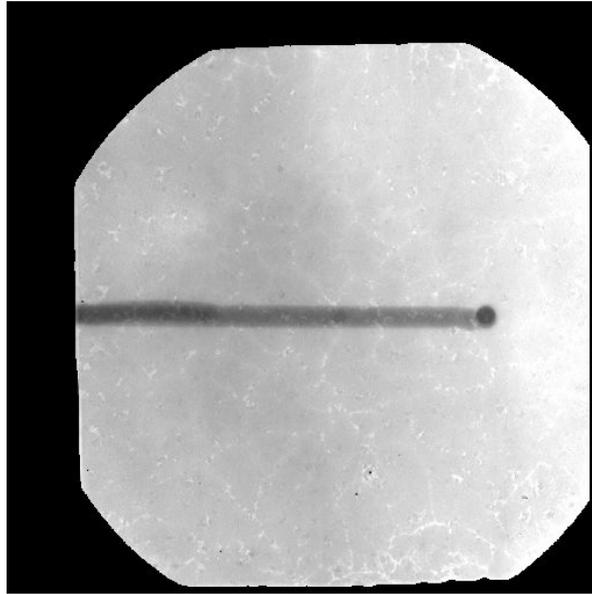
Figure 2.4 shows the UV image taken during the pericentre pass when Venus fully occupied the VMC field of view.

Figure 2.4 UV image v0004_0033.uv2 taken during the first pericentre pass.

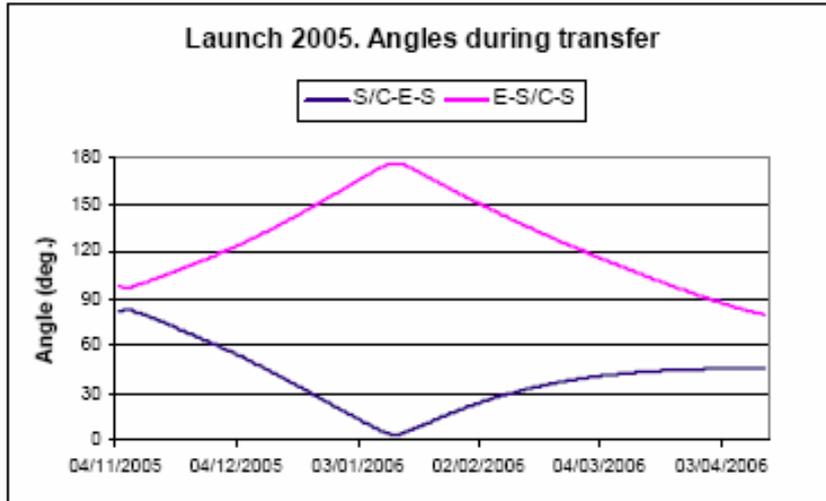
The dark stripe is oriented perpendicular to the columns of the CCD which are parallel to the Y axis of the spacecraft. Thus the dark stripe is oriented in the XZ plane in which the sun was kept during the approach phase (so-called power optimized spacecraft orientation). Figure 2.4 shows the evolution of the angle between Earth and Sun as seen from the spacecraft (magenta curve). When the angle was close to 90 degrees (end of March-beginning of April) the sun was close to the +Z axis of the spacecraft shining directly in the VMC field-of-view.

Figure 2.5 Earth-spacecraft-Sun angle during the cruise phase.

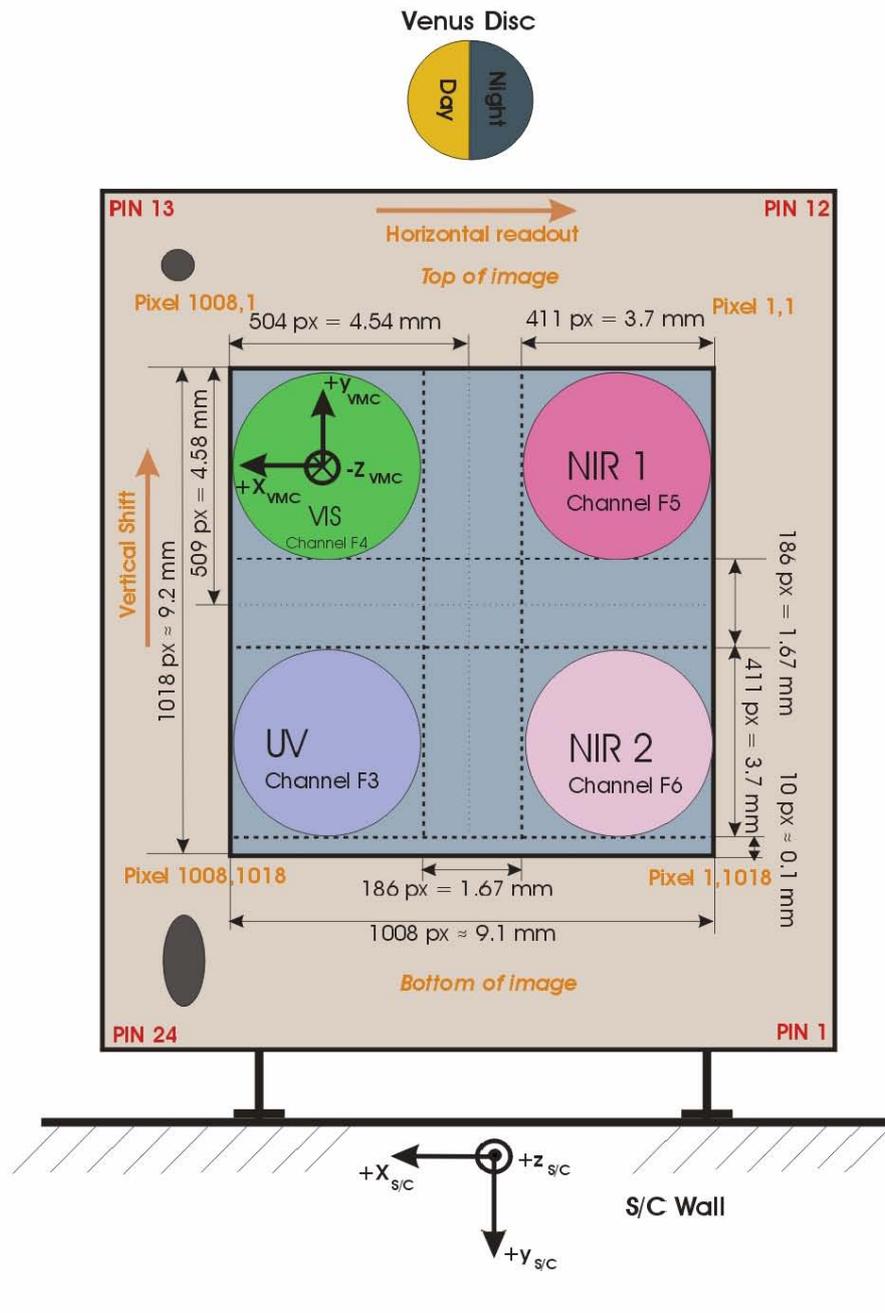
VMC: Front View on CCD Photosensitive Area, Co-ordinate System and Pixel Numbering

Figure 2.6 CCD orientation wrt spacecraft coordinates. CCD columns are vertical in this figure

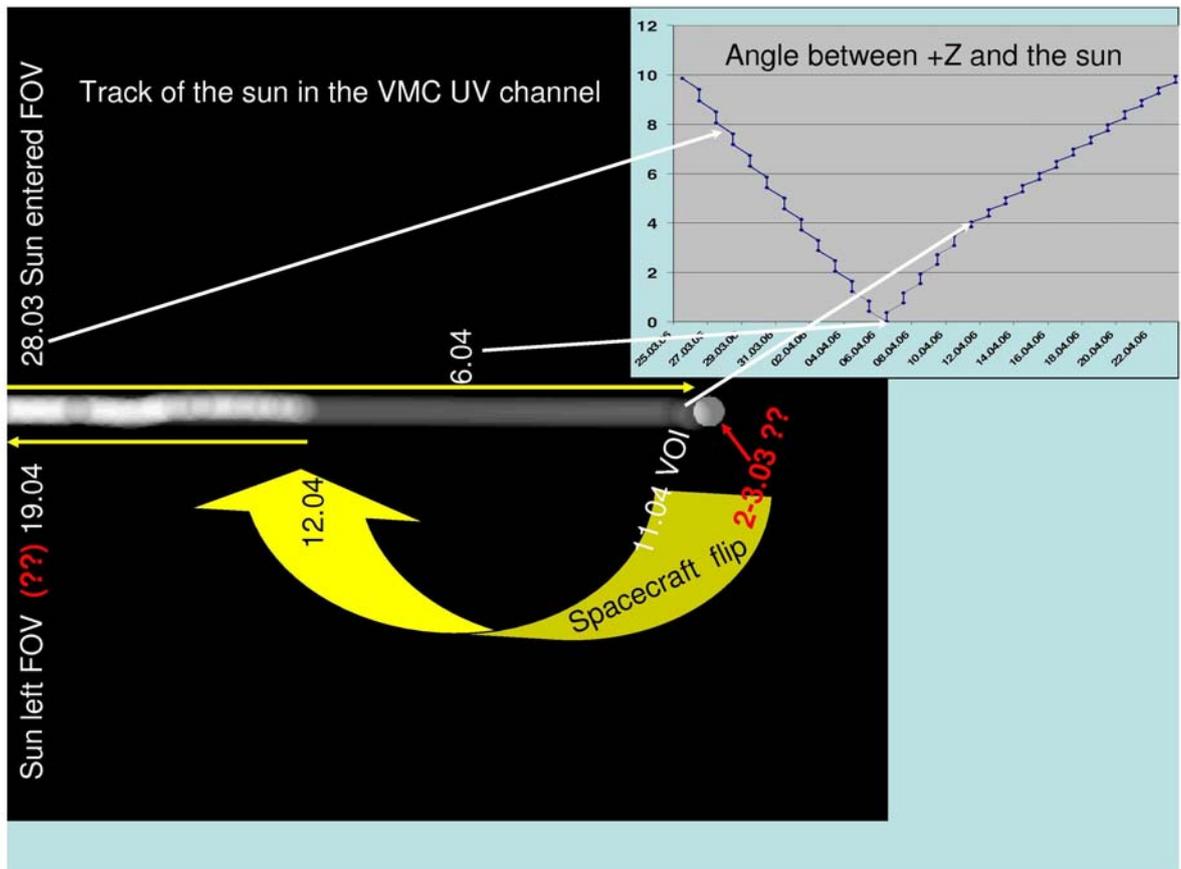
Analysis of the VMC Spice kernels allowed us to reconstruct the apparent motion of the Sun image on the UV quadrant of the CCD and to determine total solar illumination load for each pixel (figures 2.8, 2.9)

Figure 2.7 Track of the Sun image on one quadrant of the CCD reconstructed from the Spice kernels. Brightness of the stripe marks total illumination load. Venus disc is shown schematically.

Current working hypothesis is that the dark stripe represents the track of the sun image that slowly traveled across the CCD during the Venus approach in March-April 2006 and resulted in degradation of the detector sensitivity in illuminated pixels due to exposure of intensive UV light. The size of the stripe and its orientation support this explanation.

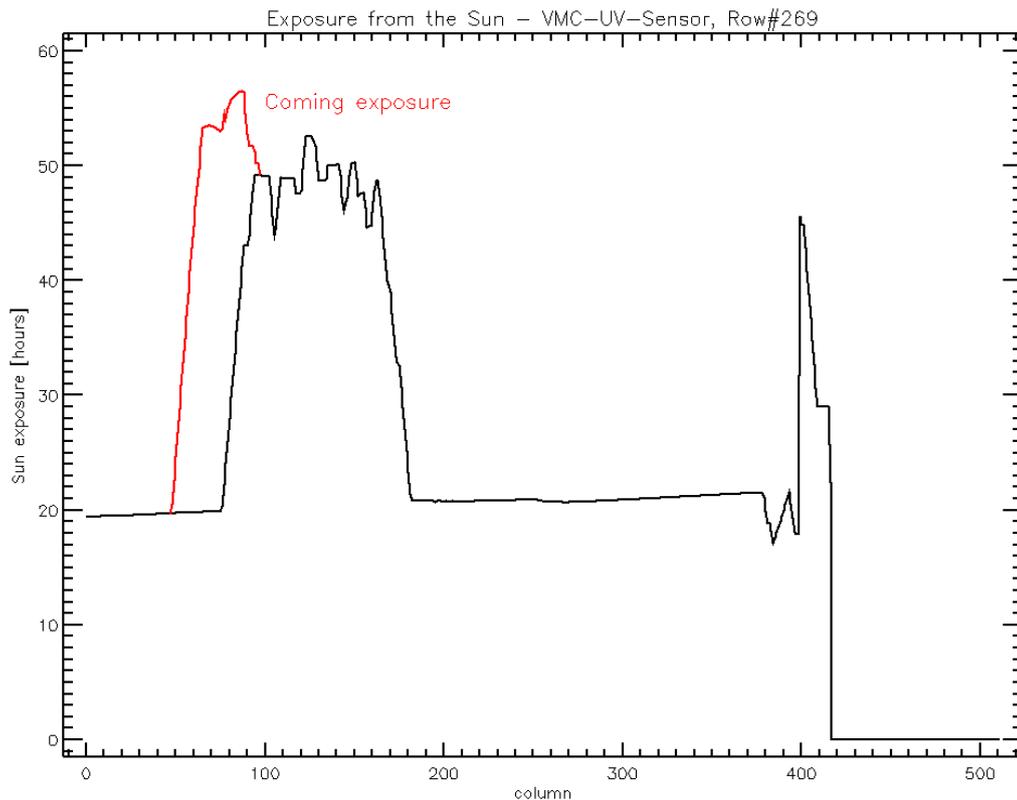
Figure 2.8 Exposure of the UV quadrant to the Sun illumination between March 1 and April 19, 2006 reconstructed from the Spice kernels. Venus disc is shown schematically.

Figure 2-8 above shows the degradation of the sensitivity of the pixels as a function of exposure to the sun. Although the data is very scattered two quasi-linear regions can be seen. 0-20 hours seems to have somewhat steeper slope than the region 20-60 hours. This could imply that we may reach a non-zero asymptote at certain point.

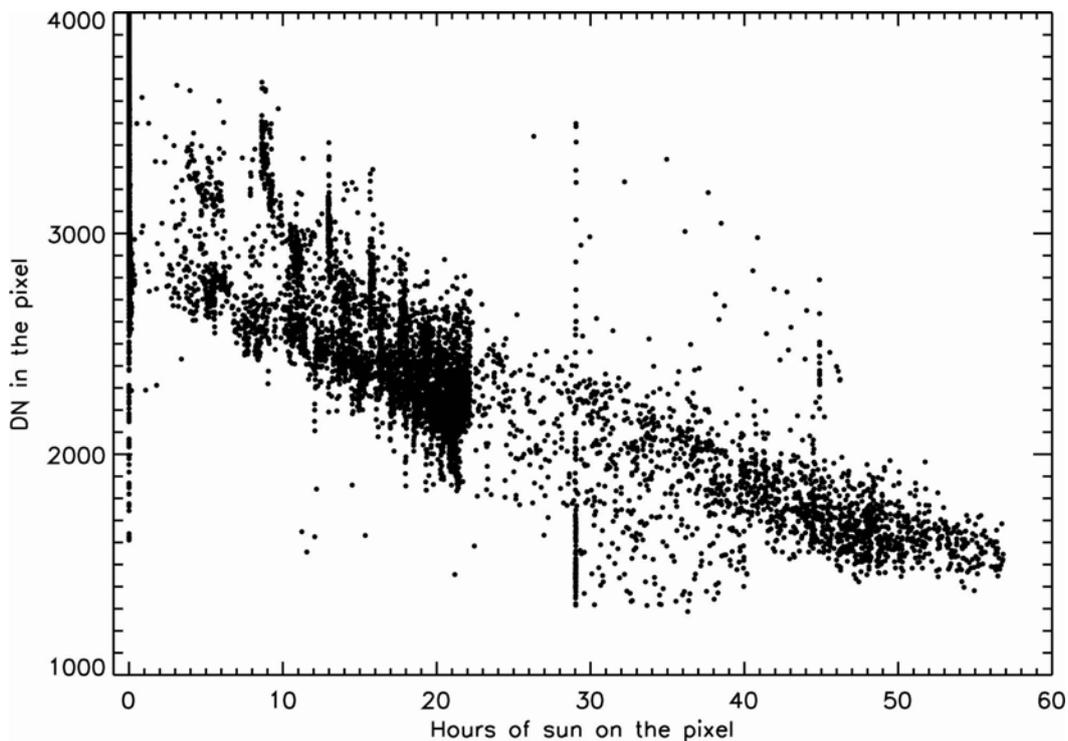
It is clear from the plot that the effect is accumulative (see section 2.2.4)

Further, it is also clear that degradation is already significant after exposure to the sun for several hours. For this reason we need to avoid exposure to the sun of this order.

Figure 2.9 DN in the pixel vs hours the pixel was exposed to the sun.

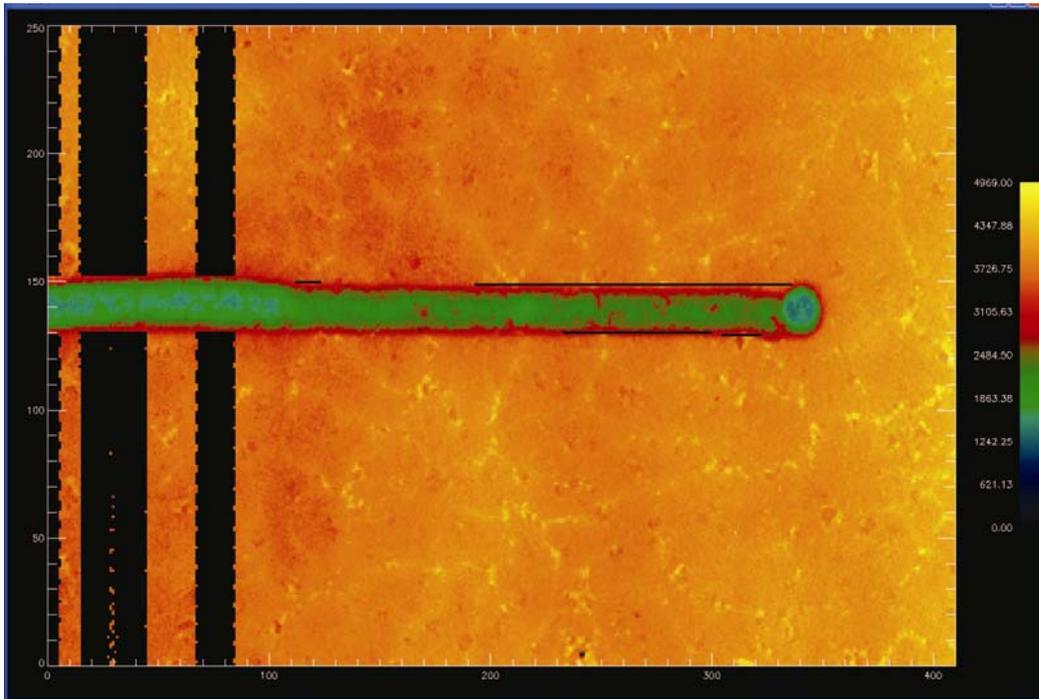
It not however clear if there is a threshold for the effect. All of the pixels with sun exposure greater than 60 seconds come from the strip of the sun track as seen in Figure 2-7. There are however other pixels that have been exposed to the sun during several reorientations of the S/C (slews and possibly VMC stray light test). The slews tracks are shown in Figure 2-10. The corresponding pixel vs sun exposure plot is shown in Figure 2-11. From this Figure we see that the maximum of the DN values decreases with sun exposure but the minimum does not. This

Figure 2.10 See text for details

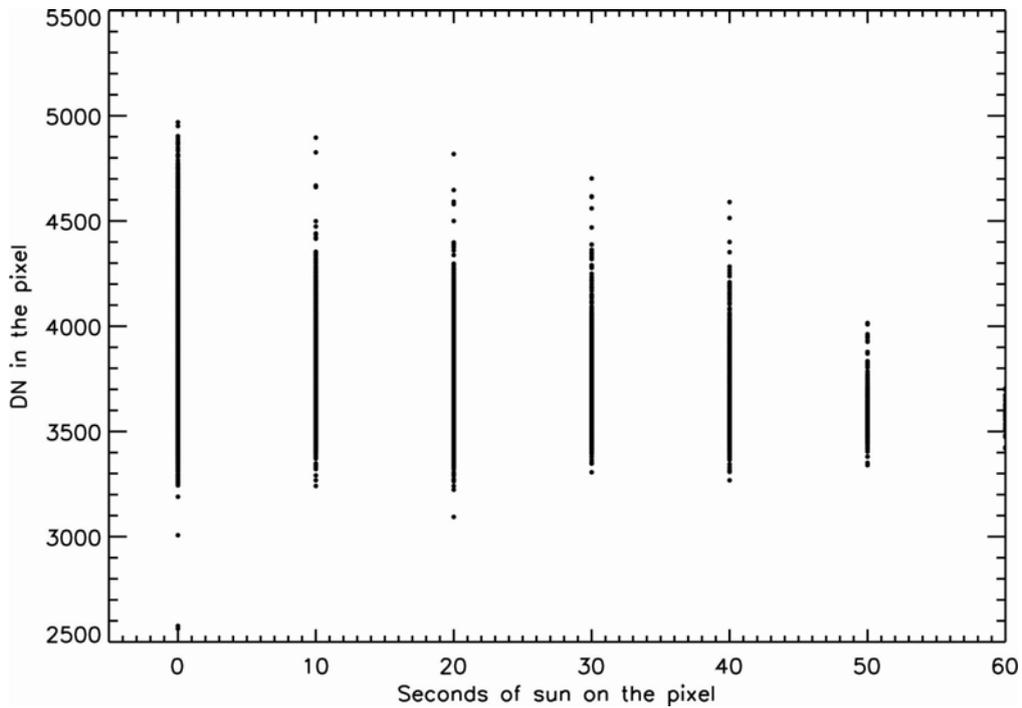
seems to be contradictory in the first instance. However looking carefully from which part of the slews tracks these pixels come from we find that the pixels with sun exposure greater than 30 sec come from a somewhat darker part of the image (left lower corner) and hence have a lower maximum. We can therefore conclude that the CCD sensitivity degradation is within the noise for these pixels. We can not however say anything about potential accumulation of the degradation effect.

Figure 2.11 Pixels effected by slews with sun exposure of less than 60 seconds.

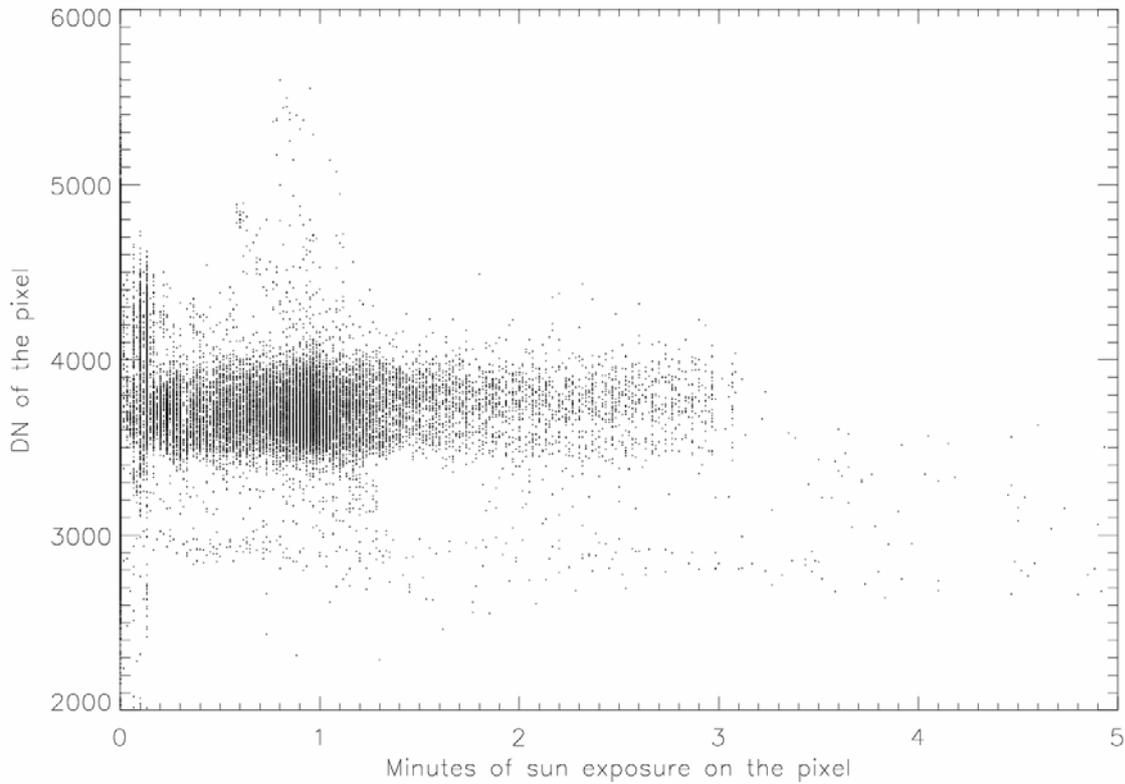
Figure 2.12 Similar to Figure 2-11 but going out to five minutes and with sampling of every second.

In Figure 2-12 we show all pixels exposed to the sun for five minutes or less. The sampling in time is now every second. The pixels exposed to the sun for more than 1 minute are those in the neighborhood of the main stripe (Figure 2-10). It can be concluded that a few minutes exposure to the sun does not degrade the CCD sensitivity. It can not be excluded however that effect may accumulate with repeated short exposures to the sun.

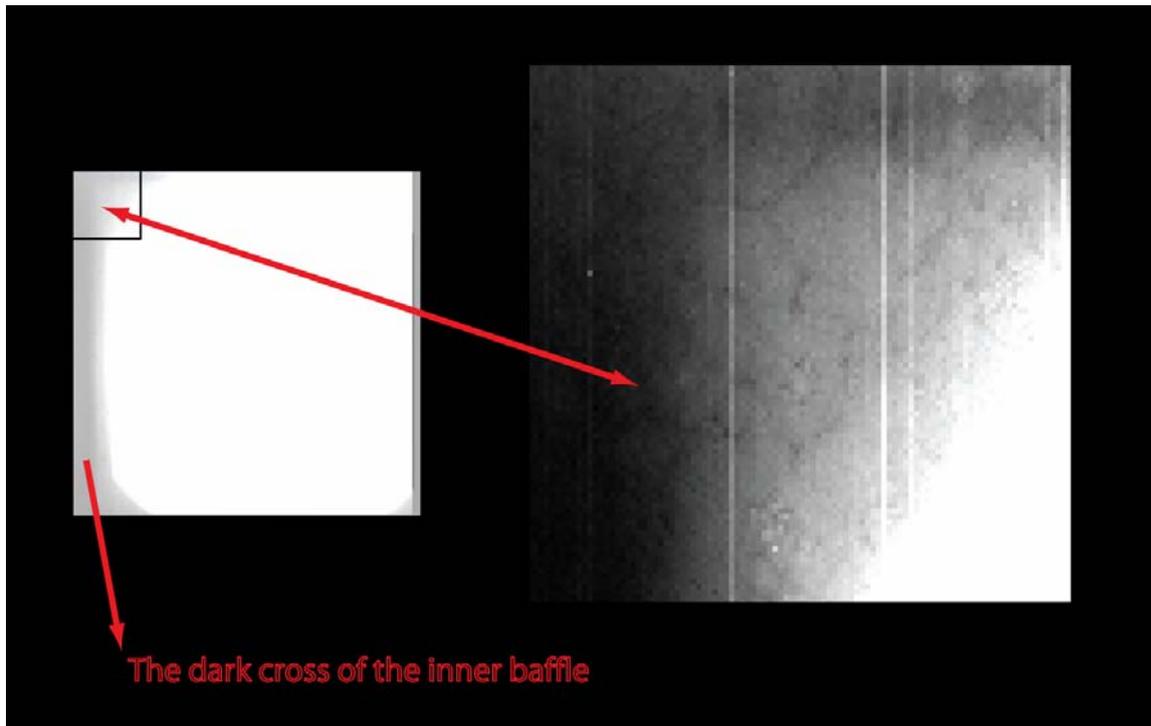
Figure 2.13 UV channel. A very overexposed image. Stray light illuminated area underneath the cross. The pattern is visible.

Left side of Figure 2-13 shows a very saturated UV VMC image. There was so much stray light that even the dark area underneath the inner baffle was partially illuminated. The honeycomb pattern is visible there. Since this area is not illuminated directly it would seem to exclude that the pattern is on any of the optical surfaces and must be on CCD. We have not however been able to show this for the other channels. This may be simply due to the fact that the signal is very weak.

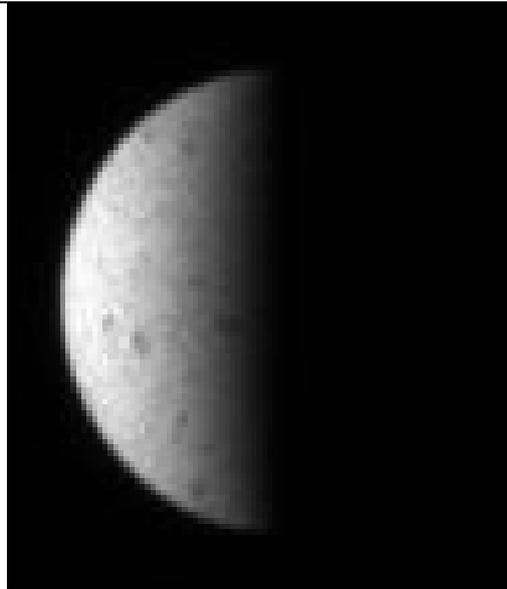
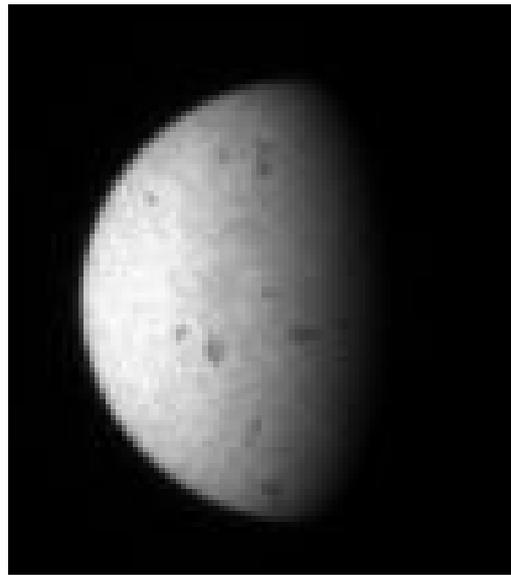
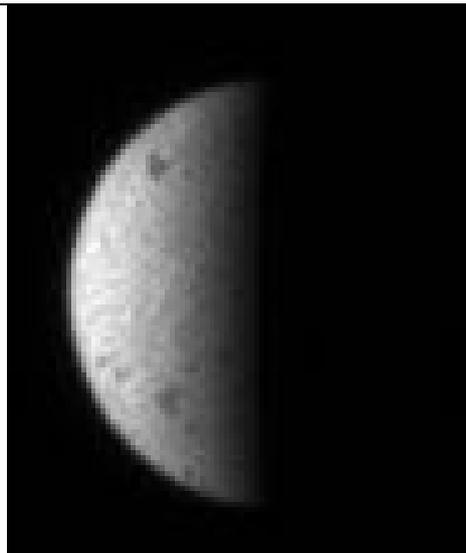
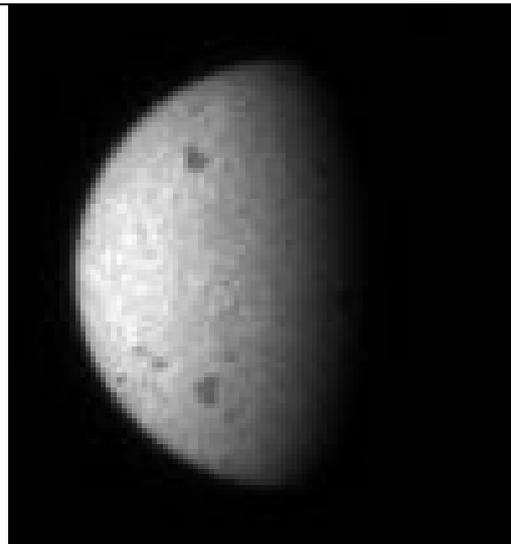
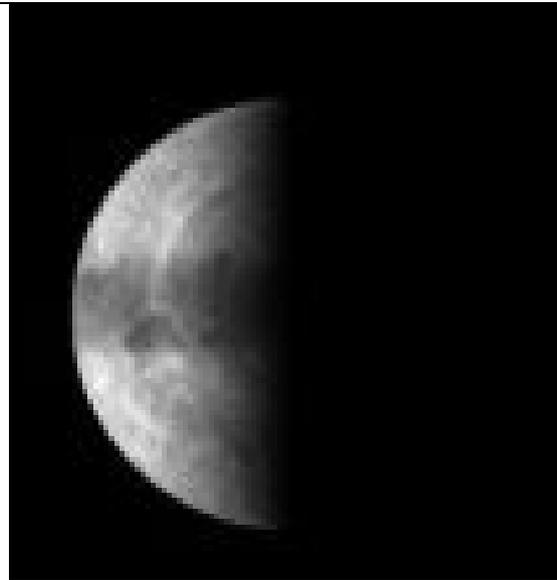
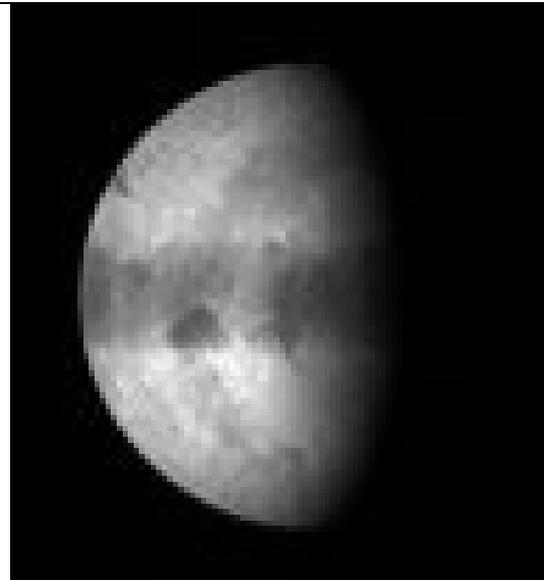
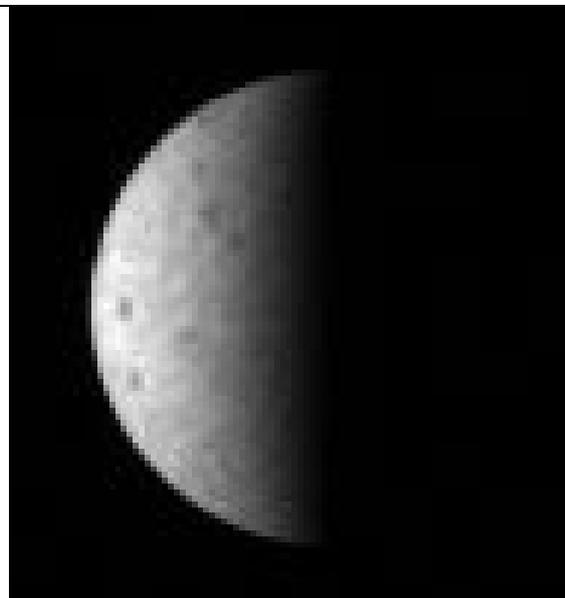
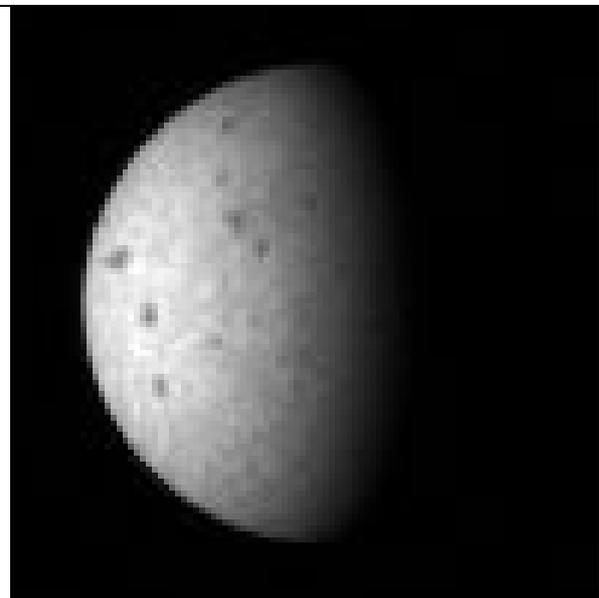
The figures below show the appearance of dark spots in four quadrants of the CCD. For each channel two images are shown: the left one corresponds to the first slot of observations in Capture orbit. The right image is one of the last taken in Capture orbit. Note that the figures 3.1 – 3.8 show only central part of the CCD about 100x100 pixels.

The most prominent features seen in figures 3.13-3.17 are the sun track in the UV image, spots and filament structures. Spots and filaments are visible in all VMC channels, but the details of these structures vary from channel to channel. Positions of the spots observed in the first pericentre images (figs. 3.13-3.17) correlate with the dark spots observed in the Capture orbit (figs. 3.5-3.8) and stray light images (figs. 3.9-3.12).

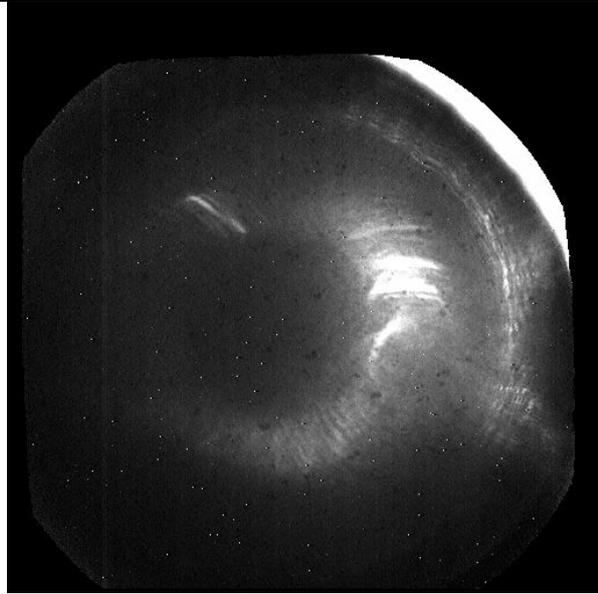
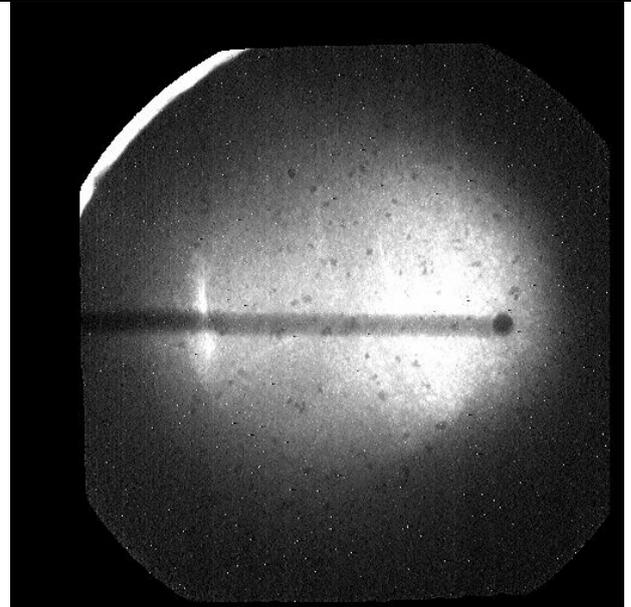
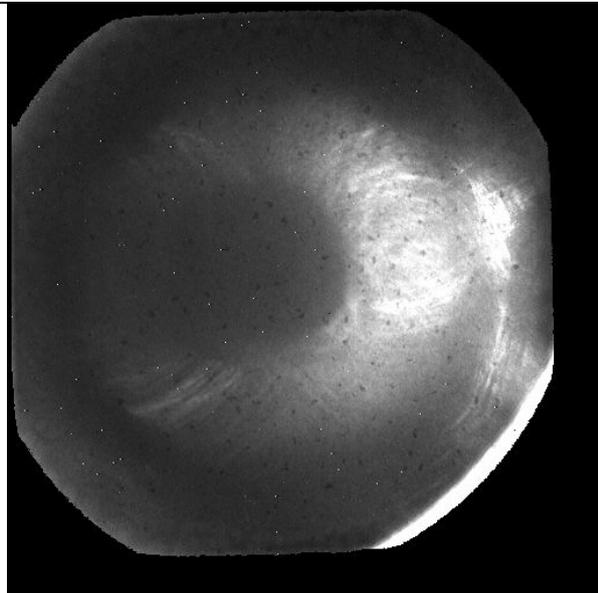
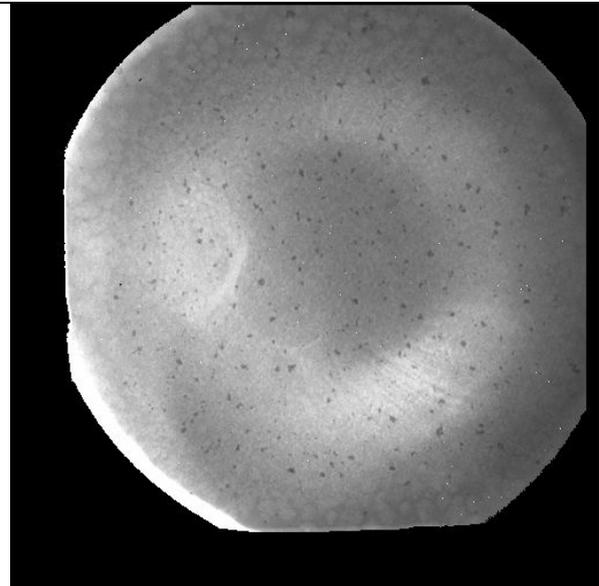
In-orbit stray light measurements gave the first opportunity to see the above mentioned features in the whole FOV. Figure 3.9 -3.12 show the dark spots randomly spread in all four channels.

Typical spot size is ≤ 5 . Sensitivity loss inside the spot area as compared to surroundings is between 30 and 70 %.

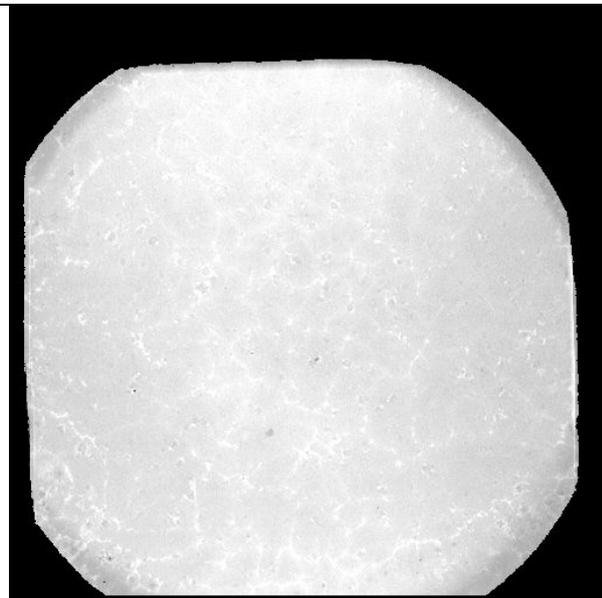
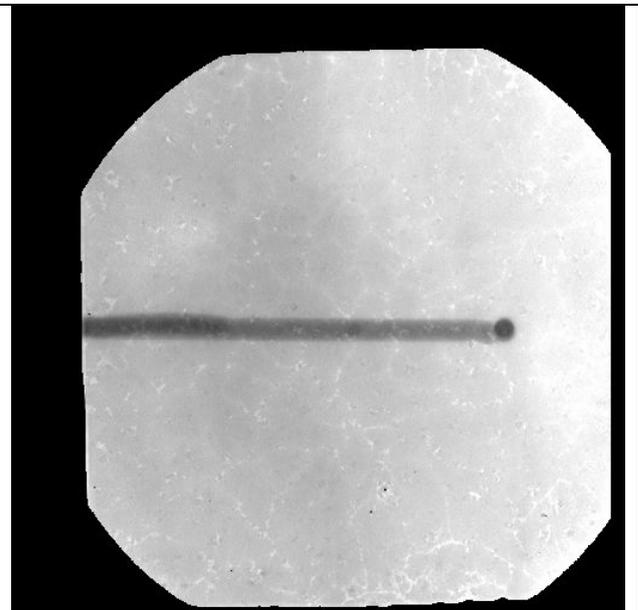
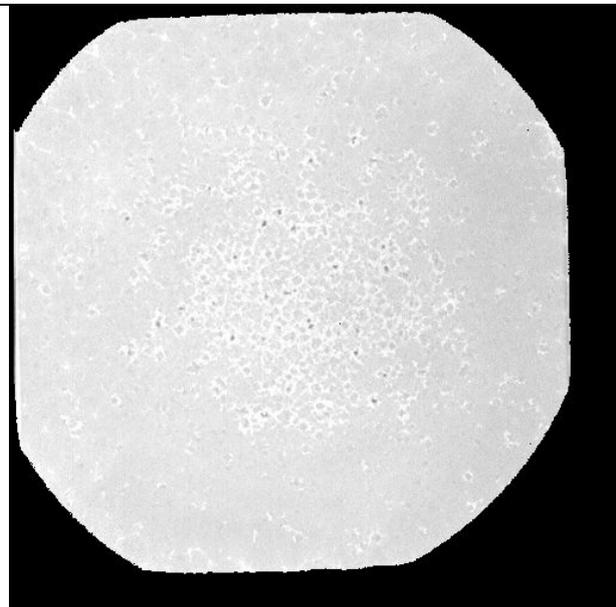
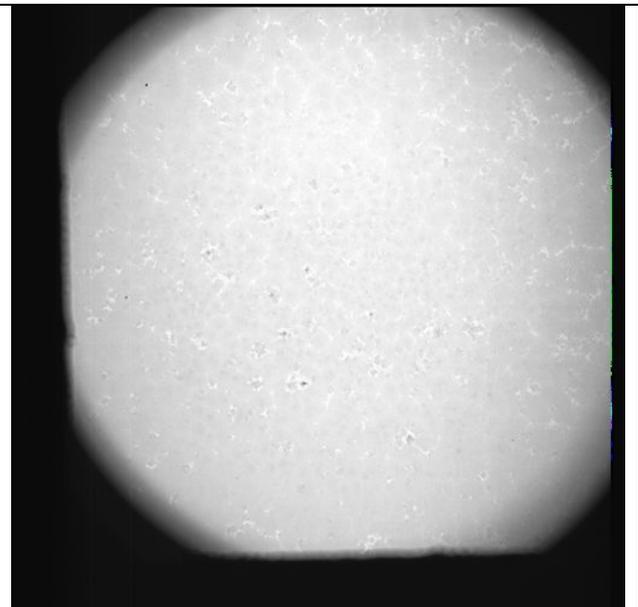
The first pericentre images taken by VMC (Figures 3.13-3-17) gave a chance to see the changes in the flat field since Venus at close distance is relatively uniform object.

In the first pericentre images the spots appear brighter. In the UV images the filaments cross the dark stripe that indicates that the processes that formed both were independent. Sharpness of the structures indicates that they are unlikely to be on the VMC optics but are rather on the CCD detector. Discussions with the optics manufacture (FISBA, Switzerland) confirmed this conclusion. See Appendix A for more details about the behaviour of the filament structures during the course of the mission.

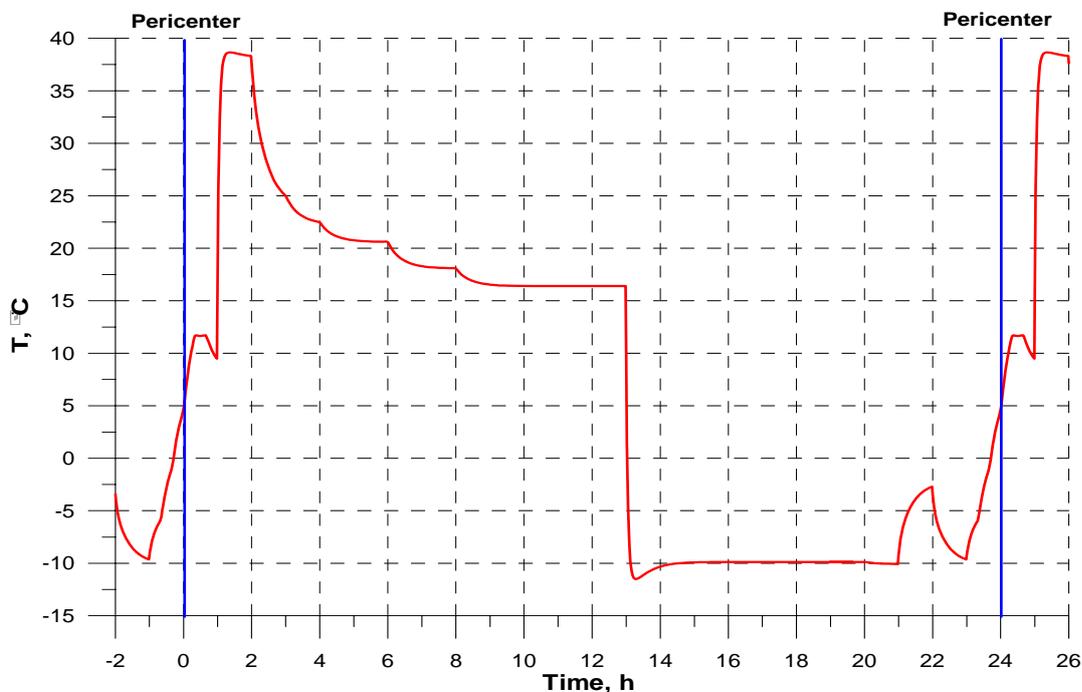
The VMC thermal model was developed and included in the spacecraft model. The model and results of the test runs are described in the Chapter 5 of the VMC PID-B (VMC-MPAE-ID-SA020-001_1, issued 01.05.03). In the full orbit modeling (section 5.5.4.2) the “hot” case was modeled. It included the hottest conditions at TRP (+Y wall) during the pericentre pass and frontal illumination of the VMC front baffle and the optics during 11 hours of telecommunication phase (2-13 hours orbital time). Figure 3.17 shows the results of the thermal modeling of the hottest case.

Figure 3.17. CCD temperature during the “hottest” case modeling.

- Thermal regime of the CCD is defined by the temperature of the TRP on +Y wall and that of electronic boards;
- The increase of CCD temperature due to direct solar illumination is about few degrees.

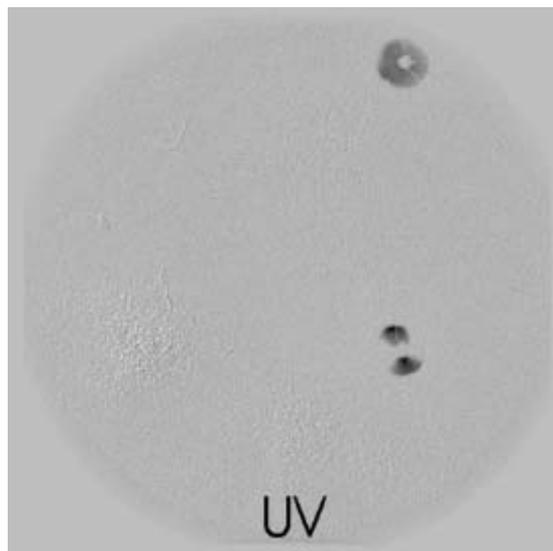
1. Maximum temperature of 69C was measured on the front baffle;
2. CCD temperature did not exceed 20 C;
3. No changes of the flat field that exceed the noise level were identified in the Visible and both NIR channels.
4. The UV channel after the test showed three places with darkening (figure 3.18). Theses spots were attributed to the plasmocere particles deposited on one of the lenses.
5. The VMC survived sun illumination test and was fully operational after the tests.

Figure 3.178. Difference between the flat field images after and before the sun illumination test.

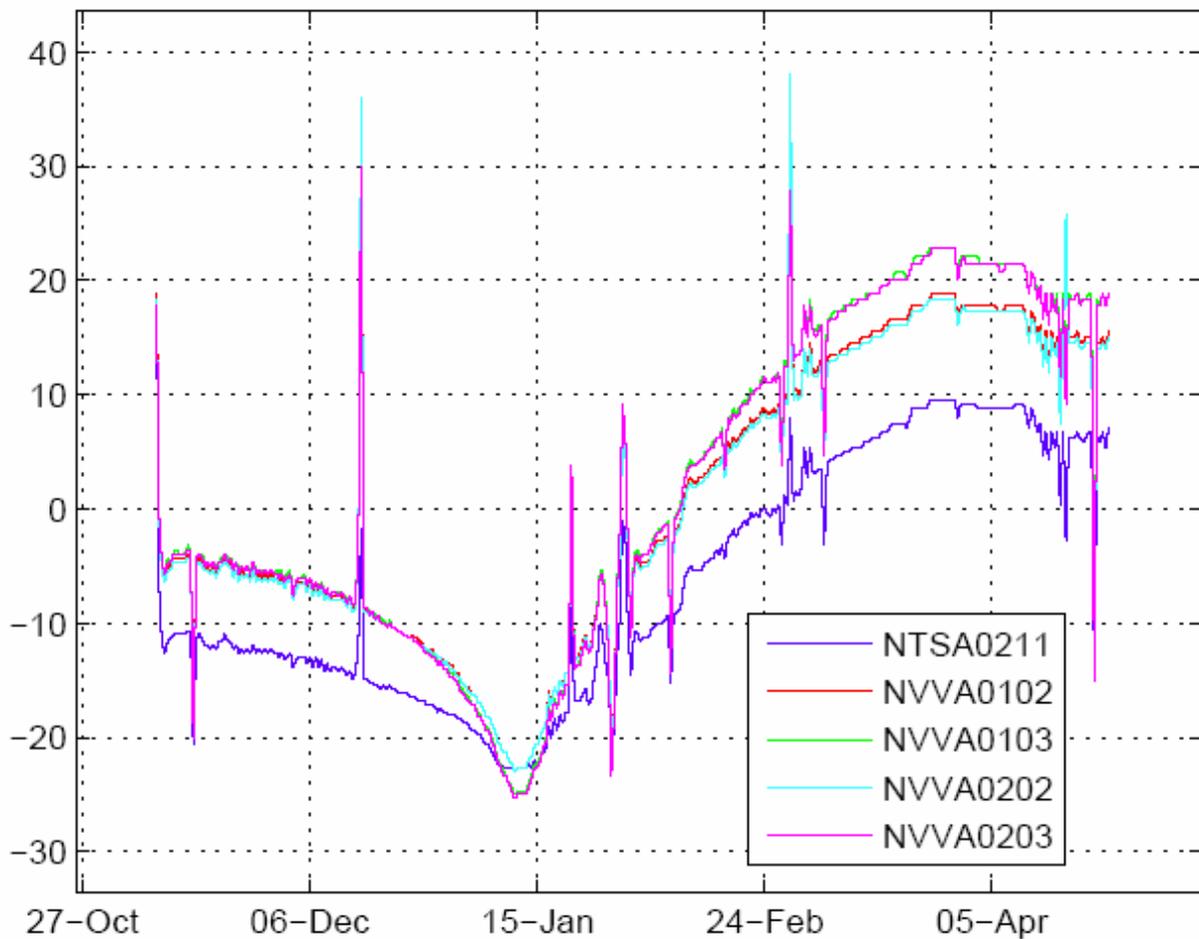
The CCD temperature was permanently monitored by the spacecraft thermistors located on the CCD housing and DPU. Figures 3.19 and 3.20 show VMC temperature changes during cruise phase and first orbit operations. The CCD temperature never exceeded +40C that is well with the detector operational limit.

Figure 3.189 Temperatures measured during cruise and first orbital operations: CCD (green and magenta), DPU (red and cyan), THAVMC (VMC TRP ??) – blue.

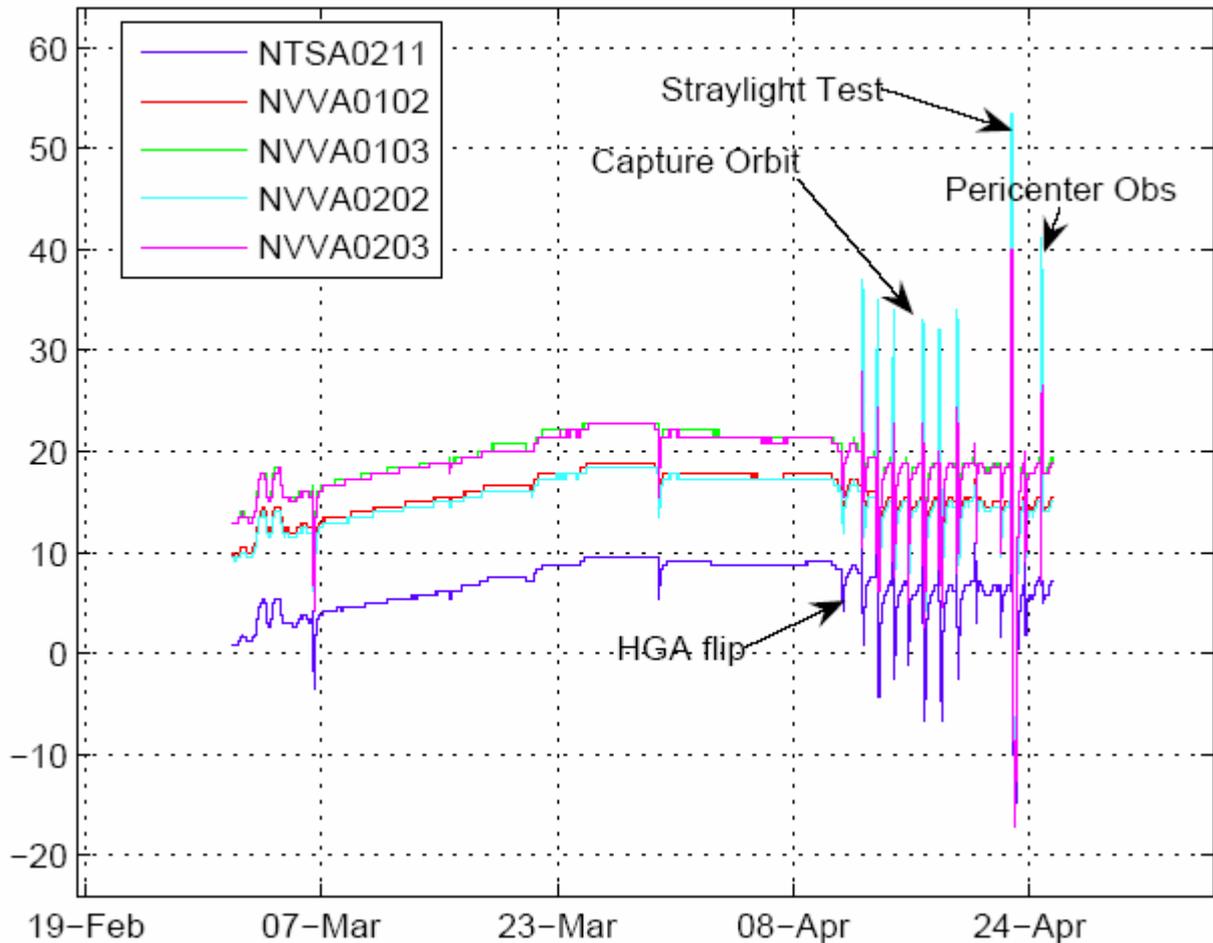
Figure 3.20 The same as in figure 3.18 for March-April, 2006.

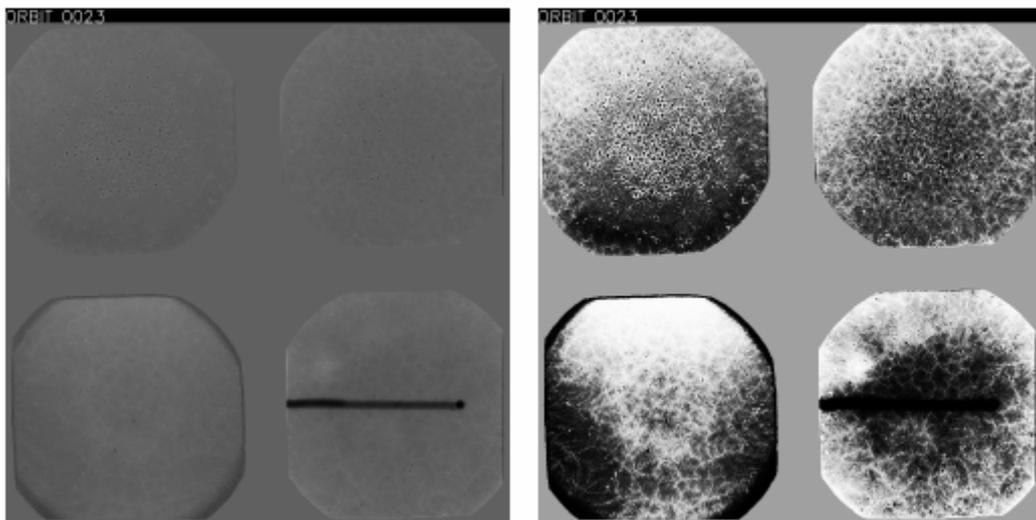
All throughout the mission two distinctive types of artifacts are present in the VMC raw images. Figure A.1 gives an example of the artifact patterns for all four channels in an early orbit. Most prominent and only occurring in the UV channel one can see a dark stripe across the middle of the image, ending in a circular feature. Present in all four channels, but with varying appearance is a pattern of bright polygonal filaments and bright and dark spots.

Figure A.1: Full CCD flat field patterns. Order of channels in both versions from top left in clockwise direction : Visible, IR1, UV, IR2. Left: Unenhanced flat field showing dark UV stripe. Right: Contrast-enhanced version showing filament and spot patterns in all four channels.

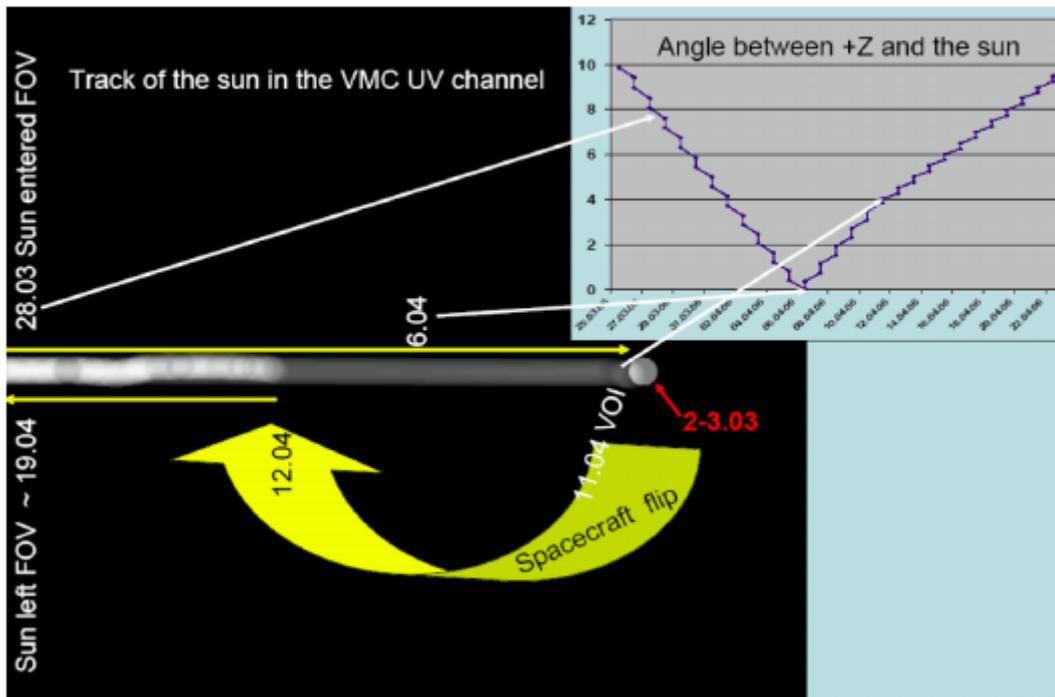
The sojourn time of the sun's image on each CCD pixel inside the dark strip correlates with the level of sensitivity degradation (see fig. A.2). The yellowing of the micro lens layer and resultant attenuation of UV signal is caused by chemical reactions in the polymer, triggered by sun UV radiation.

In the dark stripe signal levels are lowered by about 40% with respect to their surroundings. It has a mean width of ~17 pixels (corresponding to ~13mrad) and is orientated perpendicular to the CCD columns (in the XY plane of the spacecraft).

Figure A.2: Track of the Sun image on one quadrant of the CCD reconstructed from SPICE kernels. Brightness of the strip marks total illumination load.
