Venus Monitoring Camera on Venus Express

Anomalous features in the VMC images

VMC-MPAE-TN-SS010-001

Issue 3/1

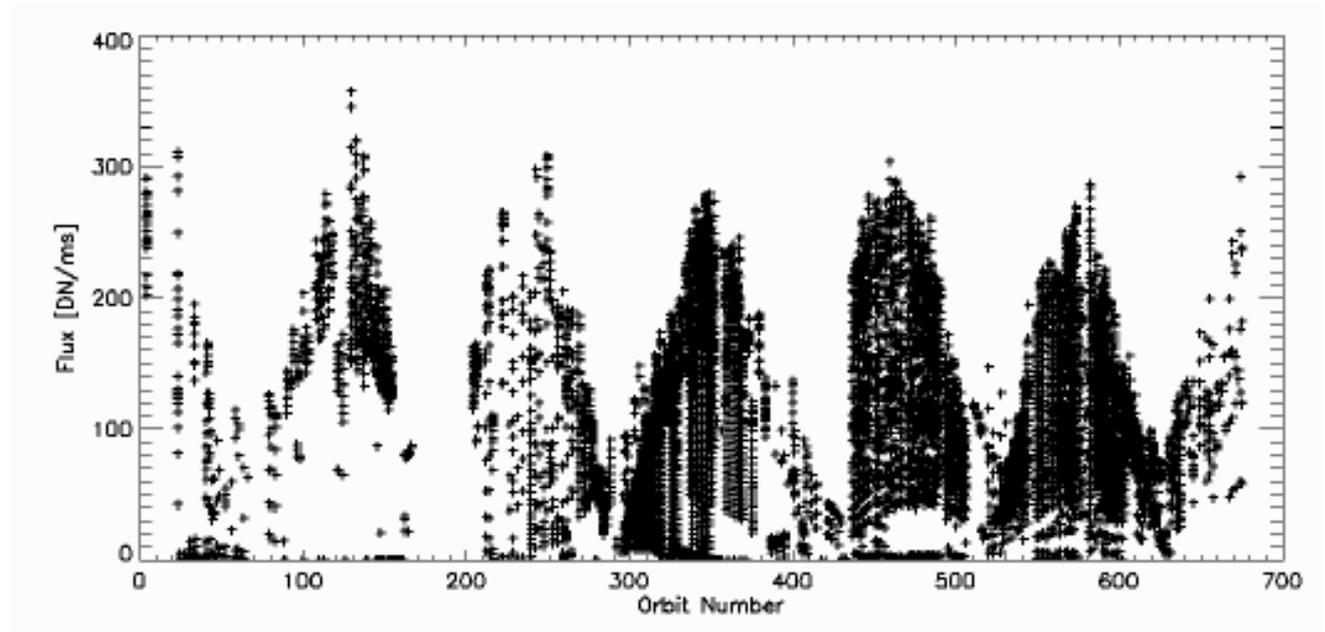
The fact that direct UV radiation from the sun is darkening the micro lens layer led to the suspicion that UV radiation in general might lead to yellowing of the utilized polymer. In particular the relatively high flux of UV radiation reflected by the Venus upper cloud deck could possibly lead to progressive degradation of the UV channel. In order to investigate on a possible progressive degradation of the UV channel, I checked maximum, minimum and mean UV flux into the detector as a function of time throughout the first 670 Orbits. Figure A.3 shows mean flux (in $\text{DN} \cdot \text{s} \cdot 10^{-3}$) per image onto the CCD in the UV channel for dayside pericenter images versus orbit number. The periodic orbit-to-orbit variations are caused by brightness variations across the Venus disc due to the change of the orbital plane with respect to sun incidence angle. The higher fluxes in early orbits are to be attributed to non-linear response of the CCD in overexposed images. Ongoing adjustment of exposure times in later orbits prevented further overexposed images. The large variability of mean brightness per image inside most orbits is governed by the sun

Figure A.3: Mean brightness per (pericenter) image as function of orbit number.

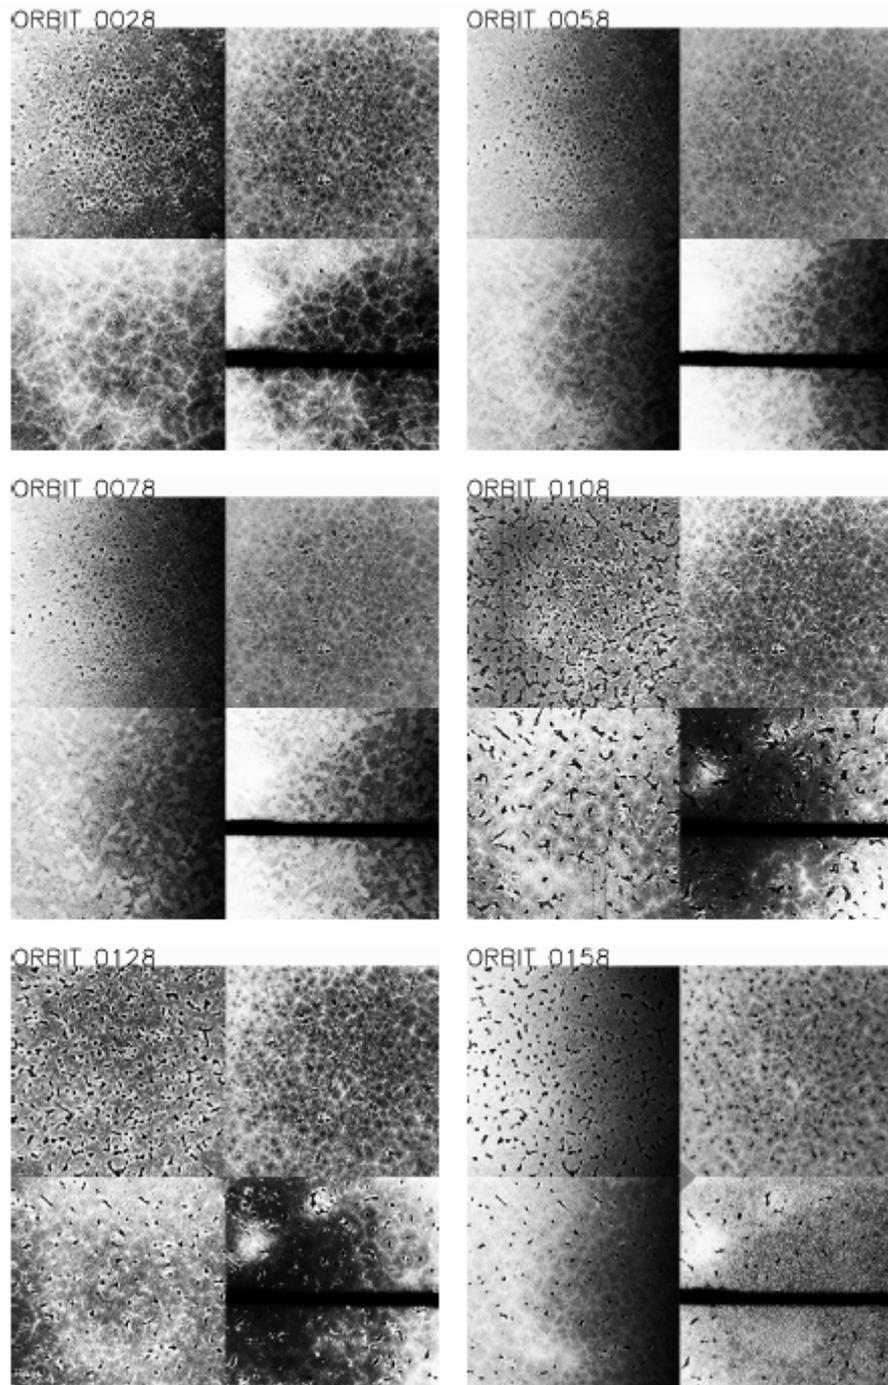
Contrary to the dark stripe, which apparently stays constant over time, the filament-spot pattern (further referred to as “FSP”) in all four channels keep evolving over time, displaying mainly erratic but partly cyclical behavior. Examples of appearance of the FSP during the mission are shown in figure A.4 .Detailed study of the FSP showed a number of properties summarized as follows:

1. The FSP includes bright filaments organized in polygonal (mainly hexagonal) shapes.
2. They also include dark spots of varying intensity and size. Smaller sized dark spots are characteristically darker than the larger ones.
3. Dark spots appear to be centered within the hexagonal filaments, giving a cell-like appearance to the FSP.
4. The FSP evolve over time. A widely observed behavior is shrinking size of dark spots and simultaneous darkening thereof.
5. Evolution of the FSP displays cyclic behavior. After dark spots have contracted completely, the cycle of shrinking starts again, usually with irregularly shifted “cells”.

Figure A.4: Excerpts of flat fields from all four channels in di_ erent orbits.

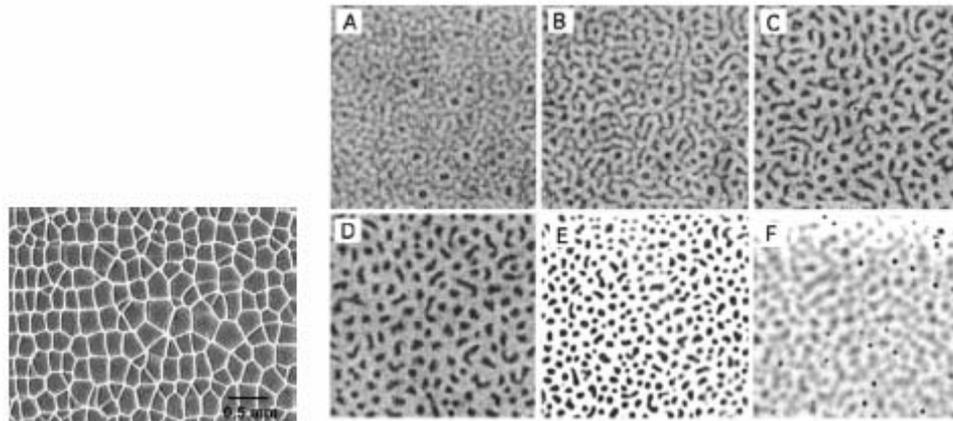
One possible scenario is therefore that a thin polymeric layer close to the focal plane of the instrument either underwent a thermally induced phase change to a highly viscous film (not necessarily implying complete melting, for which temperatures have not been high enough at any time) or is reaching this state periodically during instrument operations. In both cases the CCD temperature, which varies roughly between 253K and 300K in the course of one orbit due to heat generated from the electronics, would provide a temperature gradient perpendicular to the CCD surface. Since evaporation processes can cause local inhomogeneities in surface tension, outgassing of compounds from a polymer film could provide the necessary random surface tension gradients to produce Marangoni instabilities. Some examples of patterns observed in laboratory experiments by Weh (2005) and Müller-Buschbaum (2003) are shown in figure A.5.

Figure A.5: Examples of patterns resulting from Marangoni convection in thin polymer layers. Left: Marangoni convection pattern from Weh (2005). Right: Time series of developing Marangoni convection from Müller-Buschbaum (2003).

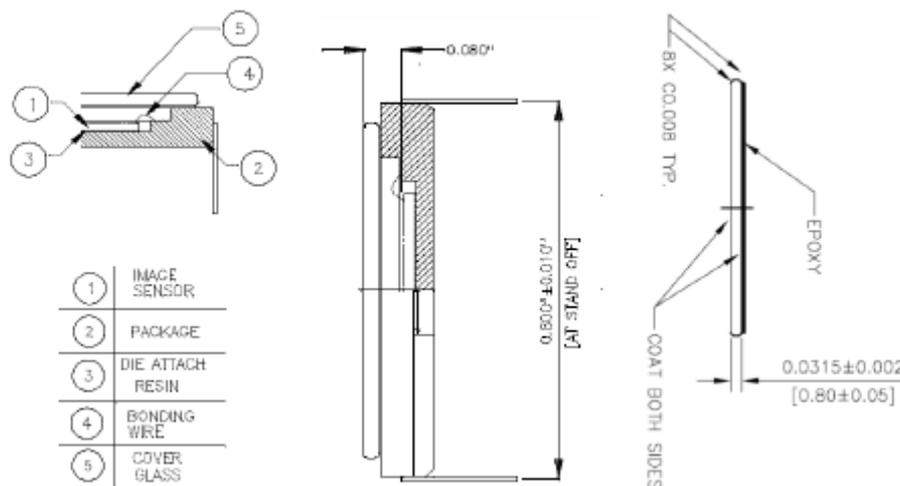
location of the Marangoni convection at least some deformation of the borders of the UV stripe should be expected. Since this is not the case, we studied the technical specification Manual for the Kodak KAI-1010M CCD chip used in the VMC. Figure A.6 shows a series of detailed sketches of the chip. In addition to the micro lens layer, an epoxy layer with a thickness of 0.05mm-0.18mm is located 2mm away from the CCD surface. This epoxy layer would be another possible location for the FSP.

Figure A.6: Detail sketches of Kodak KAI-1010M. Left: Description of chip structure. Middle: Dimensions. Right: Detail sketch of the cover glass, mentioning a thin epoxy layer.
