**SMART-1  
AMIE-FM Thermal Vacuum Test**

**Test report: TOS-MCV/2001/2677/ln/SR**

Subject: AMIE-FM Thermal Vacuum Test

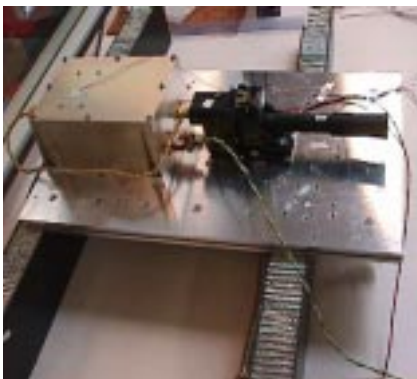
Fig 1: Set up on cold plate

The facility used for this test was the LIVAF of the Mechanical Systems Laboratory (TOS-MCV). Units 1&2 were mounted on an aluminium interface plate using thermal interfiller between the cold plate and the aluminium interface plate (Sigraflex, based on graphite).

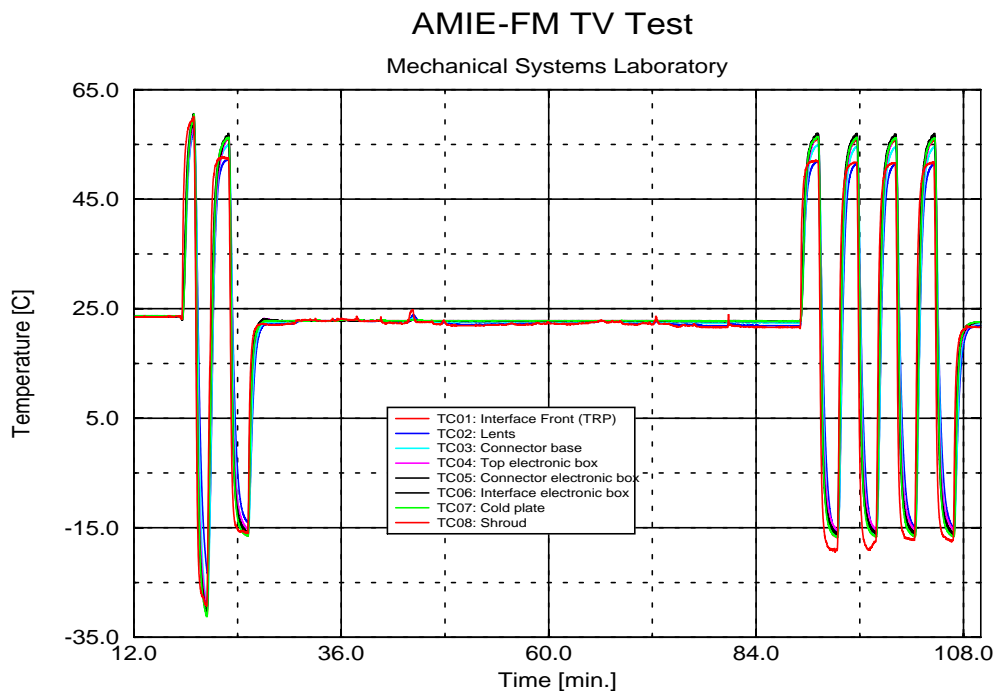
The following plot show the complete test sequence performed on AMIE FM.

A 60 hours dwell was performed between cycle 2 & 3 to stay at ambient temperature during the week end.

A dwell of 60 hours at ambient temperature was performed between cycle 2 & 3 during the week end. At each operational minimum/maximum temperatures, the dwell was increased from 1.5 to 2 hours to have a better stabilisation phase for all thermocouples.
