## HERSCHEL/SPIRE

### HS\_DRCU (HS\_DCU & HS\_FCU) FM Configuration Item Data List / As Built Configuration List

**Reference:** Sap-SPIRE-QA-0417-06  
**Issue:** 1.0  
**Date:** 31/07/06

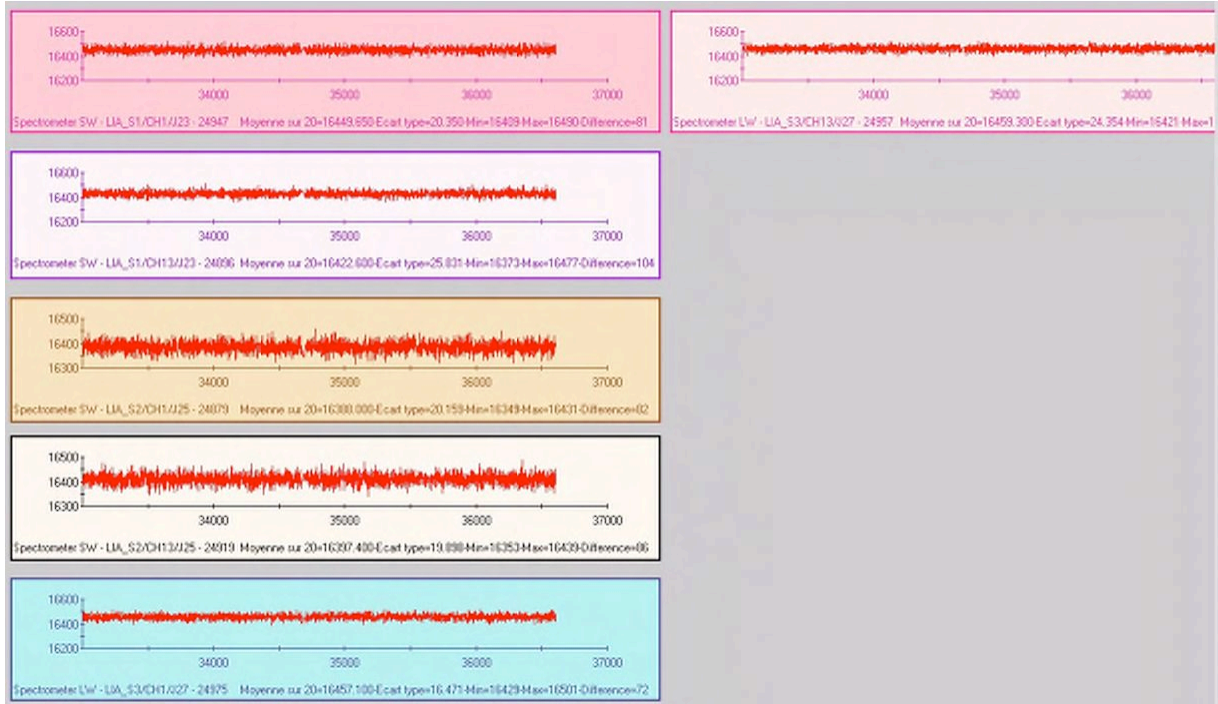
Failure detection and manual operator actions are required to recover nominal performances. This situation does not fully cope with the basic requirement, the DUT is then considered as not compliant.

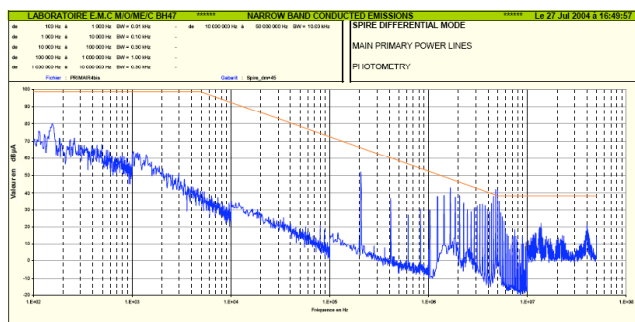
CURVE 5.1-3 : DIFFERENTIAL MODE – MAIN – PHOTOMETRY

On the redundant i/f no peaks over the limit are present (measured values are about 1dB below the limit).
