Minutes of SPIRE CQM BDA Kevlar Failure Non-Conformance Review Board

1 October 2007

CQM BDA Kevlar Failure Report

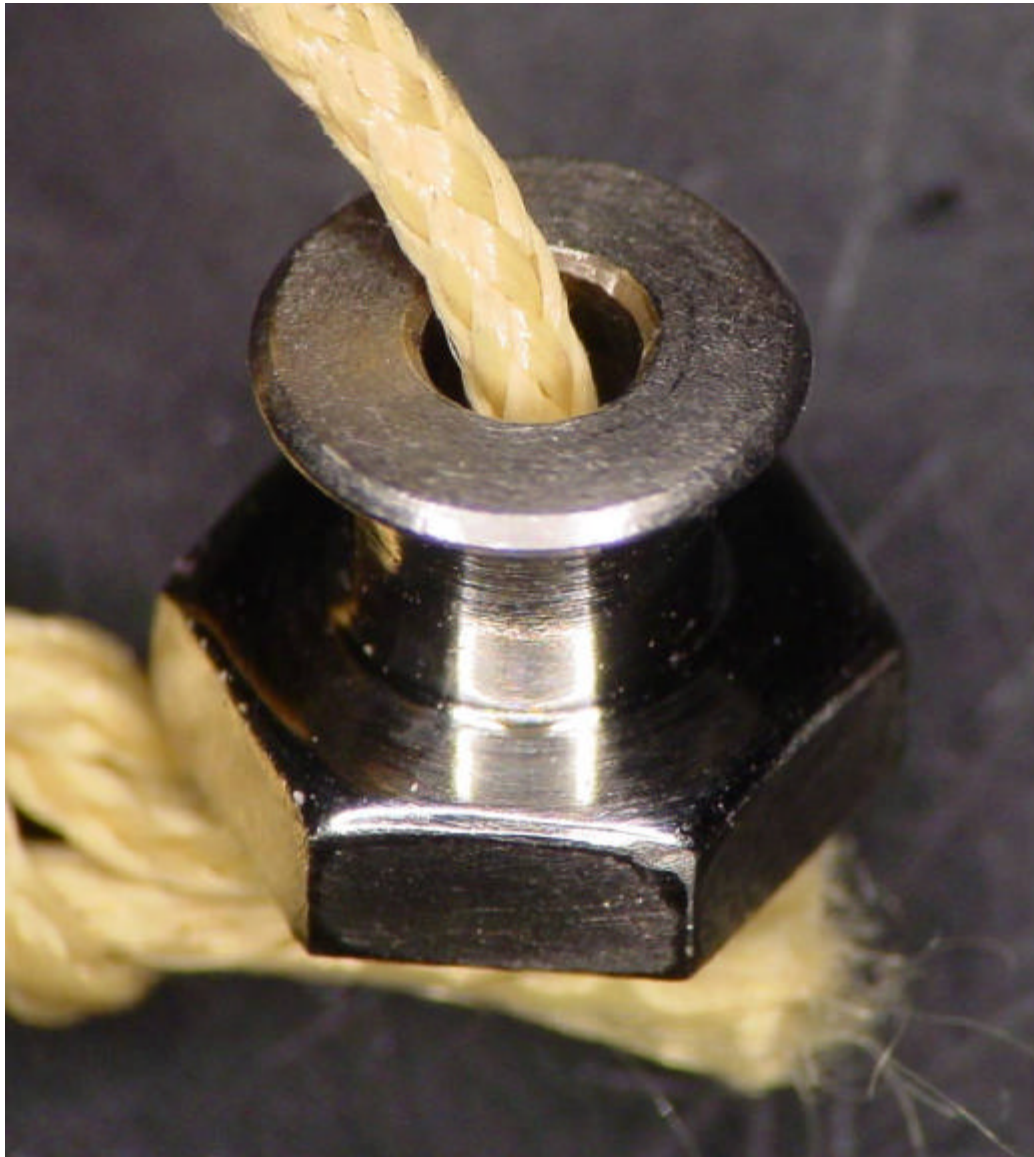
Figure 3: Polished pulley typical of those used in later BDAs.

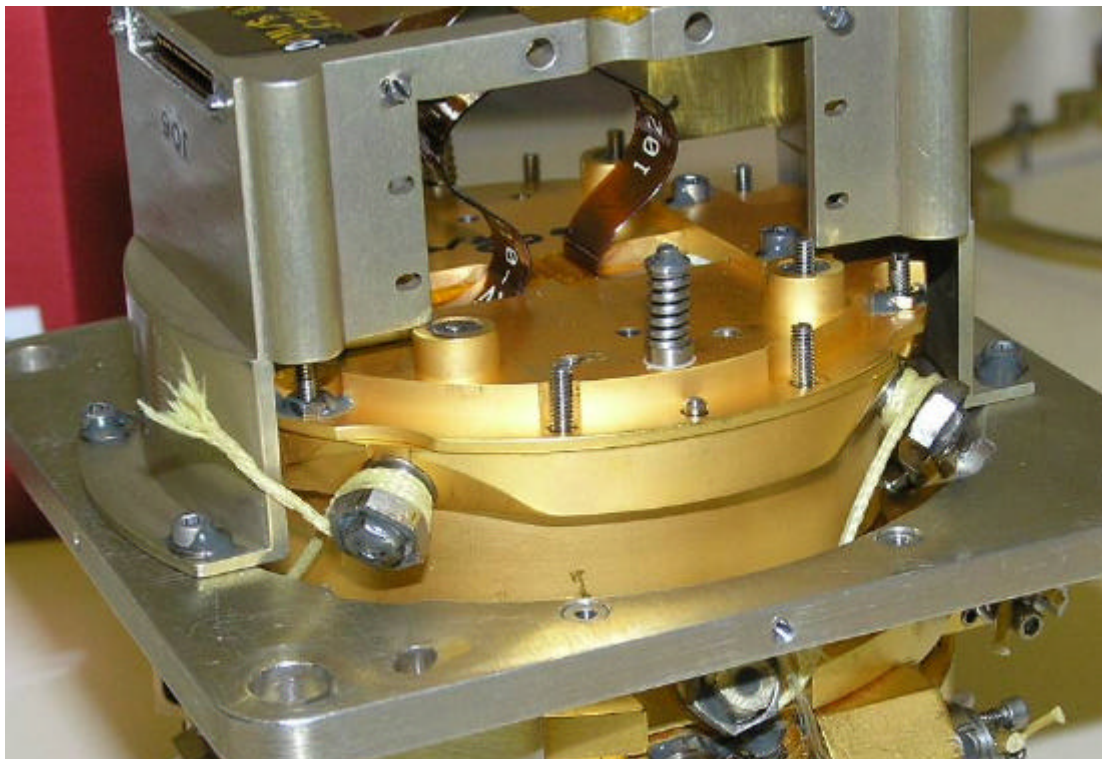
The BDA light can was removed to allow for improved access to the lower Kevlar braid and investigation of the touch. Photographs are shown below. With the can removed the touch between the 300mK coverplate and the connector bracket was immediately visible; see Figure 5 and Figure 6. The suspended portion of the BDA was still fairly rigid as the tension in the intact upper braid and the residual tension in the lower braid pushed the coverplate against the bracket.

This strong touch between the detector mounting coverplate and the aluminum connector bracket within the warm parts of the BDA would certainly have caused a significant thermal short if it had been present during the previous functional tests.

Figure 6: Another CQM BDA view with the light can removed.

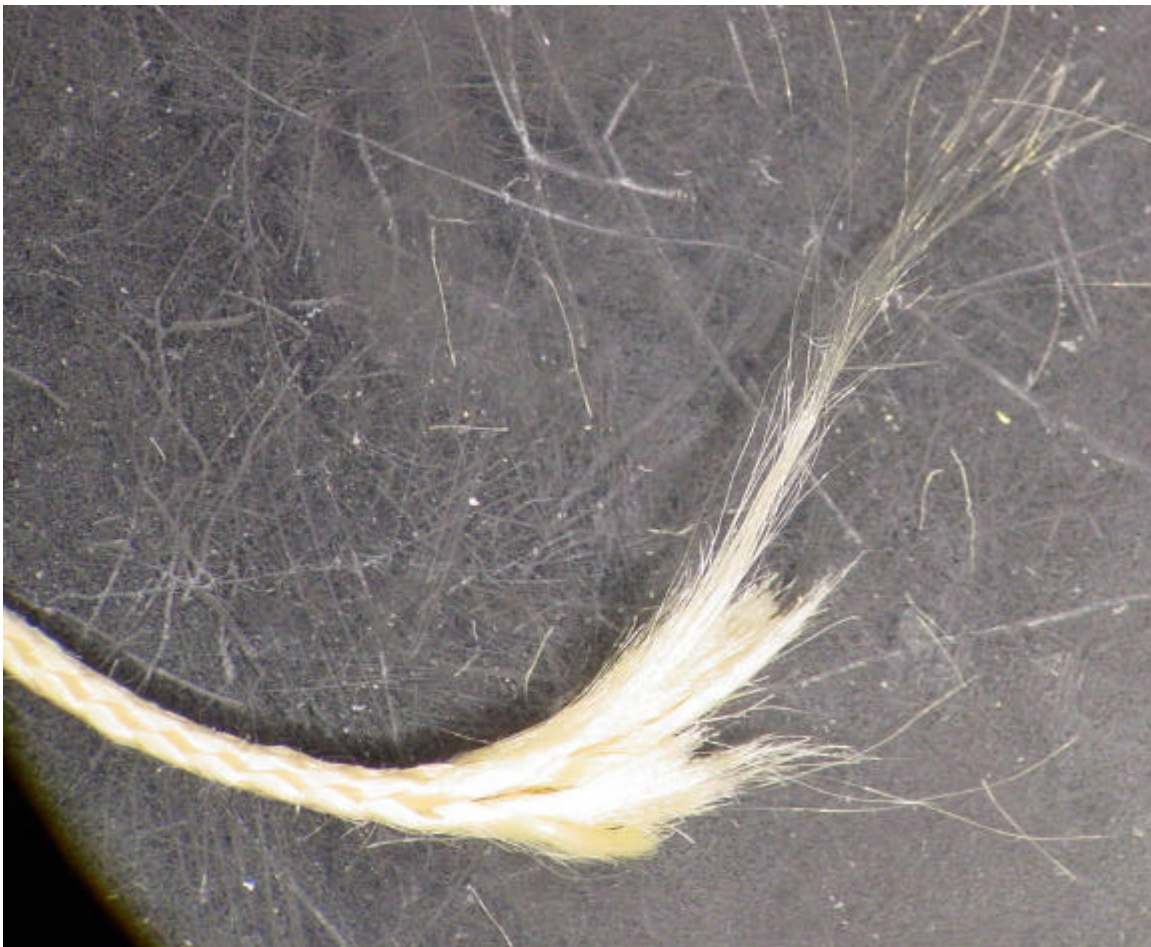
The break is seen at the end of a wrap around pulley #2 and the Kevlar is still fully wrapped around pulley #3. (Pulleys are numbered following the Kevlar path starting at the “capstan-3” Kevlar termination.) From the disposition of the Kevlar, it was clear that the failure had occurred somewhere in the vicinity of pulley #2, probably either where the Kevlar was on the pulley or in the span between the 2nd and the 3rd pulley. Visual inspection of pulley near the break did not show any obvious defects that would have caused the failure. Since the Kevlar springs back after the break, a more exact determination of the failure location was not possible without detailed inspection of the Kevlar. It was decided to perform that inspection after shipping the unit to JPL.

Figure 8: CQM BDA Kevlar break, Capstan-3 end.

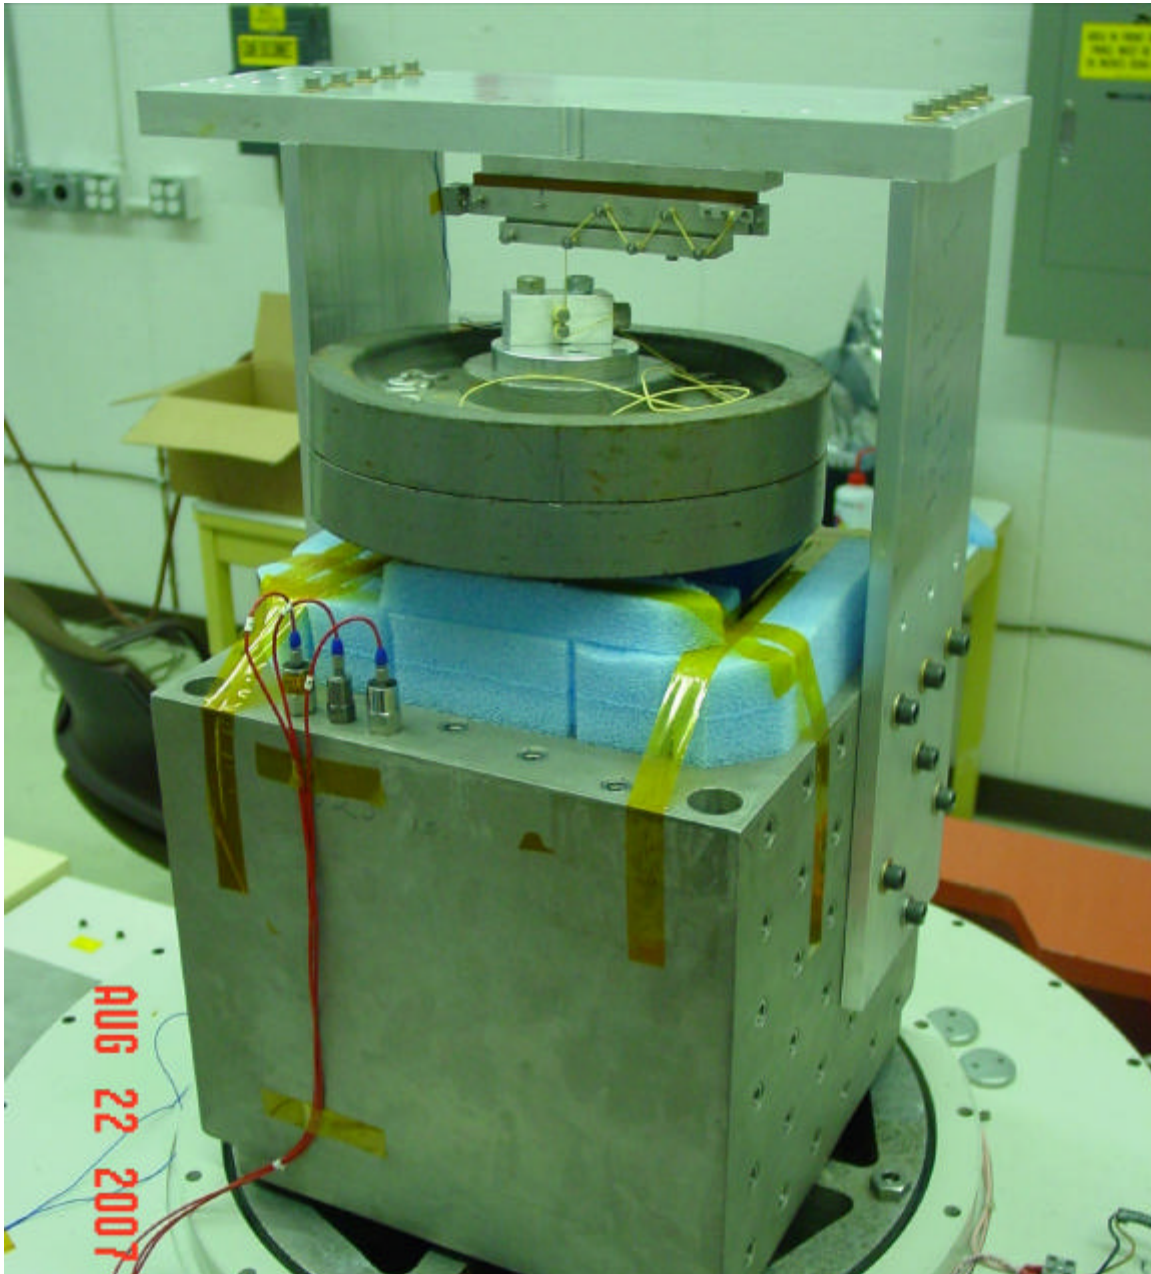
While it seems that the likely root cause of the CQM failure is the abrasion of the Kevlar by the unpolished pulleys, it is difficult to quantitatively assess the impact of the abrasion. In order to make a more quantitative comparison of the performance of the polished and the unpolished pulleys, we performed a shake test using the setup shown in Figure 16 and Figure 17.

Figure 16: Kevlar abrasion shake test setup. The blue foam below (and not touching) the weight is to catch the weight when the Kevlar breaks. The whole fixture vibrates vertically.

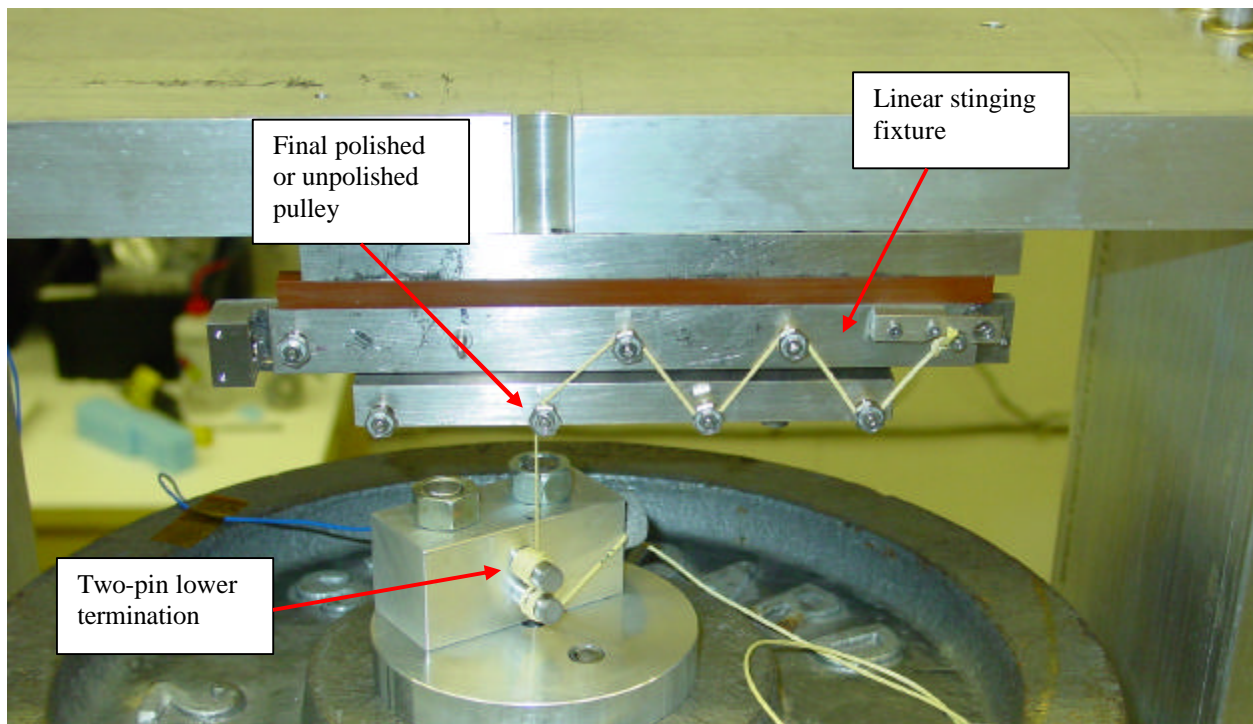
Two sets of tests were performed with this setup. In the first set, an ~3" length of Kevlar was shaken with a 200Hz sine dwell for 30 minutes at a peak-peak drive amplitude of 0.010". This exposure did not break the Kevlar using the unpolished pulley, so we repeated the same exposure using the polished pulley. The pulleys, which had been cleaned of any Kevlar residue before the test, were then compared using UV illumination as above. As can be seen in Figure 18 through Figure 21, the shaft of the unpolished pulley is clearly covered with Kevlar debris from abrasion, while the polished pulley shows only a few isolated fibers and a bit of abrasion at some

Figure 17: Detail of abrasion shake test setup.

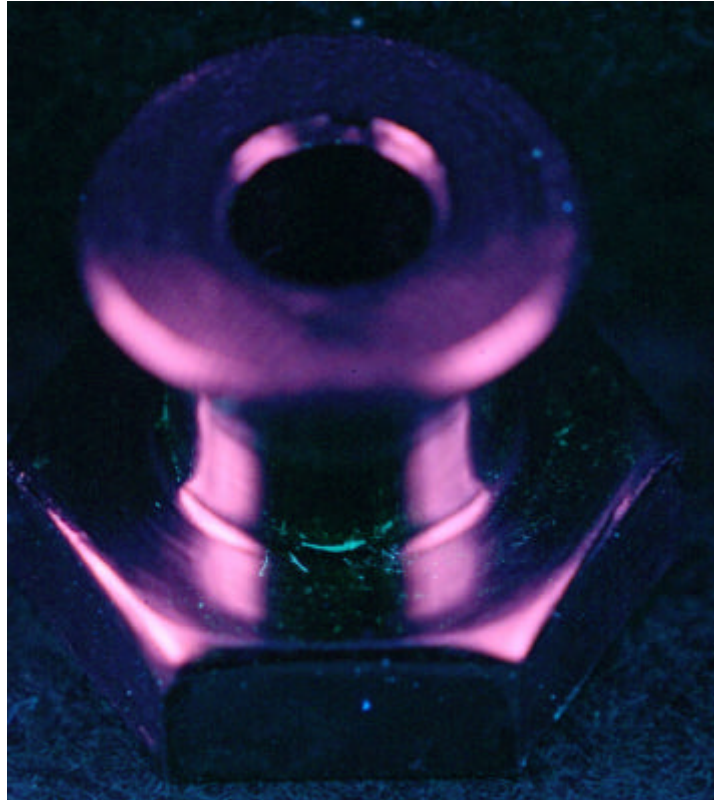
Figure 20: Polished pulley after initial abrasion shake test. Viewed under UV light.

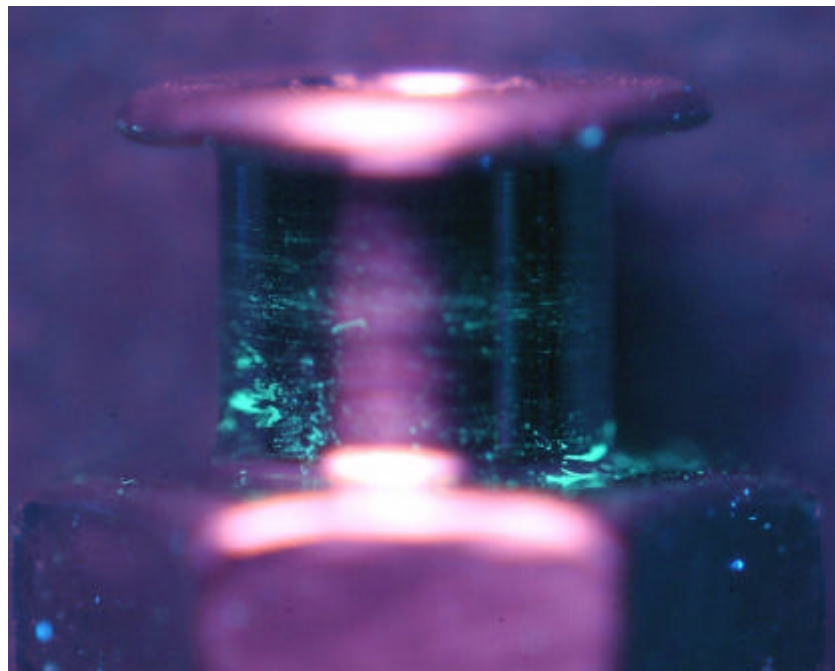
Figure 21: Another view of polished pulley shown above.

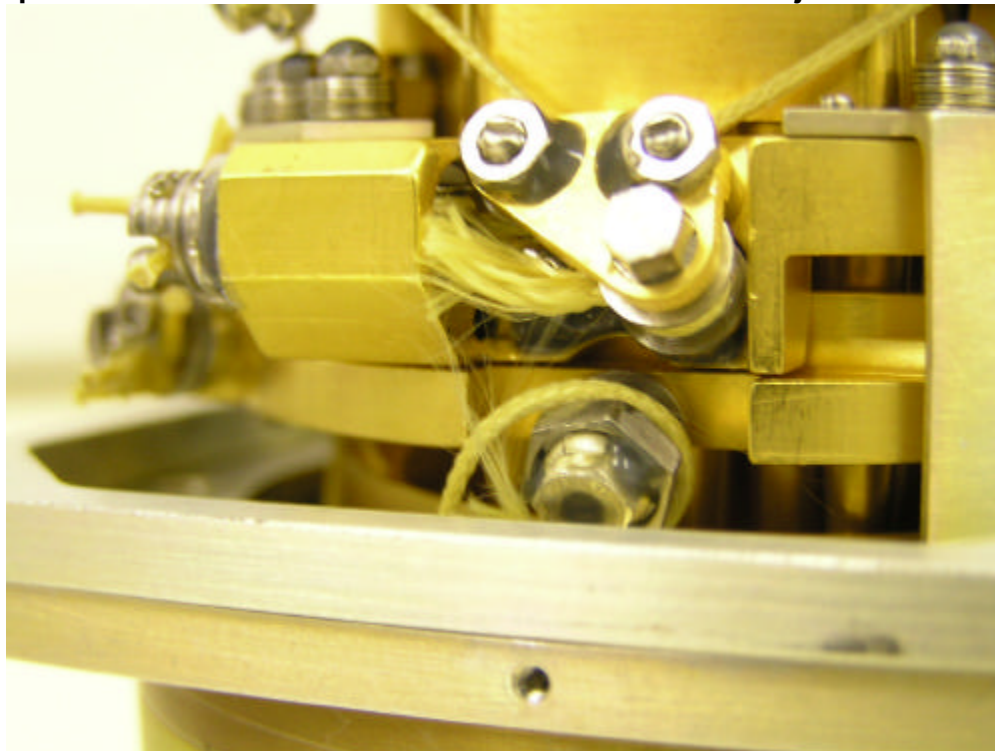
Close up: Note it is the lower cord that's broken the end is just visible

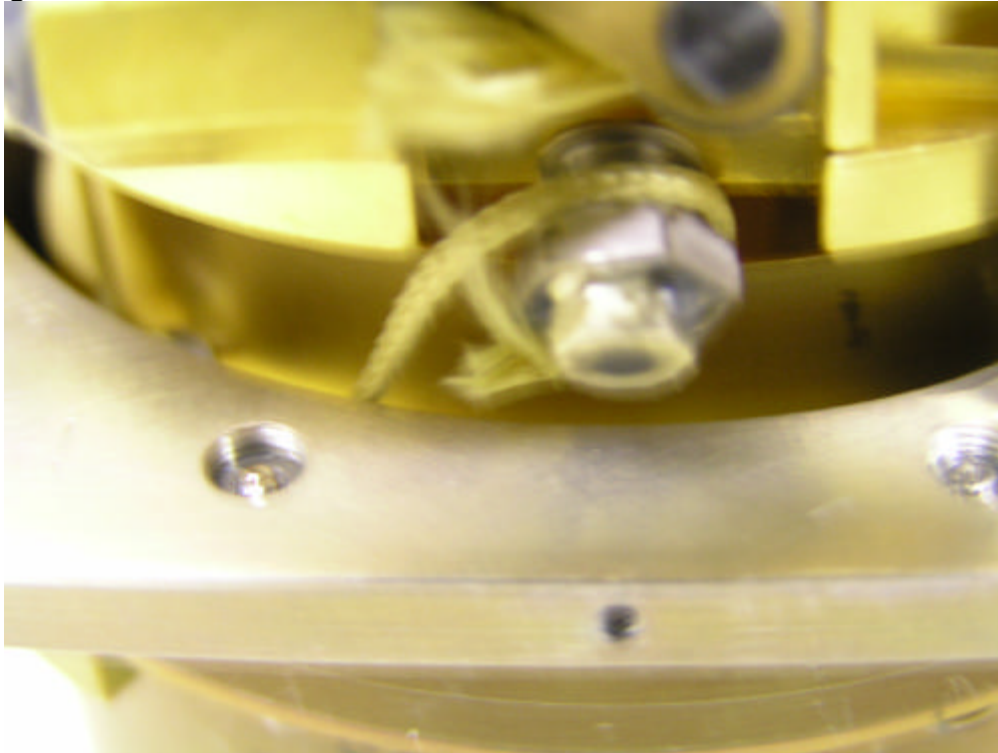
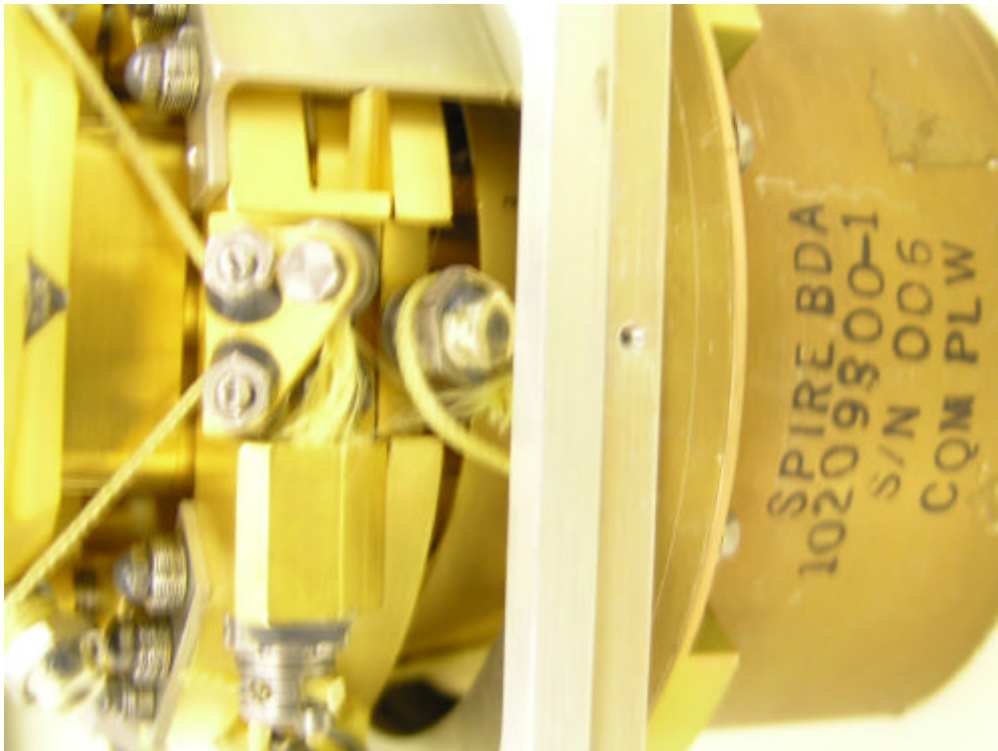
Photos from Second inspection following JPL telecon on 5th June 07
Looking down into the BDA

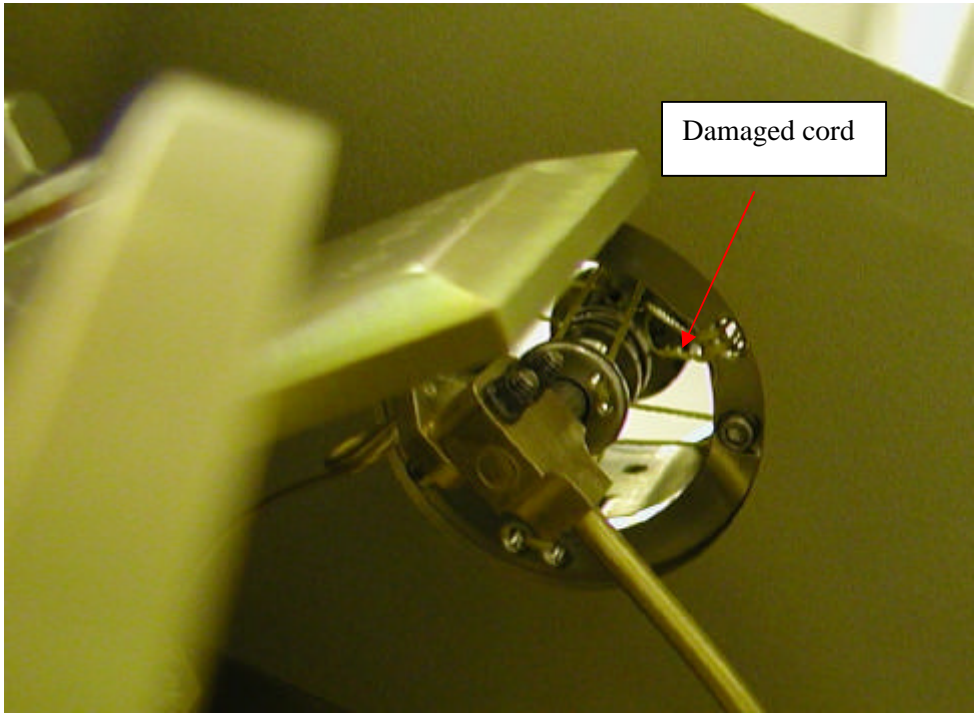
The light baffle cover was then removed. Figure 3 shows the baffle assembly after removal of the outer cover. The damaged cord is evident. Another view from inside the 2-K box is shown in Figure 4.

Figure 4 View from inside 2-K box with outer light baffle cover removed

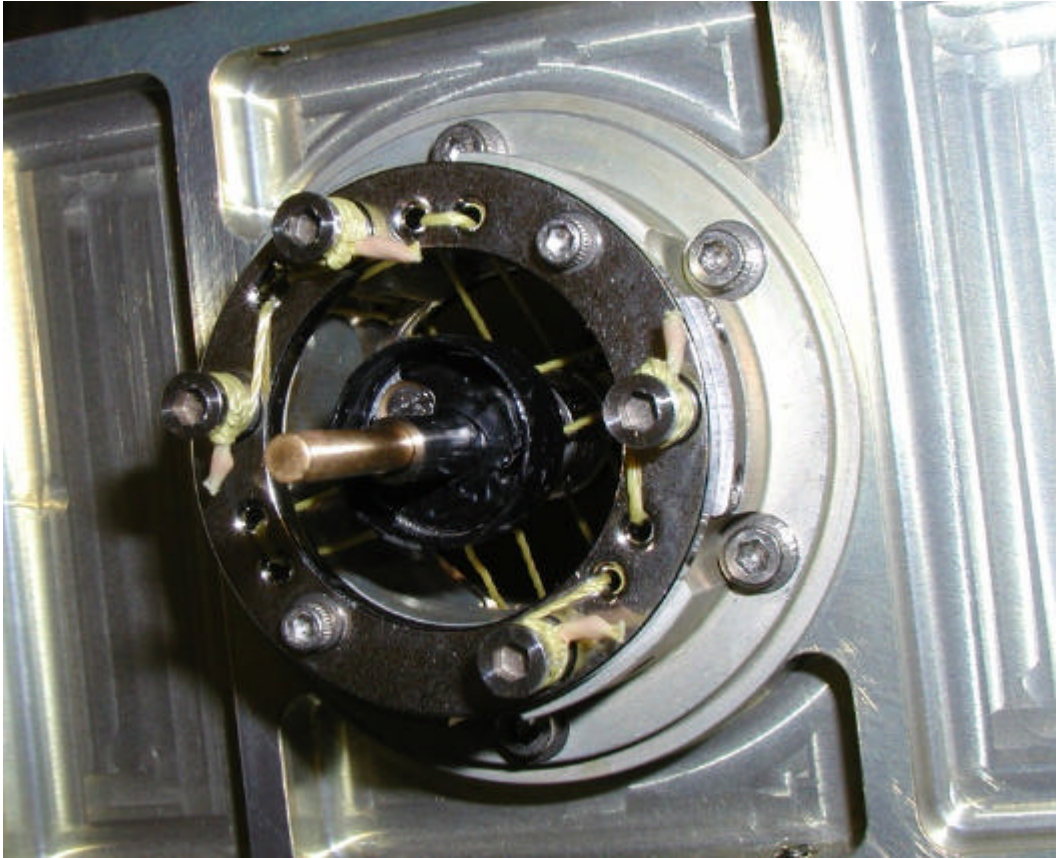
In addition, the hub and cover were inspected for damage to the black coating. There was no evidence of damage to the coating, as shown in Figure 5 and Figure 6.

Figure 5 Preliminary inspection for integrity of black coating on hub

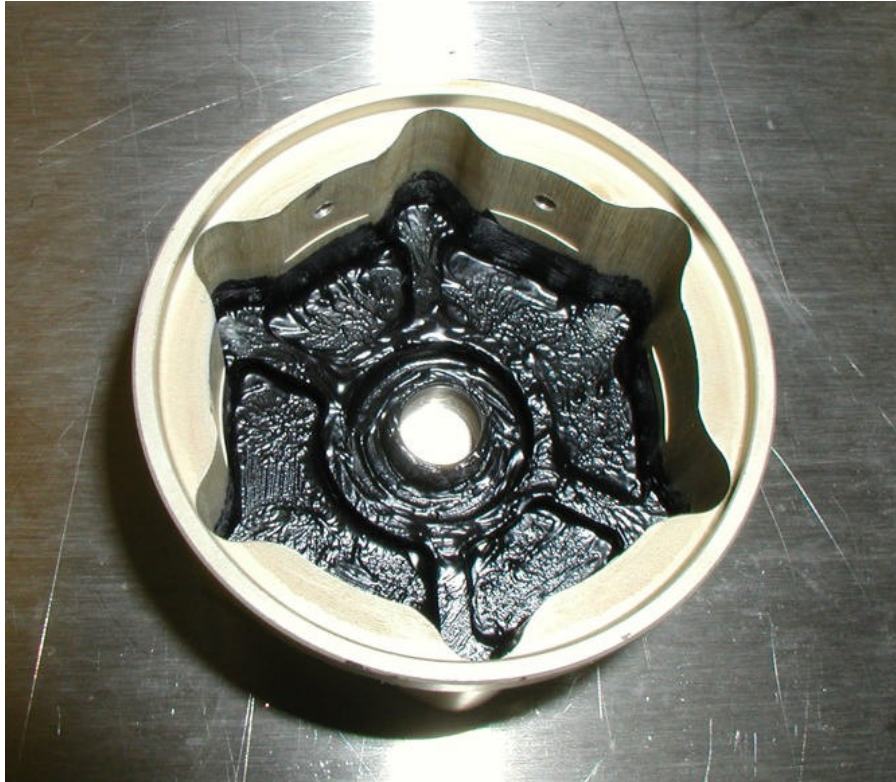
Figure 6 Preliminary inspection for integrity of black coating on cover

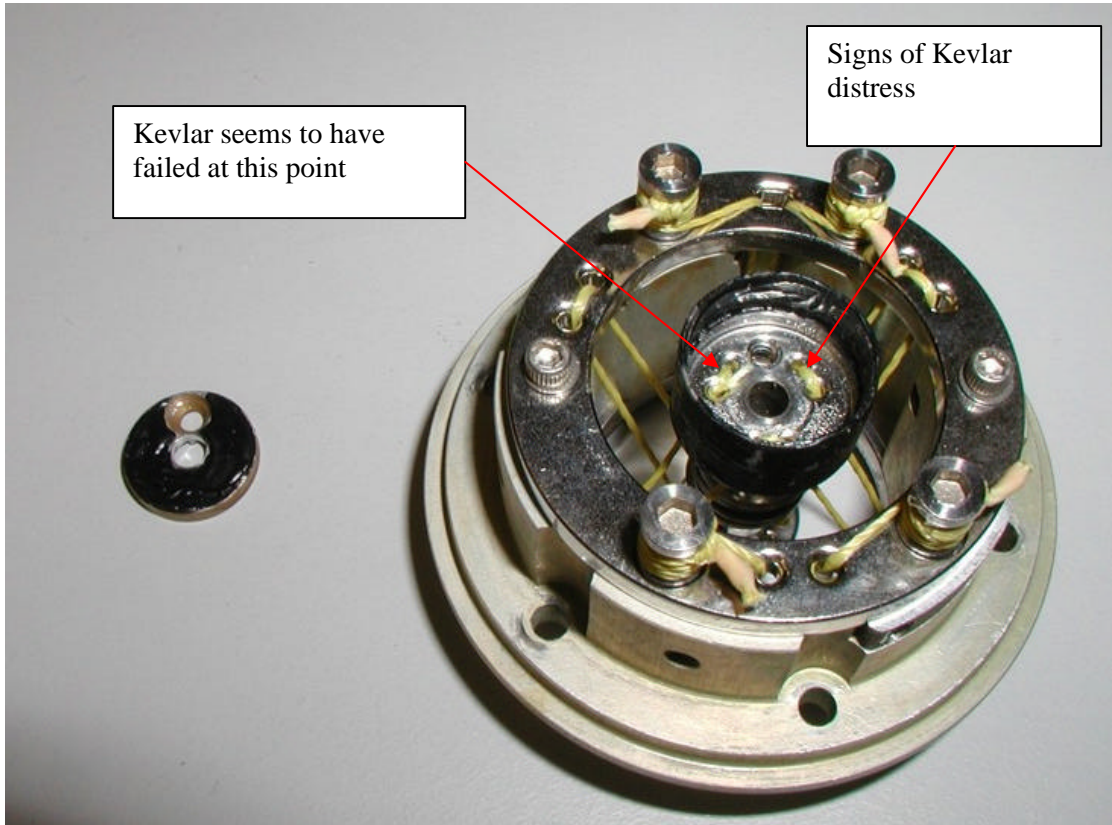
The light baffle assembly was de-mounted from the 2-K photometer box spine, and inspected further in the RAL clean room. The baffle cap was also removed at this point to examine the Kevlar underneath it, as shown in Figure 7. The Kevlar seems to have failed at the point, indicated in Figure 7, where the Kevlar passes over the guide between the radiused holes in the central hub.

Figure 7 Unit after initial de-mounting from structure at RAL (baffle cap removed).

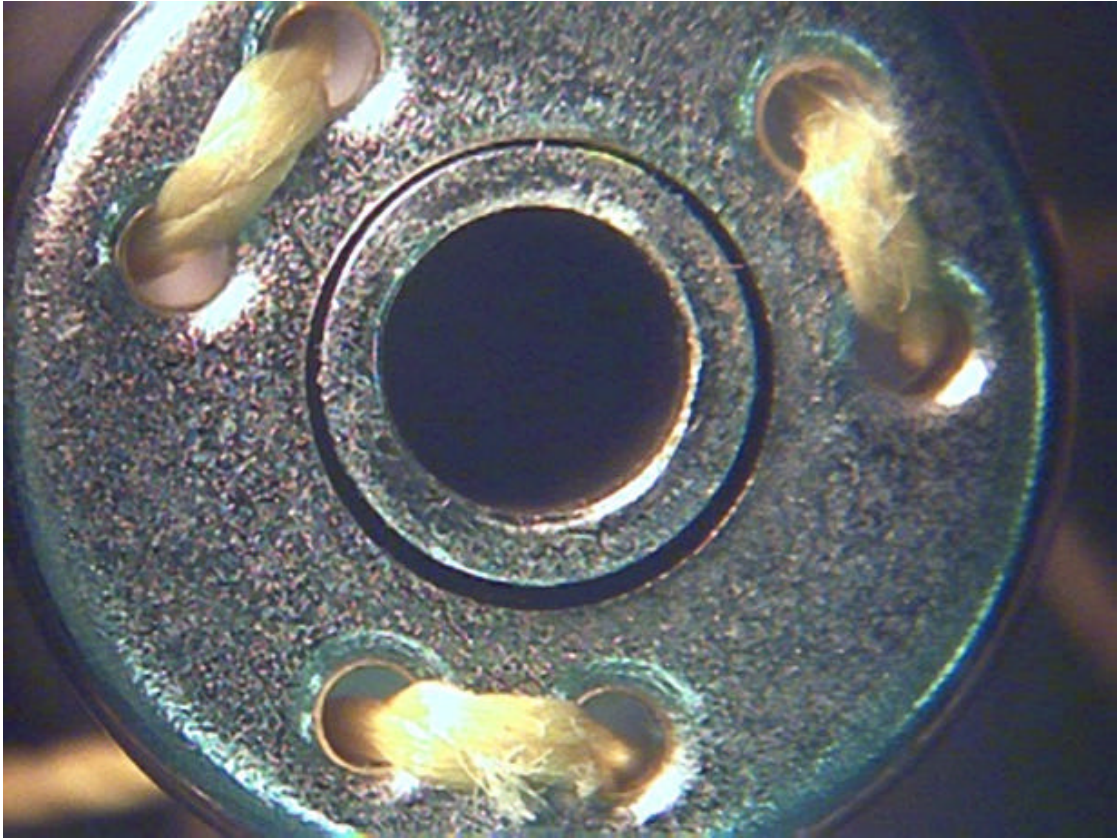
The Kevlar around the inner hub was also examined (Figure 10). Mild abrasion was evident. However, this may have been caused by incorrect handling. Slight surface abrasion may result from the light baffle assembly being placed temporarily on a bench in the wrong orientation (with the inner hub in contact with the bench).

Figure 10 View of inner hub, showing signs of mild Kevlar abrasion

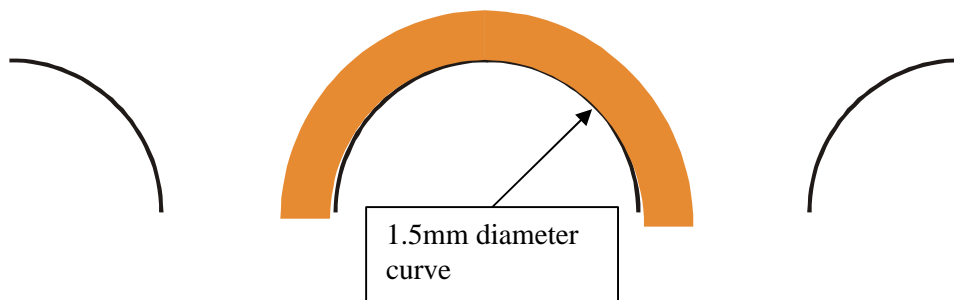
- The failure occurred at the apex of one of the radiused guide hole pairs on the light baffle end of the central hub, with signs of severe distress at one of the other apices on this end.
- There were signs of slight surface abrasion on the inner hub end. This may have been due to incorrect handling.
- There appear to be differences in the quality of machining of the radiused guide holes on the inner hub and the light baffle end. The guide holes were designed to be arranged such that the Kevlar bends around a smooth radius of 0.75mm, as shown in Figure 11. However, initial examination appears to show poor quality of machining of the guide holes on the light baffle end.

Figure 11 Designed guides for Kevlar on central hub

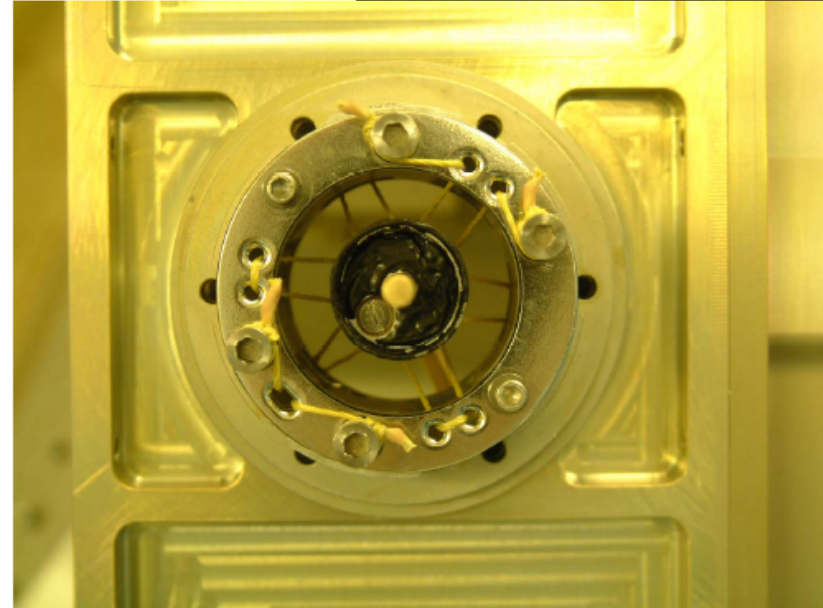
Figure 1 - Image of the SLB prior to the Warm Vibration

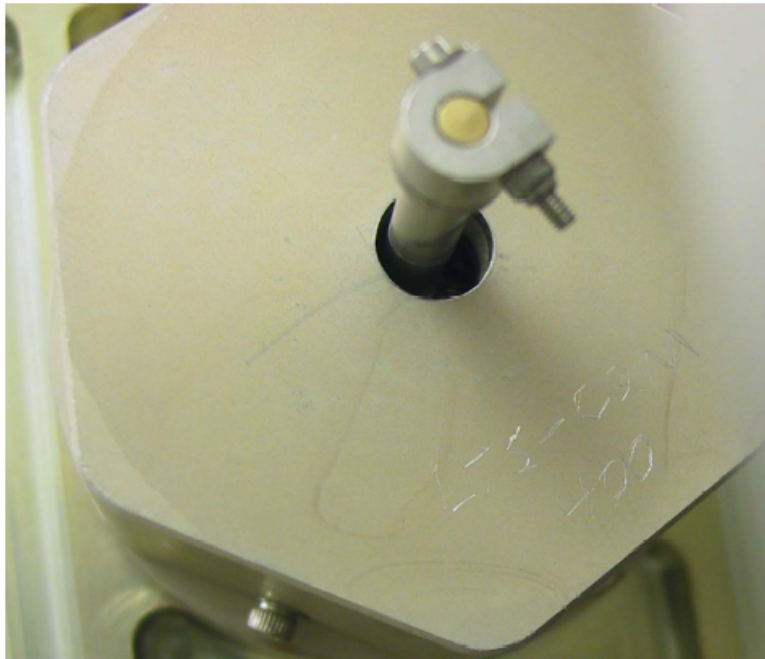
Figure 2 - Image of the outside of the SLB after warm vibration. This view is partially obscured by the presence of the cooler.

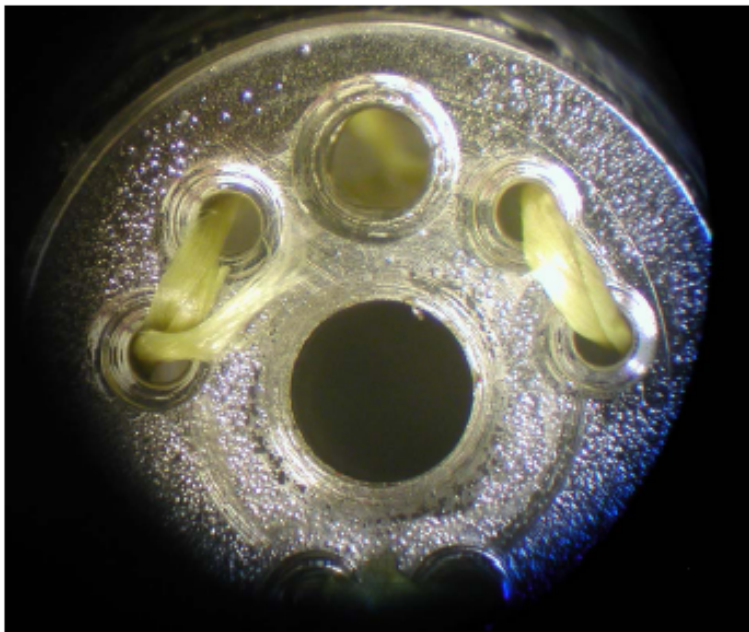
Figure 4 - View of the cord fraying around the tight bend radius.

- Kevlar cord visibly damaged – two of three cords broken – asymmetry leading to misalignment
- Black coating undamaged
- Close inspection showed cord failure as radiused hole – badly machined with slight discontinuity instead of smoothly radiused transition from one hole to another

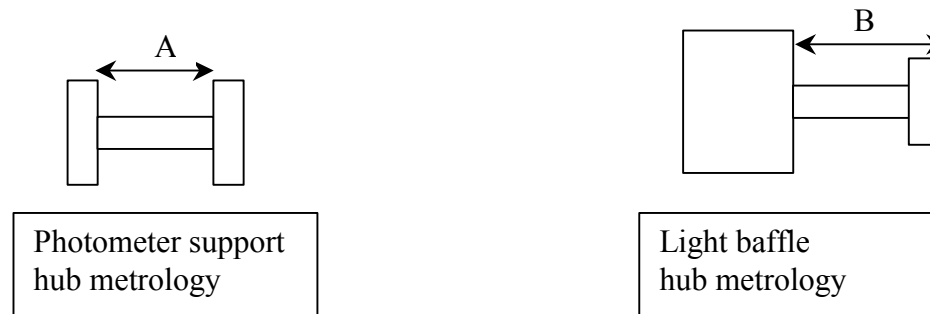
Figure 26 The dimensions marked “A” and “B” are used for monitoring hub extension as a function of time for the photometer supports and light baffles respectively

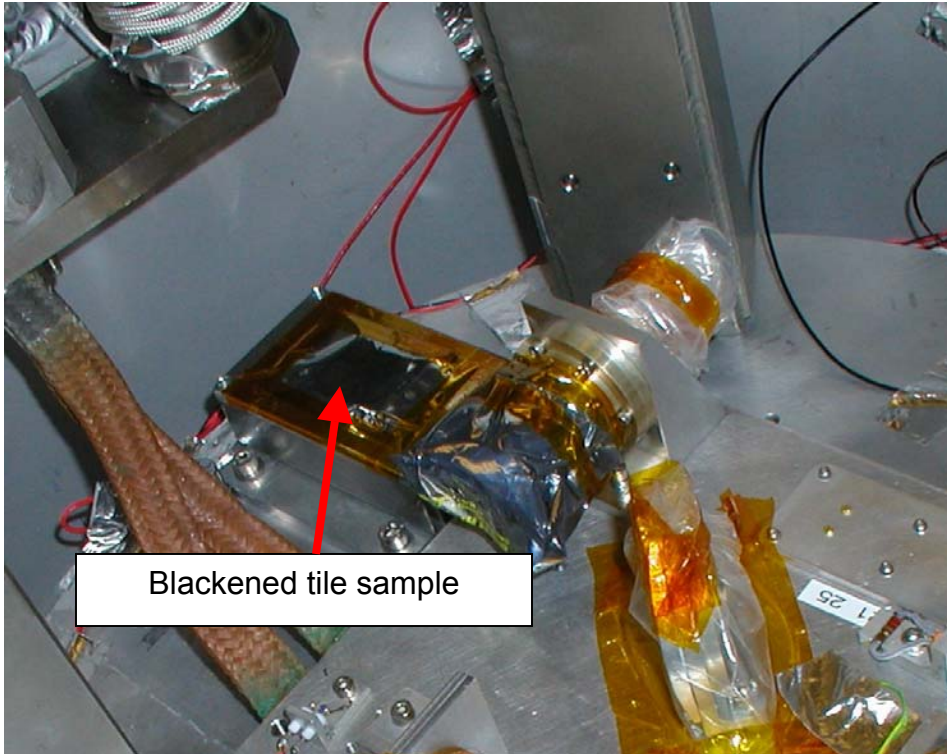
Figure 6 Tile mounted on aluminium box – bagged for cleanliness and for capture of any particles which may be dislodged.

Careful microscopic examination of the tile sample shows no sign of cracking.

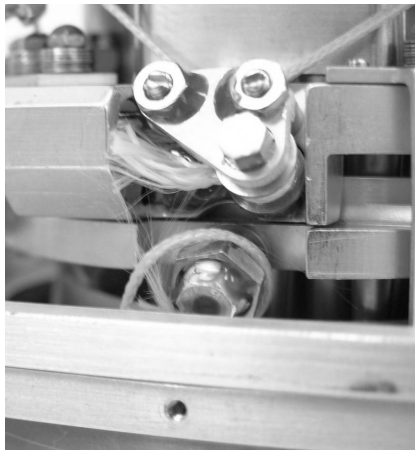
CQM PLW BDA, 10209800-1 SN006

- Lower Kevlar braid broken
- Discovered during tear-down of CQM instrument, May 2007
- Found after shipping back from STM2 testing – BDA had been working normally
- Break discovered visually, also internal touch (electrical short)
- CQM delivered to RAL Sept. '03
- Break after 3½ years of post-delivery testing
- Shipping apparently benign – only 5g monitors tripped.

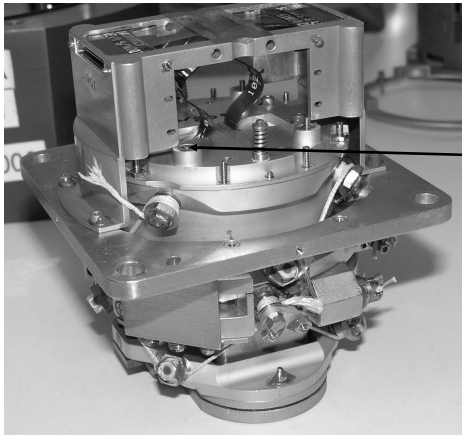
Disassembly At RAL- Touch Location

- JPL inspection at RAL
- Light can removed
- Touch identified:
 - coverplate to connector bracket
- Break ~near pulley#2
 - no obvious smoking-gun
- Shipped back to JPL for more investigation

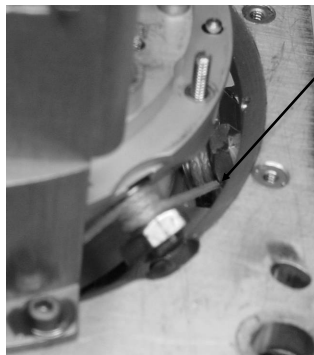
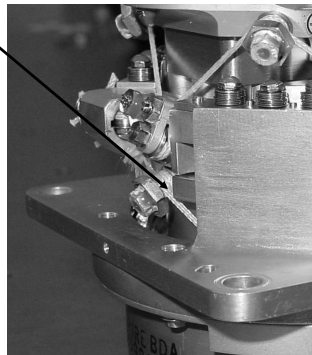
Failure Area

- Inspection determined failure just where kevlar leaves pulley #2
- No obvious pre-existing defect (also had been inspected carefully at JPL)

- Kelvar likely failed during shipping (proximate cause)
- Root cause is kevlar abrasion damage at the pulley

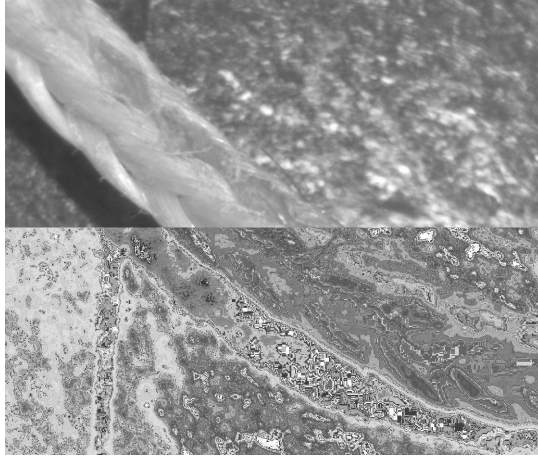
Kevlar Abrasion

- Abrasion damage at all pulleys
- Worse near Capstan-3 (pulleys 1,2...)
- Braiding exposes different parts to damage

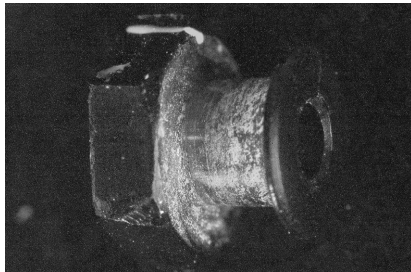
Pulley 1

UV light illumination reveals fluorescence from extensive kevlar residue on CQM pulleys.

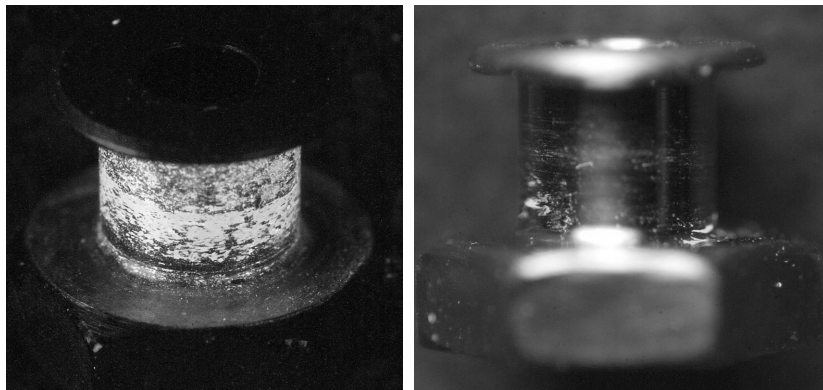
Pulleys after 1st abrasion test (no failure)

unpolished

Same shake exposure

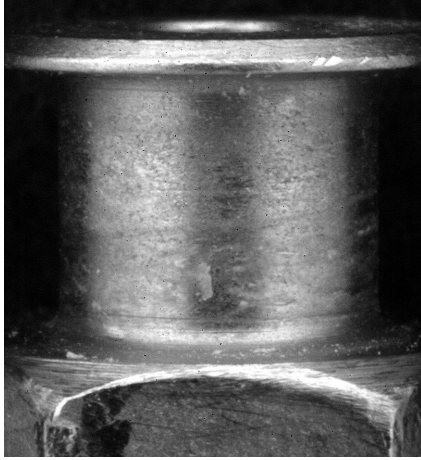
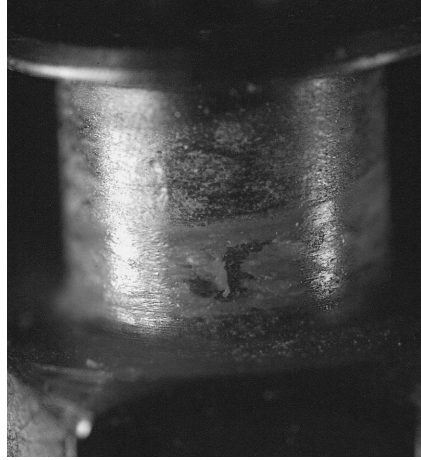
Unpolished Pulley after shake-to-failure

- Failed after 7.7 min at highest shake level
- Failed at pulley

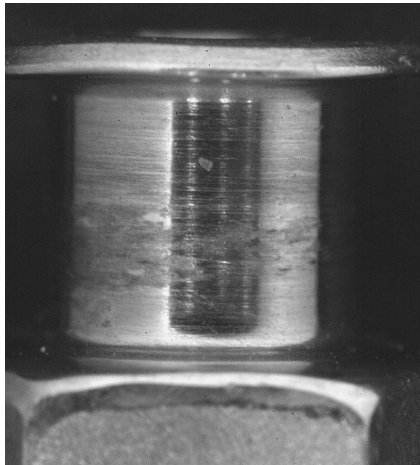
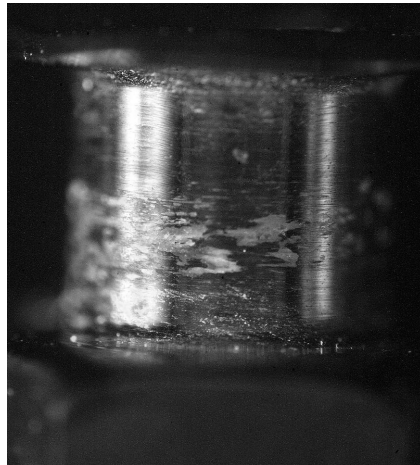
Polished Pulley after shake-to-failure

- Failure after 36 minutes at max shake level
- Failed at lower tie-off
