SSTD Incoming Inspection Report

Spacecraft/Project **HERSCHEL / SPIRE**

Document Number **SPIRE-RAL-REP-003017**

Sub System **DPU**

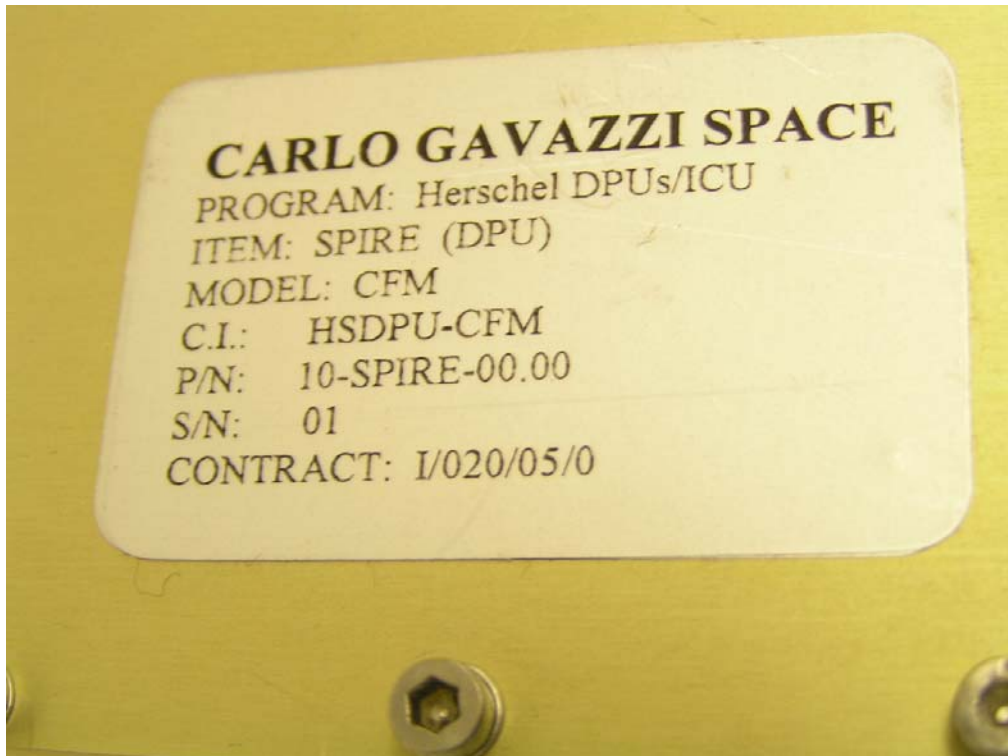
CHECK LIST	REMARKS (LIST CONNECTOR NUMBERS)	RESULTS
Pin Alignment	Flight quality parts not fitted	See remark
Damaged Sockets		None
Internal Debris	Dust seen inside connectors	See remark
Connector Covers fitted	Connectors were unprotected	See remark
Connector Savers Fitted		None
EMC Covers Fitted		None
RED Tag Item / Green Tag Items fitted		N/A
Additional Comments		None

Uncovered connectors and peeling blanking plates on DPU
