**GIADA FS MODEL  
IN-FLIGHT COMMISSIONING  
REPORT**

This document reports the in-flight commissioning activities performed on GIADA experiment in the night between 3 and 4 April 2004 @ ESOC.

This report is applicable to GIADA FS model on board the Rosetta S/C now flying @ about 11000Km from earth. The Rosetta S/C has been launched from Kourou on 2 March 2004. The data have been retrieved from DDS by means of the PI Workstation located @ PISA in ESOC.

**Doc : GIA-GAL-RP-517**

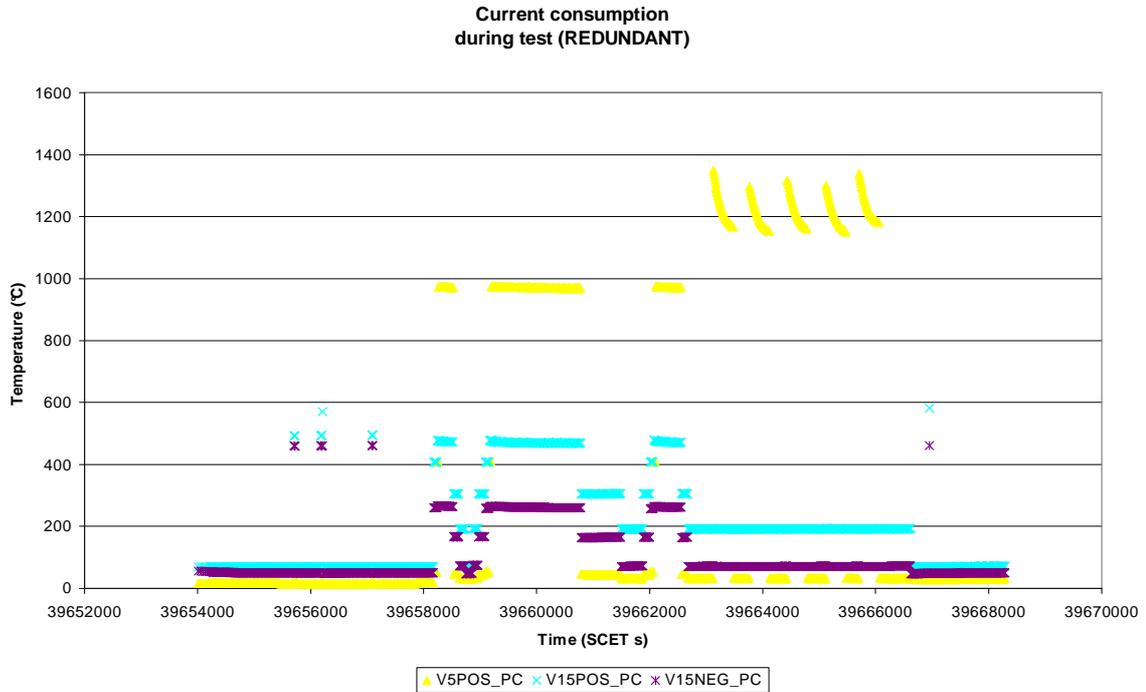
**Figure 13 Current consumption on +5V, ±15V power supplies (REDUNDANT)**

As we can see in the following pictures, the GIADA experiment behaved correctly along the test. The current consumption and the Power Supply temperature are in the expected range. In Figure 13, the first three peaks (on  $\pm 15V$ ) appear when the internal heaters are activated during the Frangibolt and the two following cover open operations. The last three peaks (on  $+5V$ ) are when the MBS heaters are switched-on during the MBS heating. The Power supply temperature increases of about  $20^{\circ}C$  from the power-on and reaches its maximum (below  $38^{\circ}C$ ) when GIADA is in Normal mode with all sub-systems and Lasers switched on. The IS temperature has two different behaviours: when the IS sub-system is switched-off, the temperature decreases even below  $10^{\circ}C$  (the sensors is looking to deep space); after the IS sensor is switched-on, the temperature increases above  $15^{\circ}C$  (the sensor power dissipation heats-up the sensor it-self). The Lasers have been properly switched-on (from minimum to nominal power) and their temperatures increase up to  $15^{\circ}C$  (less than the maximum temperature that is reached during the previous test on Main Interface with the cover closed). The laser monitor signals, which are proportional to the laser light output, are little above the last measurements, which have been taken @ Kourou before launch (end of November). This is due to the temperatures, which are below the temperatures reported in the test done on-ground. They are similar with those acquired in the TV test during on ground test campaign in 2002 (refer to Figure 17). Figure 18 shows the temperatures of the five MBS. After the sub-system switch-on, the temperatures are little above the TRP (in the range  $19$  to  $30^{\circ}C$ ). During the heating, the temperatures increase to a maximum temperature of  $60^{\circ}C$ . However, each MBS unit has different behaviour:

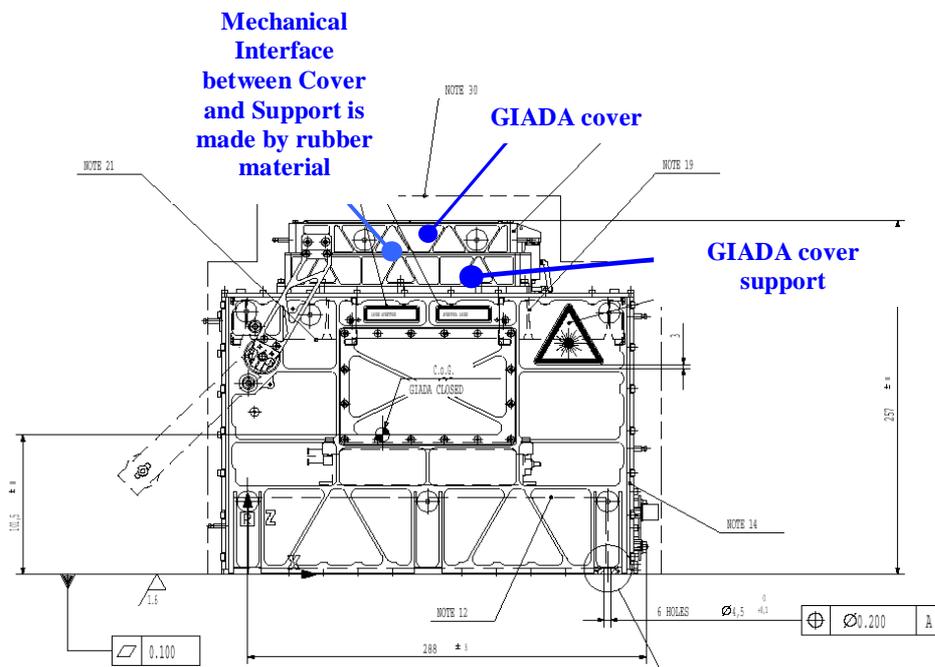
**Figure 24 GIADA with Cover is closed Configuration**

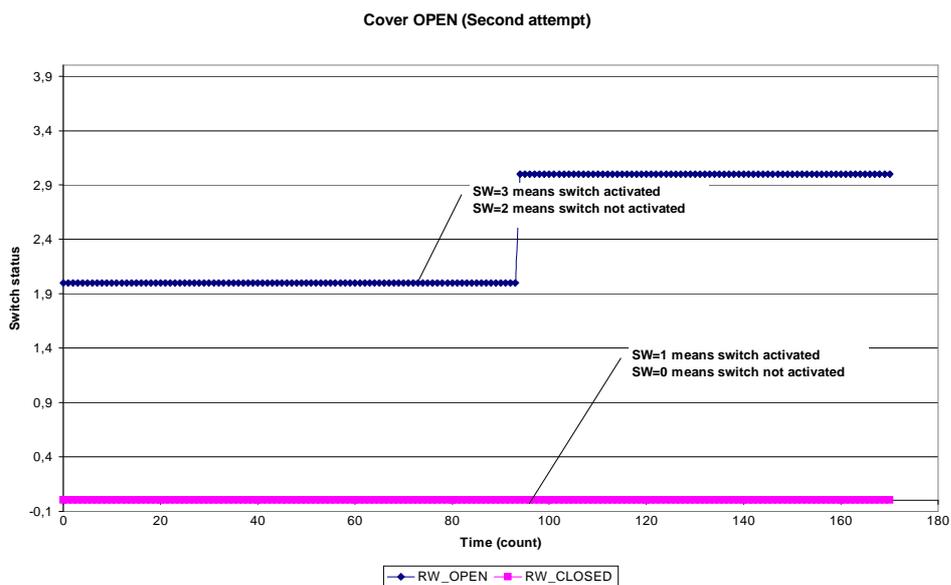
**Figure 26 Reed switches Status during the 2<sup>nd</sup> Cover Open operation (REDUNDANT)**

At the end of discussion, a new cover open operation was decided to attempt. The second cover report, which was received after the completion of the operation, is show in the Figure 26. After 93 steps, the reed switch that indicates the ‘open’ position was finally activated and cover reached the open position. Therefore, a total of 193 steps were necessary to reach the final position, that is about 70 steps more than the nominal expected value, which was experienced during the on-ground tests. This, again, could be due to the possibility that the cover was unlikely ‘stuck’ to the GIADA support and, being the motor torque small, the stepper motor loose several steps before winning the situation and reaching the final position.

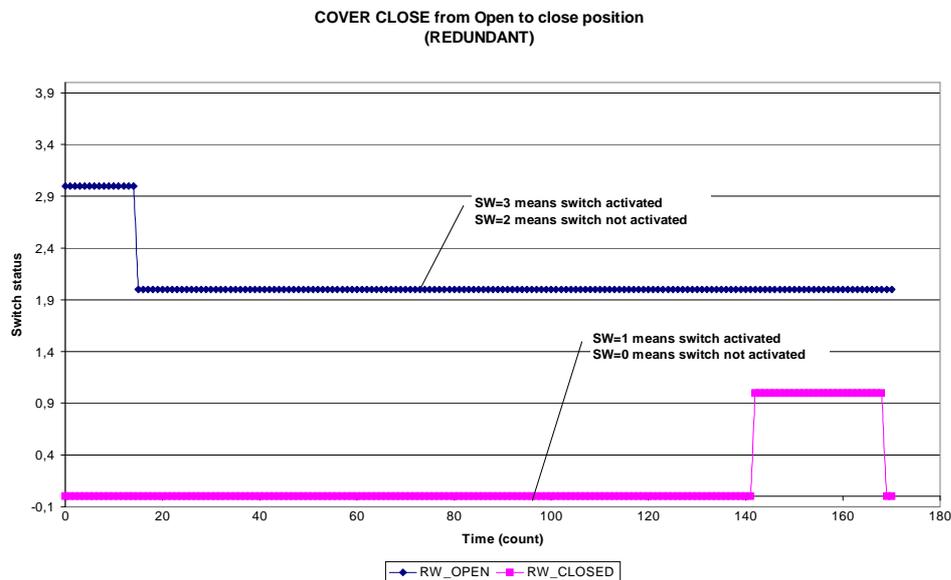
**Figure 27 Reed switches Status during Cover Close operation (REDUNDANT)**

After the completion of the tests on the REDUNDANT interface, the cover was successfully closed by ground command. Figure 27 reports the correct sequence of the two reed-switches. As expected:

- The reed switch (named RW\_OPEN), which indicates the Cover-Open position, is activated for a small number of steps (about 14 steps) and then remains not active for all remaining movement.
- The reed switch (named RW\_CLOSE), which indicates the Cover-Close position, is activated after 127 steps for 27 steps and finally reaches the not-activated status that means the cover is close to the closed position.

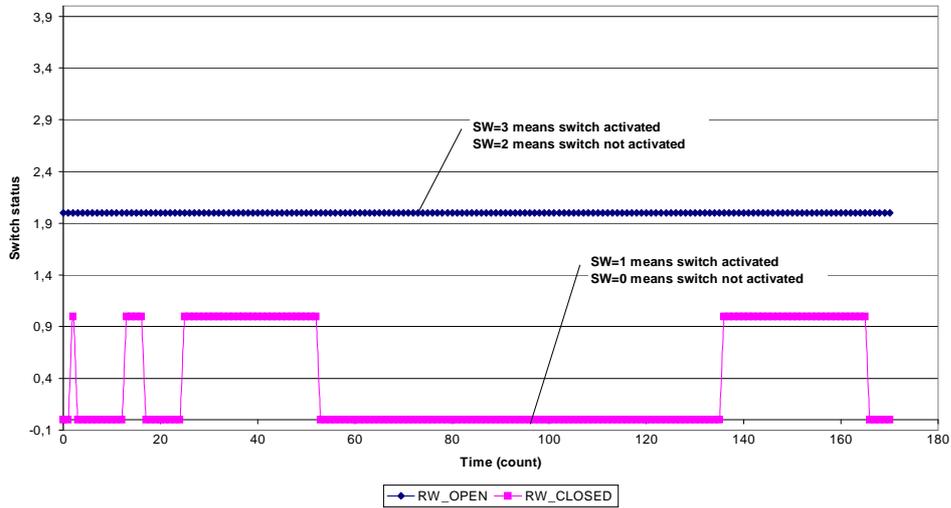
Figure 28 Reed switches Status during Cover Close operation @ power-off (REDUNDANT)

During the power-off, GIADA cover is automatically closed by the OBCP (Close Cover) despite its real position. Since the cover was already closed, the new close cover operation resulted (as expected) in a continuous cover bunching over the cover support. This is the reason of the shown status of the two reed-switches in Figure 28, in which the reed switch indicating the Cover-Open position remains always not active and the other is active several time. In fact, after a bunch on the cover support, the cover returns back and the reed switch indicating the Cover-Close position is newly activated. Considering its last status and the movement direction, the cover results closed when the reed switch passes from activated to not-activated condition.

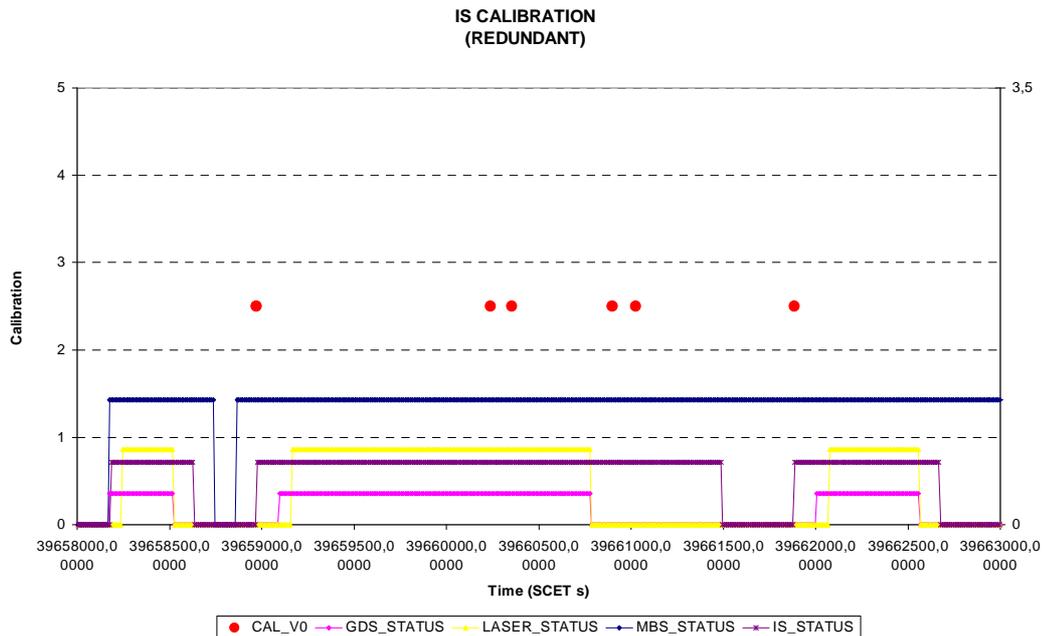
**Figure 30 IS Calibration wrt Sub-system switch-on/off (REDUNDANT)**

Figure 30 shows the sequence of the IS calibration: the 1<sup>st</sup> is done at IS power-on, the 2<sup>nd</sup> and the 3<sup>rd</sup> are done when the lasers are on, the following two are repeated when lasers (and GDS) are switched-off (only MBS are remained on) and the last one at the last IS power-on. The first calibration is performed with four stimuli and 10V stimuli level, while the others are done with eight stimuli and 9.6V stimuli level. Before the start of each internal calibration, GIADA measures the electronics noise of each channel. The following Table 3 reports the mean and the standard deviation:

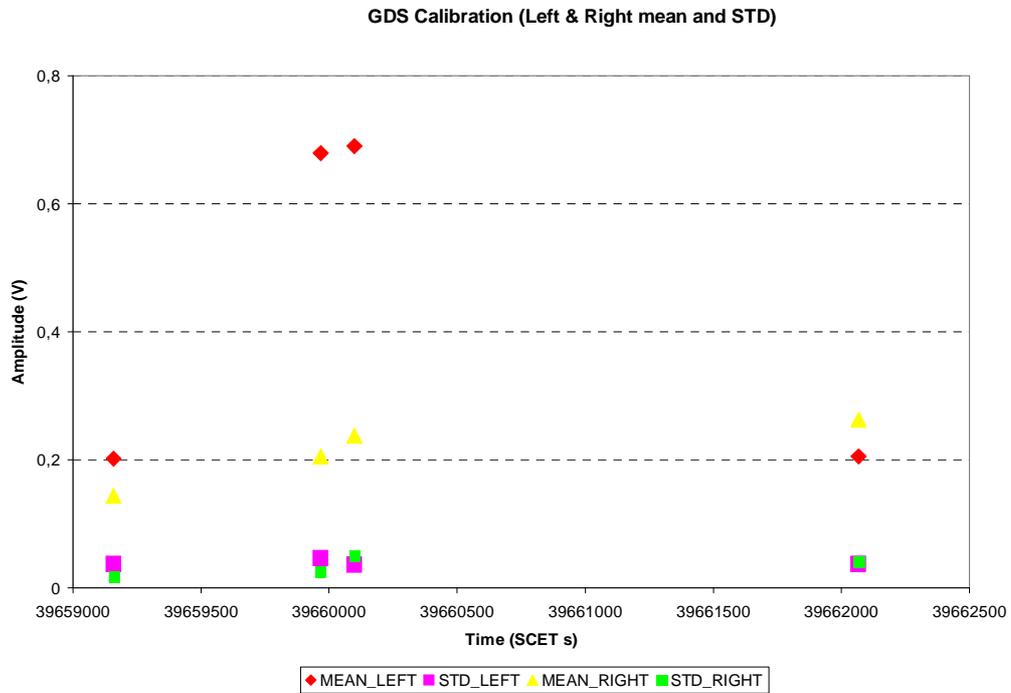
**Figure 43 GDS Calibration (Left & Right mean value and STD) (REDUNDANT)**

When the lasers are switched-off (i.e. the 1<sup>st</sup> and 4<sup>th</sup> set of data in Figure 43), the noise level of the Left and Right channels show an average of  $0.15 \pm 0.26V$  and a standard deviation ( $3\sigma$ ) below 40mV. These values represent the electronics noise level at the output of the two channels. They are in the same order of those measured during on-ground test campaign. When the lasers are switched-on (i.e. the 2<sup>nd</sup> and 3<sup>rd</sup> set of data in Figure 43), the output level of the Left and Right channels reports a direct measure of the internal stray-light in combination with the electronics noise. In this case the Left channel has a higher average than the Right (Left=0.67V and Right=0.24V) while the standard deviations ( $3\sigma$ ) are almost the same ( $<50mV$ ). This condition was already found during the storage and pre-launch test campaign in Kourou. The internal stray-light (in combination with the electronics noise) is of the same order of magnitude of the Left receiver detection threshold. Finally,

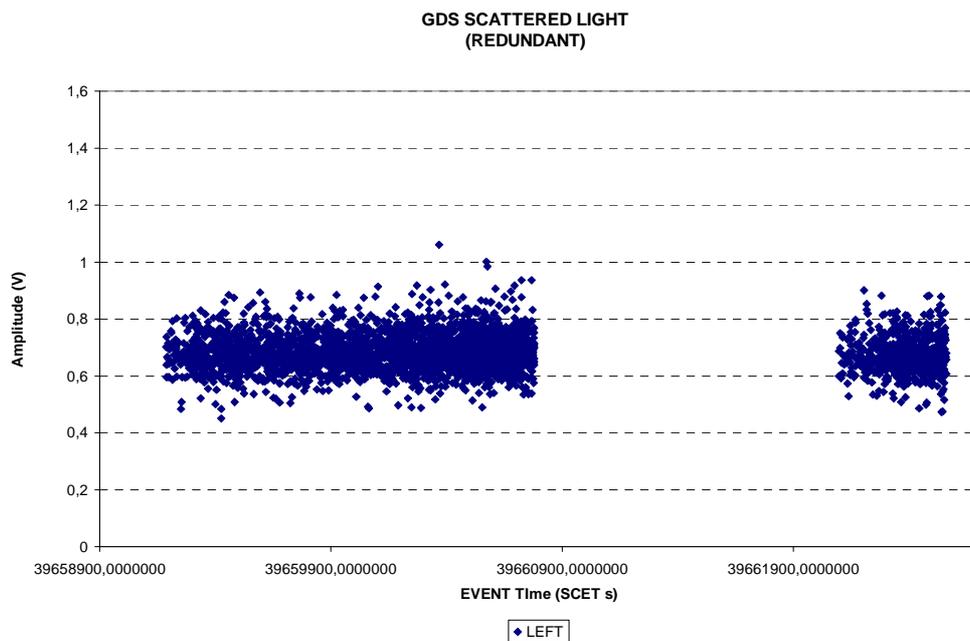
**Figure 46 Amplitude of ‘ghost detections’ on Left receiver (REDUNDANT)**

In summary, as soon as the Lasers have reached nominal power, the internal stray-light, due to contamination problem, has produced several ‘ghost detections’ on Left channel. The next two figures show the detections on Left and Right receivers and their relevant amplitudes.

- The first, in which the detections amplitude is of the order of 0.8V (Left channel); these are ‘ghost detections’ due to the high level of the internal stray-light (contamination problem). The noise level is confirmed of the same order than that found before launch (refer to Figure 47). In order to minimise these numbers of detections (and thus the data rate and production), the detection threshold of Left channel should be increased at least at 1V. It is suggested to keep under control this situation and only after a consolidated behaviour, update the value in the context file.

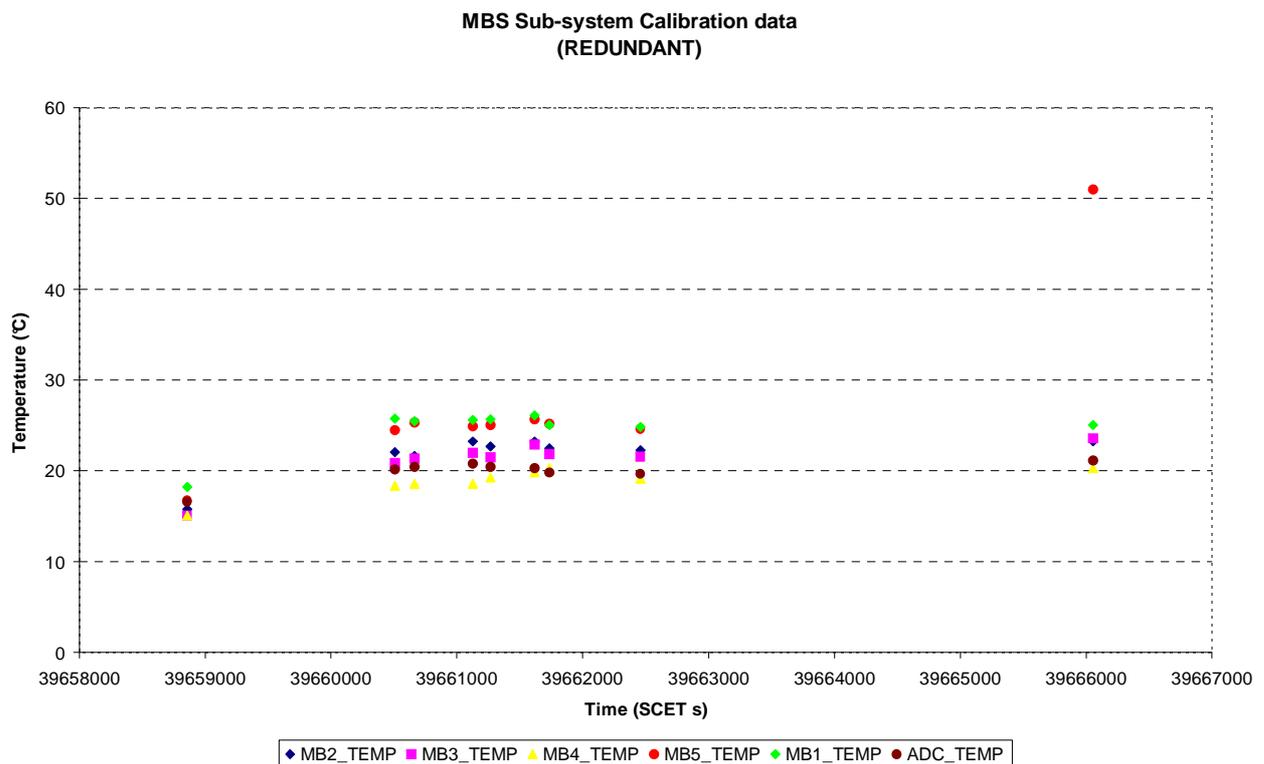
**Figure 49 MBS Sub-system Calibration Data (REDUNDANT)**

The figure shows no interference of the MBS temperatures reading with respect the status (on or off) of the other sub-systems. The last value of the MBS5 temperature seems incoherent with respect to the others (T above 50°C), but this is due to the execution of the calibration close to the MBS5 heating.

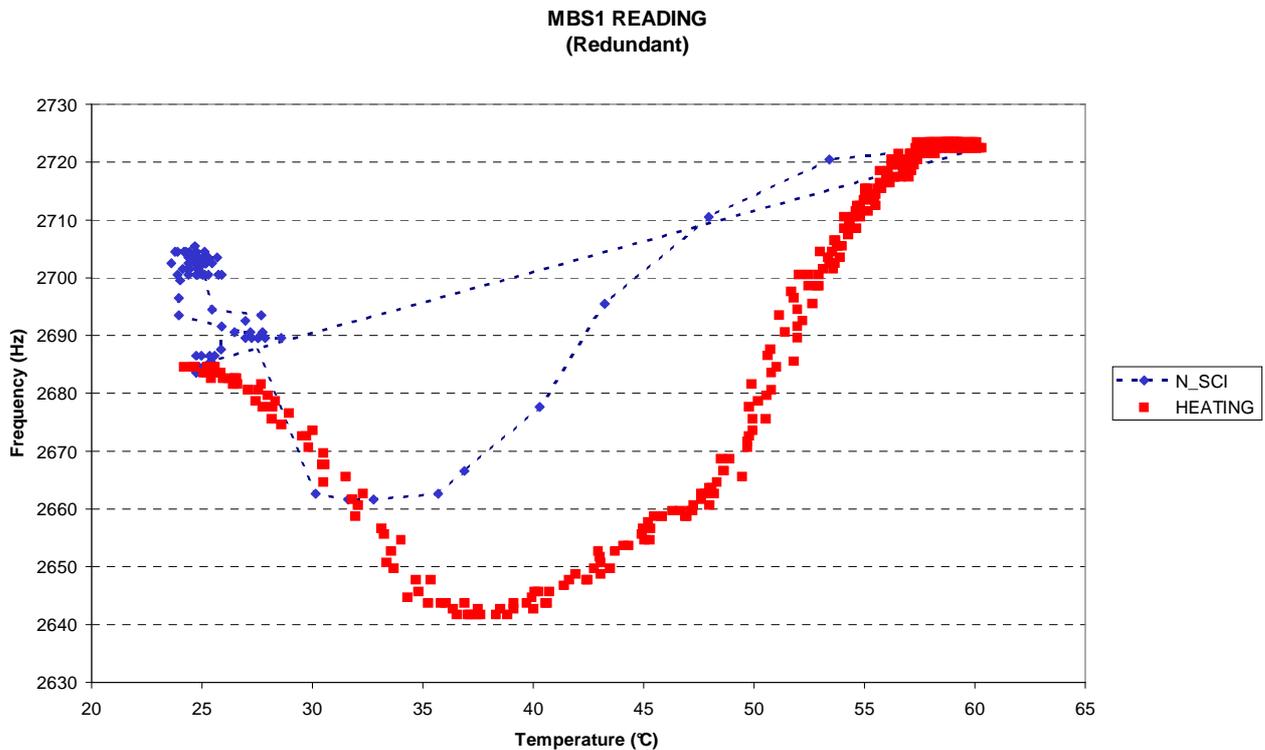
**Figure 50 MBS1 Frequency wrt temperature in Normal Acquisition and heating  
(REDUNDANT)**

The frequency value after the completion of the heating and when the temperature is returned to its initial condition has approximately the same value before the start of the heating. The frequency shift, which is calculated from the figure of the frequency wrt. temperature during heating, is plotted in Figure 52. The frequency shift results outside the expected range: it is within the range  $-10/+5$  Hz/°C (nominal expected range is  $\pm 3$  Hz/°C).

**Remarks:** This discrepancy is a known behaviour of the MBS unit, which was already detected during on-ground test campaign, when the MBS temperature changes too fast (temperature gradient  $> 1^\circ\text{C}/\text{minute}$ ), as during heating process. On MBS1, a  $\Delta t$  of  $30^\circ\text{C}$  is reached after 200s; this means a thermal gradient of about  $9^\circ\text{C}/\text{minute}$ , as we can see in Figure 53.

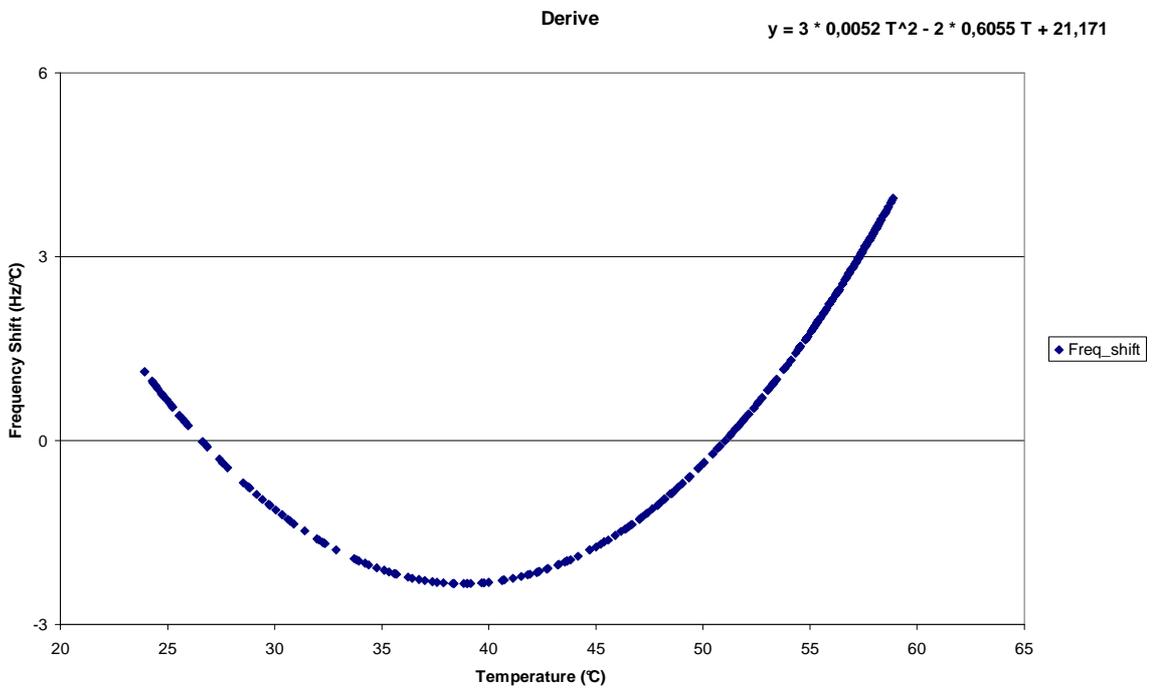
**Figure 56 MBS2 Frequency shift (REDUNDANT)**

As seen on MBS1, the frequency value after heating, when the temperature is returned to its initial condition, has almost the same value as before the start of the heating (the  $\Delta$ Frequency is less than 3 Hz). For MBS2, the frequency shift remains inside the expected range ( $\pm 3$  Hz/ $^{\circ}$ C).

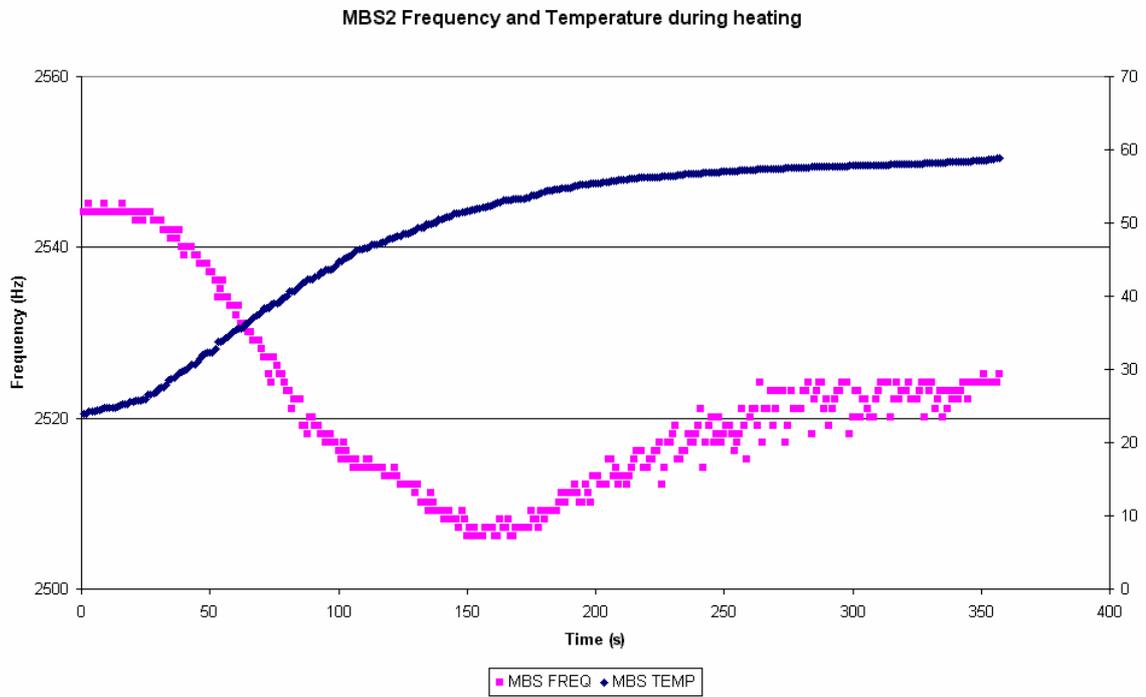
**Figure 57 Frequency and Temperature during MBS2 heating (REDUNDANT)**

The first frequency reading of the MBS2, in the TM packet during heating, jumps to a not-expected value (the expected value is about 2544 Hz in the heating TM packet, while the first value was 3972 Hz). This is a known behaviour and already happened on ground. The value has been simple discarded from the data elaboration, as indicated in the **AD4**.

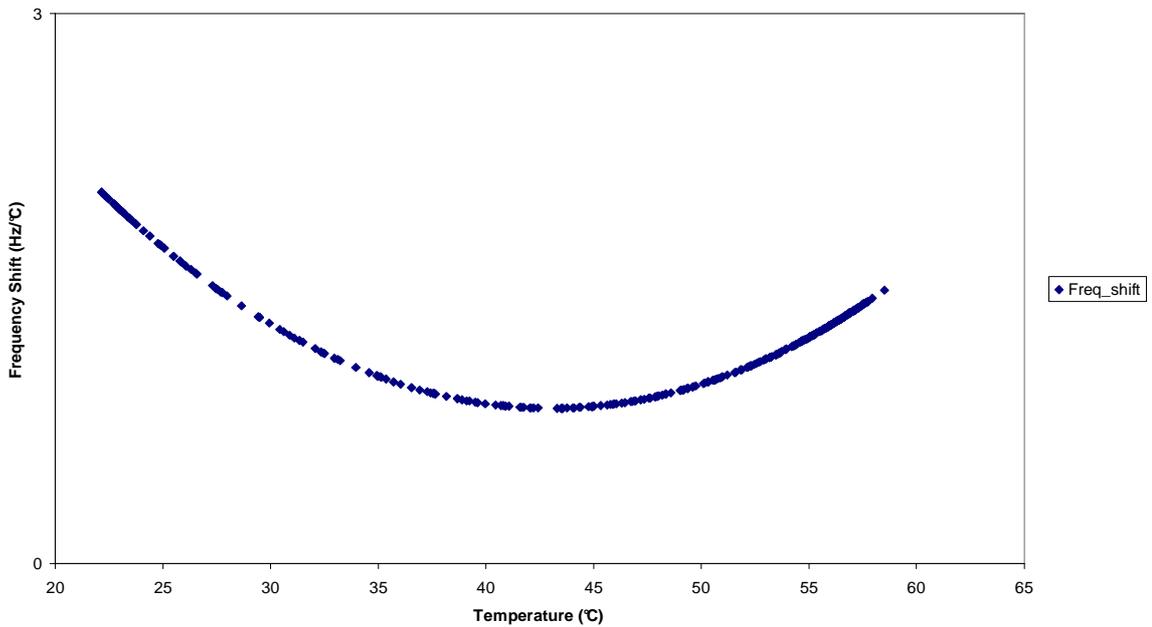
Figure 60 MBS3 Frequency shift (REDUNDANT)

As reported in Figure 58, the frequency value after the completion of the heating, when the temperature is returned to its initial condition, is different from the value before the start of the heating (measured  $\Delta$ Frequency is about 11Hz). For MBS3, the frequency shift results inside the expected range ( $\pm 3$  Hz/ $^{\circ}$ C).

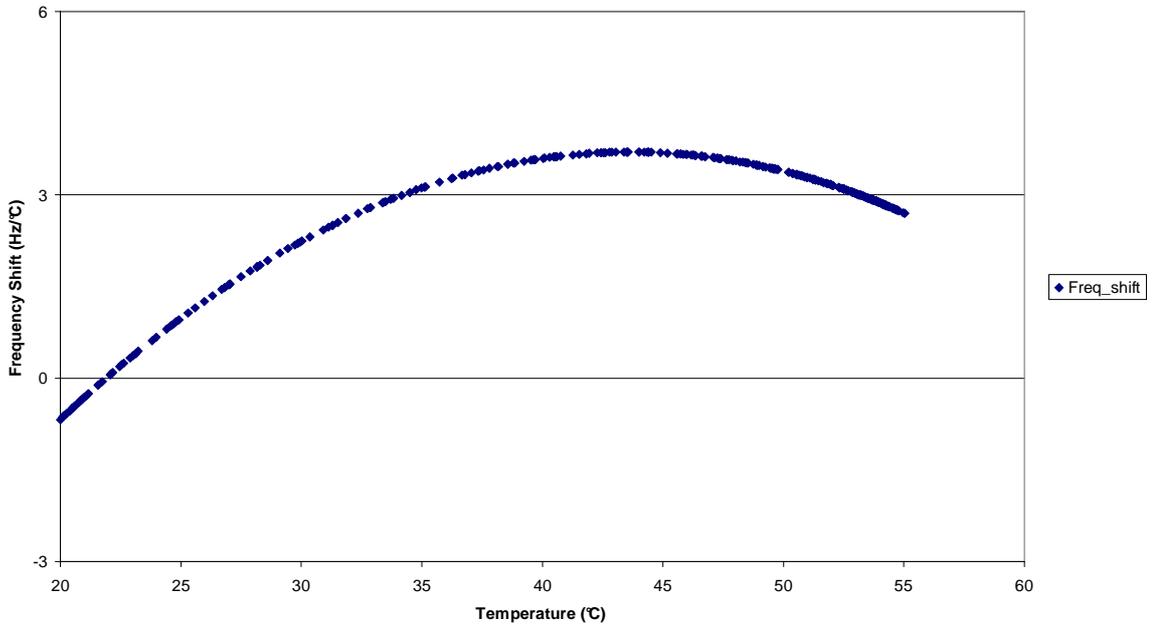
Figure 64 MBS4 Frequency shift (REDUNDANT)

As seen on MBS3, the frequency value after the completion of the heating, when the temperature is returned to its initial condition, is different from the value before the start of the heating (measured  $\Delta$ Frequency is about 18Hz). For MBS4, the frequency shift results almost inside the expected range (-1/+4 Hz/°C respect to  $\pm 3$  Hz/°C).

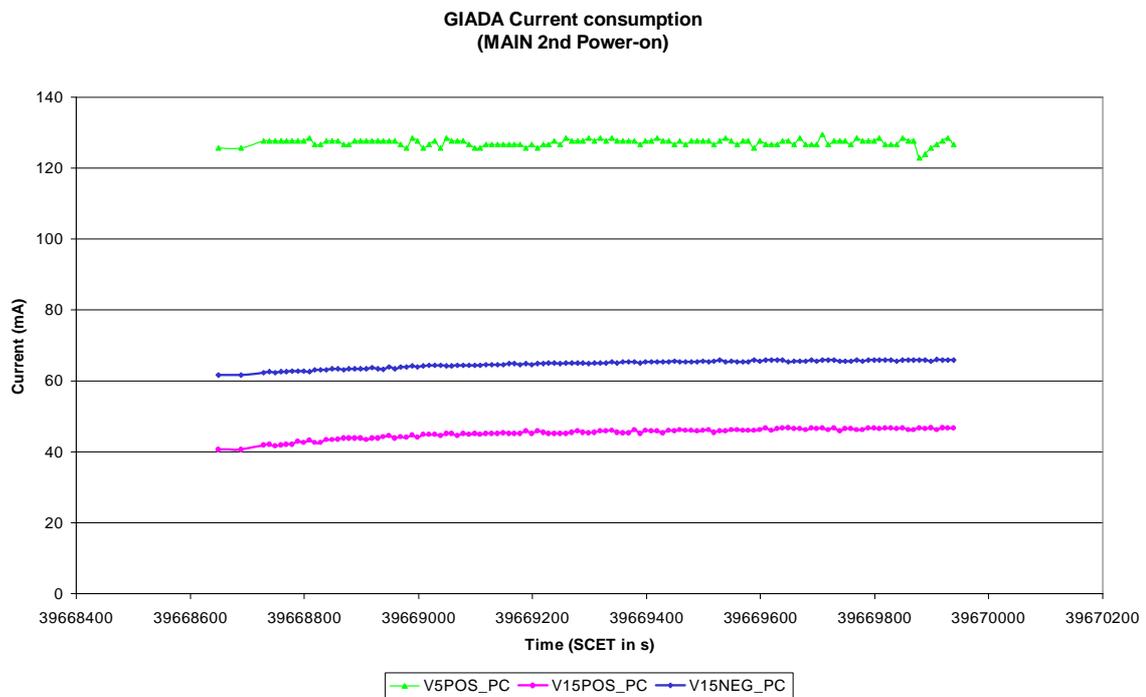
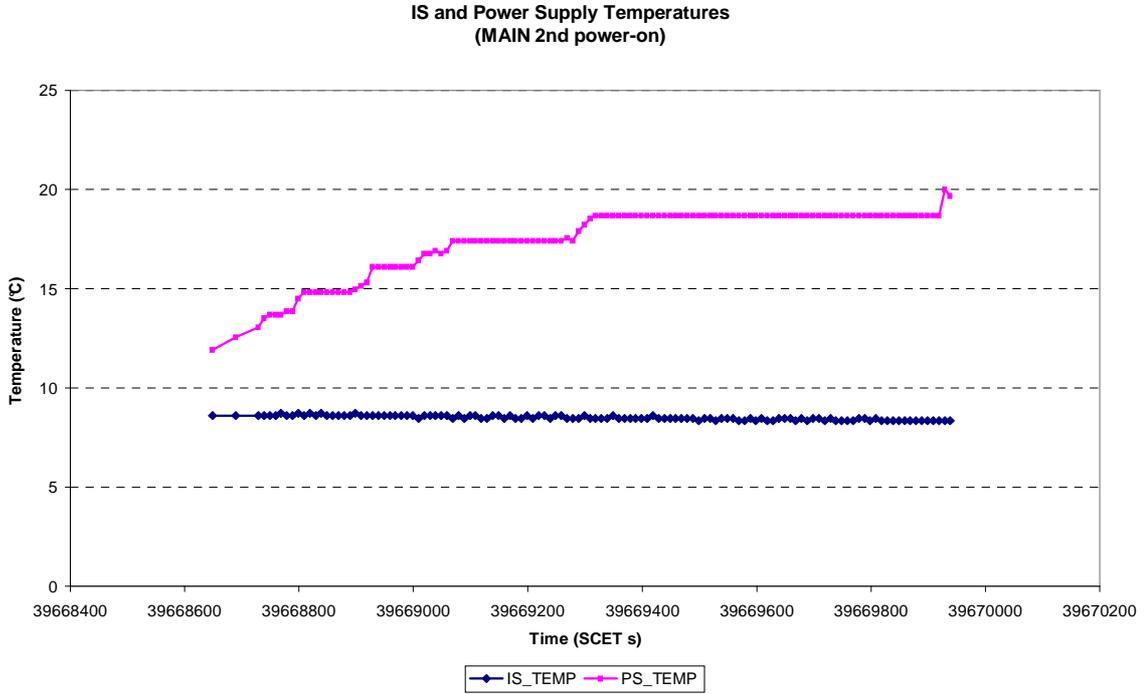
As we can see in the following pictures, the GIADA experiment behaved correctly along the test. The current consumption and the Power Supply temperature are in the expected range. The Power supply temperature increases of about 5°C from the power-on and reaches its steady state @ about 18°C, being GIADA always in Safe mode with all sub-systems switched off. The IS temperature remains stable around 8°C being the sensors always switched-off. In Safe mode, the Lasers and MBS remains off and the relevant temperatures are not read. No missing HK packets have been observed during the test.

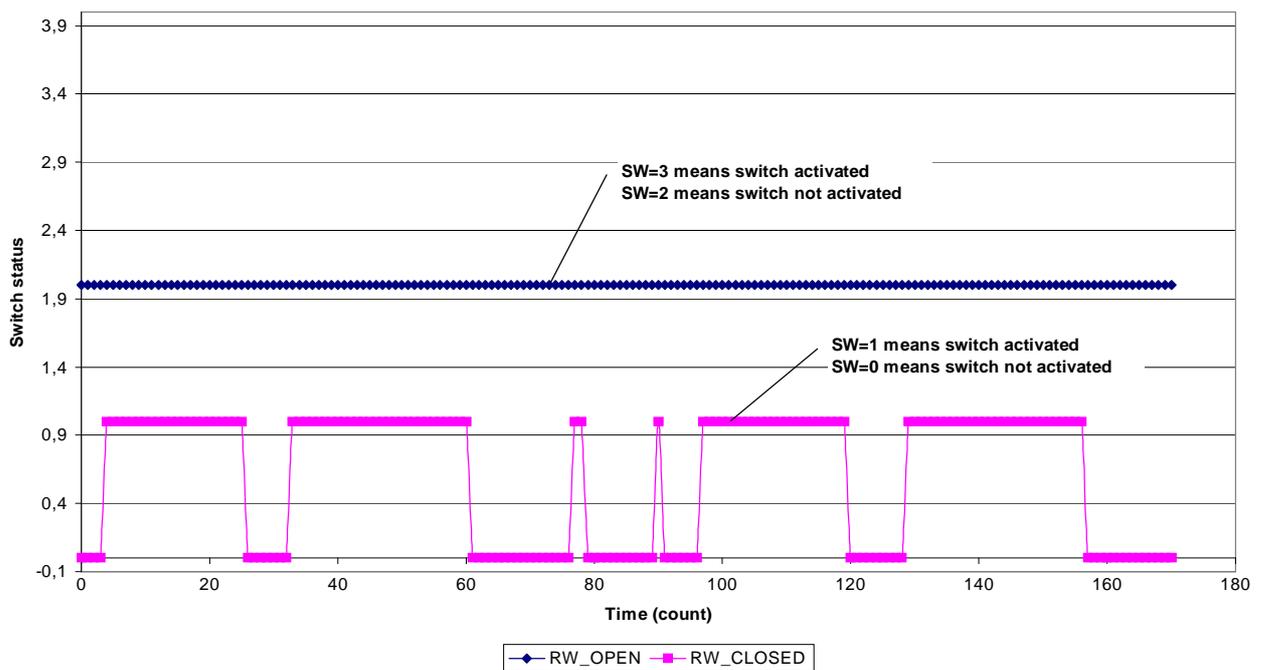
**Figure 76 Reed switches Status - Cover Close operation @ power-off (MAIN 2<sup>nd</sup> power-on)**

During the power-off operation, GIADA cover is automatically closed by the OBCP (Close Cover) despite its real position. Since the cover was already closed, the new close cover operation resulted (as expected) in a continuous cover bunching over the cover support. This is the reason of the status of the two reed-switches shown in Figure 76, in which the reed switch indicating the Cover-Open position remains always not active and the other is activated several time. In fact, after a bunch on the cover support, the cover returns back and the reed switch indicating the Cover-Close position is newly activated. Considering its last status and the actual movement direction, the cover results at the end in closed position when the reed switch passes from activated to not-activated condition.
