Title: **GIADA FS MODEL REPORT OF IN-FLIGHT INTERFERENCE SCENARIO PART 1A (20 - 21 SEPT '04)**

## GIADA FS MODEL

This document reports the II part of the in-flight commissioning activities performed on GIADA experiment in the period from 20 and 21 September 2004 (Interference scenario 1A).

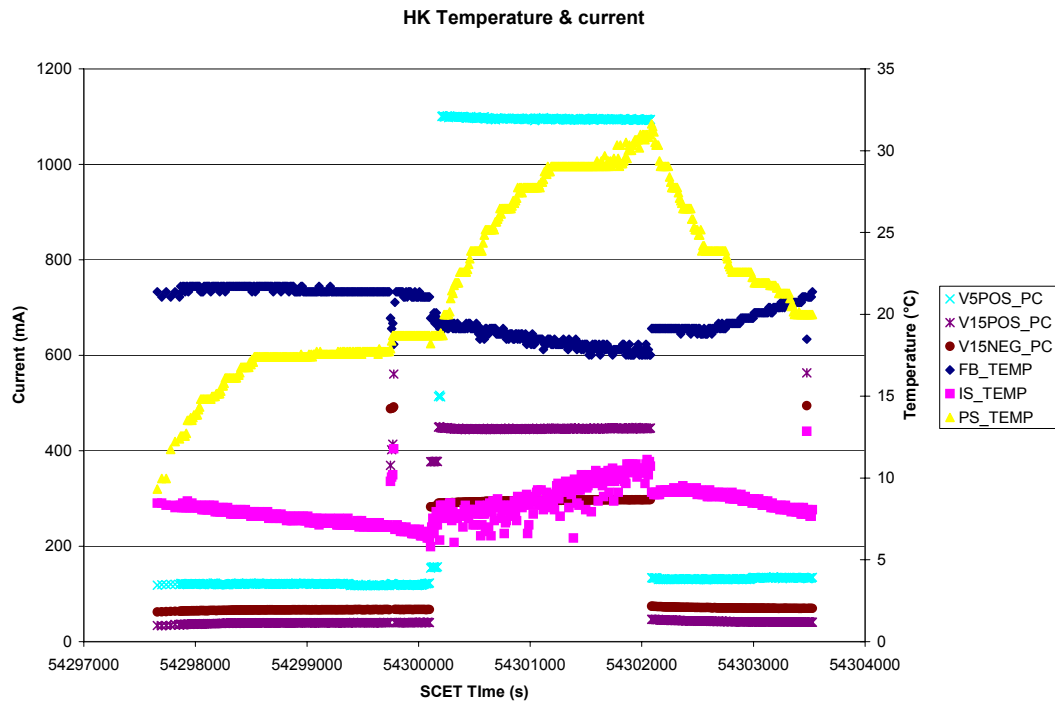
**Figure 1** Frangibolt, IS and Power Supply temperatures and +5V,  $\pm 15V$  Currents (MAIN)

As we can see in Figure 7, the GIADA experiment behaved correctly along the test, as the Cover opened and closed at the right time. The current consumption and the Power Supply temperature are in the expected range (Figure 1). The Power Supply temperature increased from 10°C (@ power-on) up to 30°C at the end of the test (when GIADA was in Normal mode and the maximum power was drawn). The IS temperature was still around 8°C, even with the cover open. The Lasers were properly switched-on and their temperatures increased from 8°C to 11°C at the end of the Normal mode. The five MBS, after switch-on, showed a temperature between 15 - 20°C. No missing packets were found in the TM.

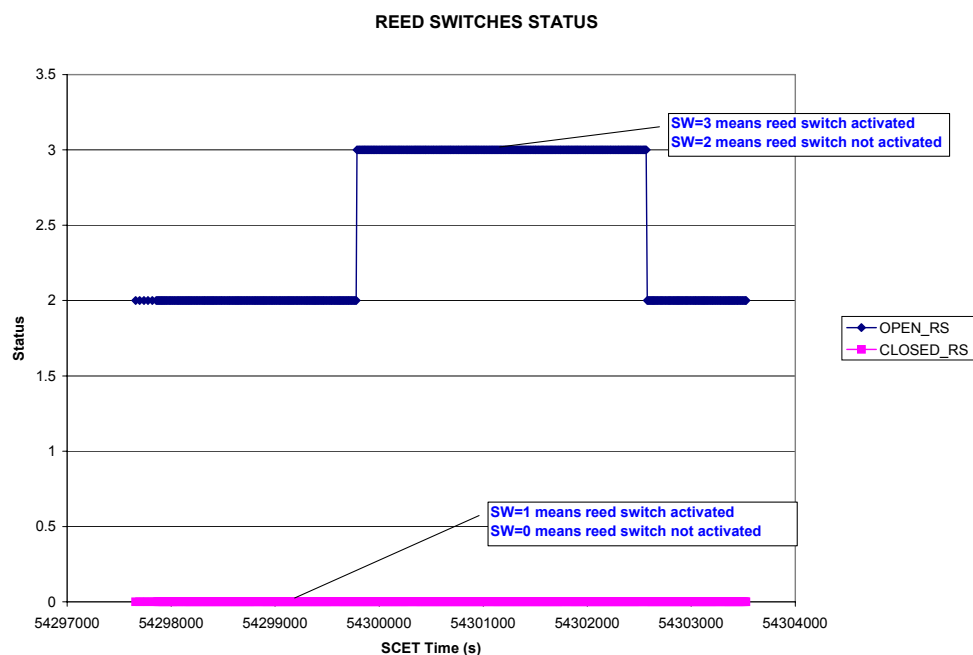
**Figure 7 Cover Report (Cover open & close operation) - MAIN**

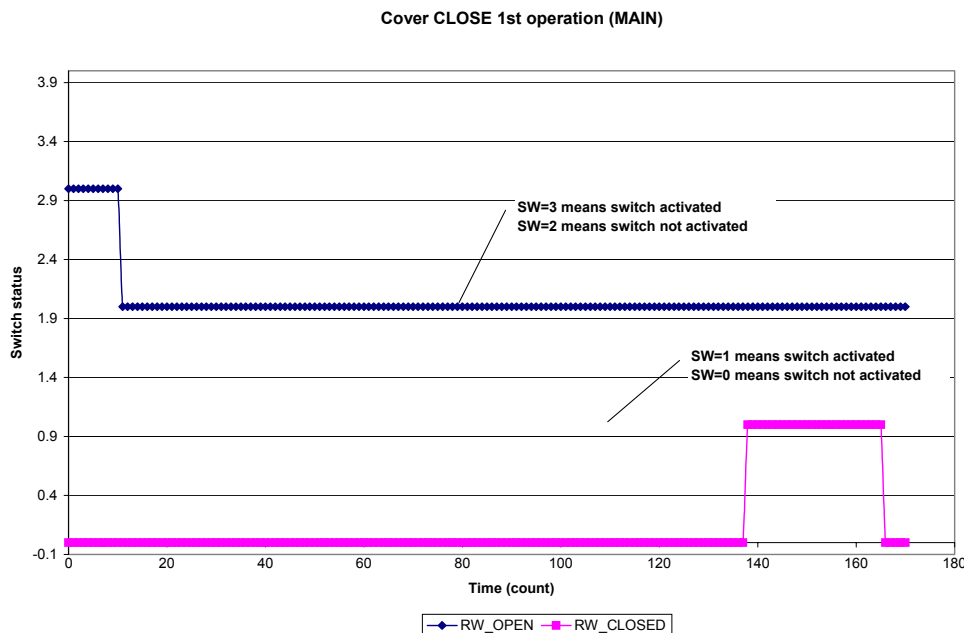
After the completion of the tests on the MAIN interface, the cover was successfully closed by command. Figure 9 reports the correct sequence of the two reed-switches. As expected:

- The reed switch that indicates the Cover-Open position (named RW\_OPEN) is activated for a small number of steps (about 10 steps) and then remains not active for all remaining movement.
- The reed switch that indicates the Cover-Close position (named RW\_CLOSE) is activated after 126 steps for 27 steps and finally reaches the not-activated status that means the cover is close to the closed position.

**Figure 9 Reed switches Status during Cover Close operation (MAIN)**

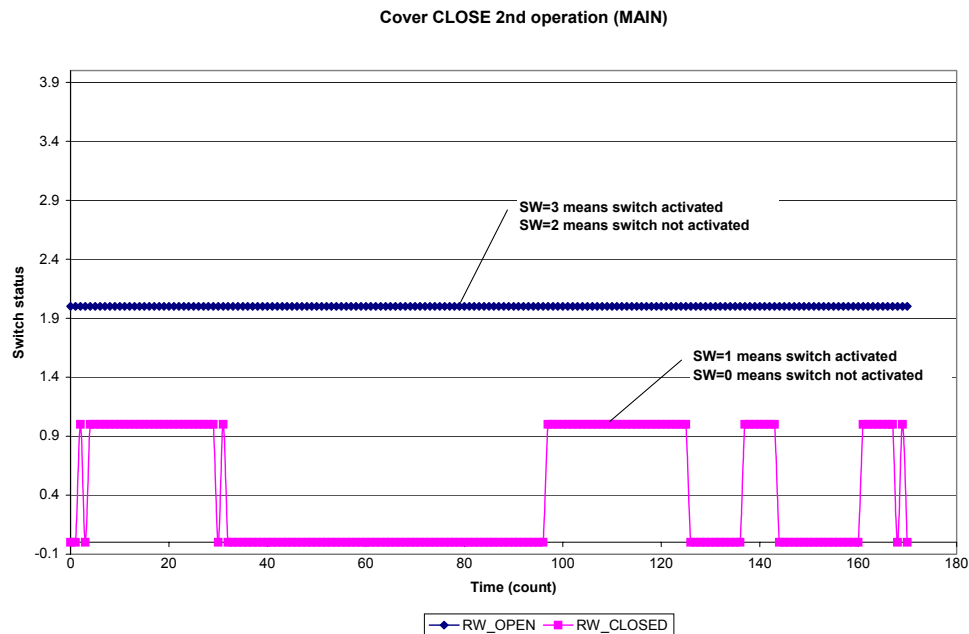
During the power-off, GIADA cover is automatically closed by the OBCP (Close Cover) despite its actual position. Since the cover was already closed (by the previous Close Cover operation), the new close cover operation resulted (as expected) in a continuous cover bunching over the cover support. This is the reason of the shown status of the two reed-switches in Figure 10, in which the reed switch indicating the Cover-Open position remains always not active and the other is activated several time. In fact, after a bunch on the cover support, the cover returns back and the reed switch indicating the Cover-Close position is newly activated. Considering its last status and the movement direction, the cover results closed when the reed switch passes from activated to not-activated condition.

**Figure 10 Reed switches Status during Cover Close 2<sup>nd</sup> operation @ power-off (MAIN)**

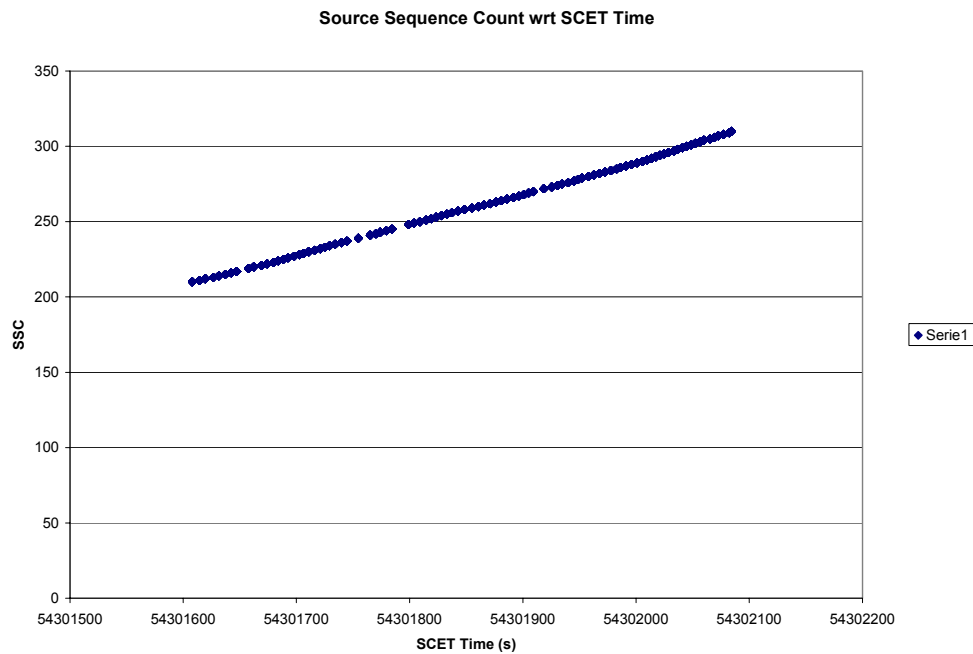
***Figure 12 GDS Left receiver production rate wrt. time***

Figure 12 shows the GDS (left receiver) production rate with respect to time. It seems that the rate is slightly increasing at the end of the test. The calculated average rate (over the entire production time) is one TM science packet every about 6s. **With such rate, the SSMM allocated GIADA buffer (1 Mbytes) should not saturate.**

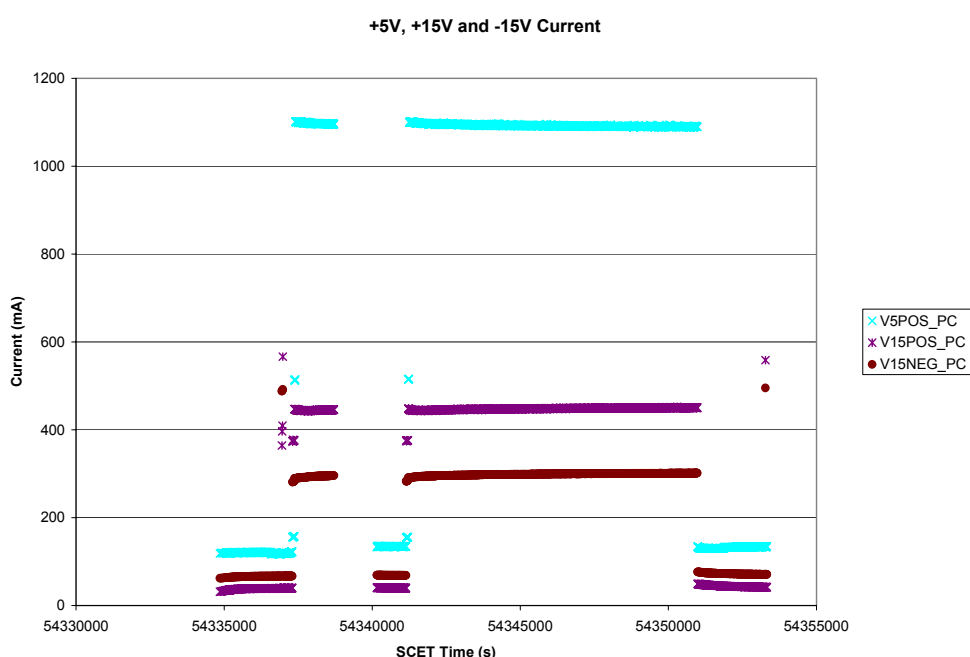
As we can see in the following figures, the GIADA experiment behaved correctly along the test. **The current consumption and the Power Supply temperatures (Figure 16) are in the expected range. The current consumption measured in Normal mode for +15V and -15V is about 450mA and 295mA respectively. These values are consistent with previous data from Commissioning test and on-ground TV test (GIA-GAL-TR-527).**

**Figure 16 Current consumption on +5V,  $\pm 15V$  power supplies (MAIN)**

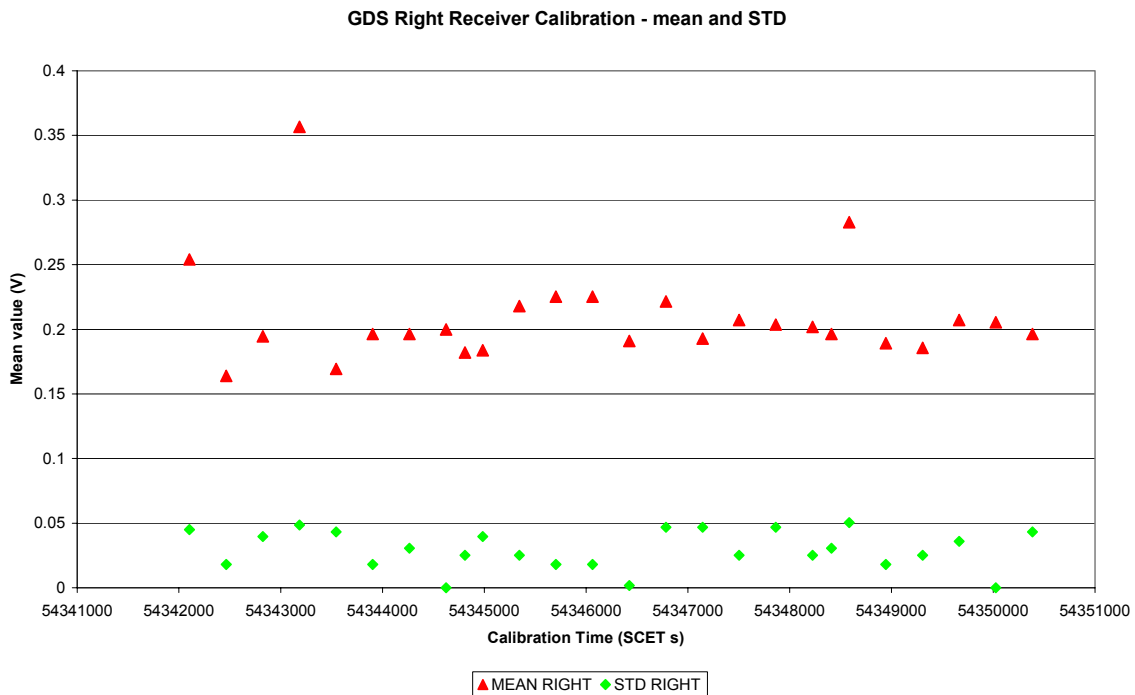
**Figure 34 GDS Calibration (Right mean value and STD deviation)**

The output level of the Left and Right channels reports a direct measure of the internal stray-light in combination with the electronics noise (may be conducted on the power lines from other instruments). As we can see, the mean value of the Right receiver is always below the detection threshold (no ghost detections were observed on the Right channel) and practically the same as during the previous in-flight test of April '04 (GIADA commissioning) when GIADA was switched on alone. Its average is below 0.25 V (only once increases up to 0.35 V), while its standard deviation is always below 50 mV always. A different situation is observed for the Left receiver:

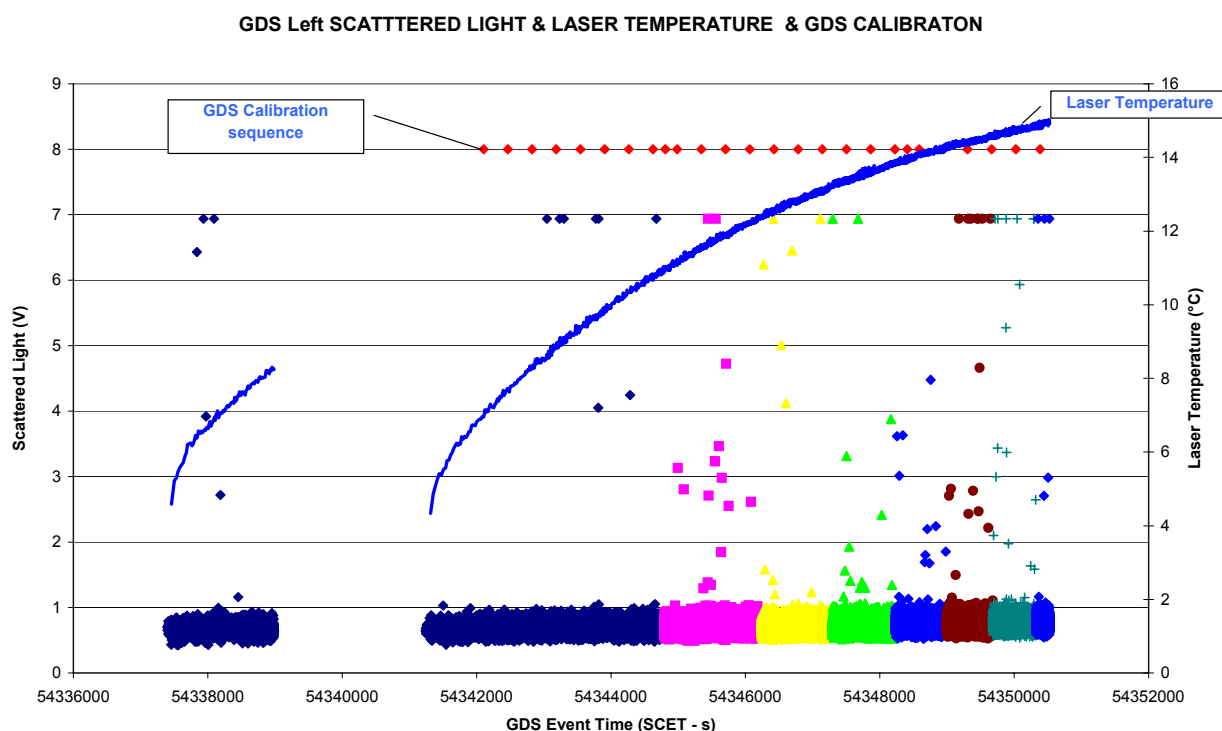
- The first type in which the detections amplitude is of the order or little above of detection threshold (0.8 V); these are 'ghost detections' due to the high level of the internal stray-light, now in combination with the electronics noise. The noise level is confirmed of the same order than the one found during the 1<sup>st</sup> Commissioning in April '04 (see Figure 39) only at the beginning of the test. Then, when all the other experiment were operative and the GIADA internal temperature increased, the noise increased and went little above the detection threshold. Due to this high production rate (which is shown in Figure 41), it can be possible to saturate the SSMM Memory, but since the downloading rate was sufficiently high, the SSMM memory allocated for GIADA was not saturated during the test.

**Figure 40 'Ghost detections' on Left receiver wrt Calibration and Temperature**

- The second type, in which the detection amplitude on the left receiver is well above the detection threshold or in saturation (6.9375 V). These detections have happened more often than in the 1<sup>st</sup> Commissioning and seem not correlated to any specific GIADA internal events (such as calibration or relay on-off switching). **An explanation could be the interference (conducted on the power line) of the other experiments.** Further dedicated analyses are needed to understand if they are correlated to specific operations of other payloads.

However, in order to minimise these numbers of detections (and thus the GDS data rate and production), the detection threshold of Left canal should be increased at least at 1-1.2V.

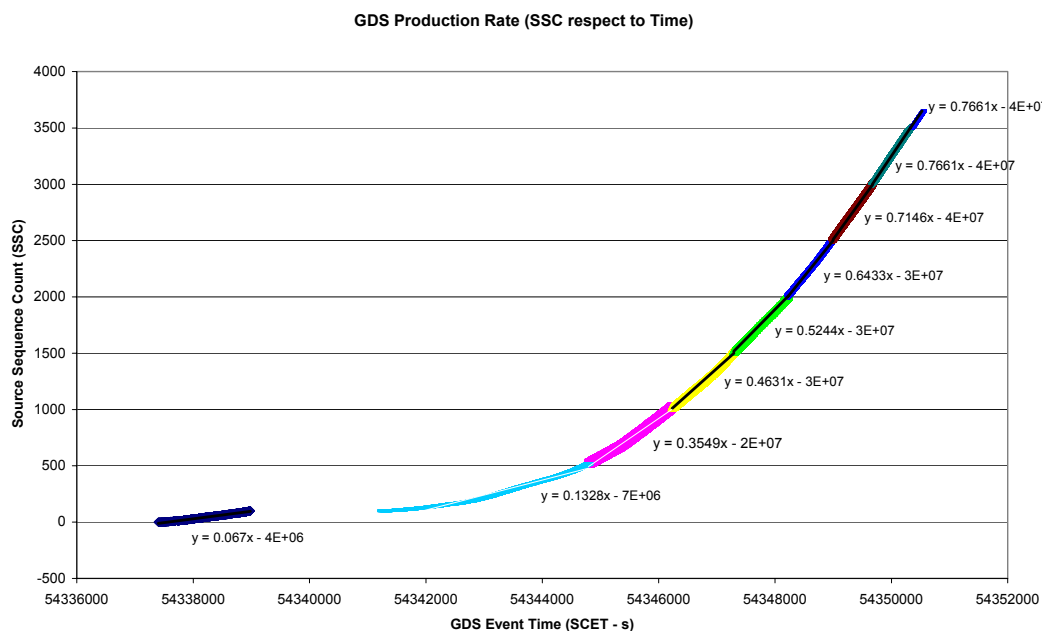
The internal stray-light (in combination with the electronics noise) is above the Left receiver detection threshold and increases from the begin to the end of the test. This is also confirmed by the production rate of GDS ghost events, that is shown in Figure 41: it results lower at begin (about 1 packet every 7.5 s, i.e. 0.133 packet/s) and maximum at the end (about 1 packet every 1.3 s, i.e. 0.766 packet/s). Finally, Figure 36 and Figure 37 shows the laser light monitor and the laser temperature at the time of the GDS calibration.

**Figure 41 GDS Left Receiver Production rate**

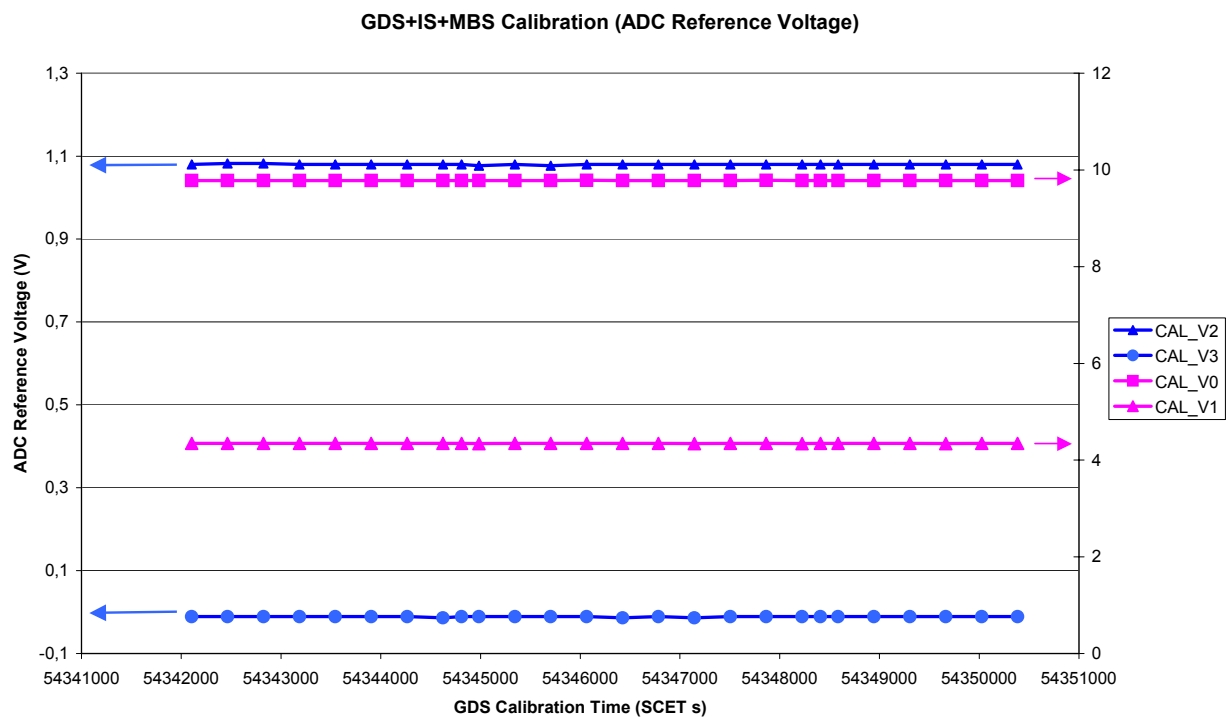
Table 4 and Figure 42 show the ADC Reference Voltages along the Interference Part 1A test for the sequence of the IS, GDS and MBS Calibrations. The voltages are quite stable in the temperature range 11 to 20 °C, except in few measurements, where they jump of about 3 mV (which is two-three digits of ADC).

**Figure 42 ADC Voltage Reference during Calibration**

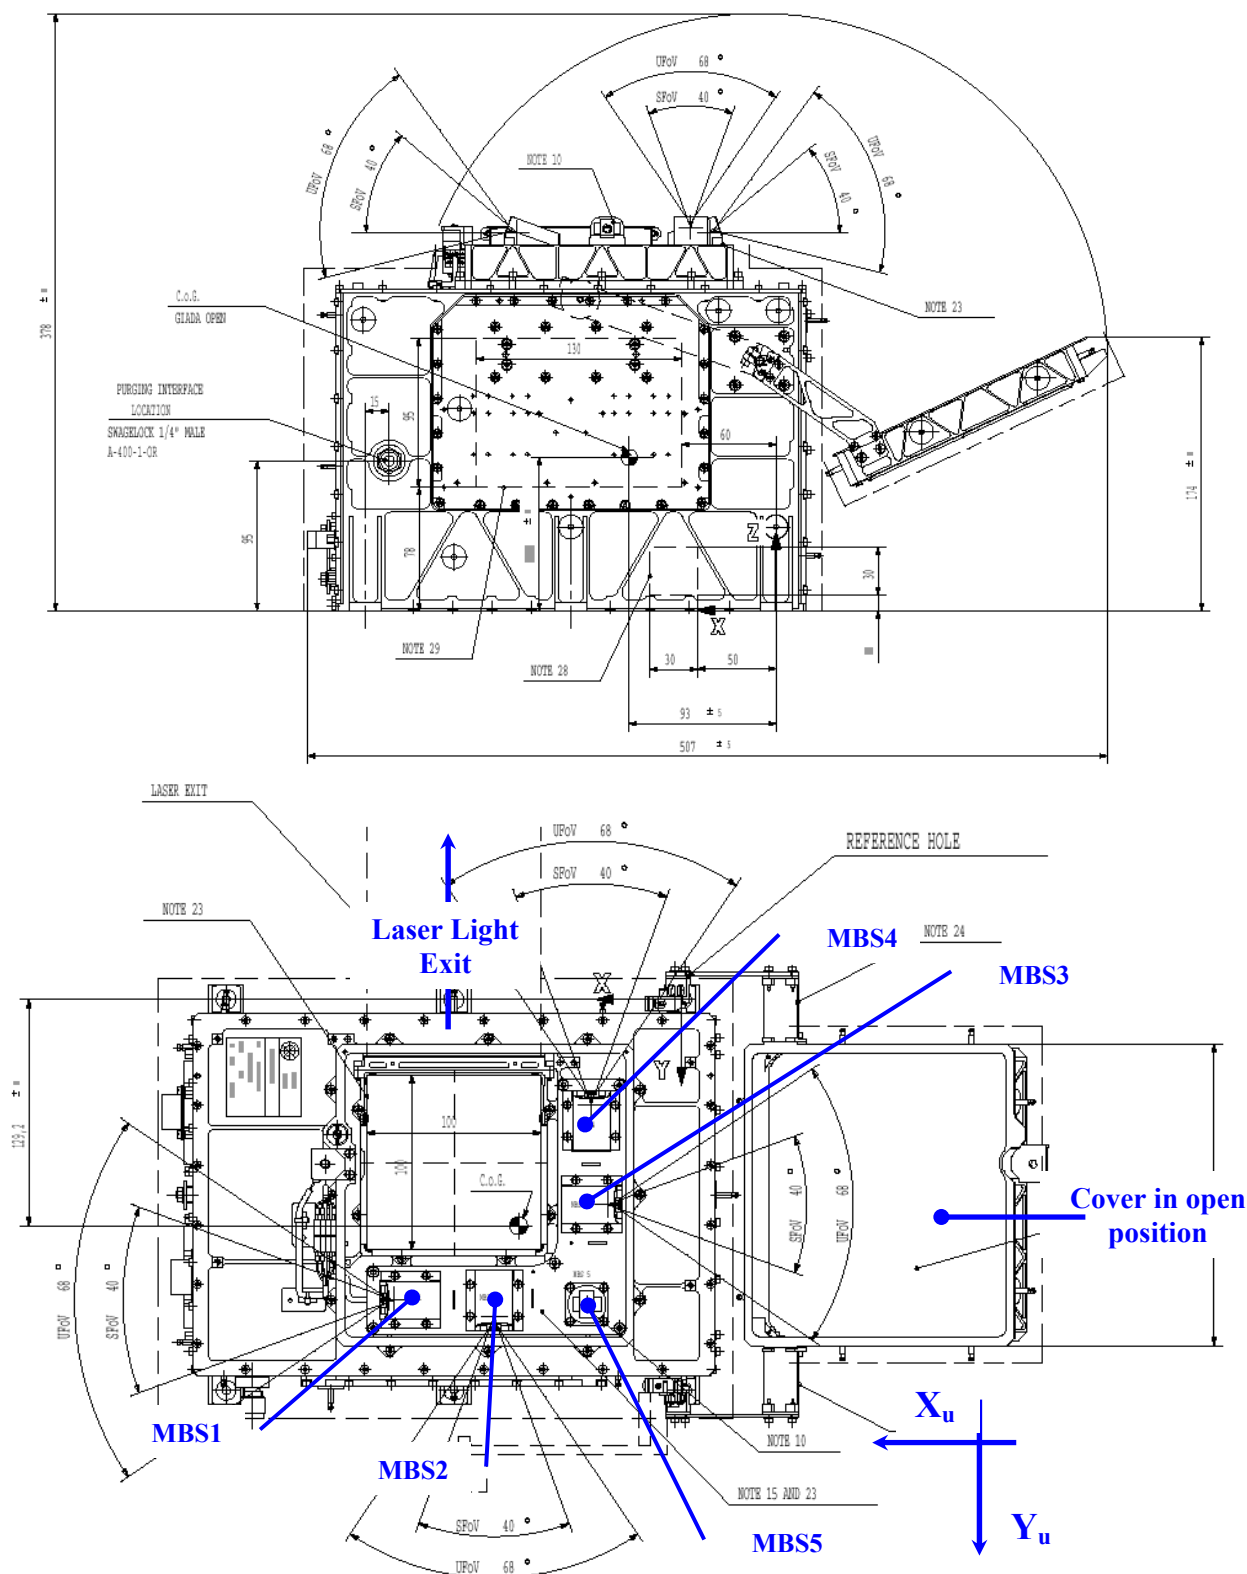
**Figure 45** *GIADA Cover Open Configuration – MBS location & pointing wrt GIADA unit axes*

- The MBS1 frequency (MBS1 points to the +Xu direction, as it is shown in Figure 45) is about doubled, from 2700 Hz (data taken during the GIADA 1<sup>st</sup> Commissioning, refer to Figure 48) to about 5227 Hz @ 25°C.

This seems possible because of MBS in-flight contamination due to offgassing-volatilised material. **Reasons of this change must be investigated together with other experiments/payloads that have observed similar situation and may require MBS heating at the next GIADA-on opportunity.** From operational point of view, all MBS's work as expected and the frequency dependence vs. temperature (frequency shift due to temperature change) is consistent with the commissioning data.

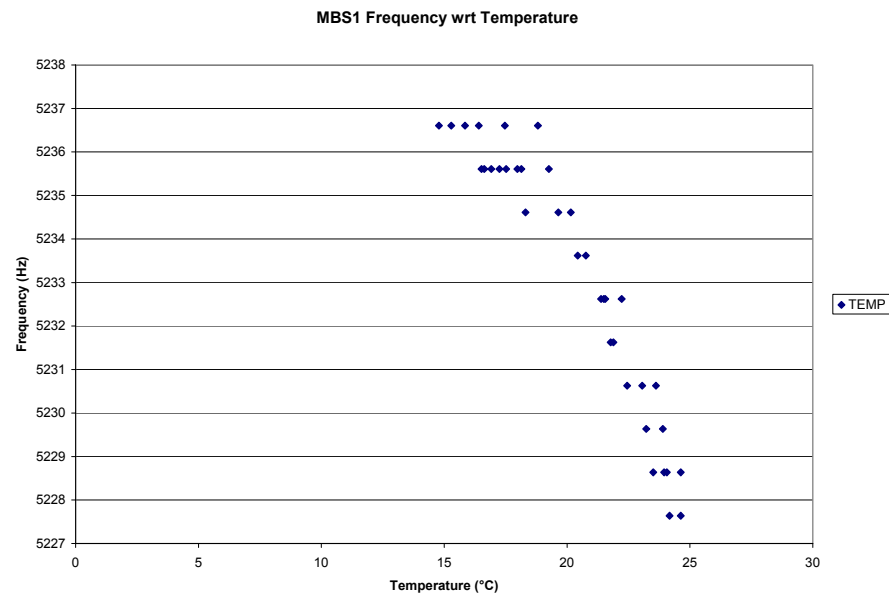
**Figure 47 MBS1 Frequency wrt Temperature**

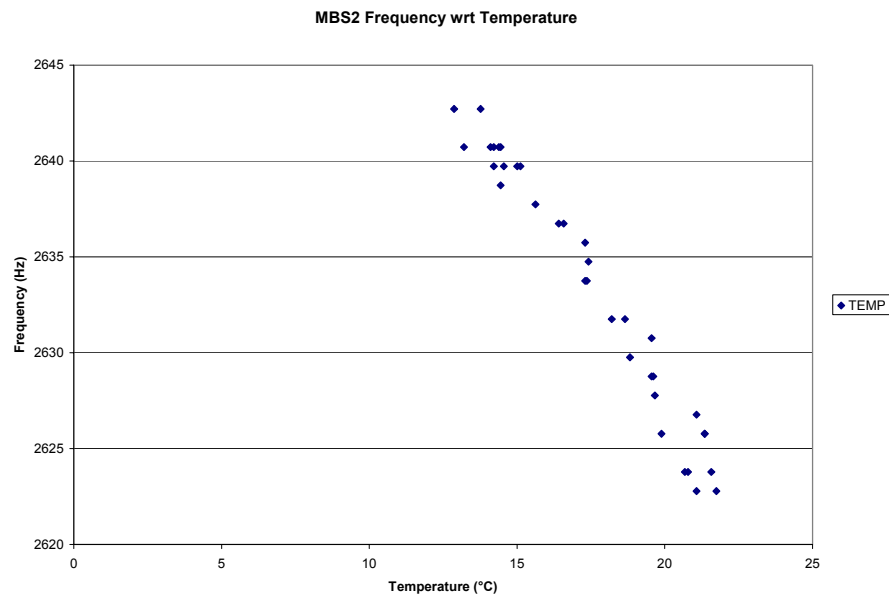
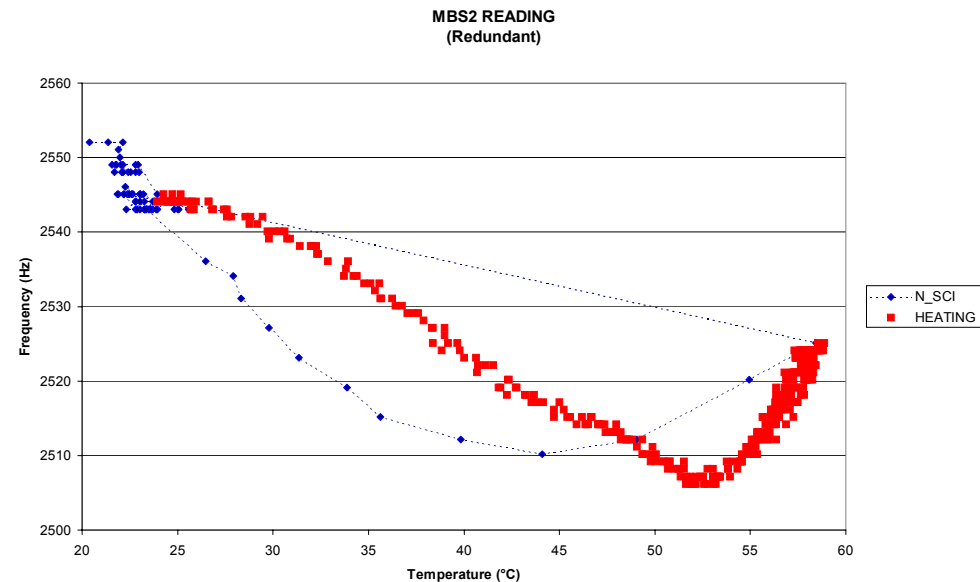
**Figure 49 MBS2 Frequency wrt Temperature**

- The MBS2 frequency (which points to the +Yu direction) is slightly increased of about 100Hz, from 2625Hz (data taken during the GIADA 1<sup>st</sup> Commissioning, refer to Figure 50) to about 2550Hz @ 20°C.

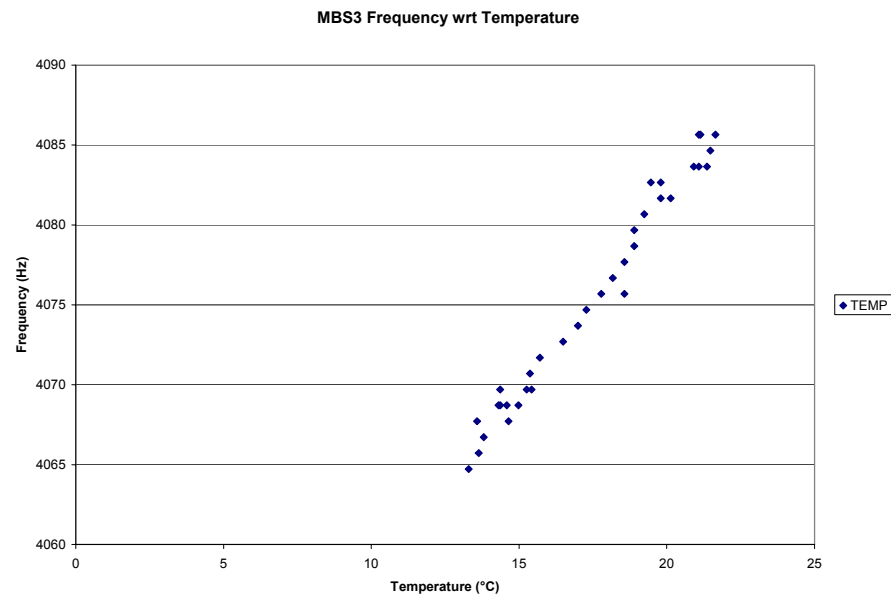
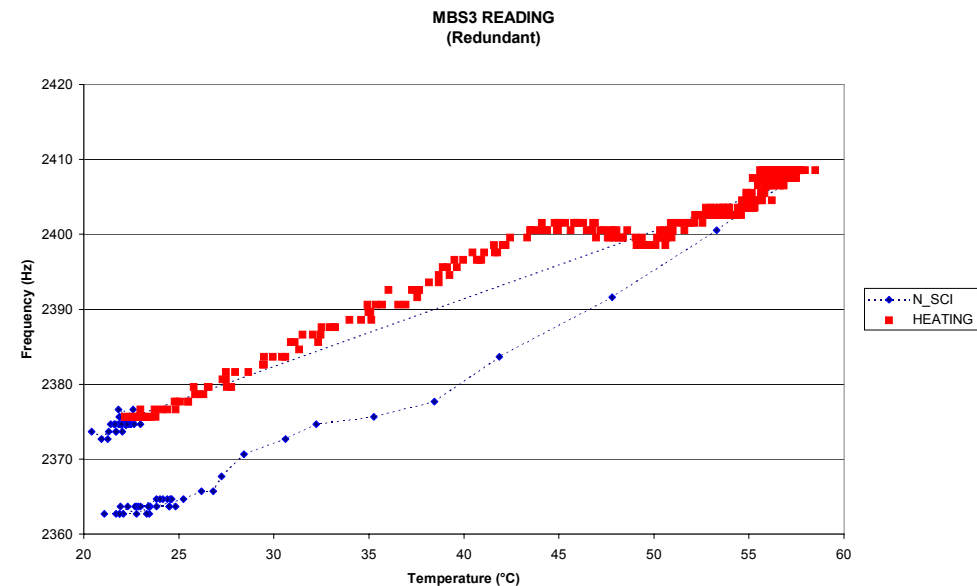
**Figure 51 MBS3 Frequency wrt Temperature**

- The MBS3 frequency (which points to the -Xu direction) is increased of about 1700Hz, from 2365Hz (data taken during the GIADA Commissioning, refer to Figure 52) to about 4085Hz @ 20°C.

- **The value of frequency for three of the MBS's (1, 3 & 5) is confirmed to be significantly higher than in the 1<sup>st</sup> Commissioning (April '04).** This seems due to MBS in-flight contamination due to out gassing of volatile material. **The reasons of this change must be investigated deeper, together with other experiments/payloads that have observed similar situation and may require MBS heating at the next GIADA-on opportunity.** From the operational point of view, each MBS works as expected and the frequency dependence vs. temperature is consistent with the 1<sup>st</sup> commissioning data.

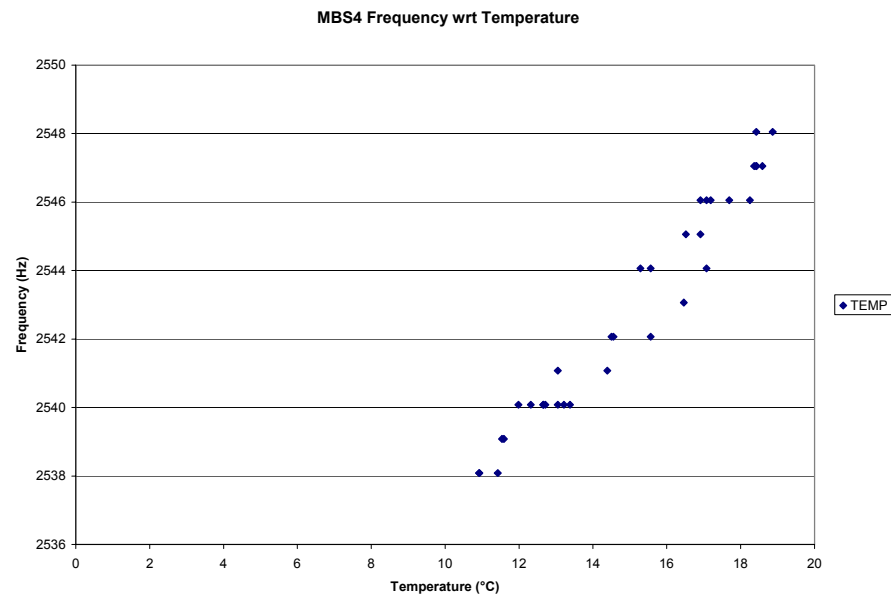
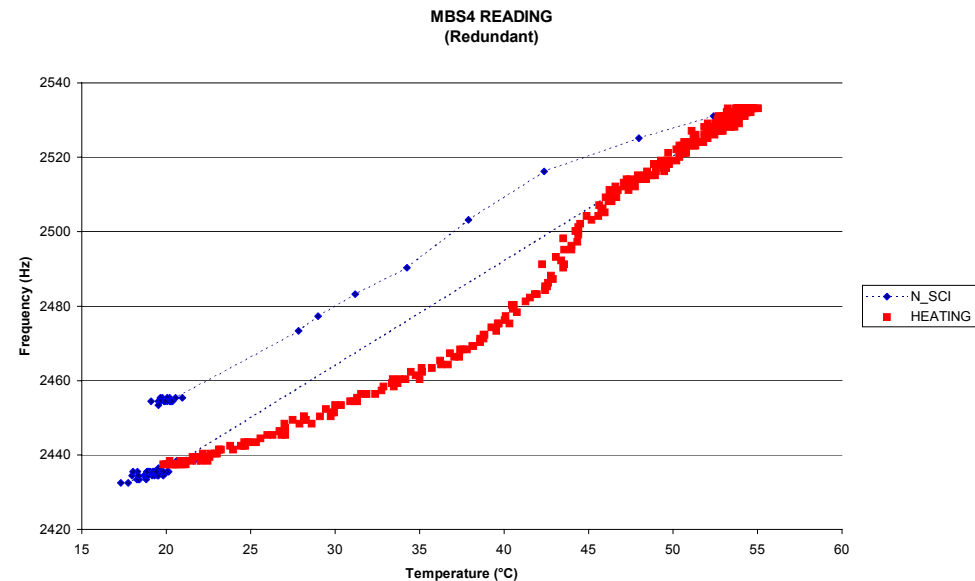
**Figure 53 MBS4 Frequency wrt Temperature**

- The MBS4 frequency (which points to the -Yu direction) is increased of about 100Hz, from 2548Hz (data taken during the GIADA Commissioning, refer to Figure 54) to about 2548Hz @ 19°C.

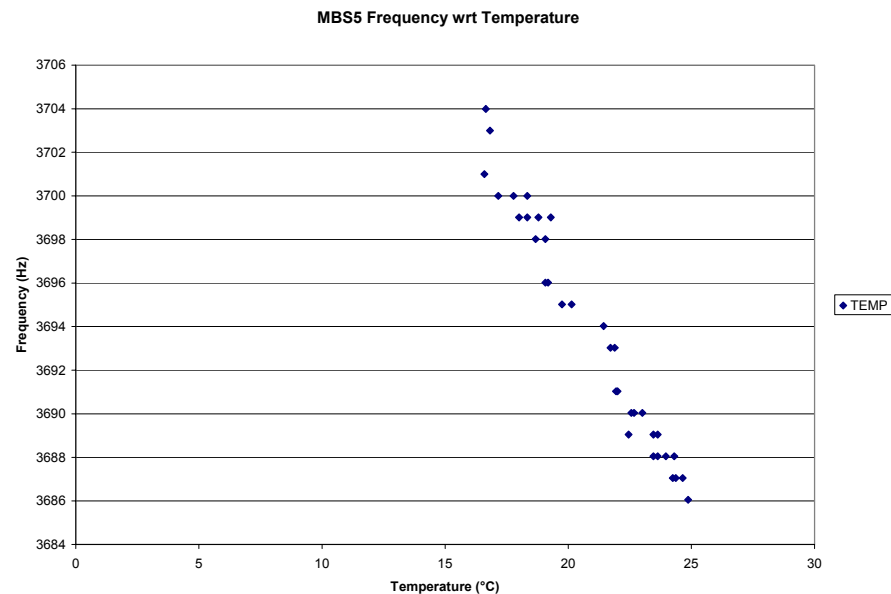
**Figure 55 MBS5 Frequency wrt Temperature**

- The MBS5 frequency (which points to the +Zu direction) is increased of about 1000Hz, from 2430Hz (data taken during the GIADA Commissioning, refer to Figure 56) to about 3686Hz @ 25°C.

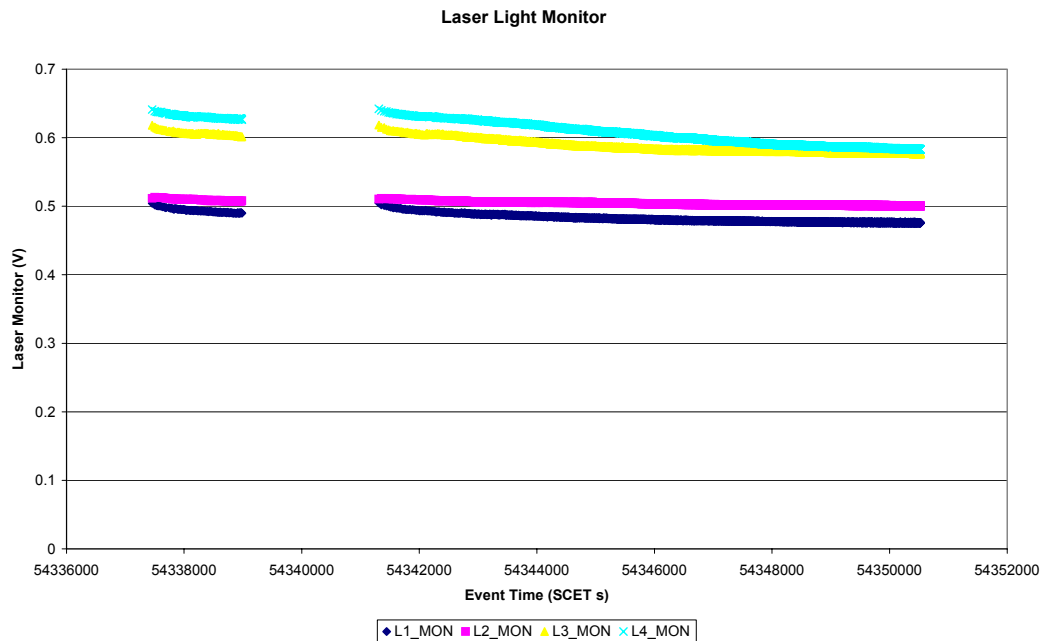
**Figure 57 Laser lights monitor (Normal science packet)**

- As expected, it is observed that the Laser light is decreasing when the temperature is increasing. No Dust Flux indication (i.e., greater than 0) is observed, but for one minute period after the sensor switch-on, performed by means of the internal relay, in which - as understood on ground - few IS ghost events can be observed (Dust Flux indication was one). After GIADA enters in Normal Mode and science TM is enabled, a flood of TM packets (from a range of 1 packet every 7.5 s, at the begin of test, to 1 packet every 1.3 s, at the end of the test) is received after the lasers are switched on. In this condition, several GDS 'ghost detections' on Left receiver are found (GDS production rate is detailed in Section 5.2.3.2) due to the level of the internal stray-light (background noise) in combination with electronic noise. Considering the SSMM down-link rate and this science data production rate, the SSMM file memory allocated for GIADA does not result saturated along all the test.
