Title: **GIADA FS MODEL REPORT OF IN-FLIGHT POINTING SCENARIO (23 & 30 SEPTEMBER '04)****GIADA FS MODEL**

This document reports the activities performed on GIADA experiment on the 23 and 30 September '04 (Pointing scenario).

This report is applicable to GIADA FS model on board the Rosetta S/C now flying @ about 74.2×10^6 km from the Earth (about 4 minutes of delay between the S/C and Earth in the radio link communication). The data have been retrieved from DDS by means of the PI Workstation located @ INAF - Osservatorio Astronomico di Capodimonte in Naples.

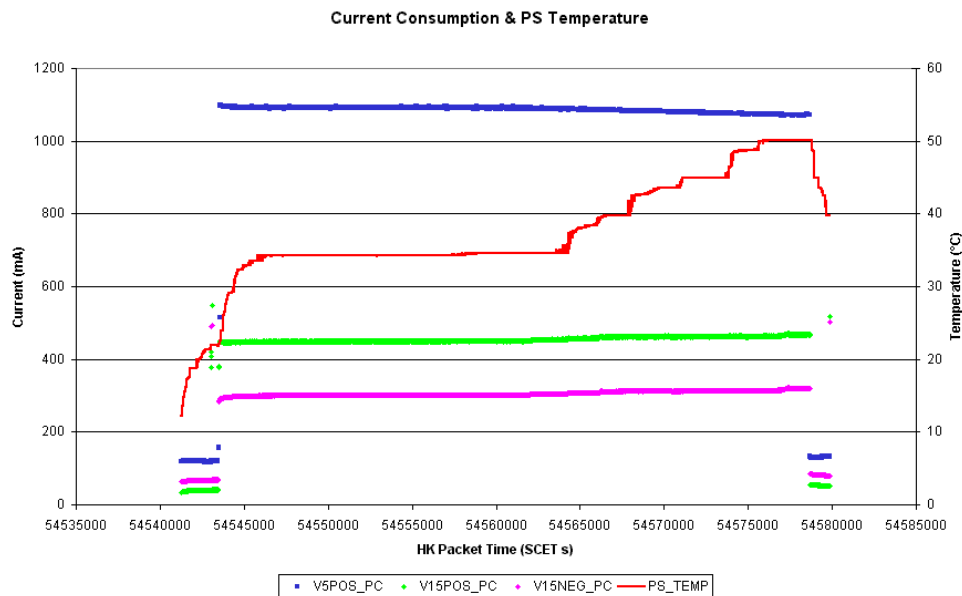
Figure 2 +5V and ± 15 V Currents and PS Temperature

The current consumptions and the Power Supply temperature (Figure 2) are in the expected ranges. The PS temperature increases while the sun orientation goes towards S/C Z axis and illuminates the GIADA instrument, but in any case is still below 50°C. The +5V current consumption measured in Normal mode decreases of about 20mA and the +15V and -15V currents increase of 20mA while the temperature of GIADA increases from 30 to 50 °C. The measured +5V, +15V and -15V currents are 1070mA, 469mA and 320mA, respectively.

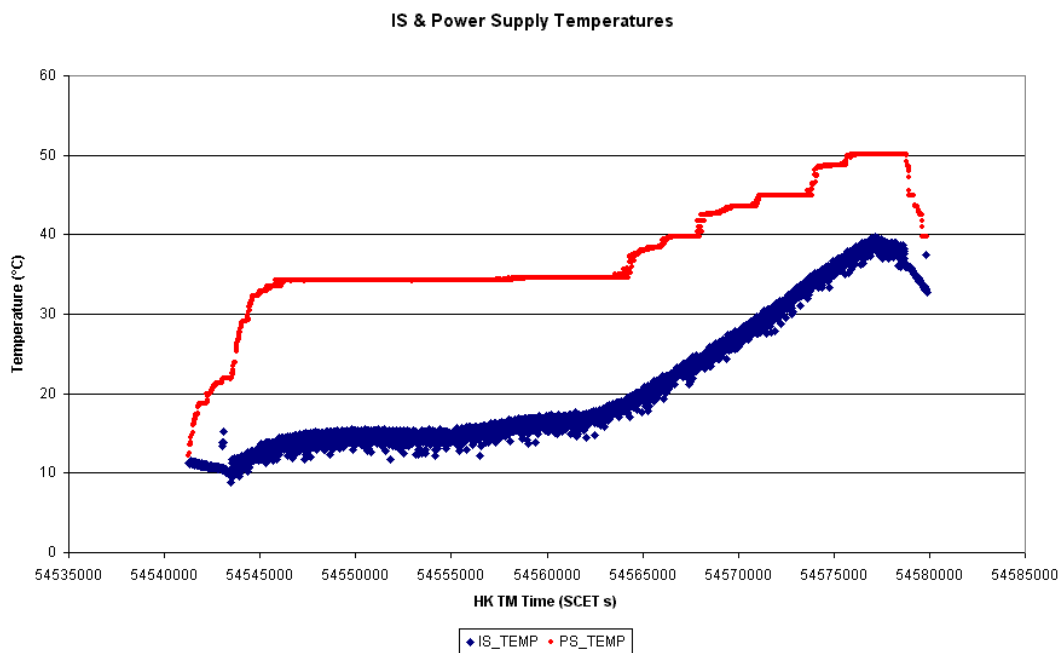
Figure 4 IS & PS Temperatures

In Figure 4, the Power Supply temperature increases from 10°C (@ power-on) up to 50°C, when GIADA is in Normal mode (in which the maximum power is drawn) and when the sun orientation is below 80 deg wrt. the S/C Z axis. The IS temperature increases from 10°C (cover is closed) to about 40°C when GIADA cover is open and the sun orientation is 45 deg wrt. the S/C Z axis. As already detected in the previous tests, when the lasers are switched on, the IS temperature becomes noisy (data are spread within 3°C) wrt. the case when GIADA is in safe mode.

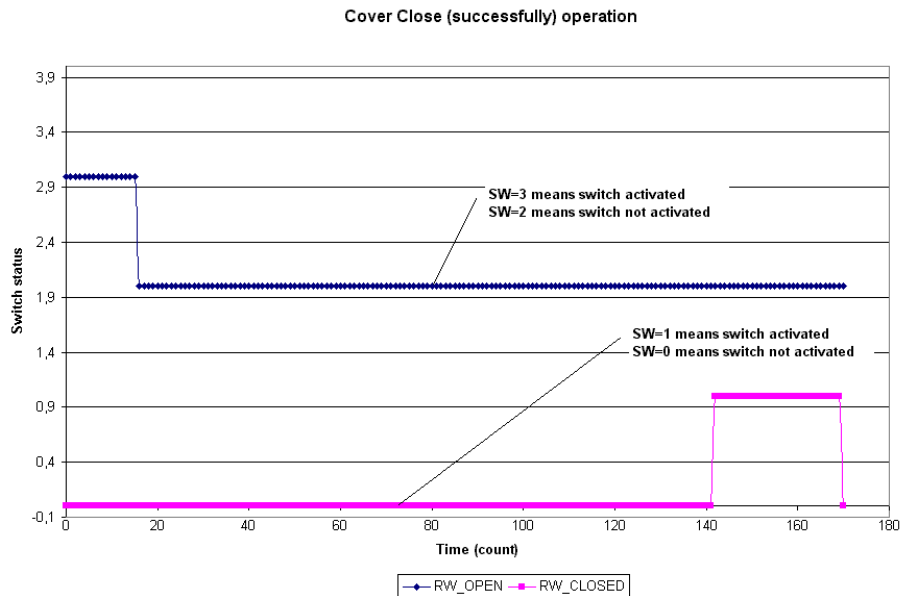
Figure 13 Reed switches Status during Cover Close operation

Before the GIADA power-off, the GIADA cover was automatically closed by a sequence of the proper TC (Close Cover). The cover was successfully closed by command @ SCET time of 54579168s, corresponding to 16:53:11 UTC time of the 23 Sept. 2004. Figure 13 reports the correct sequence of the two reed-switches. As expected:

- The reed switch that indicates the Cover-Open position (named RW_OPEN) is activated for a small number of steps (about 15 steps) and then remains not active for the remaining movement.
- The reed switch that indicates the Cover-Close position (named RW_CLOSE) is activated after 126 steps for 29 steps and finally reaches the not-activated status that means the cover is close to the closed position.

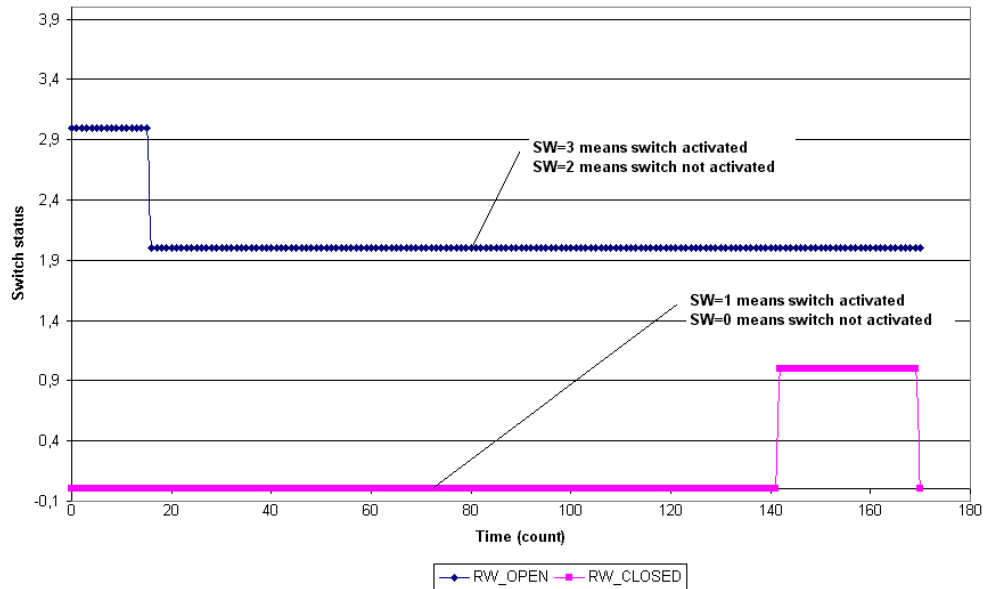
Figure 16 Reed switches Status during Cover Close SUCCESSFUL operation

In Figure 15, the two reed switches confirm that the cover was in open position (red coloured text) at the first power-off and then was successfully closed after the new power-off. These conditions are also confirmed by the Cover Report (refer to Figure 16) which was received @ 20:57:07 UTC Time of the 23 Sept. 2004.

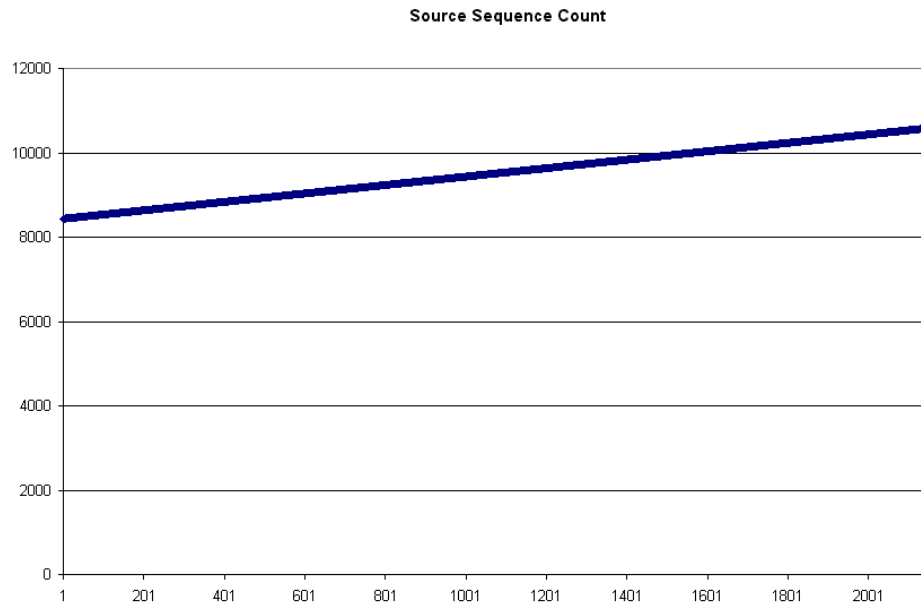
Figure 21 Science TM packet Source Sequence Count when the SSMM becomes not saturated

Many science TM packets were lost due to the **saturation of the SSMM memory allocated to GIADA (1 Mbytes)**. Figure 20 shows the Source Sequence Count of science TM packets when GIADA is in Normal mode and the science TM is enabled. The first 8437 science packets were completely lost. The flood of TM packets was observed after the lasers were switched on and until the sun illumination saturated the GDS receiver output (sun stray-light). In fact, due to the level of the internal stray-light (background noise) in combination with the electronic noise (as already seen in the previous Interference tests performed on 20-22 September), the GDS Left receiver provided several GDS ‘ghost detections’ (GDS production rate is discussed in Section 5.1.3.2). As the sunlight entered inside the GIADA aperture (sun angle < 70 deg), the GDS left and right receivers became saturated and no more GDS ghost events were produced. Consequently the SSMM started to empty by the downlink data rate and no more science packets were lost (Figure 21).

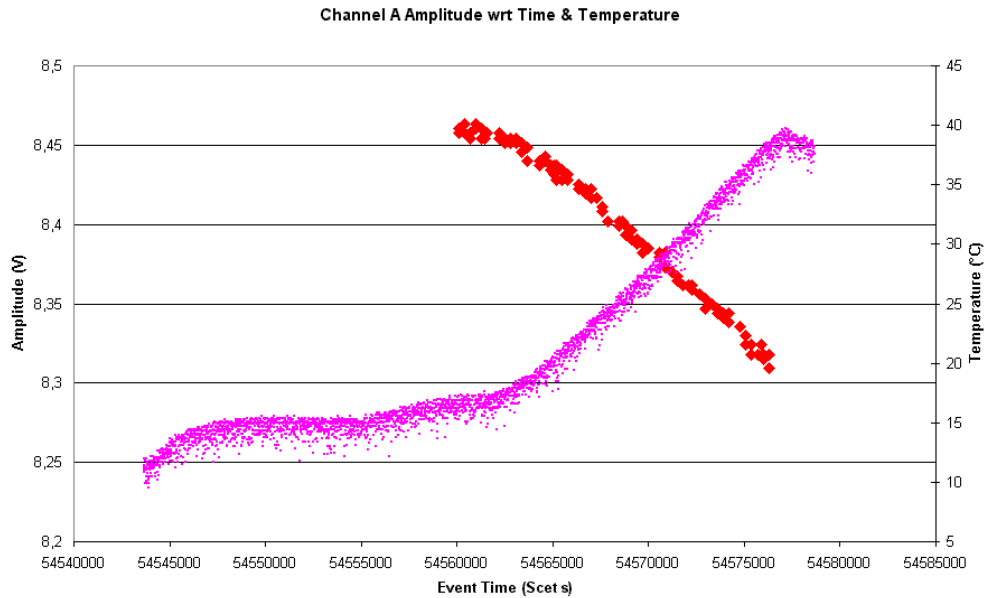
Figure 31 Channel A response wrt IS temperature

- Channel-A response is quite consistent (i.e. the same amplitude) along the test; the values result in the range 8.31 to 8.46V. The measured amplitudes depend on the temperature (Figure 31): variation is about 100mV in 30°C of temperature change.

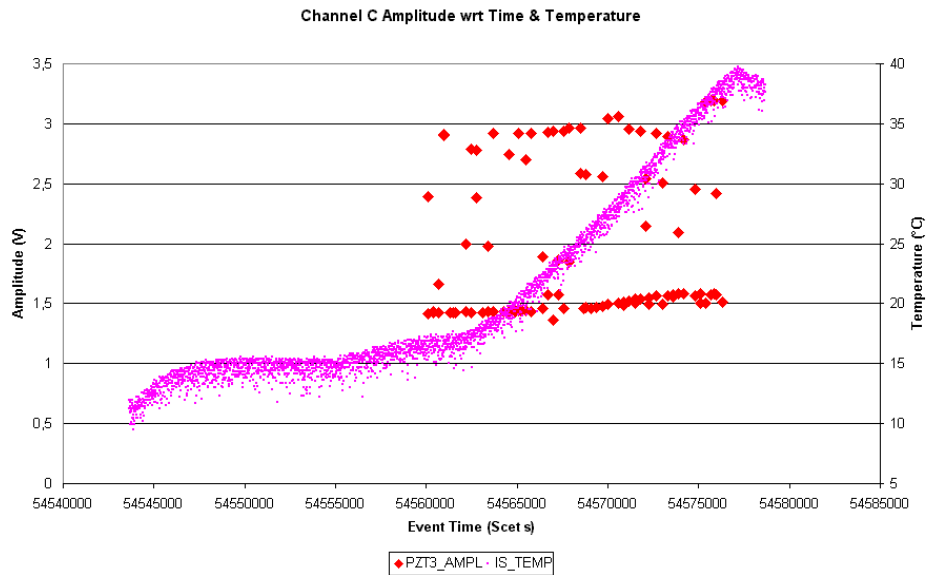
Figure 33 Channel C response wrt IS temperature

- Channel-C response is confirmed not stable along the different calibrations (refer to the voltage/delay time measurements of 2nd and 4th stimuli) and with respect to the temperature change (Figure 33). It is suggested to increase the channel C detection threshold (e.g. 100-150mV) and to compare the obtained results.

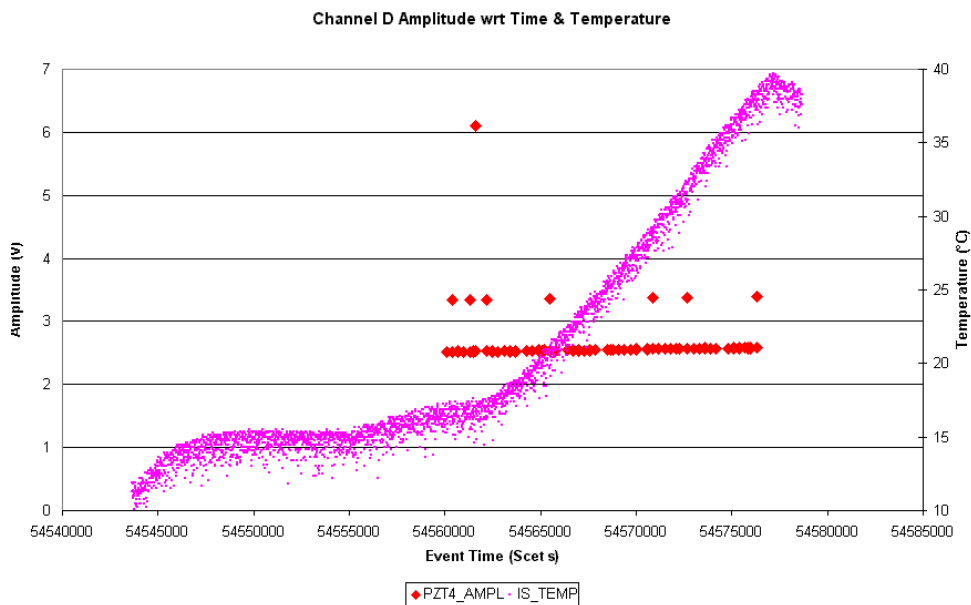
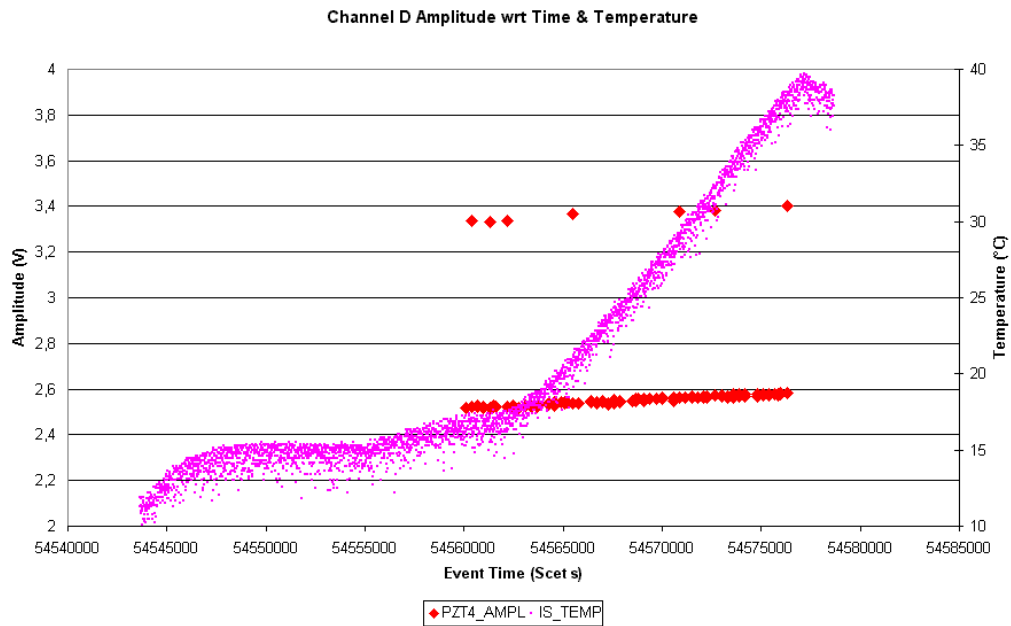
- Channel-D response results quite consistent (i.e. the same amplitude) along the test, except for eight calibrations in which the channel response was about 3.5V (1 calibration) and 1V (7 calibrations) more then the others. The measured amplitude seems slightly increasing with temperature change (variation is less then 60 mV within 30°C of temperature increase) (Figure 34 and Figure 35).

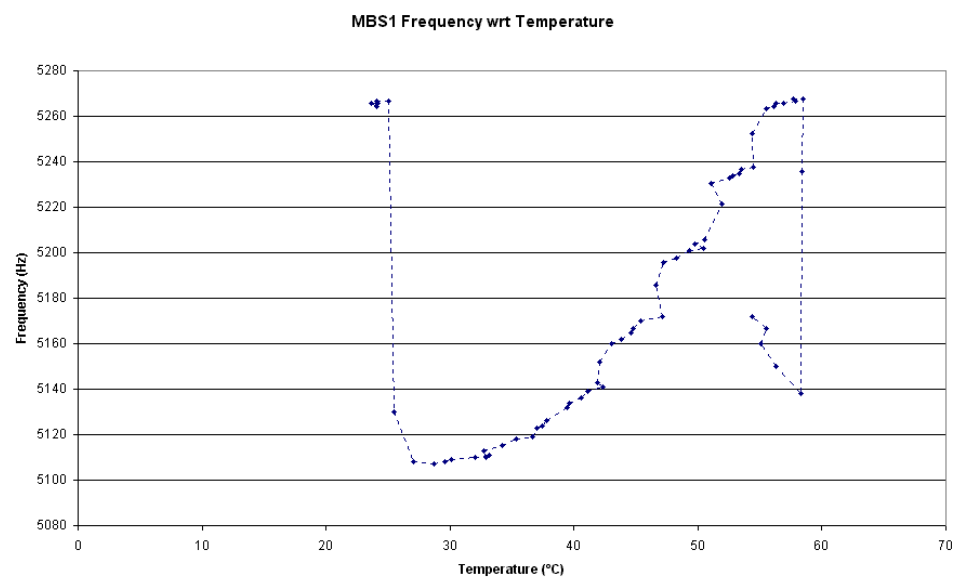
Figure 46 MBS1 Frequency wrt Temperature

- The MBS1 frequency (MBS1 points to the +Xu direction, as it is shown in Figure 6) is about doubled, from 2700 Hz (data taken during the GIADA 1st Commissioning) to about 5230Hz @ 24°C (Interference part 1B) and now to about 5265 Hz @ 24°C.

It is confirmed that some MBS in-flight contamination occurred due to out-gassing of volatile material. From the operational point of view, it is confirmed that all MBS work as expected and the frequency dependence vs. temperature (frequency shift due to temperature change) is consistent with the commissioning data. It is also requested an MBS heating to try to volatise the contamination material at the next GIADA-on opportunity.

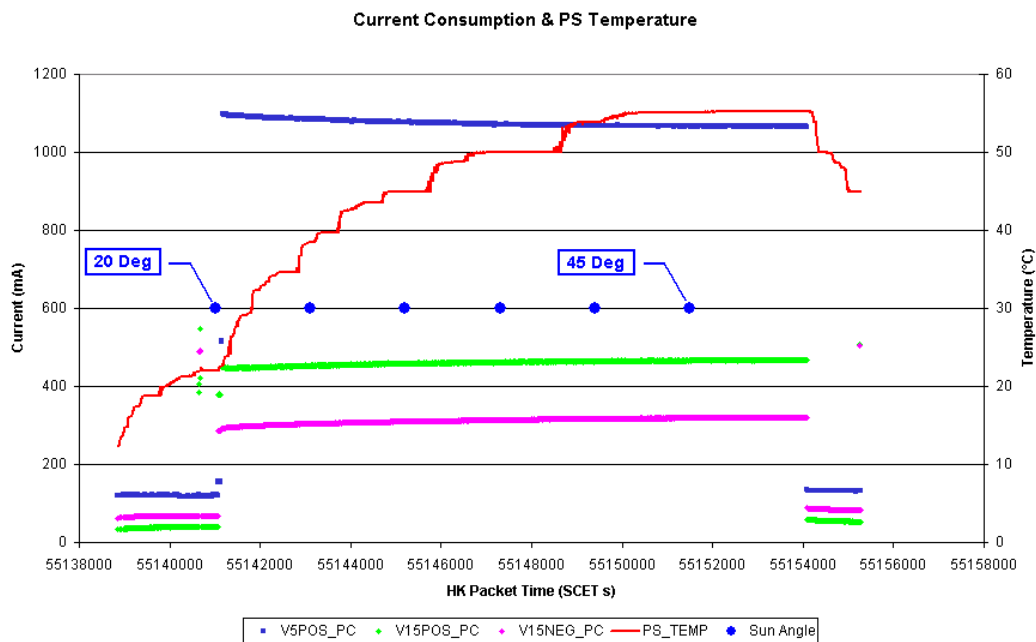
Figure 60 +5V and ± 15 V Currents and PS Temperature

The current consumption and the Power Supply temperatures (Figure 60) are both in the expected range. The PS temperature increases from 12°C to 55°C, as expected, after the cover was open, due to the thermal stabilization from the power-on to Normal mode (power consumption from minimum to maximum), due to the sun orientation (when cover is open, the sun moves from 20 to 45 deg inside the GIADA aperture) and due to the radiative coupling with the deep sky. It becomes constant after thermal stabilization and seems not strongly dependent on the sun orientation.

The +5V current consumption measured in Normal mode decreases of about 30mA and the +15V and -15V currents increase of 20-25mA while the temperature of GIADA increases from 20 to 55 °C.

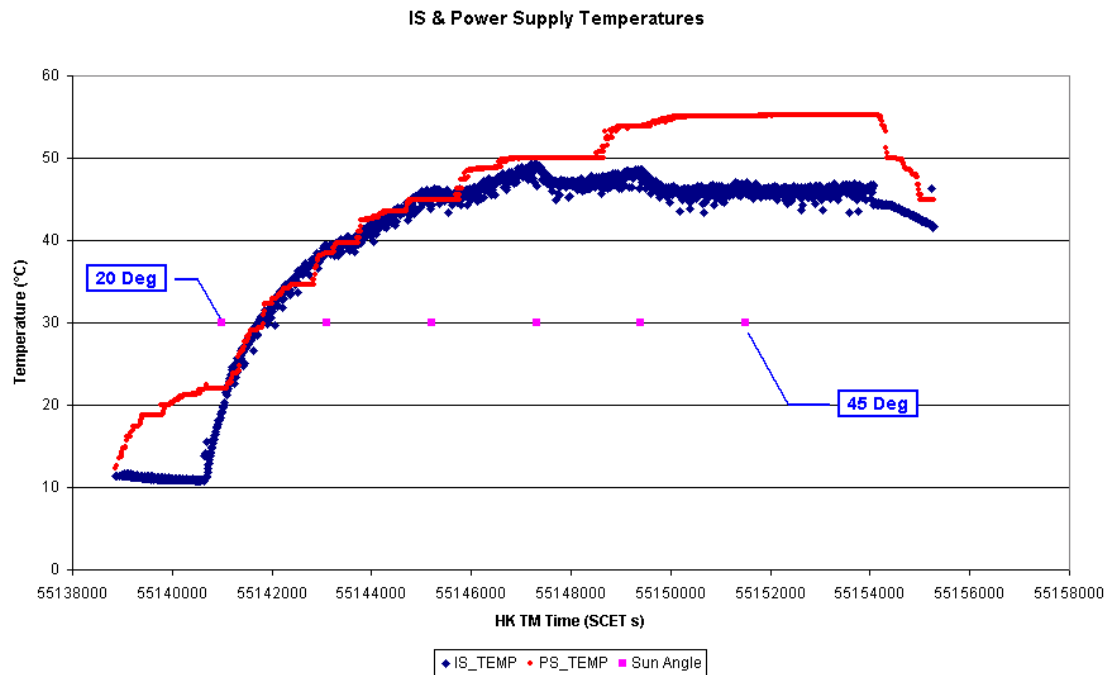
Figure 62 IS & PS Temperatures & Sun illumination angle

In Figure 62, the Power Supply temperature increases from 10°C (@ power-on) up to 55°C when GIADA was in Normal mode (in which the maximum power is drawn) and when the sun orientation was 45 deg with respect to the S/C Z axis. The IS temperature increases from 10°C (cover is closed) to about 50°C after GIADA cover is open and the sun orientation has reached 45 deg wrt. the S/C Z axis. In this state, the IS temperature seems reaching the thermal equilibrium. As already detected in the previous tests, when the lasers are switched on, the IS temperature becomes noisy (data are spread within 3°C) wrt. the case when GIADA is in safe mode.

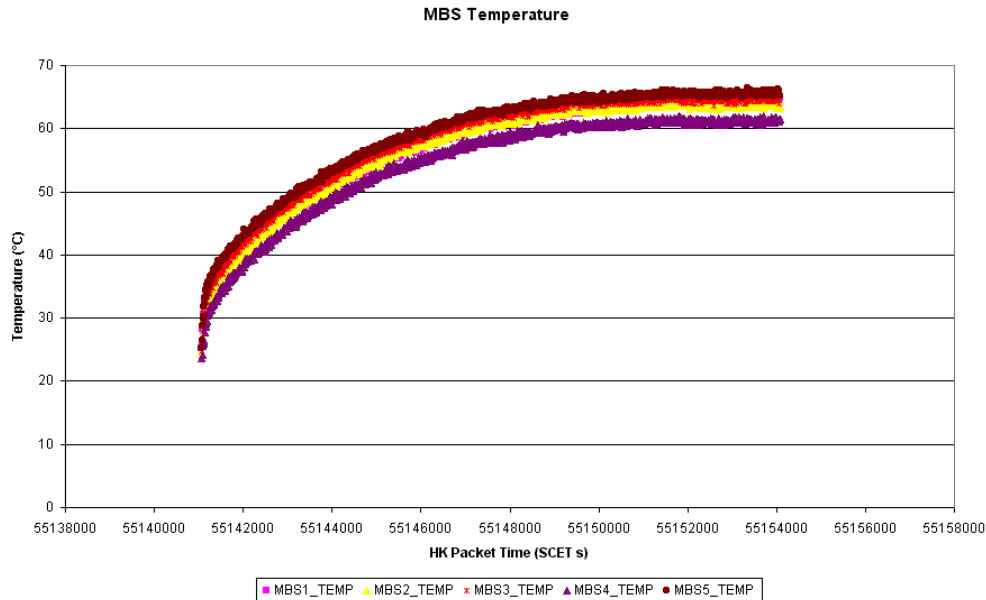
Figure 65 MBS Temperature

The five MBS, after switch-on, show a temperature between 23÷25°C (Figure 65). Then the temperatures increase due to the internal dissipation, the radiative link with the deep sky and the sun illumination angle. It reaches the thermal equilibrium at the temperature of 65°C (sun light @ 45 deg wrt. the S/C Z axis).

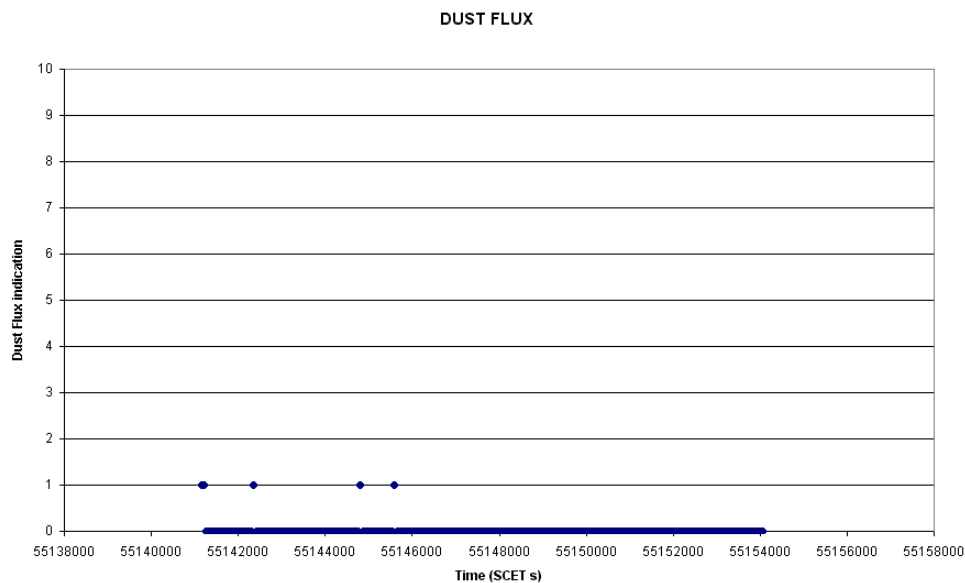
Figure 66 Dust-Flux Monitor (valid only when the IS sub-system is ON)

The Dust Flux indication is observed greater than 0 (Figure 66) four times: the first after 1 minute the sensor switch-on (in which - as understood on ground - few IS ghost events can be observed) and the other 3 are sporadic during the test. The reason is that channels A and C have detected few ‘Ghost events’.

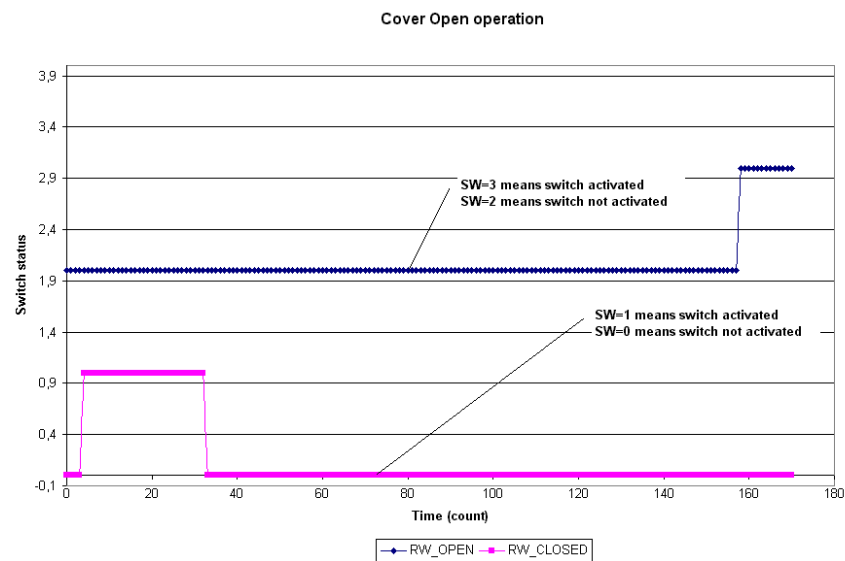
Figure 69 Reed switches Status during the Cover Open operation

After the cover open operation, the cover resulted completely open, as shown Figure 69, in which the status of the two reed-switches is reported. The figure is extracted from the cover report, which is received on-ground at the completion of the operation (@SCET time 55140684s, corresponding to about 04:51:39 UTC of 30 Sept. 2004). The behaviour is correct.

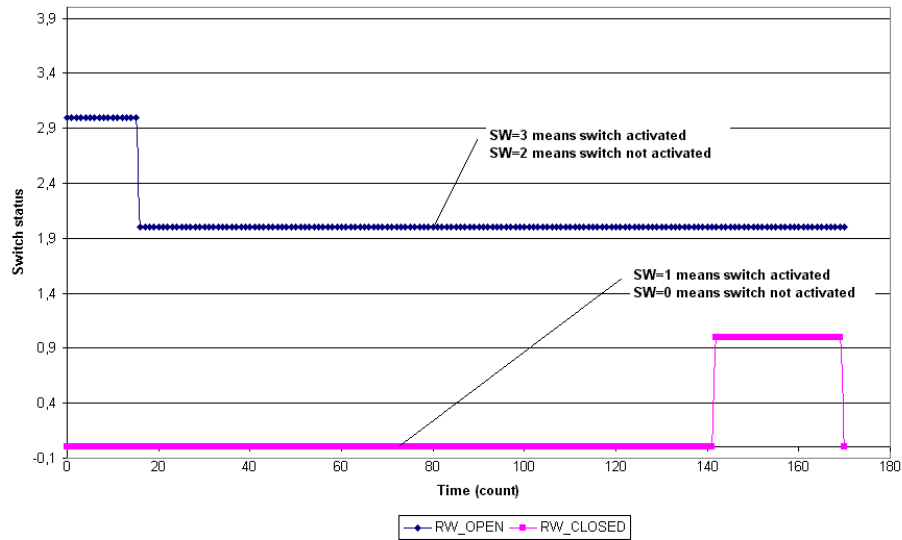
Figure 70 Reed switches Status during Cover Close operation

Before the GIADA power-off, the GIADA cover was automatically closed by means of the Power-off OBCP procedure (as already stated, the FCP was modified to avoid the cover close command before to enter in the Power-Off OBCP procedure). The cover was successfully closed as shown in the cover report received at the completion of the operation (@ SCET time of 55155240s, corresponding to 08:54:15 UTC of 30 Sept. 2004). Figure 70 reports the correct sequence of the two reed-switches.

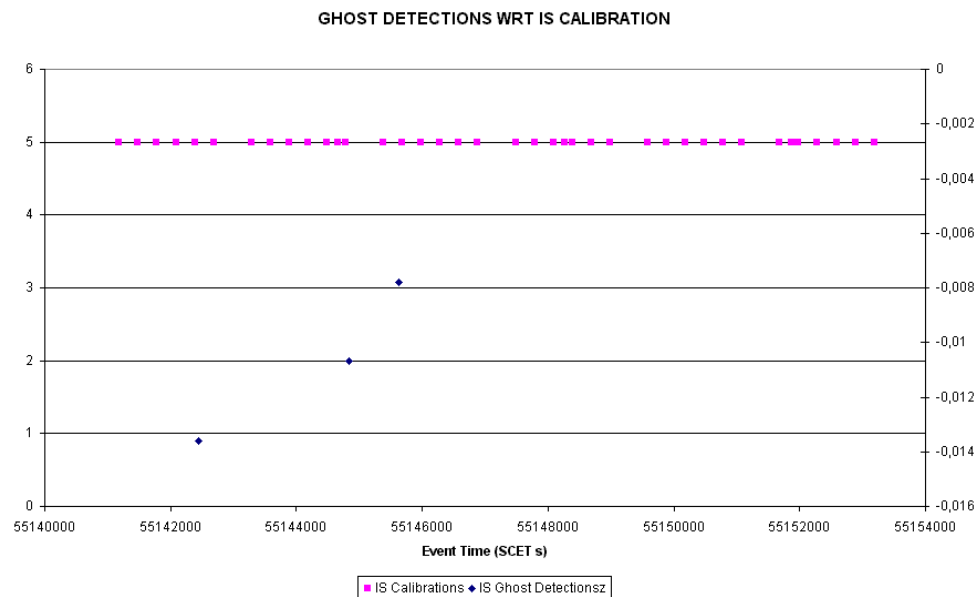
Figure 74 IS Ghost detections wrt IS Calibration

After entering in Normal mode, the IS calibration run until the end of the test every 6 minutes. Only few IS science ‘Ghost’ detections were received: 1 on Channel A and 2 on Channel C (Figure 74).

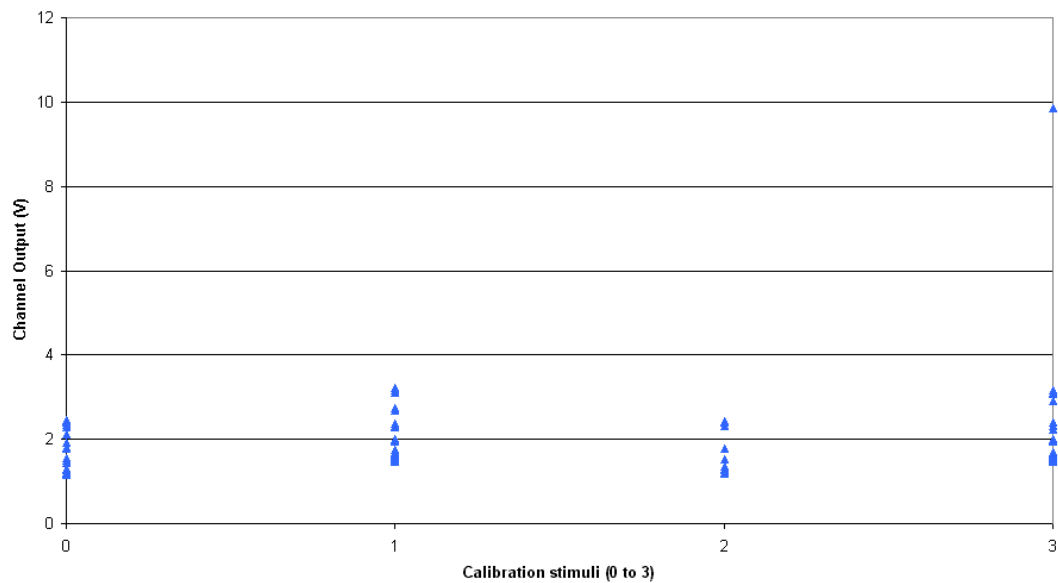
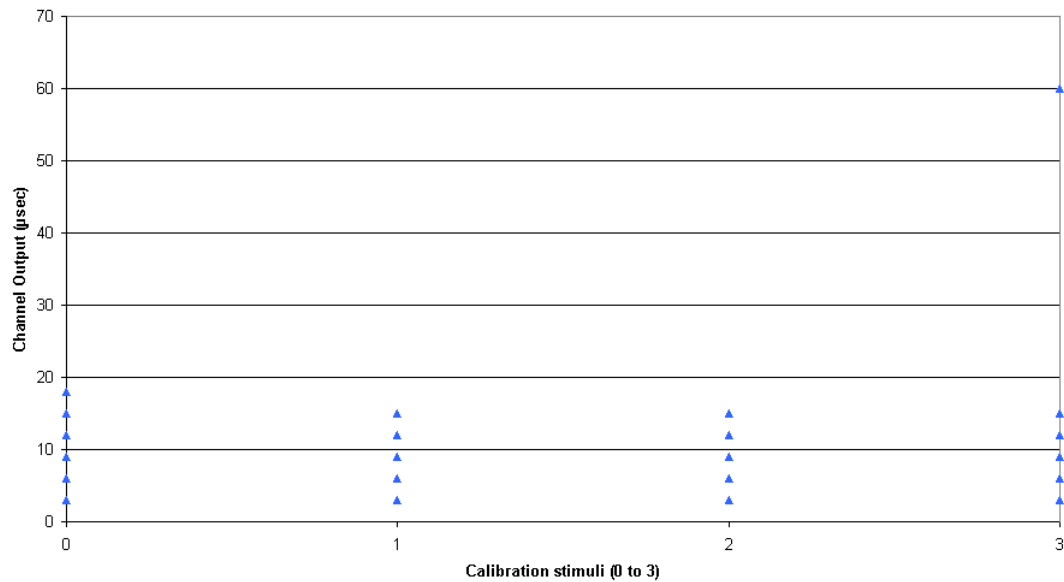
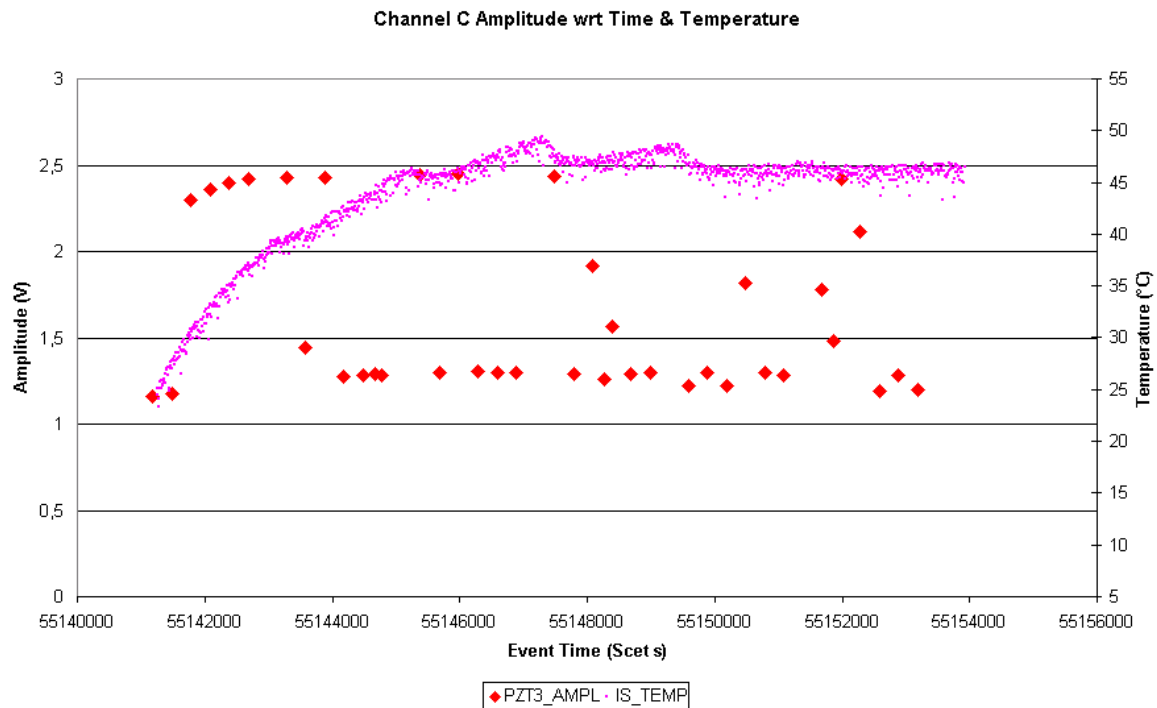
- Channel-C response is confirmed not stable along the test (refer to the voltage/delay time measurements of 2nd and 4th stimuli) and wrt. the temperature change (Figure 85 and Figure 86). The same behaviour is observed for the delay time, for which the variations are within 20-60 μsec . It is suggested to increase channel C detection threshold to 100-150mV for the next in-flight tests and compare the obtained results.

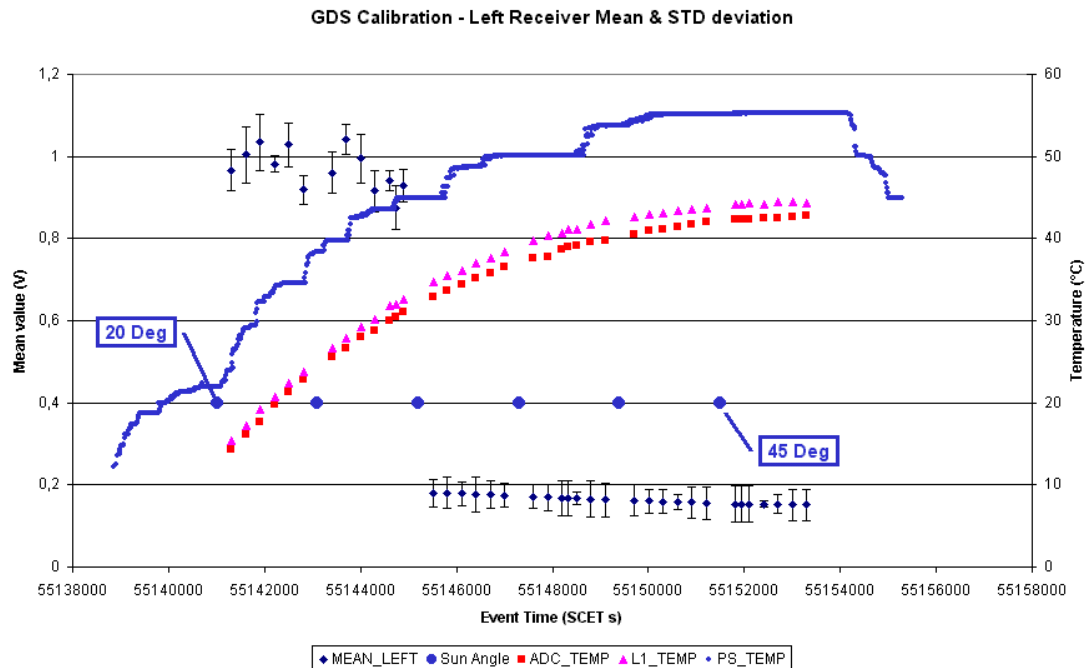
Figure 90 GDS Left Receiver Calibration (mean value and STD deviation)

The mean and standard deviations of the Left receiver calibrations (Figure 90) are quite similar to those obtained in the first part of the Pointing scenario: at the beginning the channel is not saturated (and thus due to internal stray-light it produces ‘Ghost events’); after the sun angle reaches 30 deg the Left receiver output becomes saturated until the end of the test. In particular three phases can be distinguished:

- From the beginning of the test until the sun angle has reached about 30 deg from S/C Z axis (Figure 6), the mean value is almost constant about 1V (it is of the same order of the new detection threshold). The standard deviation is below 70 mV.
- When the sun angle reaches about 30 deg, the mean value decreases from 1V to 0.18V and the GDS receiver becomes saturated. The standard deviation is below 30 mV.
- After this time until the end of the test (the sun light has reached 45 deg), the mean value slowly decreases from 0.18V to 0.15V, probably due to the increase of the internal temperatures. The GDS Right receiver is saturated. The standard deviation is below 70 mV.

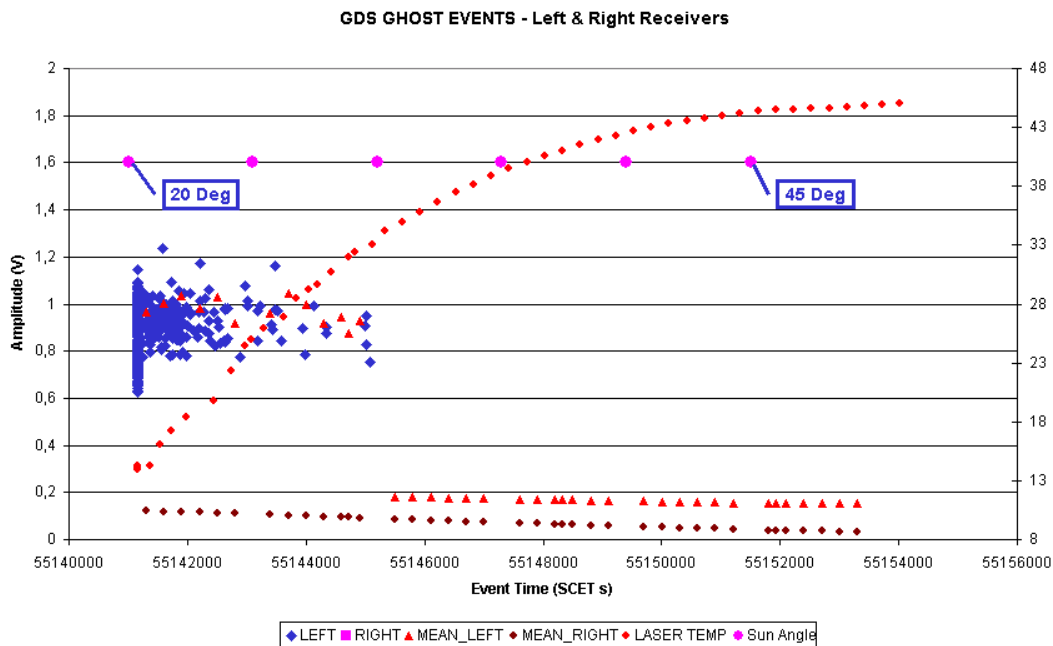
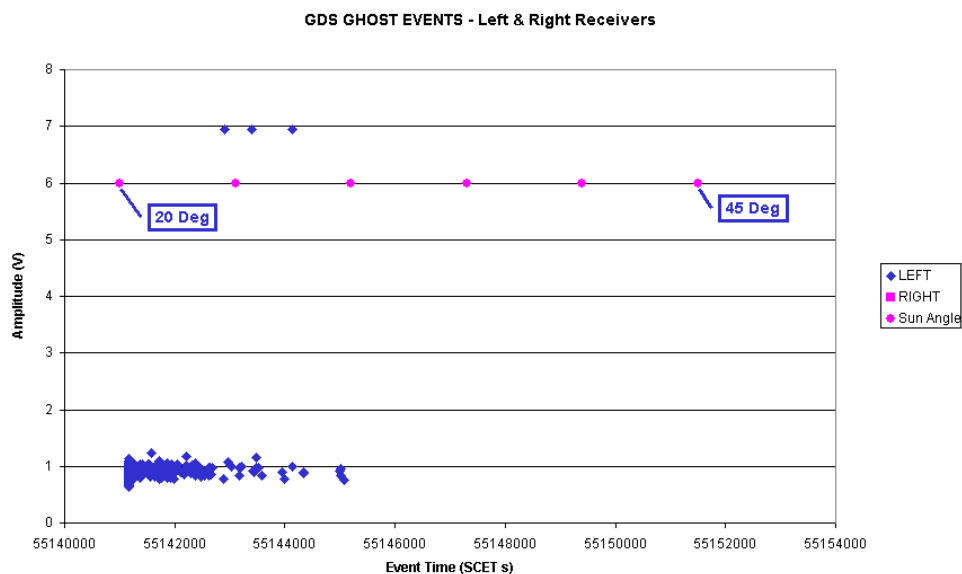
Figure 94 show the amplitude of the scattered light of the Left and Right Receiver ‘Ghost detections’, while Figure 93 reports ‘Ghost detections’ wrt. the Laser temperature and the calibrations. As expected, the ‘Ghost detections’ happened only when the receivers were not saturated.

As we can see there were no ‘Ghost detections’ on Right receiver, because it resulted saturated from the beginning until the end of the test.

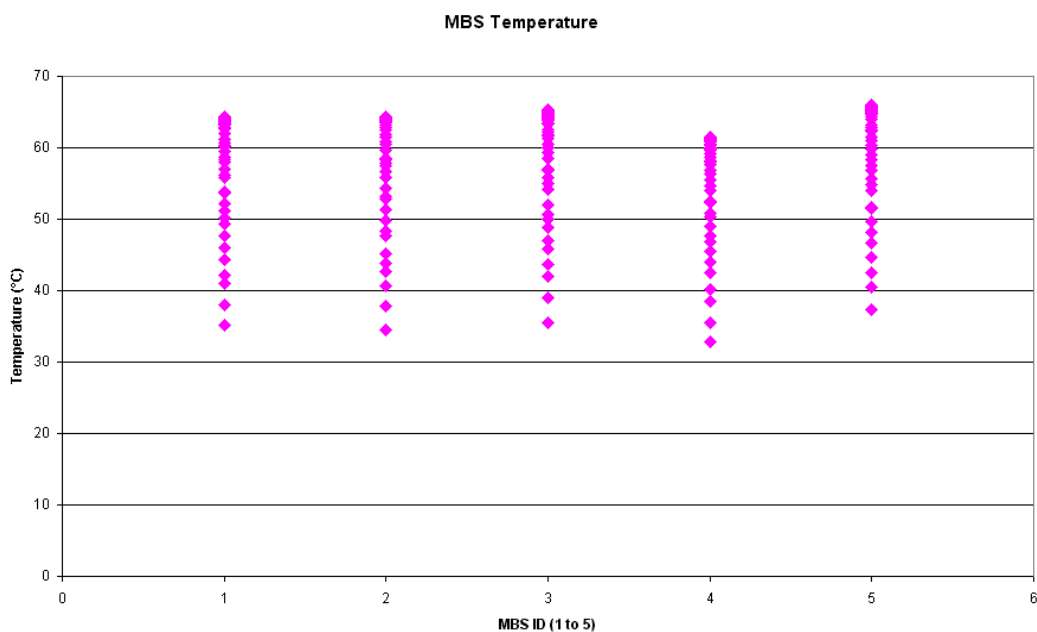
Figure 98 MBS Temperature

The MBS frequency for three of the MBS (1, 3 & 5) is confirmed to be significantly higher then in the 1st Commissioning. However, no significant deviations was observed wrt. to Pointing - I part (23 Sept. 2004), even if the MBS were heated up to 65°C due to the sun illumination.

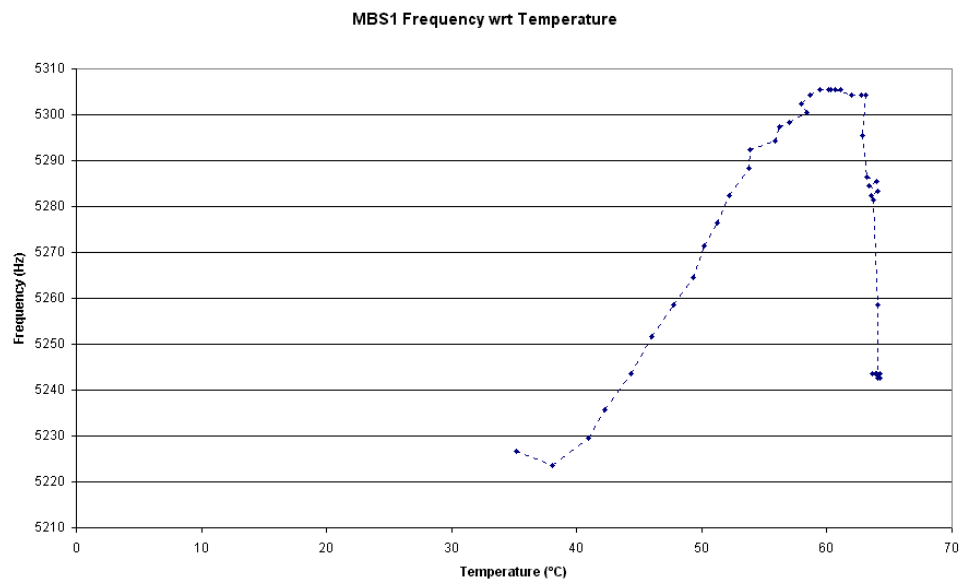
Figure 99 MBS1 Frequency wrt Temperature

It is confirmed that this seems possible because of MBS in-flight contamination due to out-gassing of volatile material. From the operational point of view, all MBS's work as expected and the frequency dependence vs. temperature (frequency shift due to temperature change) is consistent with the commissioning data.

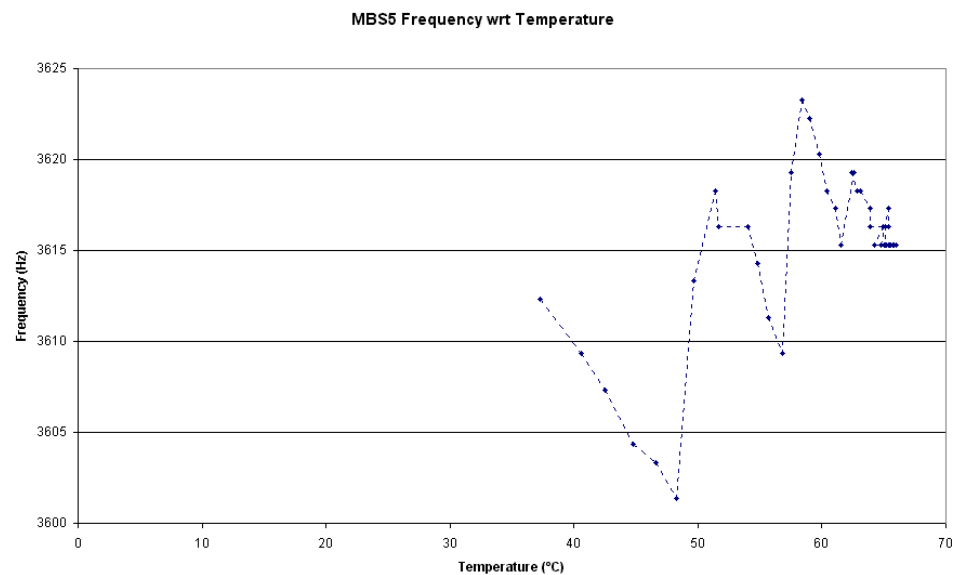
Figure 107 MBS5 Frequency wrt Temperature

- The MBS5 frequency (MBS5 points to the +Zu direction) is increased of about 1000Hz, from 2430Hz (1st Commissioning) to about 2687Hz @ 24.5°C (Interference part 1B), to about 3684 Hz @ 26.5°C (Pointing 1st part - Section 5.1.3.3) and now to about 3612 Hz @ 37°C.
