R O S E T T A
FLIGHT REPORTS
of RPC-MAG

RO-IGEP-TR-0015

Anomaly Report & Analysis

MAG-OB Failure in June 2005

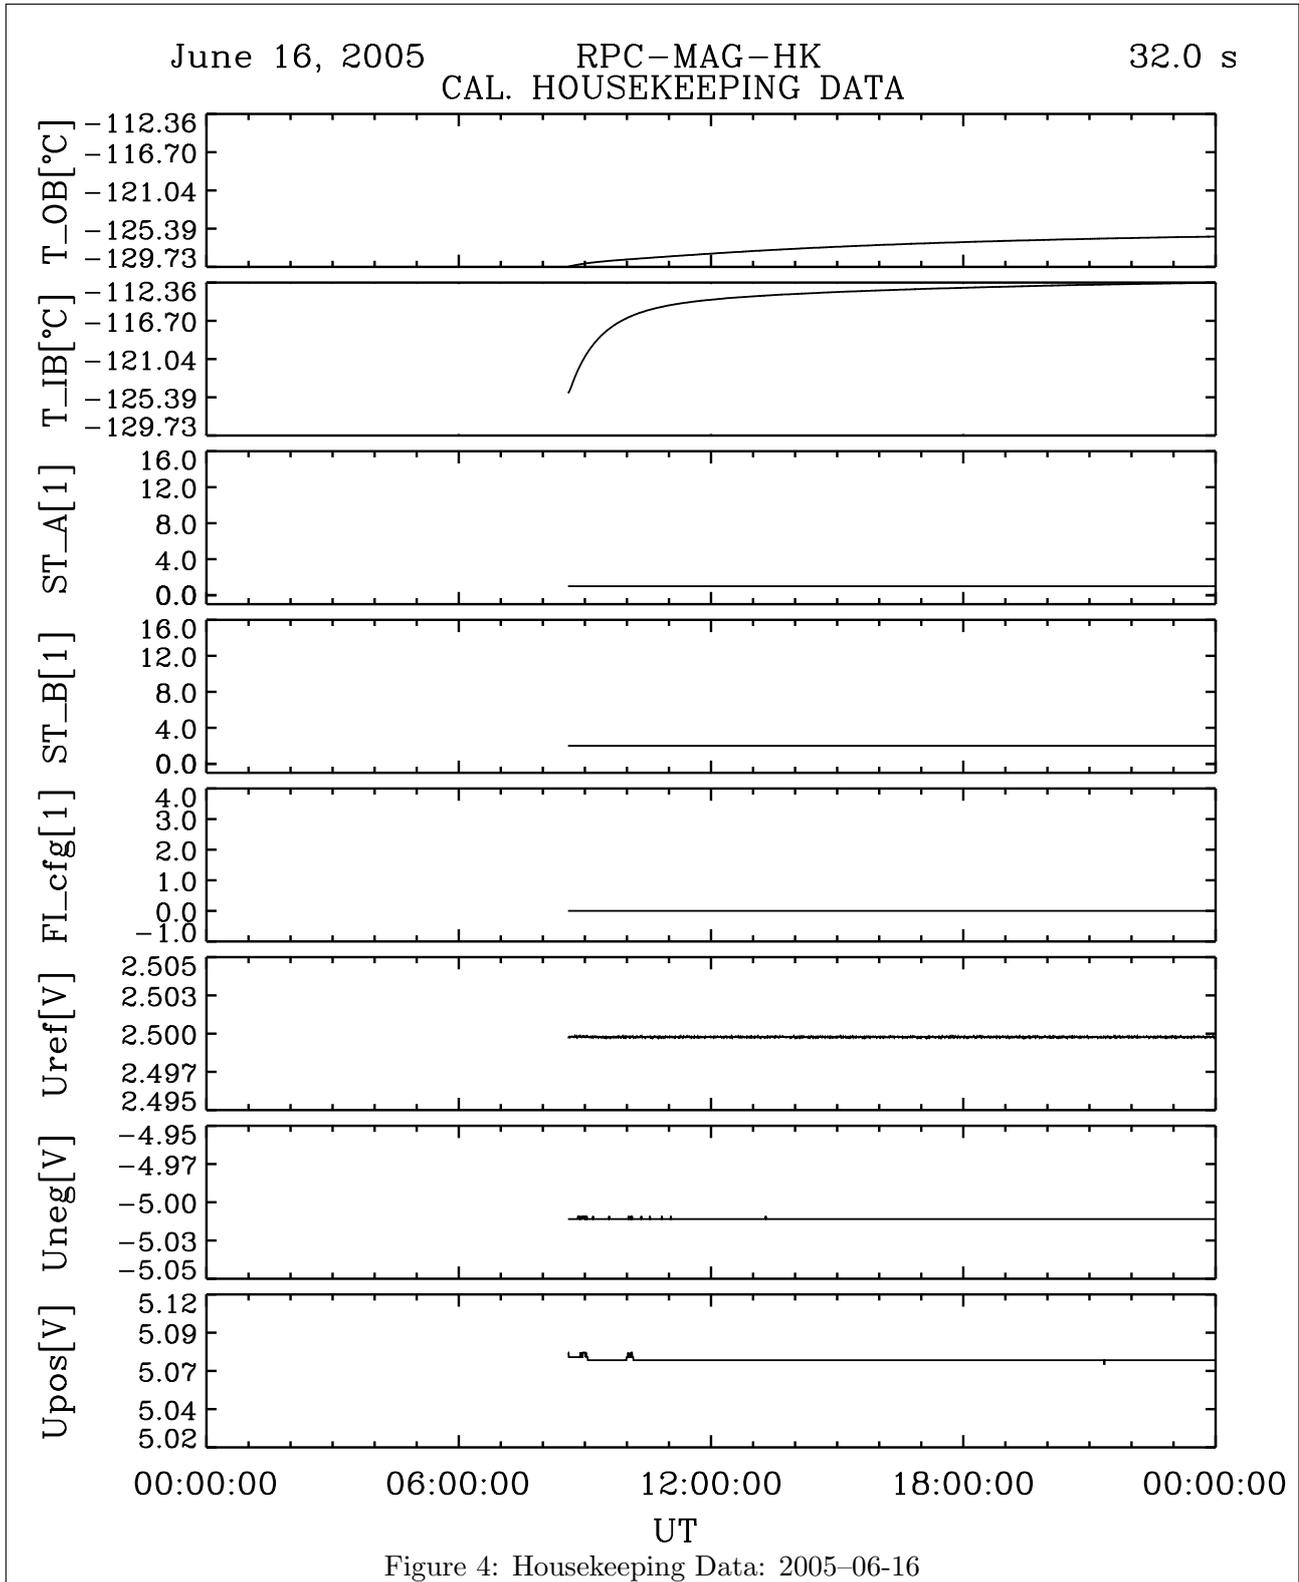
Figure 3: RPCMAG: Magnetic field measured with the OB Sensor

On the first view everything looked nominal. According to our HK data all necessary voltages had the right values (refer to the plots in Appendix B) and the RPC-MAG IB sensor transmitted reasonable data in the usual manner (refer to Figure 2). The OB sensor, however, sent a faulty signal (refer to Figure 3):

The increased noise level of the IB sensor is caused by the variations of the OB-Y sensor with an amplitude of some thousand Nanotesla. Both sensors are only 15 cm apart. Therefore, the huge OB-Y variations have a magnetic influence to the IB sensor in the order of some Nanotesla.

The failure source can not be located definitely, but with the utmost probability, a catenation of unfortunate circumstances lead through a faulty oscillation of the resonant circuit in the sensor excitation drive. This is an absolutely uncritical error which can be corrected by a repeated Power off/on cycle.

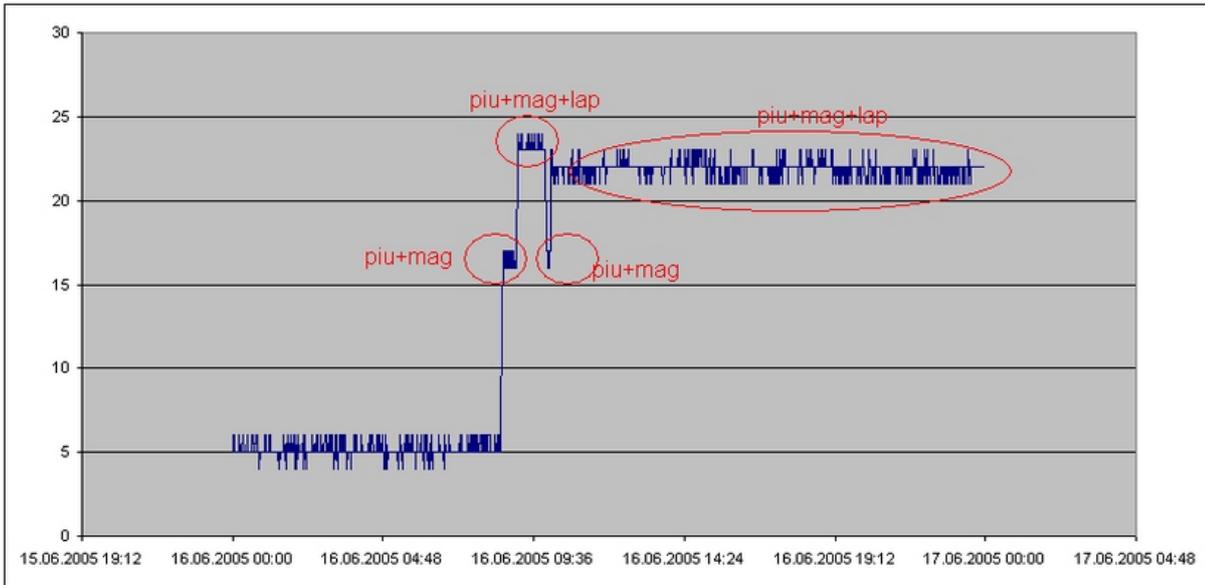
Figure 14: RPC: Total Current (in relative units): 2005-06-16

The observed failure never happened during s/c ground tests or in flight (until now) with the original s/c power units. Maybe the instrument was switched on in an inconvenient moment, when there were spikes on the main power lines or the s/c power consumption was to high for a very short time. Therefore, we had a look to the total drawn current by RPC (refer to Appendix D). These figures, however, do not show any abnormal behavior. But the time resolution (1 Minute) and also the current resolution is not high enough to reveal transient start-up events.
