SPIRE Instrument - Beam dividers - PFM

End Item Data Package (EIDP)
SPIRE Instrument - Beam dividers - PFM

SPIRE Ref.: SPIRE-UCF-
Cardiff Ref.: HSO-CDF-EIDP-060 Issue 1.0
11 August 2004

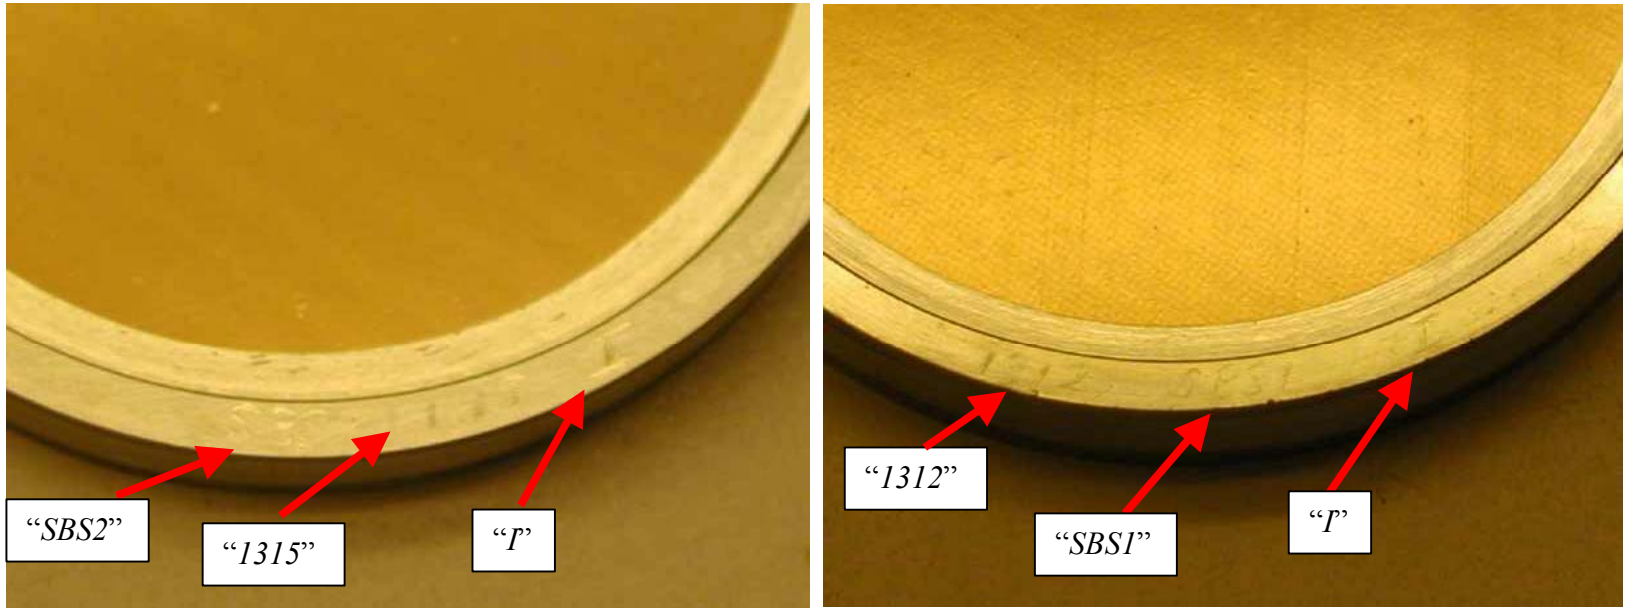
Figure 1 Identifying marks on beam divider rings (found on "I" side only). The inductive grid side is shown above, indicated by an "*I*" mark.

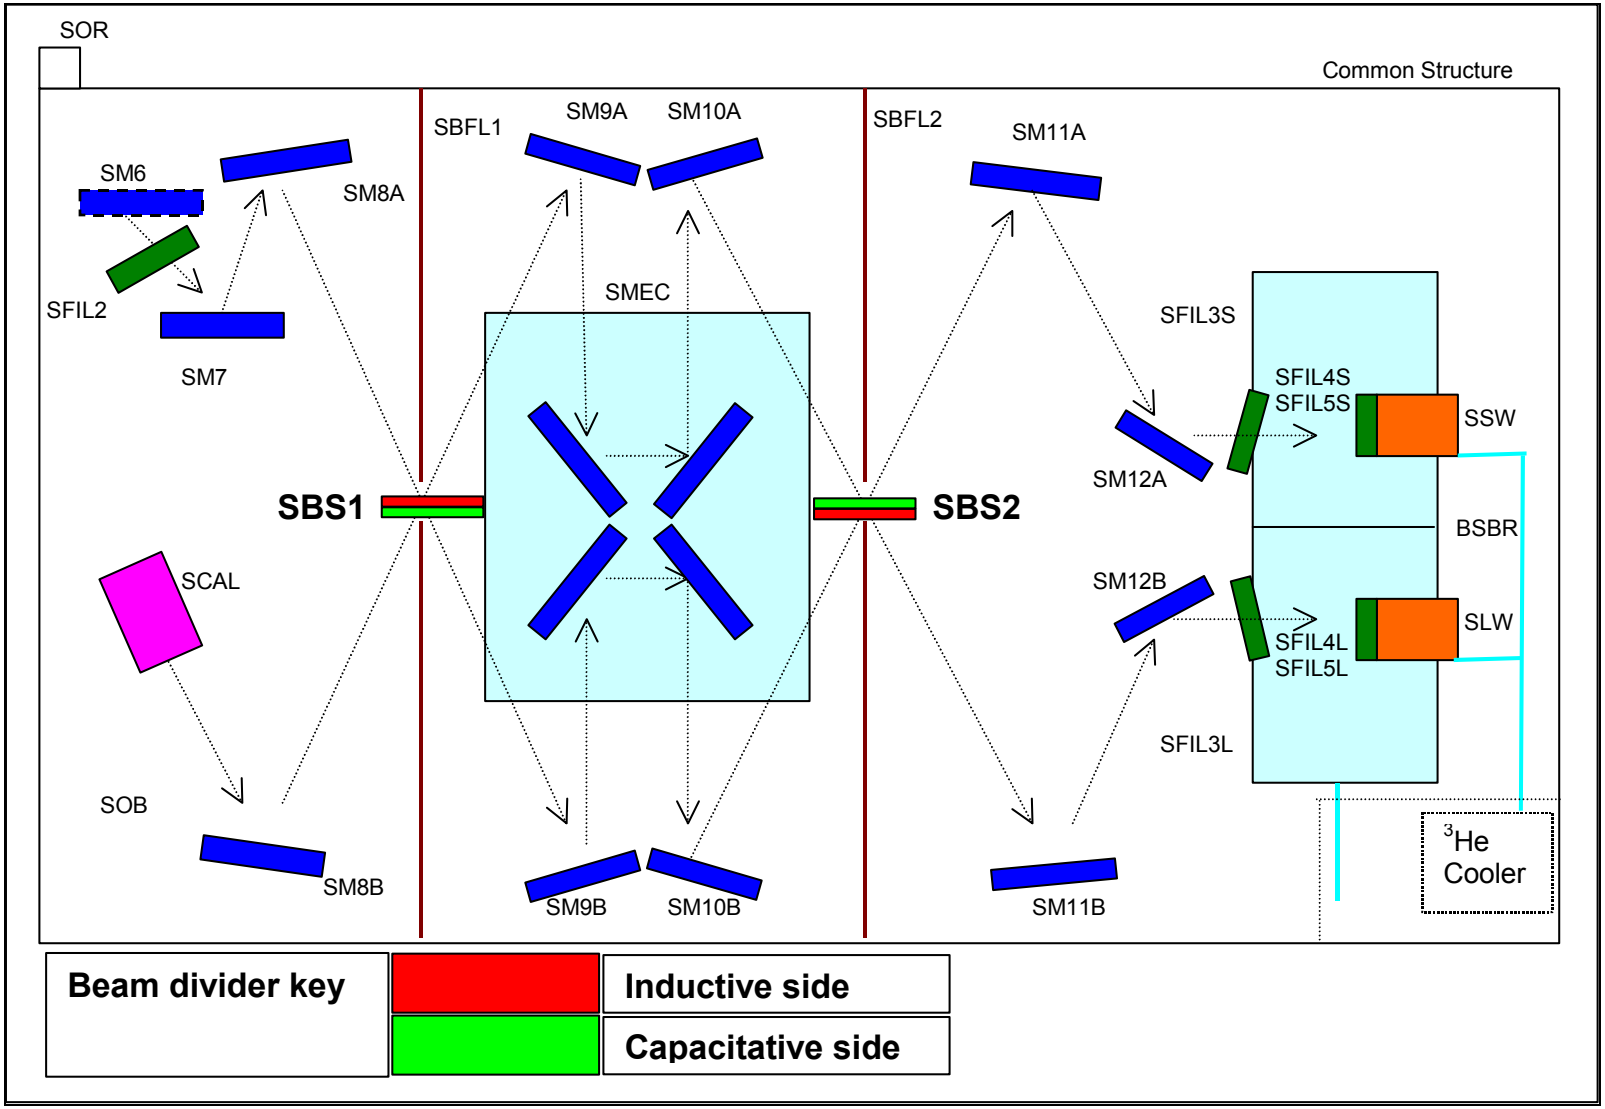
Figure 2 Beam divider mounting guide. These components MUST be mounted with the inductive and capacitative grids in opposition, as indicated.

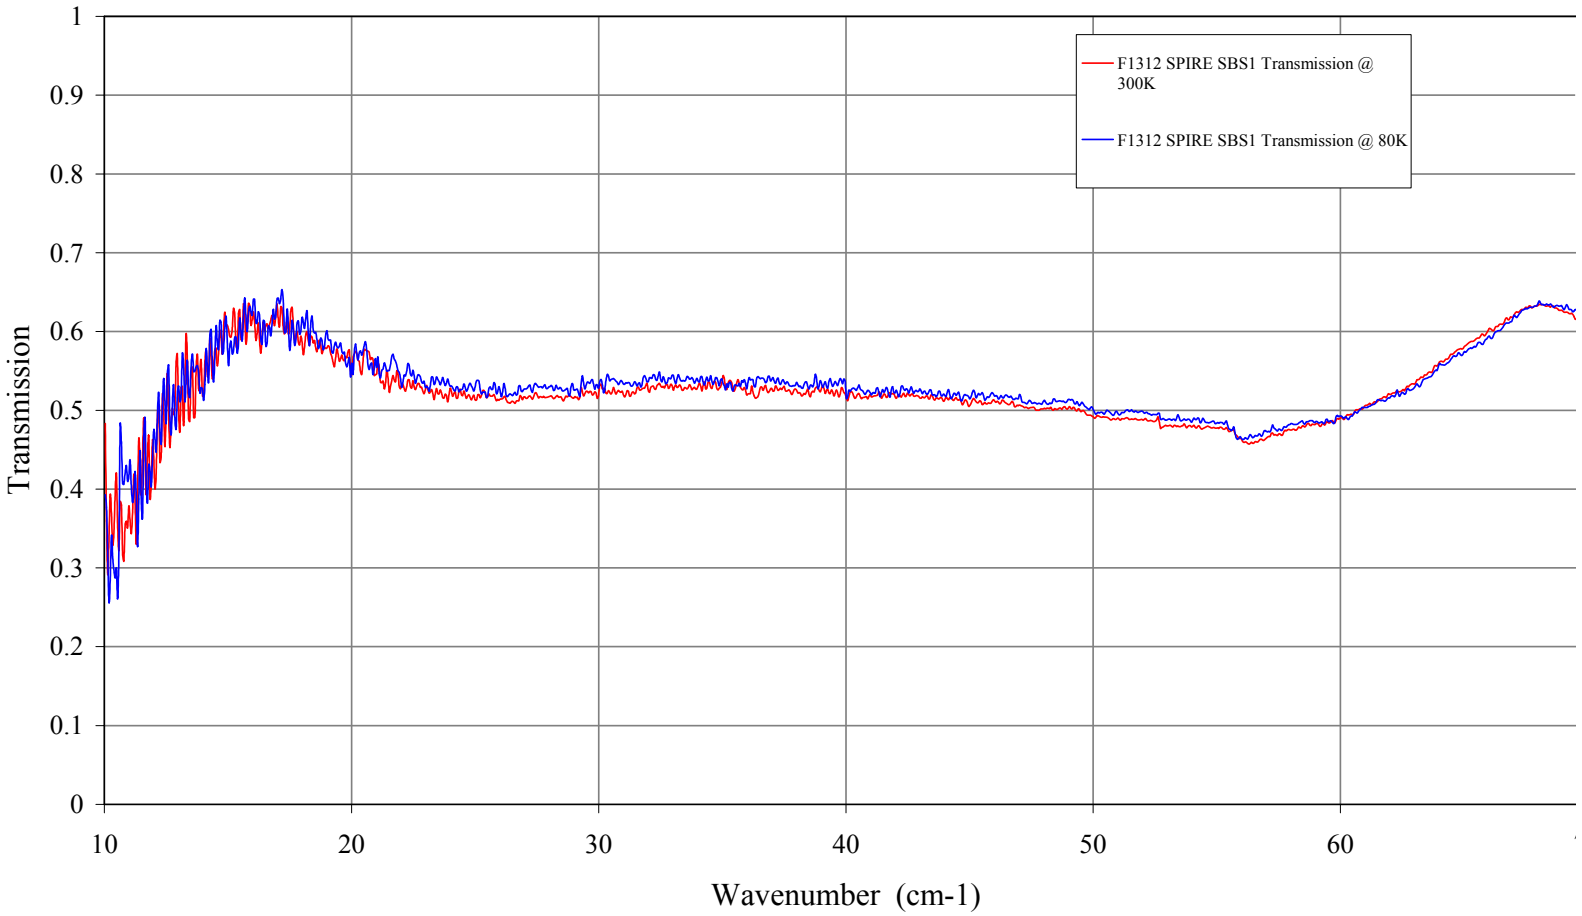
Figure 15 Warm and cold transmission data for SBS1

Transmission data for SBS1 and SBS2 are shown as Figure 15 and Figure 16 respectively. These data show no change in performance between 300K and 80K.

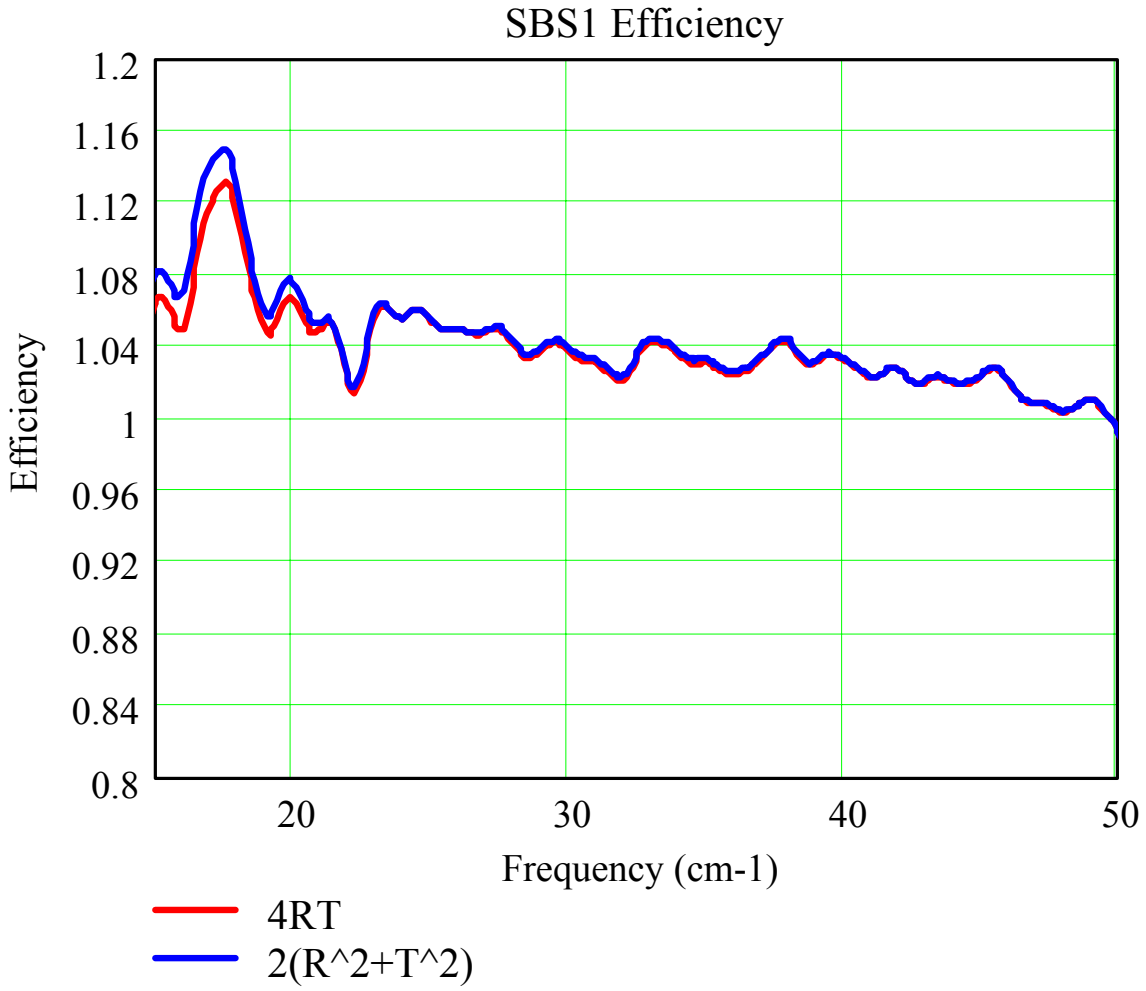
Figure 17 SBS1 efficiency

Beam divider efficiency can be expressed as the product 4*R*T, where R is the reflected component, and T is the transmitted component. For an ideal component, 4RT=100%. The requirement on the components for SPIRE is that 4RT>90% over the SPIRE band.
The requirement in the SPIRE instrument requirements document (SPIRE-RAL-PRJ-000034 issue 1.2) on efficiency is expressed in terms of “balancing of ports” (IRD-OPTS-R07). The requirement is that 2RT is within 90% of R^2+T^2 over the SPIRE band.
Figure 17 and Figure 19 show the efficiency across the SPIRE band for SBS1 and SBS2 respectively.
Figure 18 and Figure 20 show the degree to which the ports are matched. Plotted in each of these traces is the difference between the reflected and transmitted components ($2RT-(R^2+T^2)$).
