GIADA FS MODEL

REPORT ON
IN FLIGHT PASSIVE PAYLOAD CHECKOUT N. 13 (PC13)
performed on
1-12-2010 and 9-12-2010

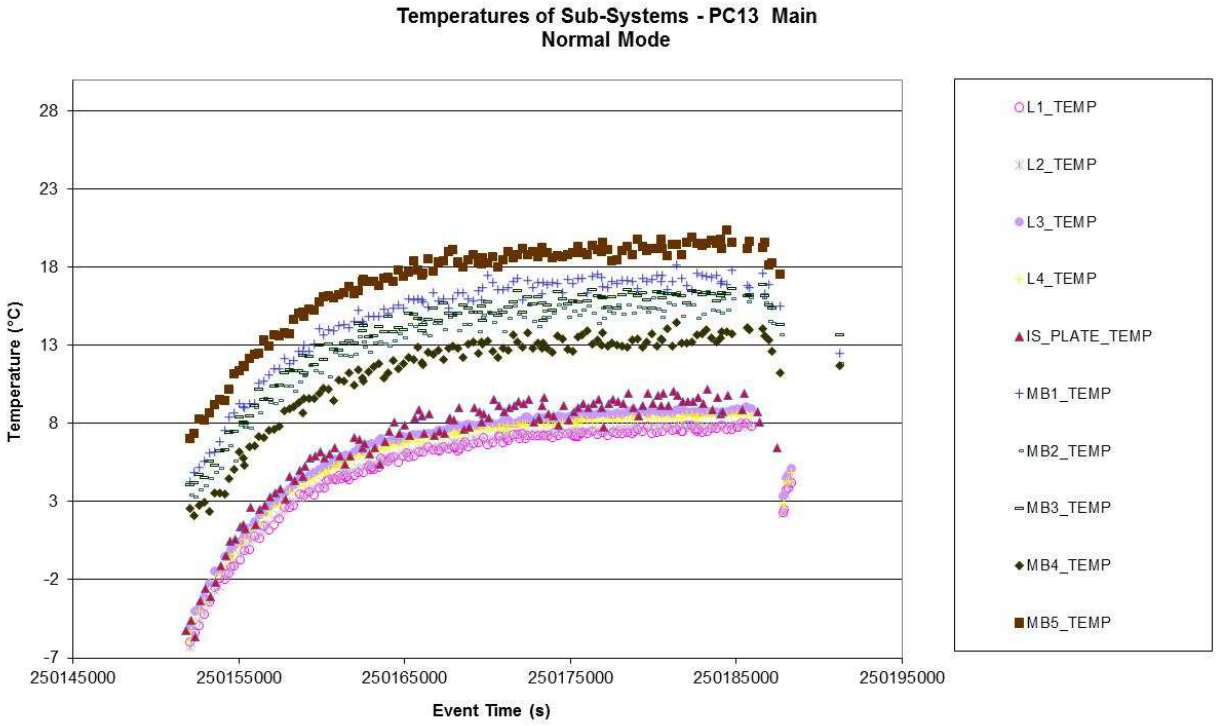
Figure 6.1-4. Evolution of temperatures of sub-systems vs. time with instrument in Normal Mode– Main

All **Temperatures** behave as expected (Main on GD01: **Errore. L'origine riferimento non è stata trovata.**3,,

Figure 6.1-4; Red on GD01: **Errore. L'origine riferimento non è stata trovata.**3, **Errore. L'origine riferimento non è stata trovata.**4. The peaks visible at the beginning and at the end of Frangibolt and IS temperature profiles are features due to the temporary increasing of power consumption at Power-on of the motor heaters (see Figure 6.1-5 and Figure 6.1-6 for Main on GD01; **Errore. L'origine riferimento non è stata trovata.** and **Errore. L'origine riferimento non è stata trovata.** for Red on).

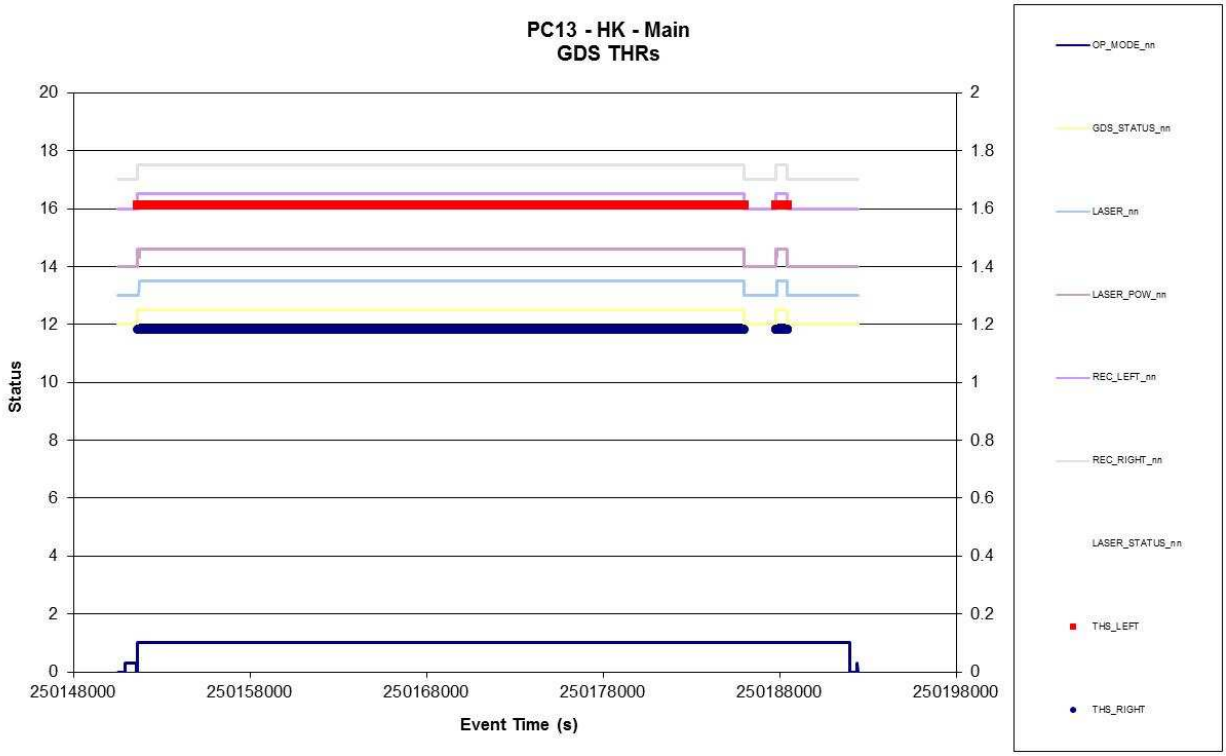
Figure 6.2-2. GDS Thresholds change vs. time – Main

The detection **Thresholds** applied on GDS are shown in

Figure 6.2-2 (Main on GD01), **Errore. L'origine riferimento non è stata trovata.** (Red on GD01, **Errore. L'origine riferimento non è stata trovata.** while those applied to PZT3 and PZT5 of IS are shown in Figure 6.3-23 and Figure 6.3-34 (Main on GD01), **Errore. L'origine riferimento non è stata trovata.**3 and **Errore. L'origine riferimento non è stata trovata.**4 (Red on GD01). Moreover, Range and Gain for IS are set as shown in Table 5.2-2.

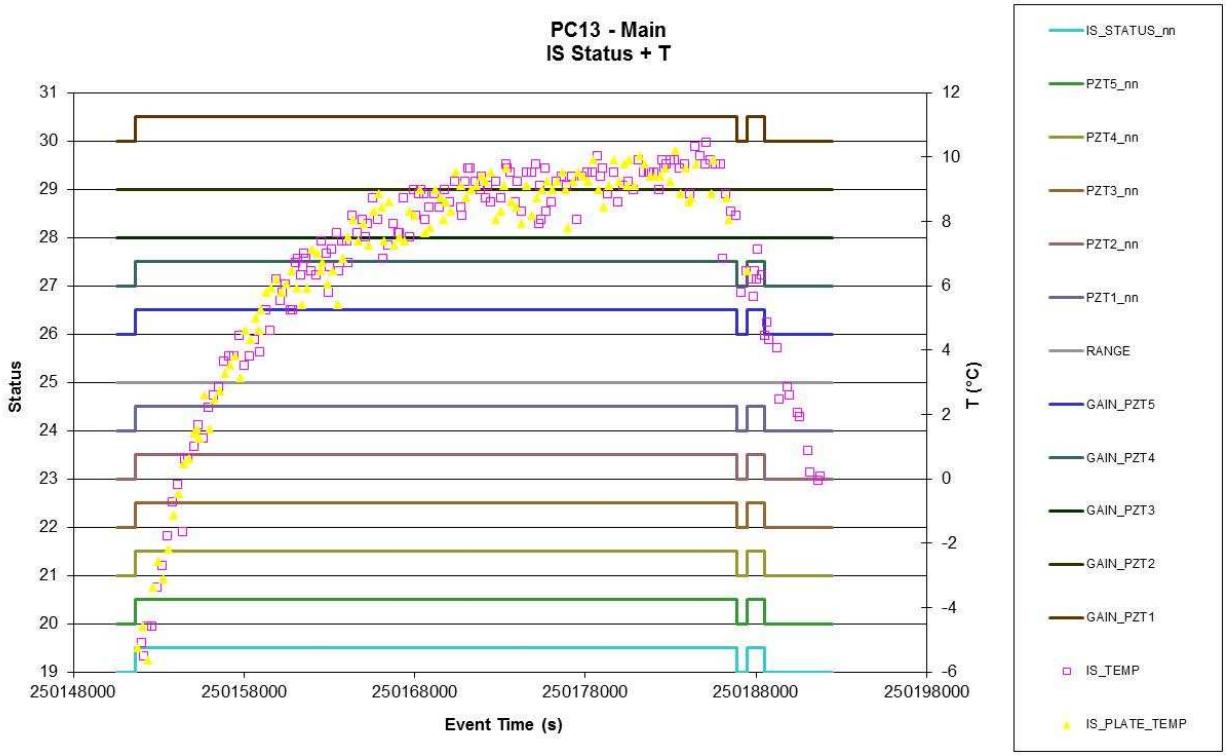
Figure 6.3-4. IS Temperature vs. time (HK, HK-SCI, SCI) – Main

The trend of the IS Temperature is more noisy with the Main than with the Red I/F (Main on GD01: Figure 6.3-4; Red on GD01: **Errore. L'origine riferimento non è stata trovata.**).

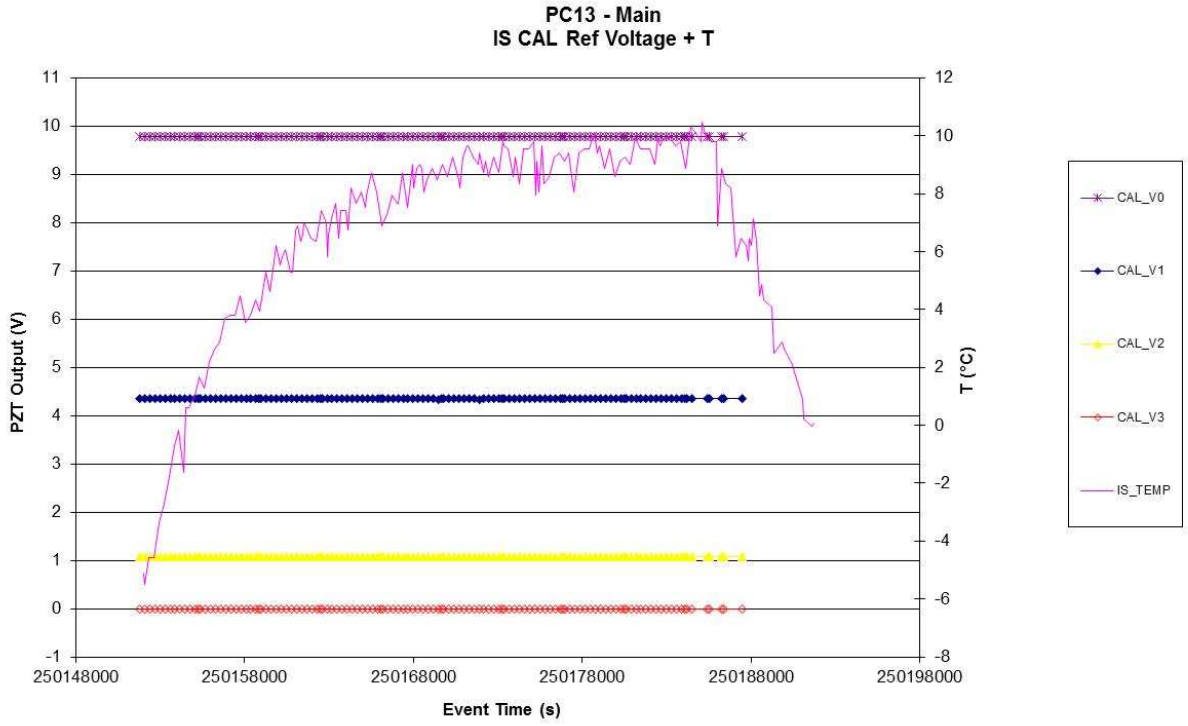
Figure 6.3-6. Reference Voltages for IS calibration vs. time – Main Voltages values for the calibrator don't show level variation

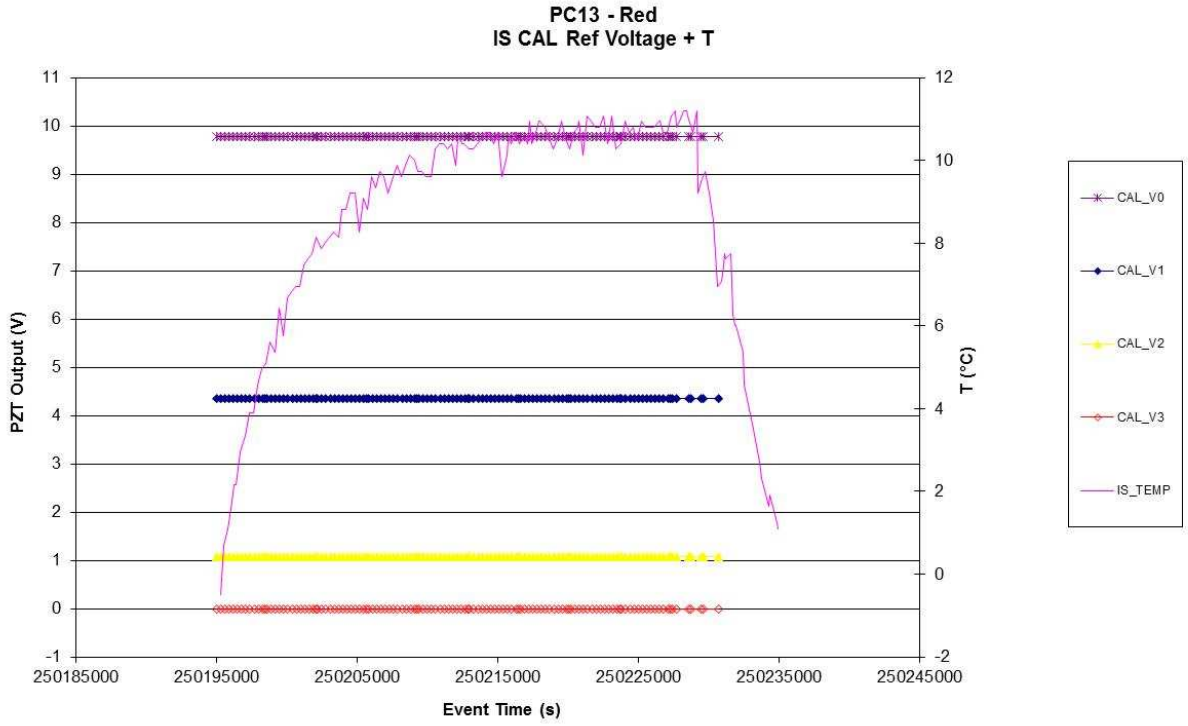
Figure 7.3-6. Reference Voltages for IS calibration vs. time – Red Voltages values for the calibrator don't show level variation
