MSSL-technote-SPIRE-26	Instrument Cold Vibration Test Report	Issue 1.1, June 2004
SPIRE-MSS-REP-002049

**SUBJECT: Instrument Vibration Test Report
 CQM Qualification (Cold)**

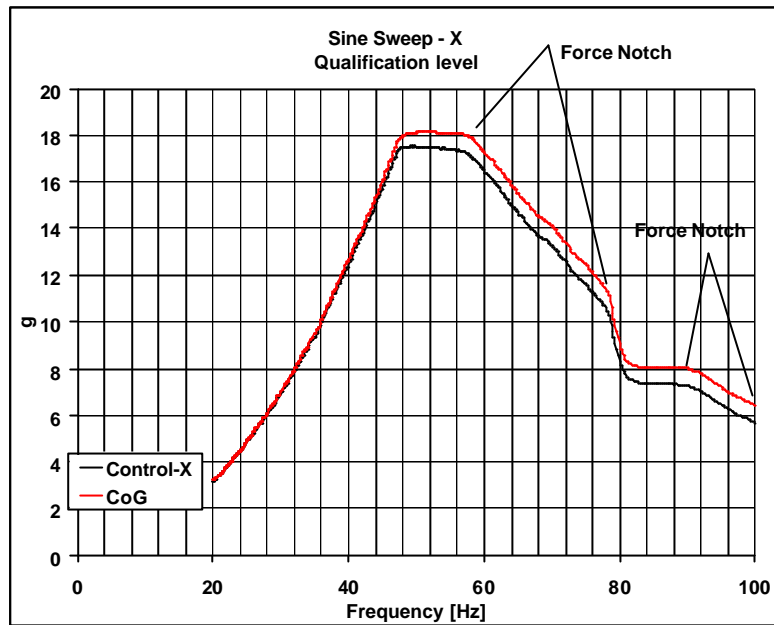
Figure 8.4-1 Achieved inputs for the X direction

During the test (see next graph) the 18 g equivalent notch kicked in at 58 Hz and continued to act till 75 Hz. Then the second notch kicks in at 90 Hz and continues up to 100 Hz (8 g equivalent). The black line is the control accelerometer and the red line the CoG equivalent accelerometer.

The accelerometer at the top of the SPIRE optical bench was used as a control to limit the interface force to an equivalent 18 g static force. The number of maximum load cycles was limited to 1000. Based on the limitation of the CSL shaker (2 mm stroke maximum) maximum input could only be achieved at 50 Hz, continuing the maximum input to 75 Hz gives roughly 1000 cycles. After 75 Hz the input is lowered to 8 g with scaled limits accordingly.

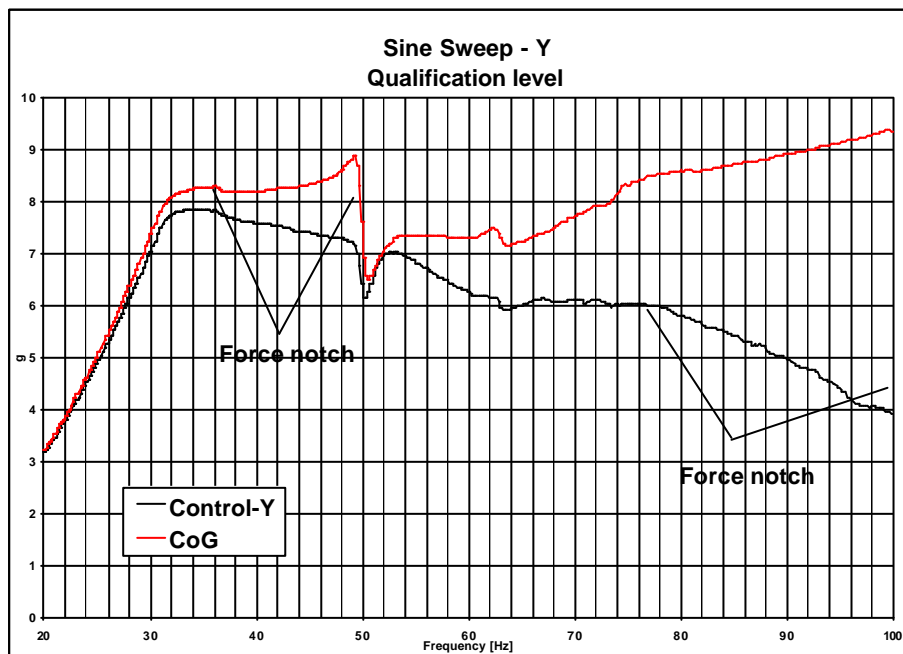
Figure 8.4-2 Achieved inputs for the Y direction

A similar strategy was followed for the Y-axis. The Y-axis has a flat input of 8 g up to 50 Hz. Then it is lowered down to 6 g at 60 Hz and continued to 100 Hz at 6 g. This was the first axis tested at CSL. The force notch was only limited to 8 g equivalent, hence the over test above 74 Hz.

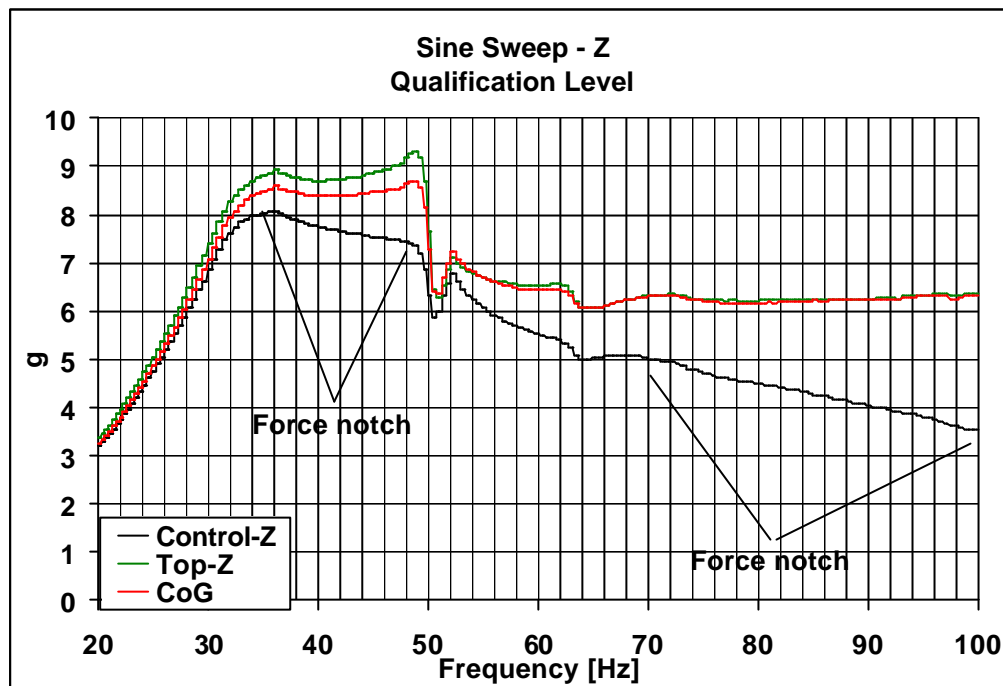
Figure 8.4-3 Achieved inputs for the Z direction (Top-Z is in Z at top of instrument)

For the Z-axis the same approach as for the Y-axis was followed with an additional scaled notch above 75 Hz. Additional was the scaled force notch above 75 Hz, preventing an over test at higher frequencies.

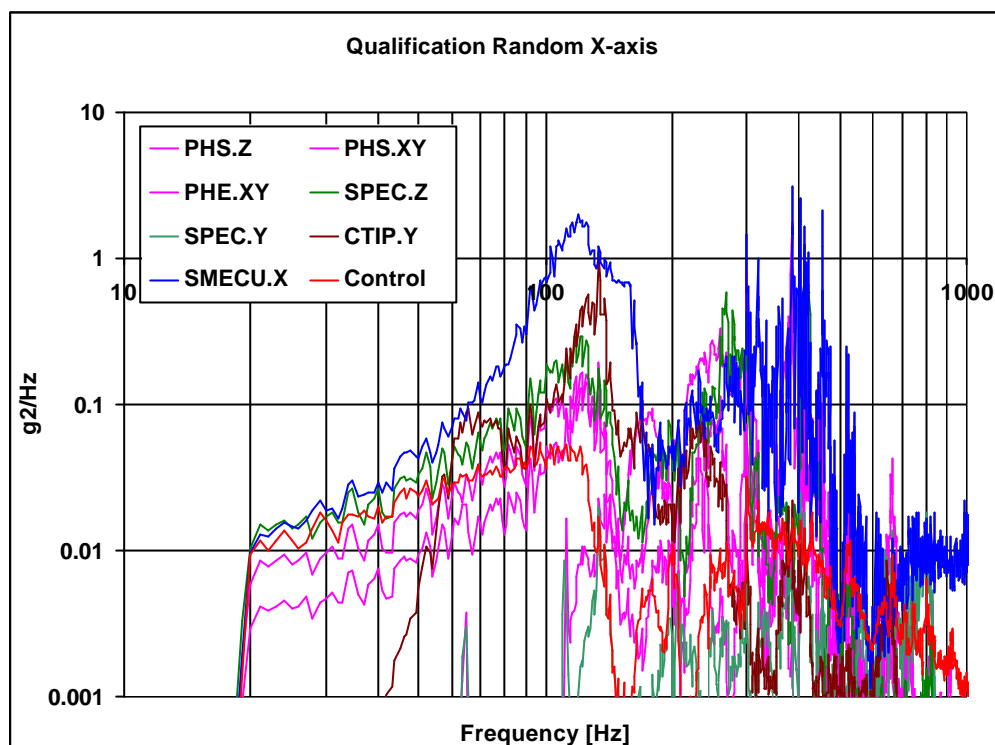
Figure 8.5-2 Achieved random input in X

Note in figure 8.5-2 the violent response of the spectrometer mechanism, it is the blue trace above all others. Green is the spectrometer box, magenta the photometer box.

For the X axis it was decided not to notch on equivalent quasi-static interface forces since the overall response of the instrument at lower frequencies showed that the interface force would not exceed the equivalent QS-interface force. The only notch applied was therefore on the suspended masses on the detector boxes and the spectrometer mechanism.

Analysis has shown that the average amplification (in g-rms) between detector box and detector suspended mass for the X-axis is about 2.3 (see table 8.5-1). In table 8.5-3 the accelerometers g-rms are multiplied in the second column with this factor to arrive at the maximum expected level. This has to be done since these accelerations can not be measured directly (cold). The requirement is that the accelerations do not need to exceed 10 g-rms for any component mounted inside the structure during random vibration testing. (Ref Thijs van der Laan/ESA). Clearly both based on analytical considerations and direct measurements some detectors do exceed that value as well does the top of the spectrometer mechanism.

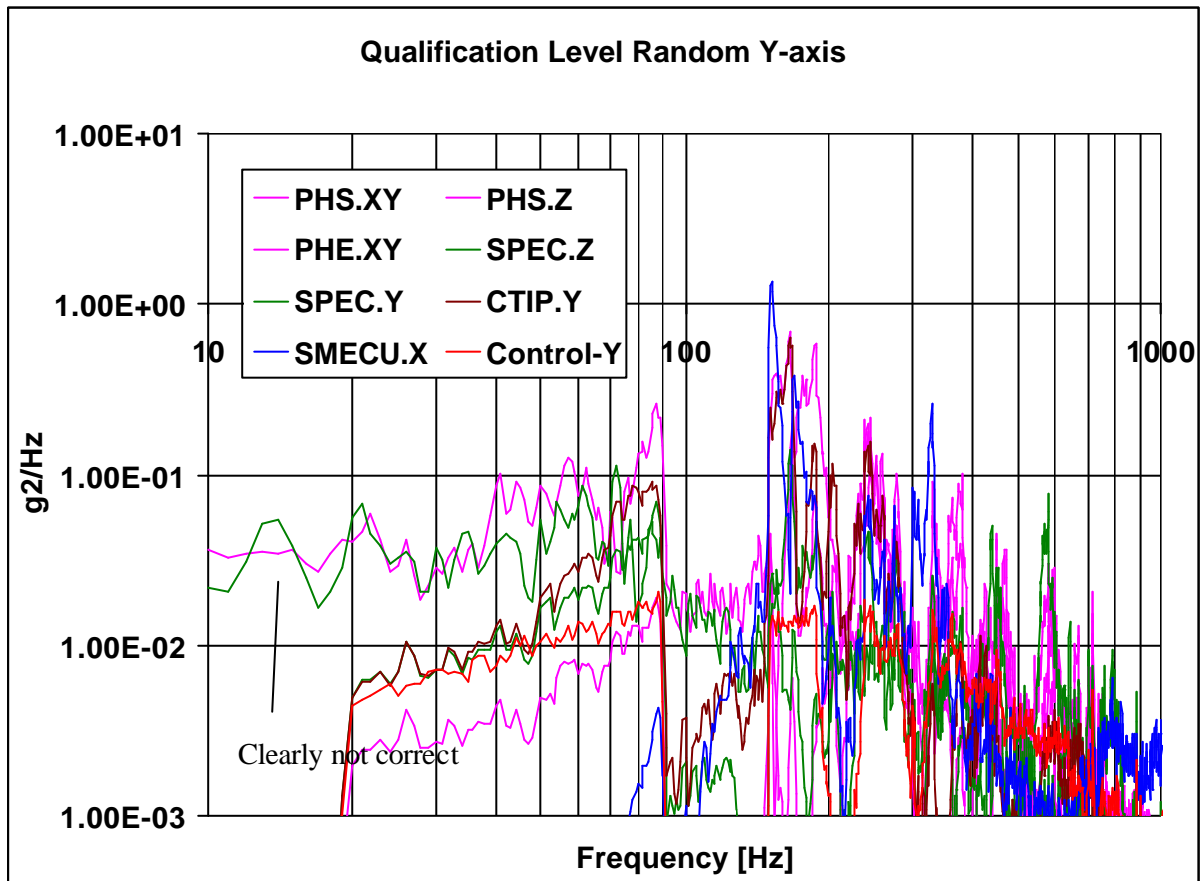
Table 8.5-4 Y-axis response graphs

For the Y-axis force notching was applied controlling the CoG acceleration to about 2 g-rms (4 sigma value gives 8 g equivalent static). The force notch was introduced between 90 and 150 Hz. This is rather wide, but the only way of limiting the force was widening up the notch since it was already quite deep and nothing much was to be gained from deepening it further. For the force notch the response up to 2 times the first resonance frequency were taken into account. The applied notch gave a response at the top of the structure 3 g-rms. Correlation between CoG and this accelerometer shows a 1:1 response in this frequency range. If we take 10% uncertainty into account we reached 2.7 g-rms. This exceeds the required 2 g-rms comfortably.

Next to the notch on interface force two more were applied to suppress the responses of the detector boxes. This to limit the response of the boxes to a value of 10% above 10 g-rms equivalent for the suspended masses. There was no need to limit the input to protect the SMec.

Note that for the detector box notches the response is limited for all detector box responses at the same time (both photometer and spectrometer). So it is not possible to discriminate between the 5 detector box responses and boost some of them whilst maintaining the 13.1 g-rms for PHE.XY.

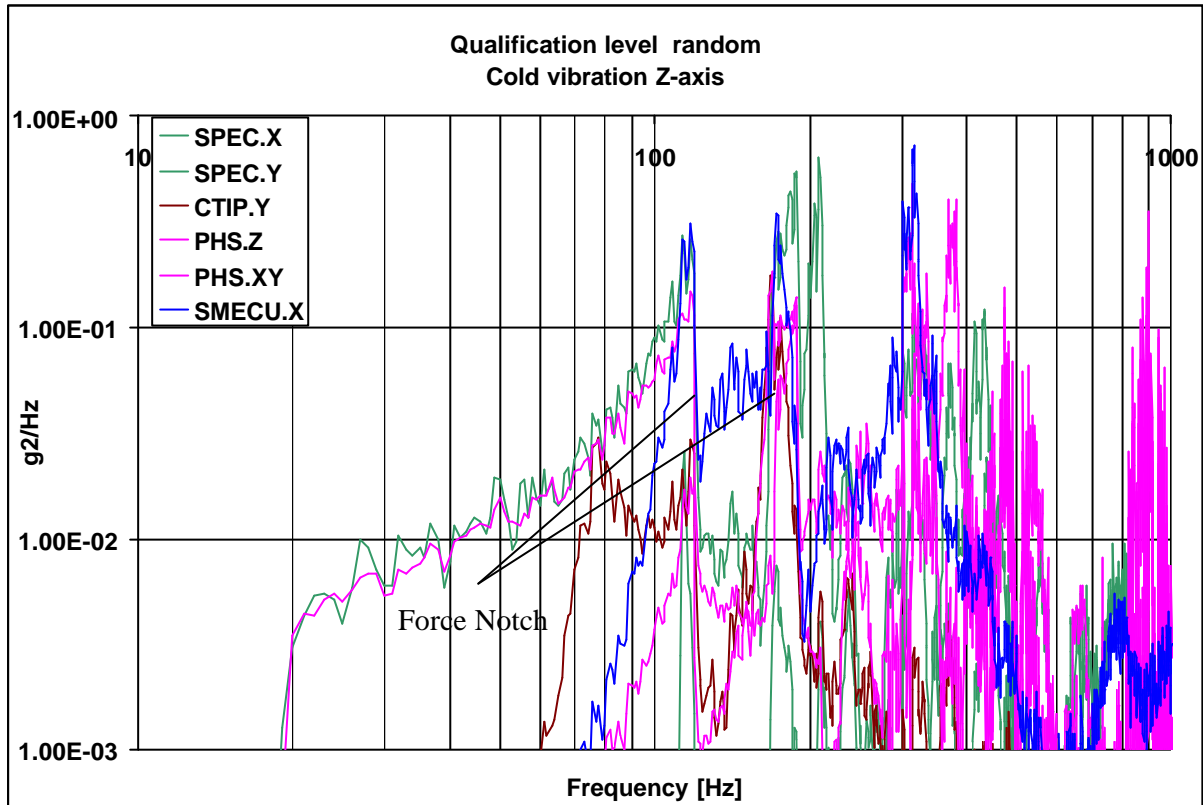
Table 8.5-6 Z-axis response graphs

As for the Y-axis force notching was applied at the CoG but now between 120 and 170 Hz. Trying to achieve 2.0 g-rms up to about 290 Hz. The achieved level was 2.6 g-rms, exceeding the required 2.0 g-rms with a comfortable margin.

And again the levels for the detector boxes were limited to reach a maximum of more than 10 g-rms for the equivalent acceleration of the detector's suspended masses. The multiplication factor applied for the Z-axis is according to the table 8.5-1, 2.76 9 due to a strong cross-coupling in X-direction.

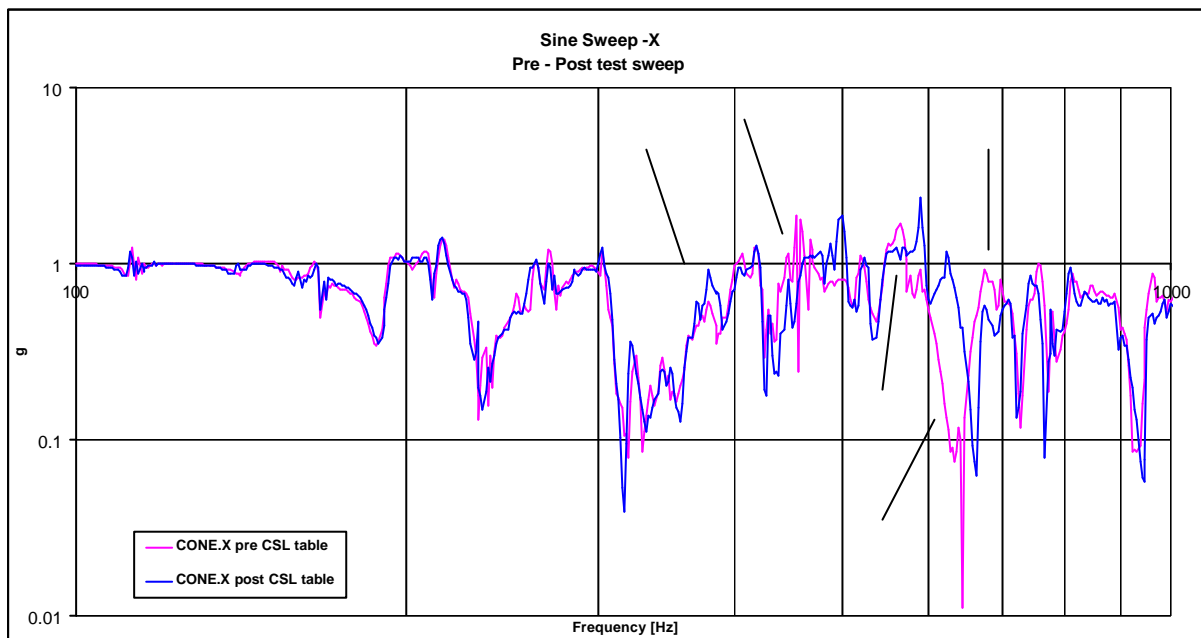
B-1: Example of a transfer function between the drive and an accelerometer on the shaker table (detail)

See as an example the following transfer function (pre-post test) between the drive and an accelerometer on the shaker table (not on the instrument)

As can be seen checking the transfer function shown in C-1 the shaker table is rather flexible. The shaker control during this test was on the maximum of three accelerometers, mounted near the three interface points of the instrument.

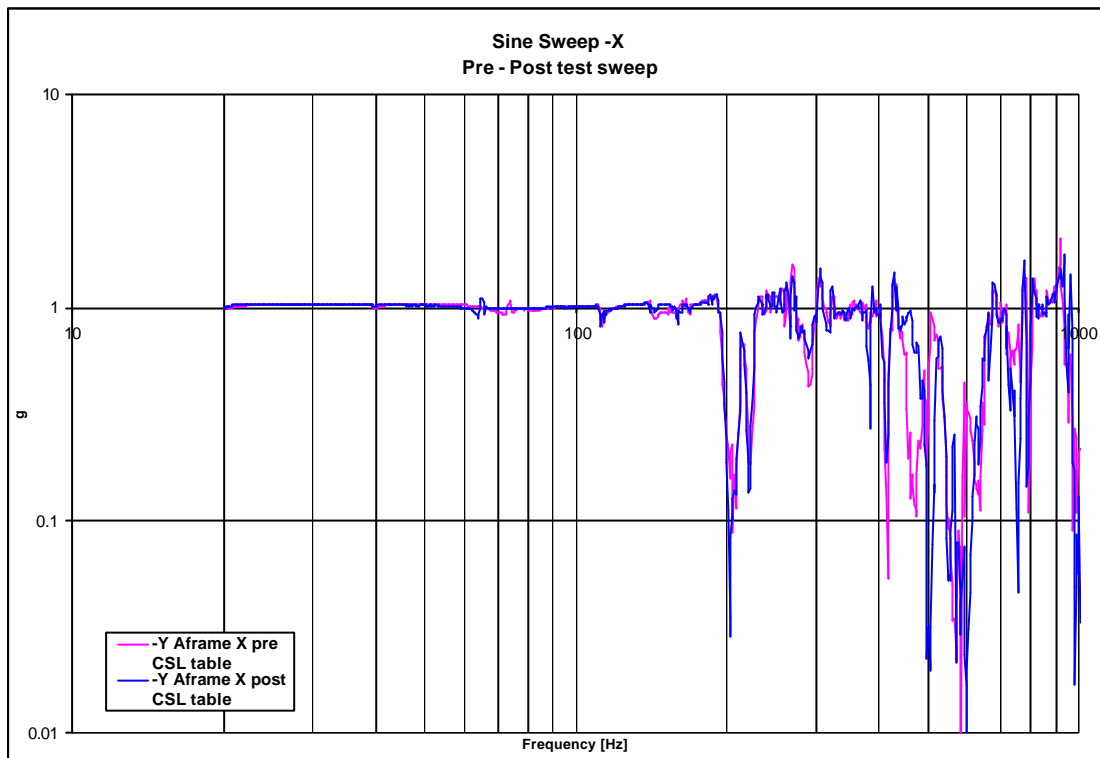
B-2: Differences in CSL table readings pre-post (at A-frame)

Hereafter the 3 different transfer functions (CSL shaker table, CSL drive) are shown between 20 Hz and 1 kHz

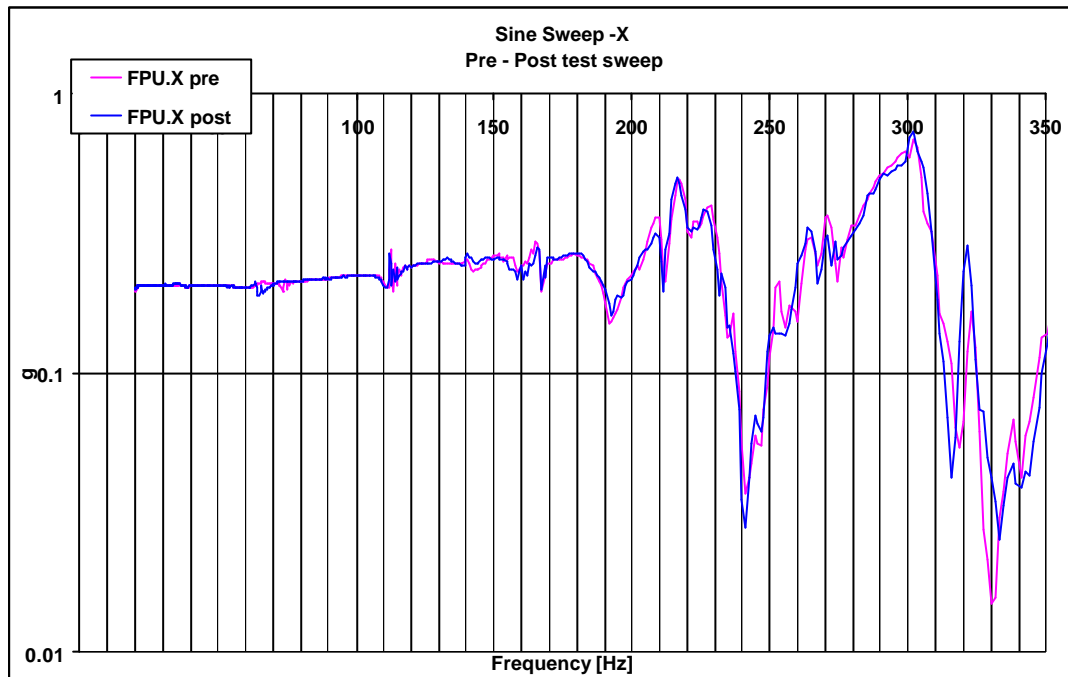
Figure B-5: Main structure in excitation direction (accelerometer at top SOB/instrument)

The following traces are some typical examples. Traces selected are on top of the instrument (FPU) in excitation direction and on one of the detector boxes. The comparison is limited to between 20 and 350 Hz
