MSSL-technote-SPIRE-26	Instrument Cold Vibration Test Report	Issue 1.4, March 2005
SPIRE-MSS-REP-002049

**SUBJECT:           Instrument Vibration Test Report  
                          CQM Qualification (Cold)**

This document lists the main results of the cold vibration test of the Herschel SPIRE instrument structural thermal model (CQM). This model is structural representative with a few exceptions as listed in section 5. The CQM model was tested in April 2004 with the stainless steel supports for the instrument itself and the detector boxes.

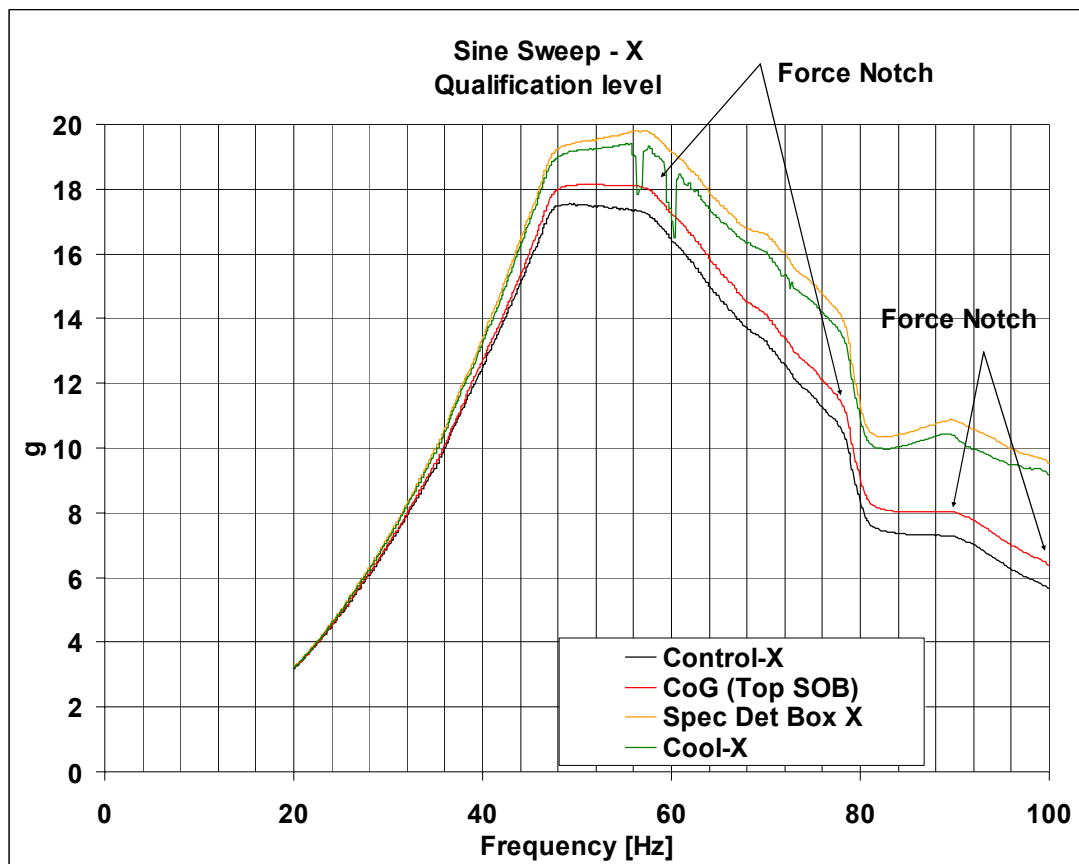
Figure 8.4-1 Achieved inputs for the X direction

During the test (see next graph) the 18 g equivalent notch kicked in at 58 Hz and continued to act till 75 Hz. Then the second notch kicks in at 90 Hz and continues up to 100 Hz (8 g equivalent). The black line is the control accelerometer and the red line the CoG equivalent accelerometer.

The achieved levels show the top of the Spire Optical Bench (Top SOB) above the instrument mounting cone as the minimum response in X. The elements mounted more in the middle of the instrument and closer to the real CoG are also plotted (Cooler-X and Spec. Det. Box X)

The accelerometer at the top of the SPIRE optical bench was used as a control to limit the interface force to an equivalent 18 g static force. The number of maximum load cycles was limited to 1000. Based on the limitation of the CSL shaker (2 mm stroke maximum) maximum input could only be achieved at 50 Hz, continuing the maximum input to 75 Hz gives roughly 1000 cycles. After 75 Hz the input is lowered to 8 g with scaled limits accordingly.

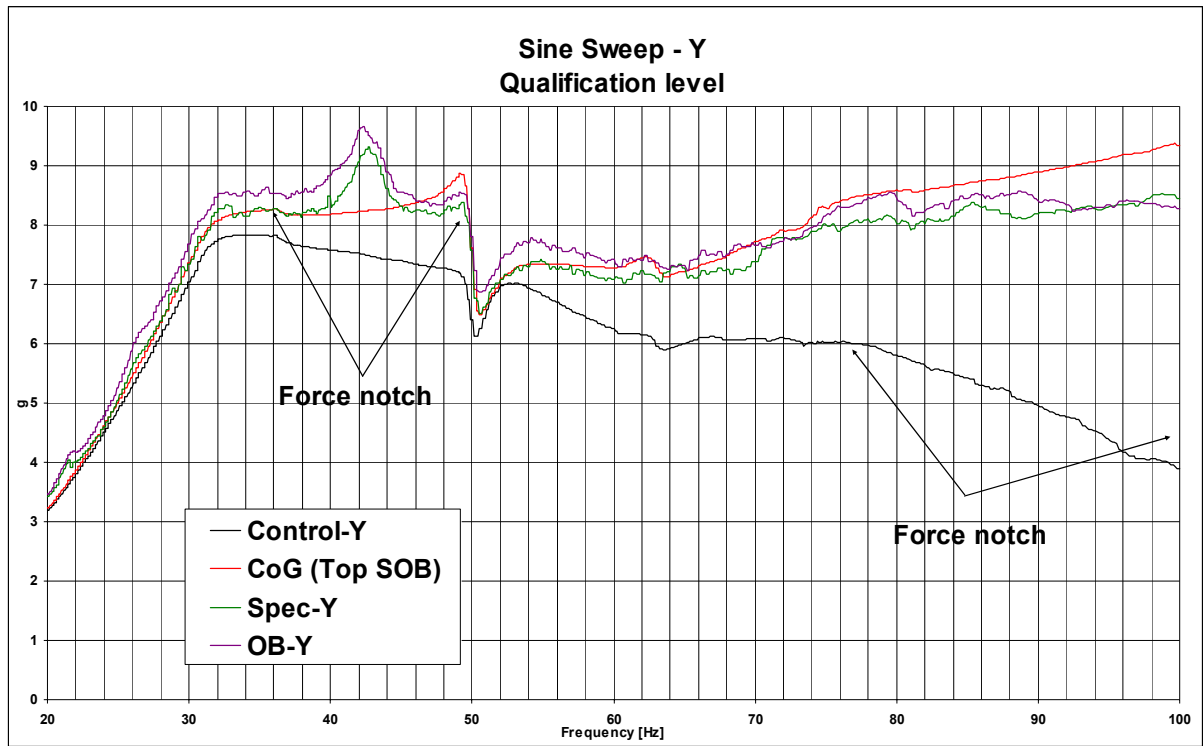
Figure 8.4-2 Achieved inputs for the Y direction

A similar strategy was followed for the Y-axis. The Y-axis has a flat input of 8 g up to 50 Hz. Then it is lowered down to 6 g at 60 Hz and continued to 100 Hz at 6 g. This was the first axis tested at CSL. The force notch was only limited to 8 g equivalent, hence the over test above 74 Hz.

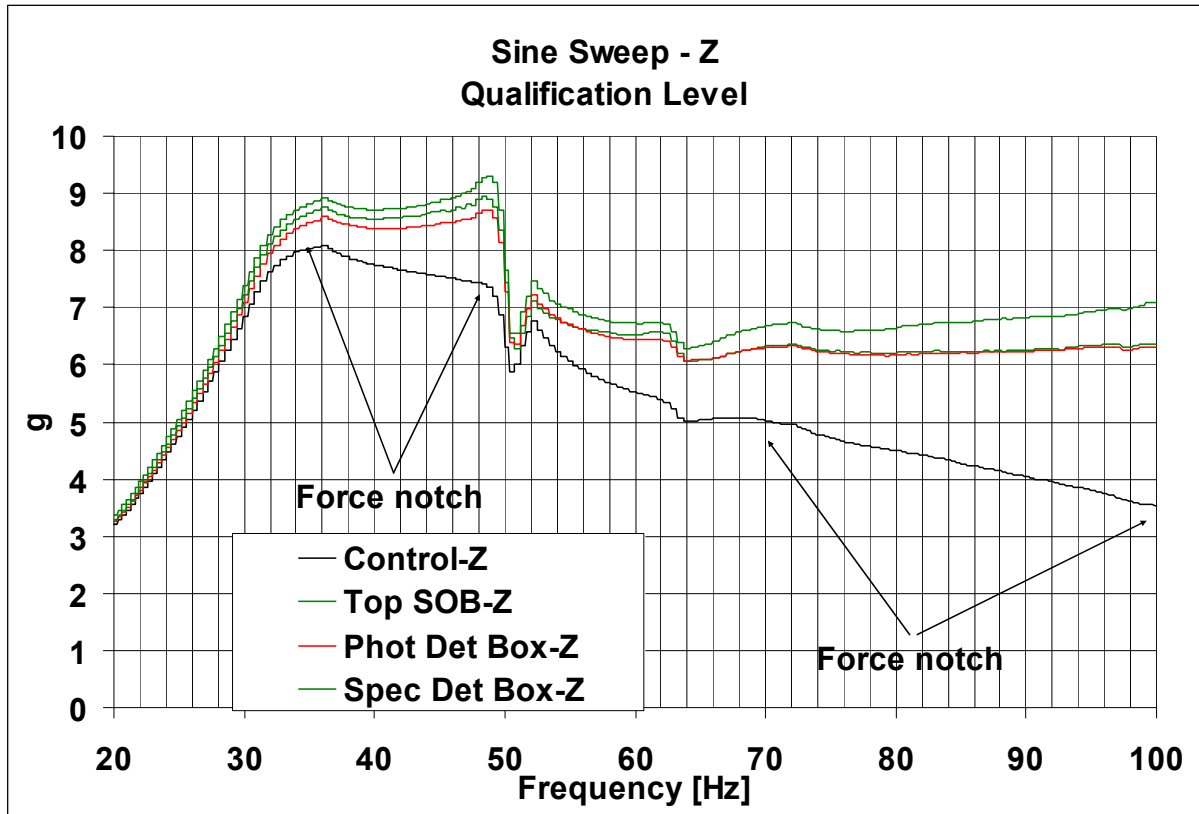
Figure 8.4-3 Achieved inputs for the Z direction (Top-Z is in Z at top of instrument)

For the Z-axis the same approach as for the Y-axis was followed with an additional scaled notch above 75 Hz. Additional was the scaled force notch above 75 Hz, preventing an over test at higher frequencies.

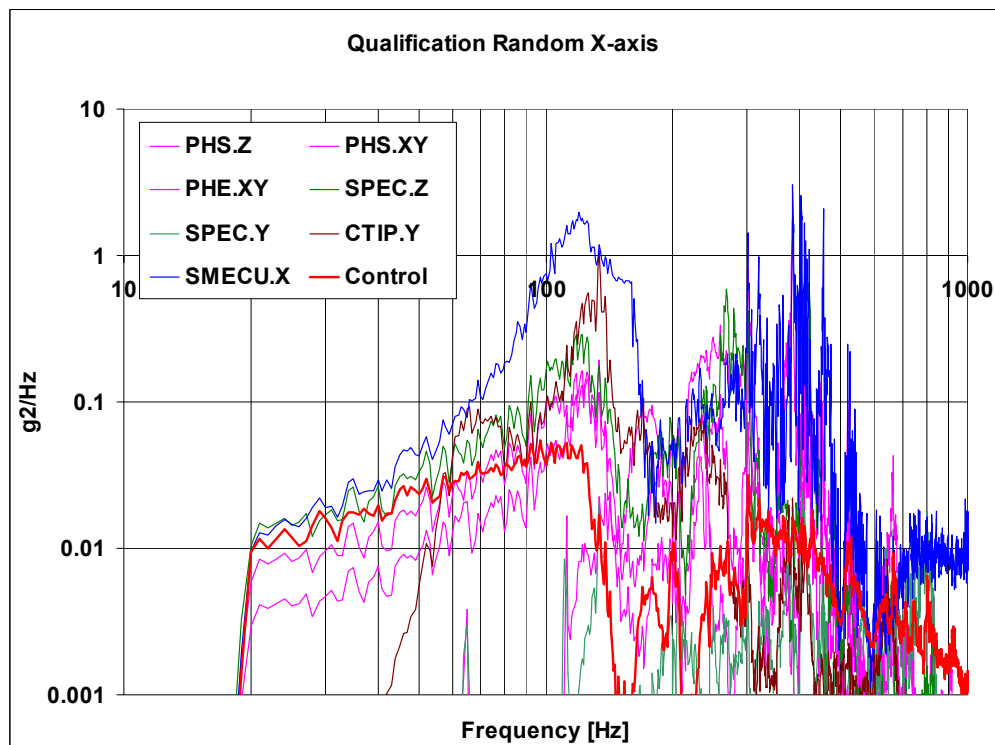
Figure 8.5-2 Achieved random input in X

For the X axis it was decided not to notch on equivalent quasi-static interface forces since the overall response of the instrument at lower frequencies showed that the interface force would not exceed the equivalent QS-interface force. The only notch applied was therefore on the suspended masses on the detector boxes and the spectrometer mechanism.

Note in figure 8.5-2 the violent response of the spectrometer mechanism, it is the blue trace above all others. Green is the spectrometer box, magenta the photometer box.

Analysis has shown that the average amplification (in g-rms) between detector box and detector suspended mass for the X-axis is about 2.3 (see table 8.5-1). In table 8.5-3 the accelerometers g-rms are multiplied in the second column with this factor to arrive at the maximum expected level. This has to be done since these accelerations can not be measured directly (cold). The requirement is that the accelerations do not need to exceed 10 g-rms for any component mounted inside the structure during random vibration testing. (Ref ESA). Clearly both based on analytical considerations and direct measurements some detectors do exceed that value as well does the top of the spectrometer mechanism.

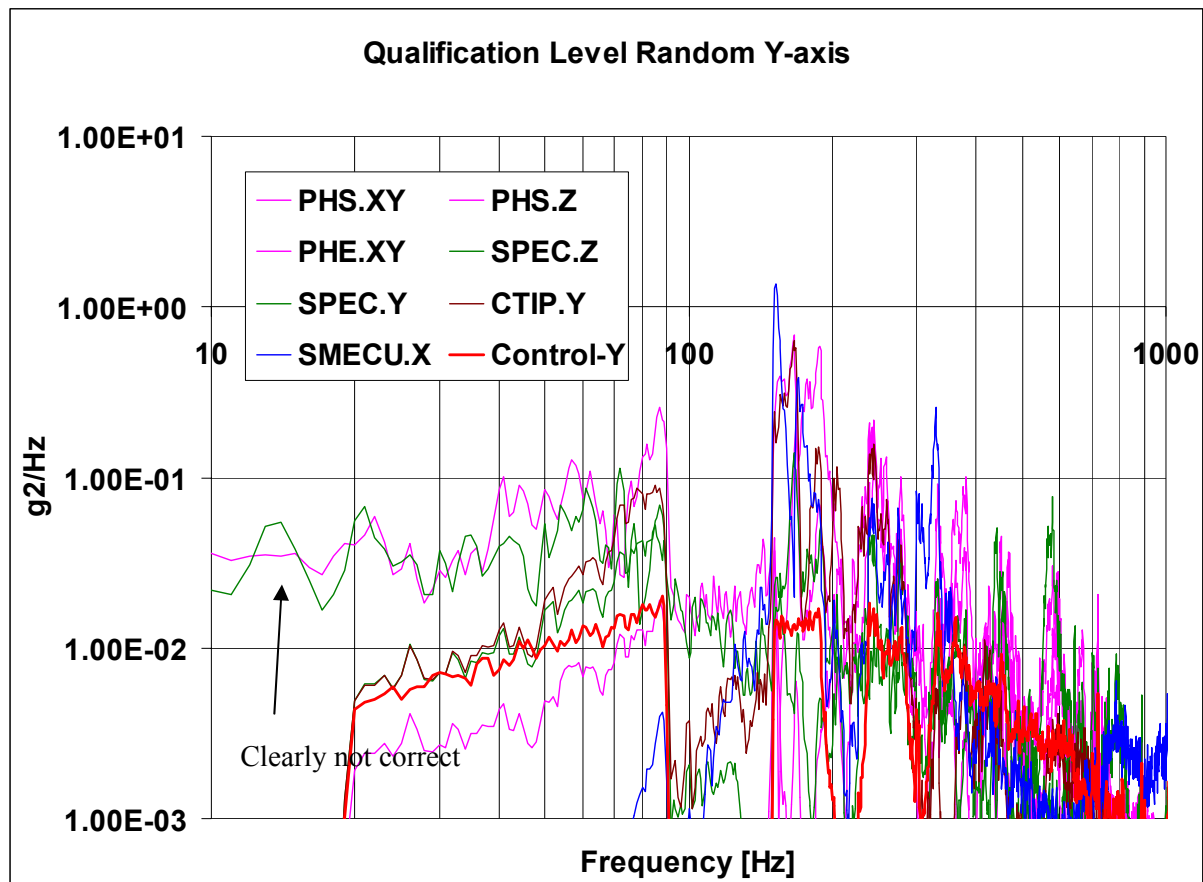
Table 8.5-4 Y-axis response graphs

For the Y-axis force notching was applied controlling the CoG acceleration to about 2 g-rms (4 sigma value gives 8 g equivalent static). The force notch was introduced between 90 and 150 Hz. This is rather wide, but the only way of limiting the force was widening up the notch since it was

already quite deep and nothing much was to be gained from deepening it further. For the force notch the response up to 2 times the first resonance frequency were taken into account. The applied notch gave a response at the top of the structure 3 g-rms. Correlation between CoG and this accelerometer shows a 1:1 response in this frequency range. If we take 10% uncertainty into account we reached 2.7 g-rms. This exceeds the required 2 g-rms comfortably.

Next to the notch on interface force two more were applied to suppress the responses of the detector boxes. This to limit the response of the boxes to a value of 10% above 10 g-rms equivalent for the suspended masses. There was no need to limit the input to protect the SMec.

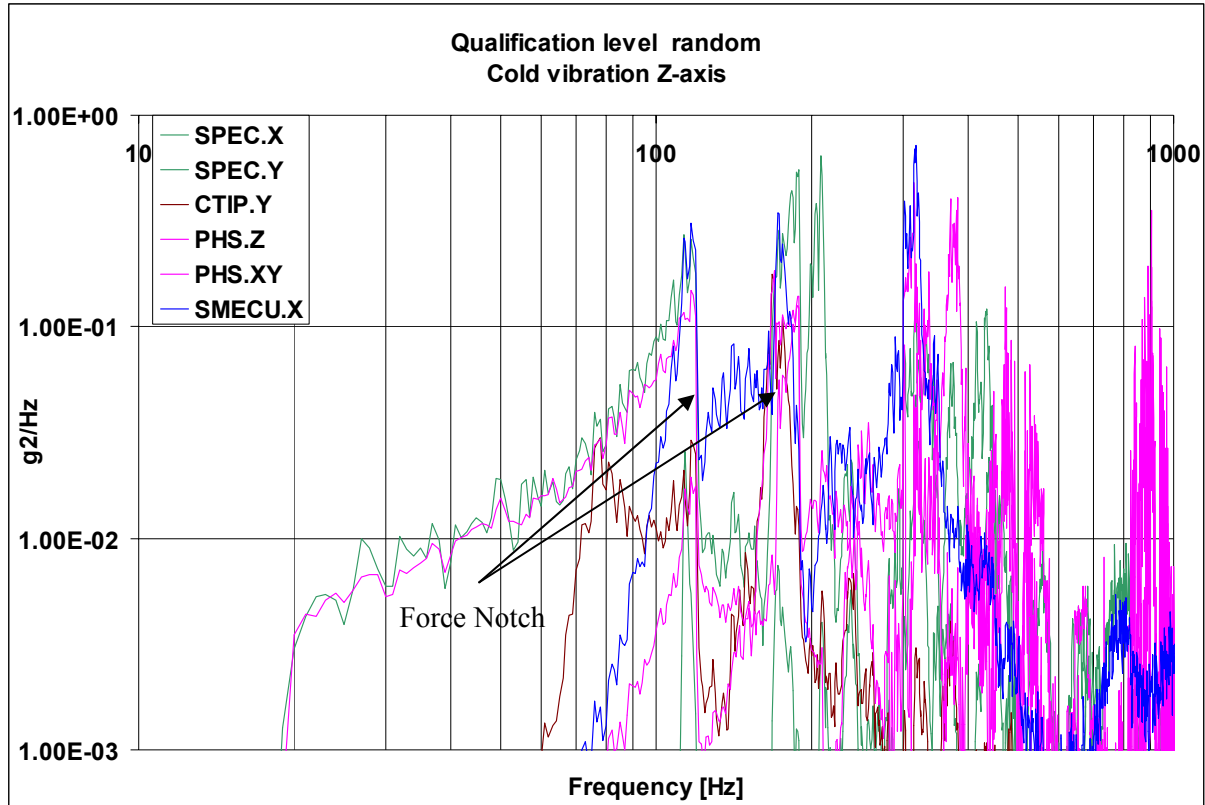
Table 8.5-6 Z-axis response graphs

As for the Y-axis force notching was applied at the CoG but now between 120 and 170 Hz. Trying to achieve 2.0 g-rms up to about 290 Hz. The achieved level was 2.6 g-rms, exceeding the required 2.0 g-rms with a comfortable margin.

And again the levels for the detector boxes were limited to reach a maximum of more than 10 g-rms for the equivalent acceleration of the detector's suspended masses. The multiplication factor applied for the Z-axis is according to the table 8.5-1, 2.76 9 due to a strong cross-coupling in X-direction.

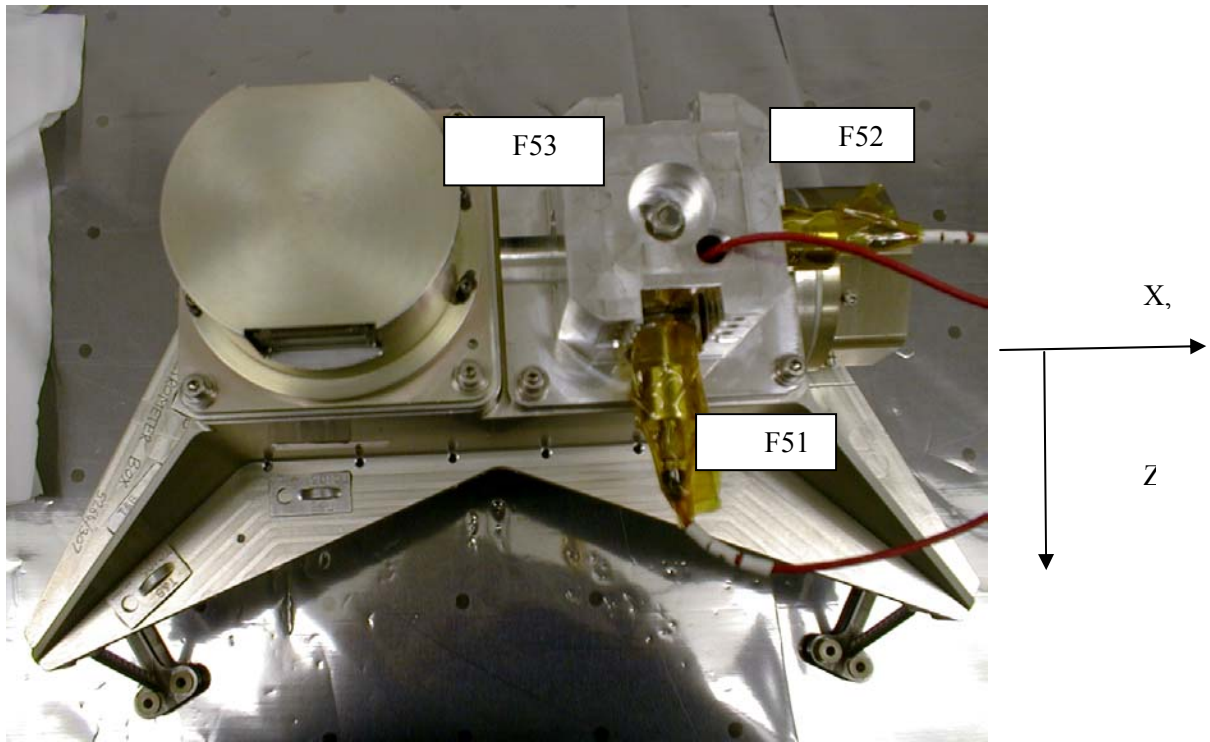
Spectrometer detector box

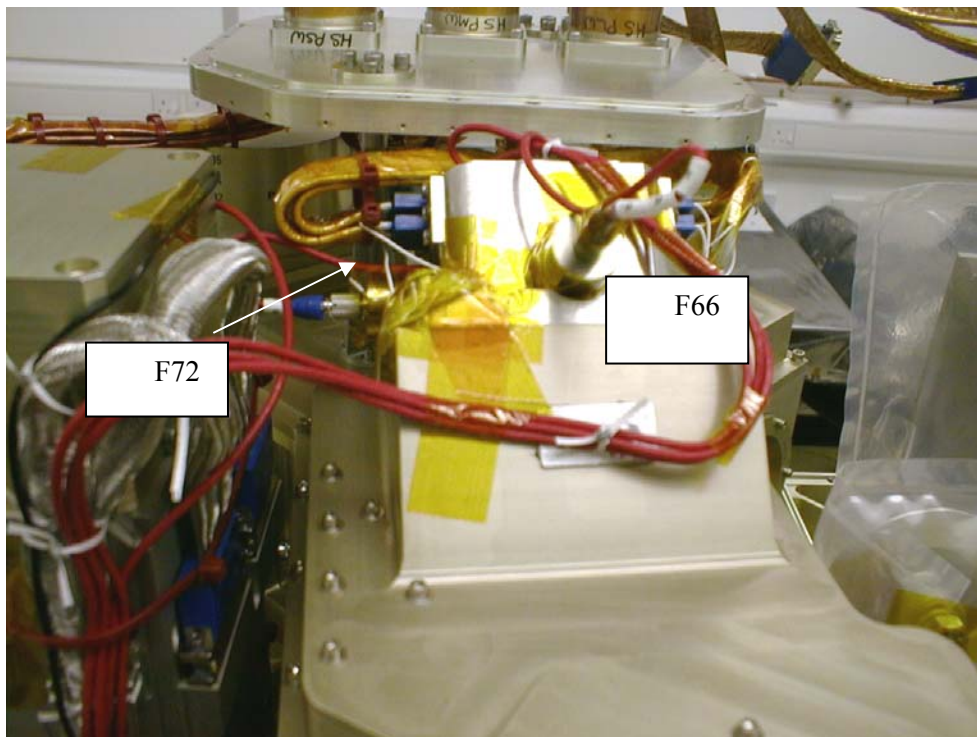
Photometer detector box

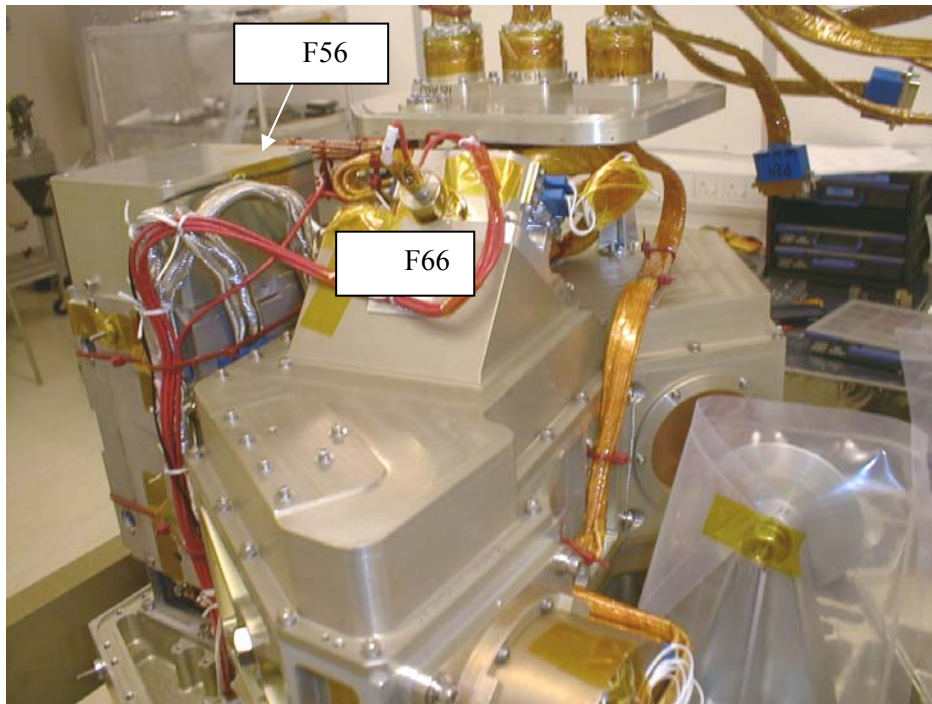
Photometer detector box and cooler

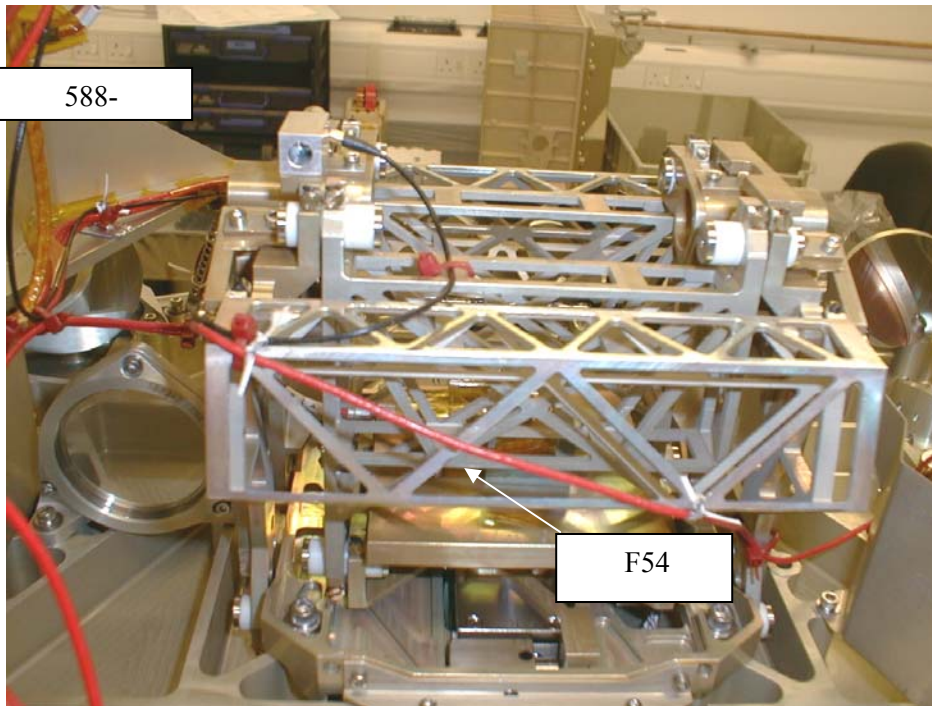
SMEC

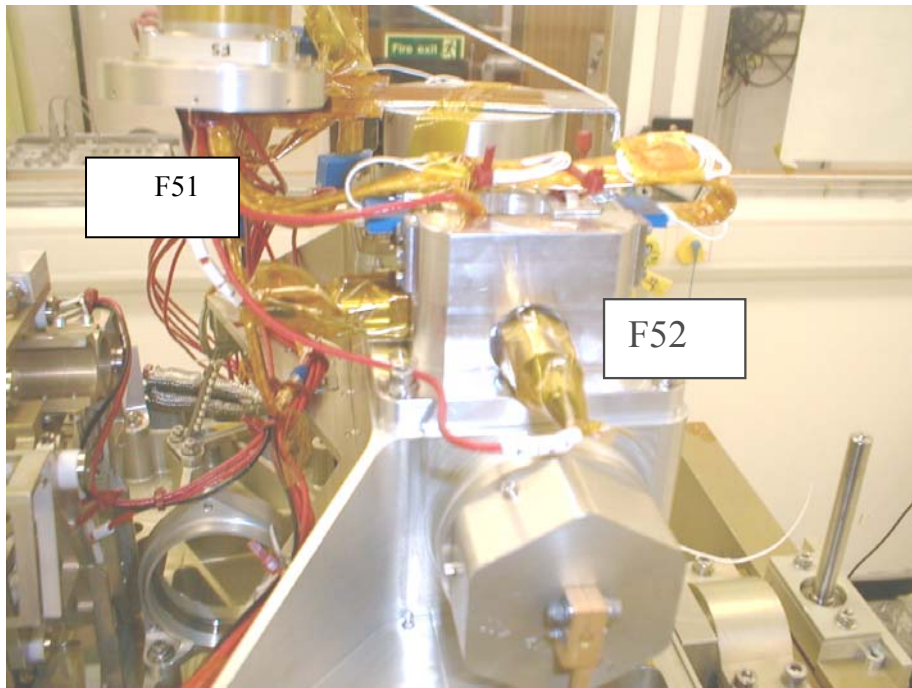
Spectrometer detector box

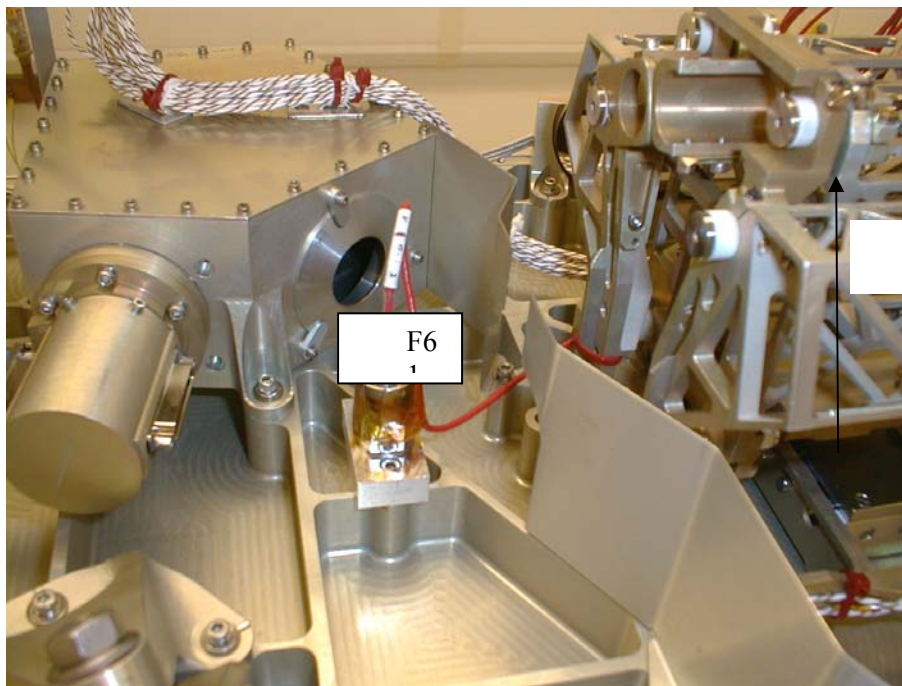
Optics bench near SMEC interface

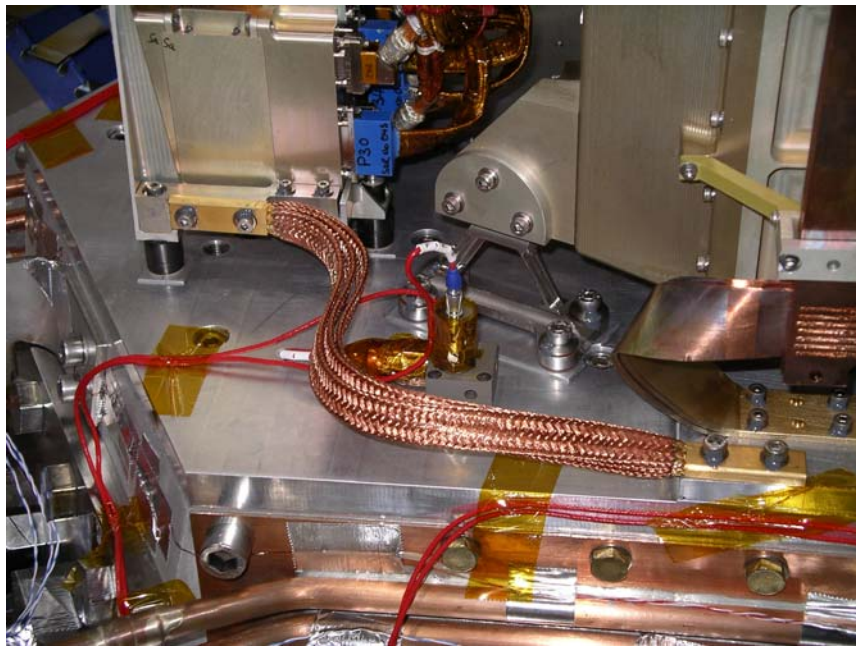
FPU -Y foot

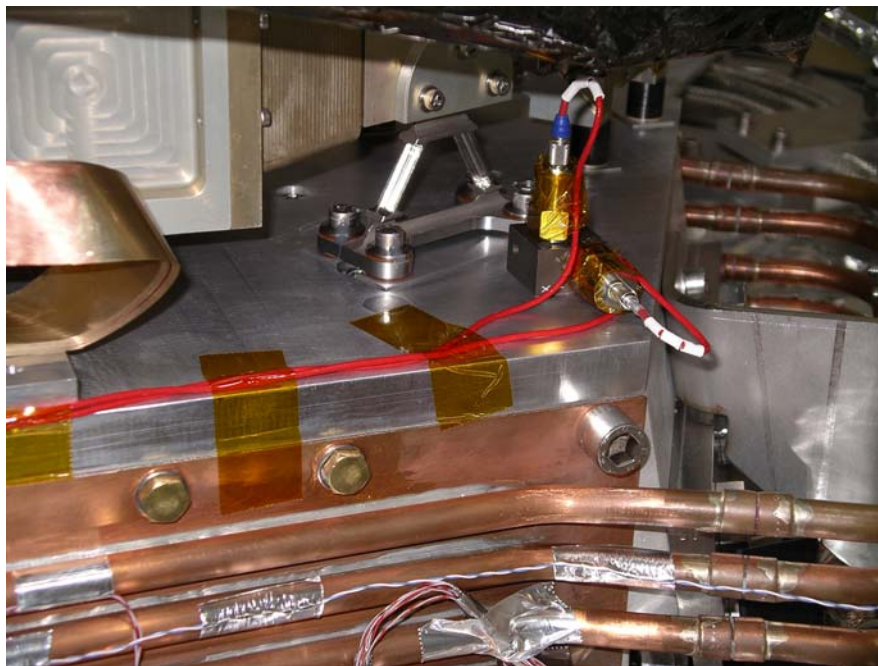
FPU +Y foot

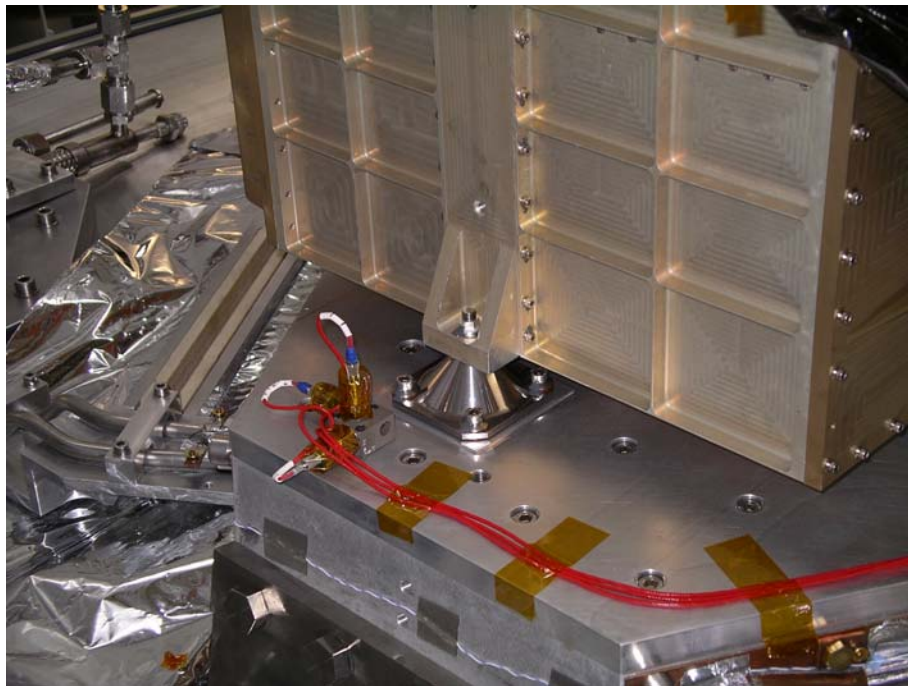
FPU Cone mount

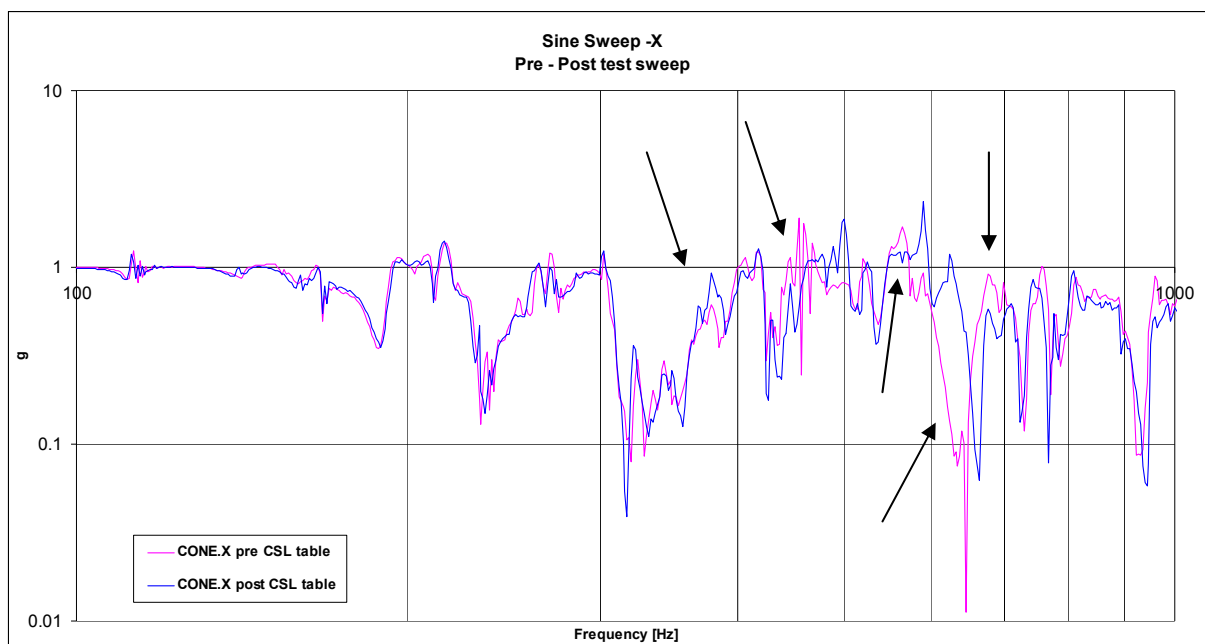
See as an example the following transfer function (pre-post test) between the drive and an accelerometer on the shaker table (not on the instrument)

B-1: Example of a transfer function between the drive and an accelerometer on the shaker table (detail)

As can be seen checking the transfer function shown in C-1 the shaker table is rather flexible. The shaker control during this test was on the maximum of three accelerometers, mounted near the three interface points of the instrument.

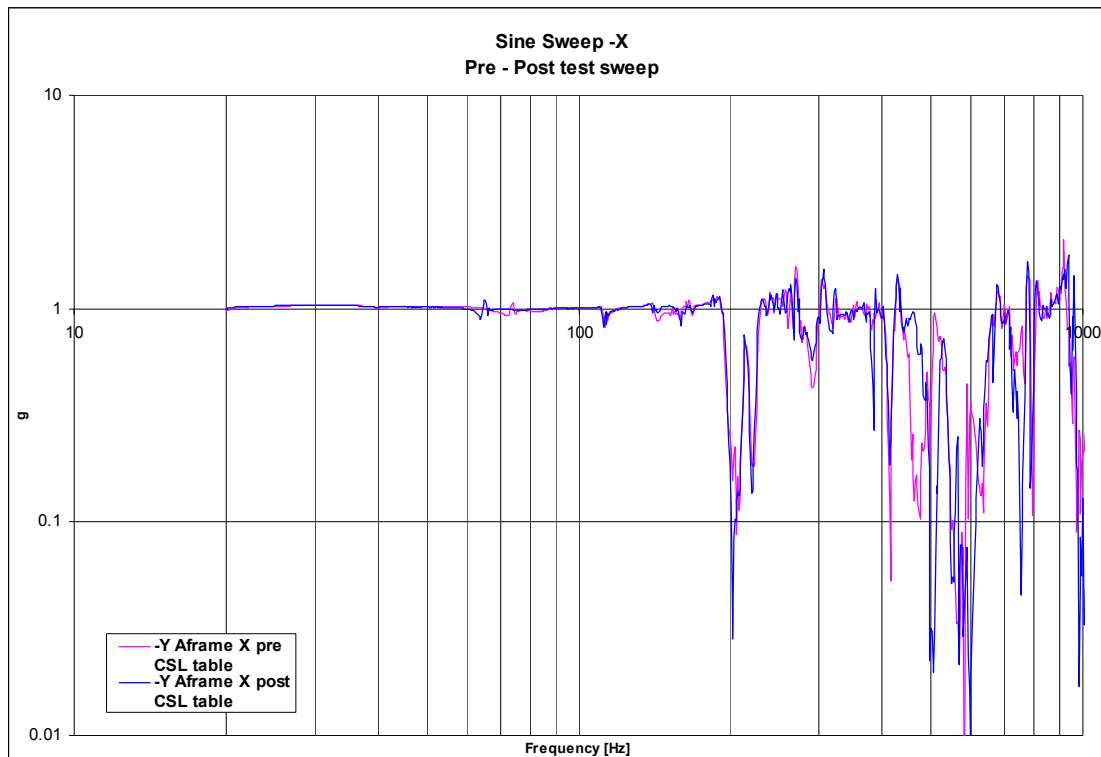
B-2: Differences in CSL table readings pre-post (at A-frame)

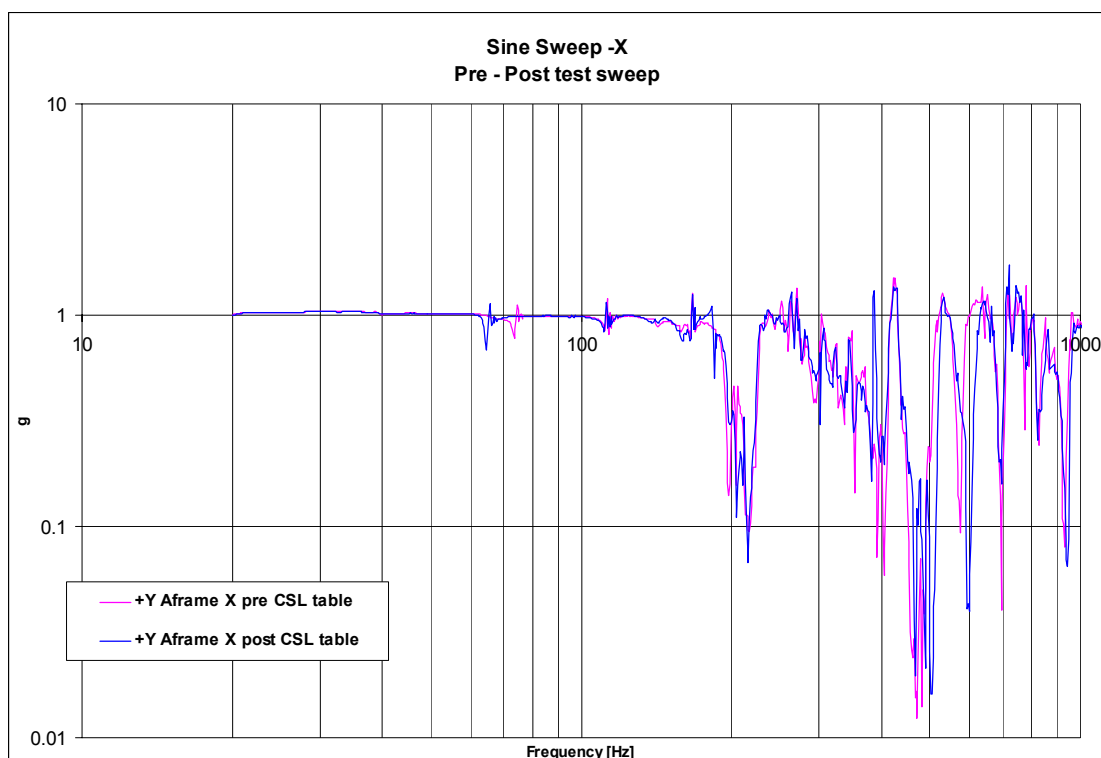
B-3: Differences in CSL table readings pre-post (at A-frame)

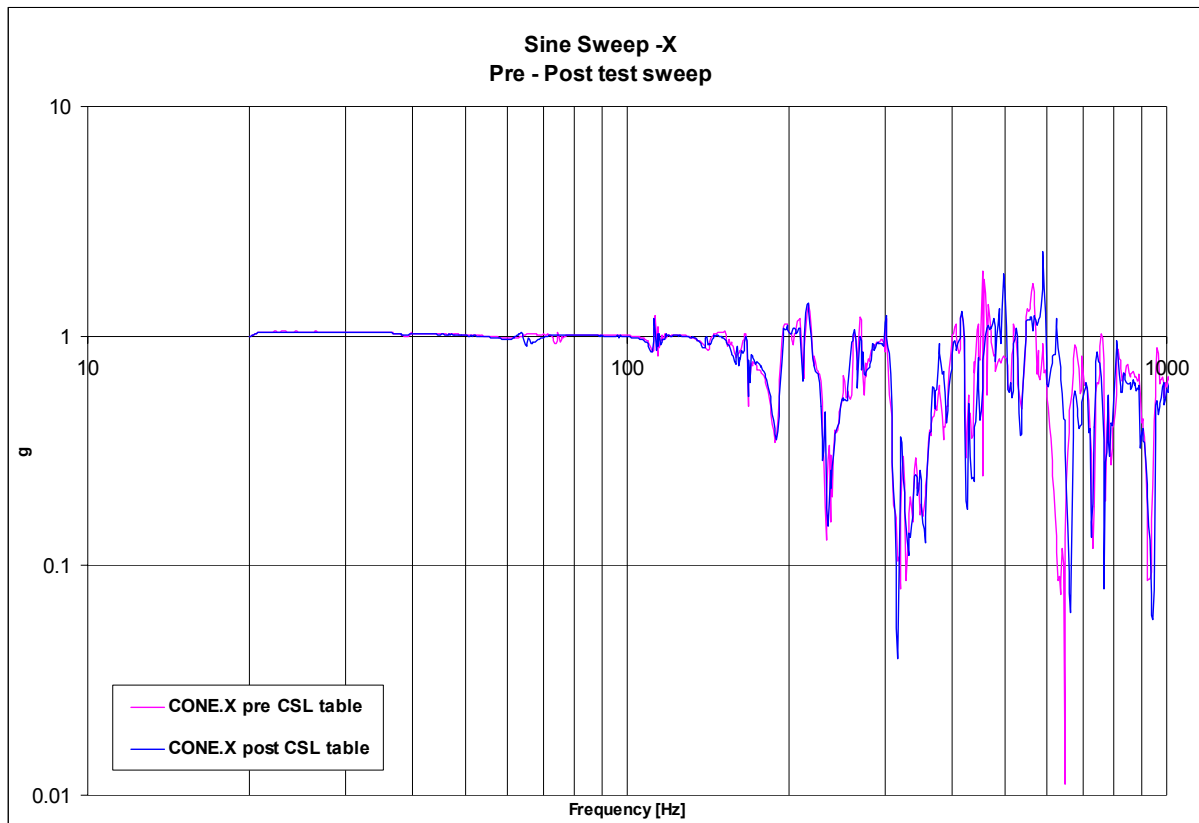
B-4: Differences in CSL table readings pre-post (at Cone)

Post test visual inspection upon return of the instrument at RAL showed now damage. The instrument supports are fine (after 2 qualification tests!) and the delicate SMec is also fine. The only change noticeable was that the dummy pivots in the SMec had shifted a little in axial direction during the various test runs. This explains the minor shifts visible in those accelerometer readings.

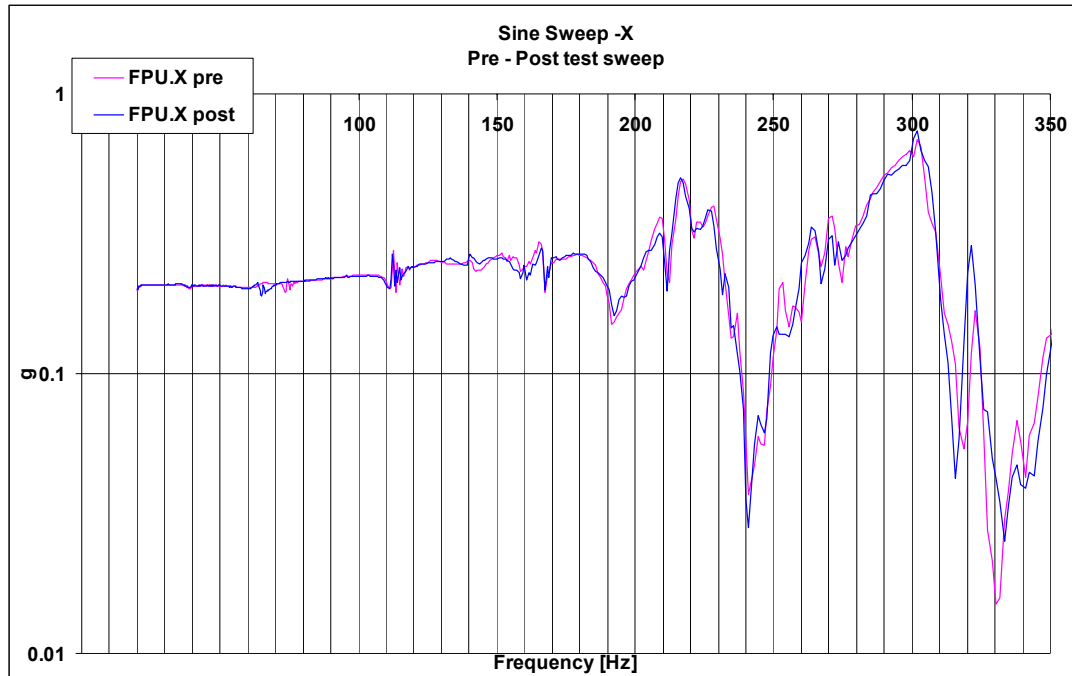
Figure B-5: Main structure in excitation direction (accelerometer at top SOB/instrument)

The following traces are some typical examples. Traces selected are on top of the instrument (FPU) in excitation direction and on one of the detector boxes. The comparison is limited to between 20 and 350 Hz

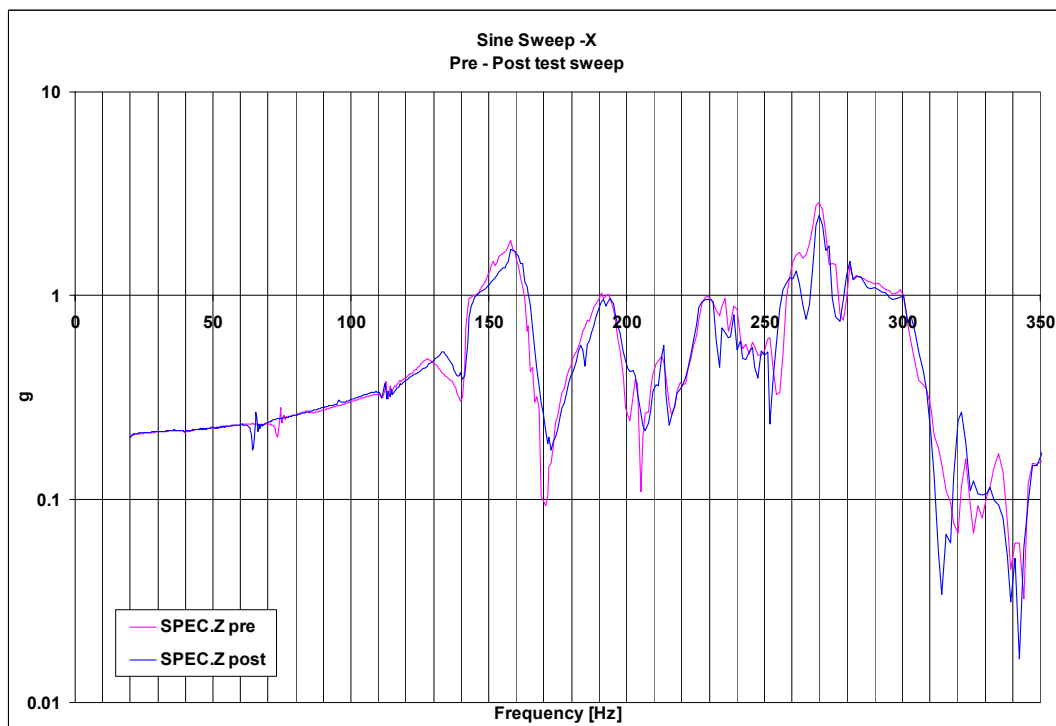
Figure B-6: Spec. det. box in excitation direction (accelerometer label Z is actually X)

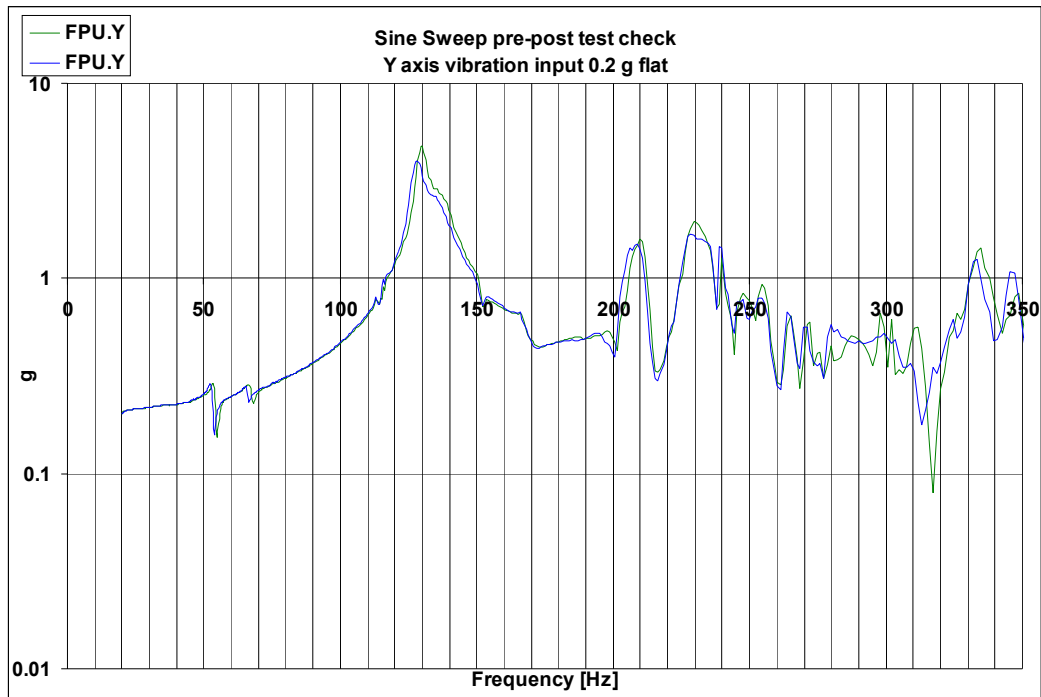
Figure B-7: Main structure in excitation direction (accelerometer at top SOB/instrument)

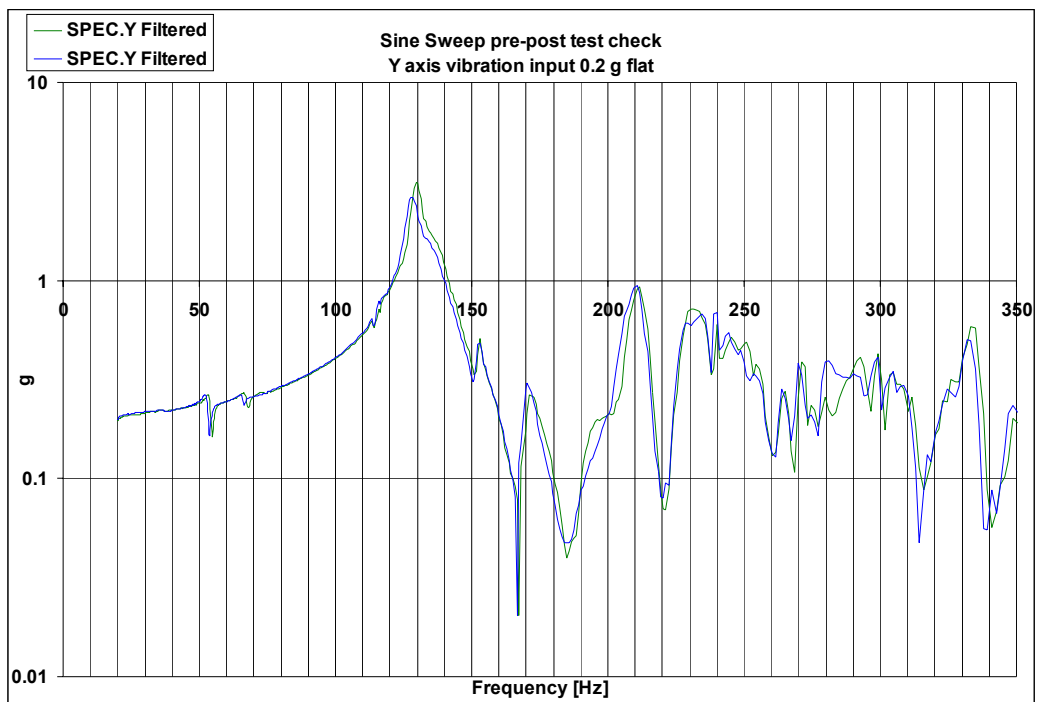
Figure B-8: Spec. det. box in excitation direction

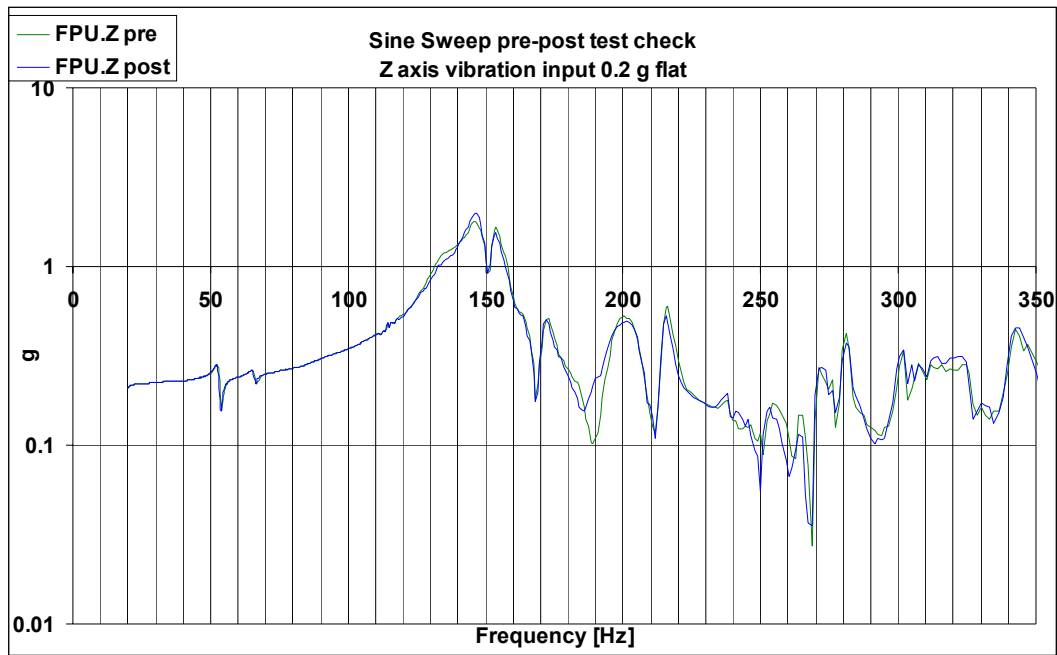
Figure B-9: Main structure in excitation direction (accelerometer at top SOB/instrument)

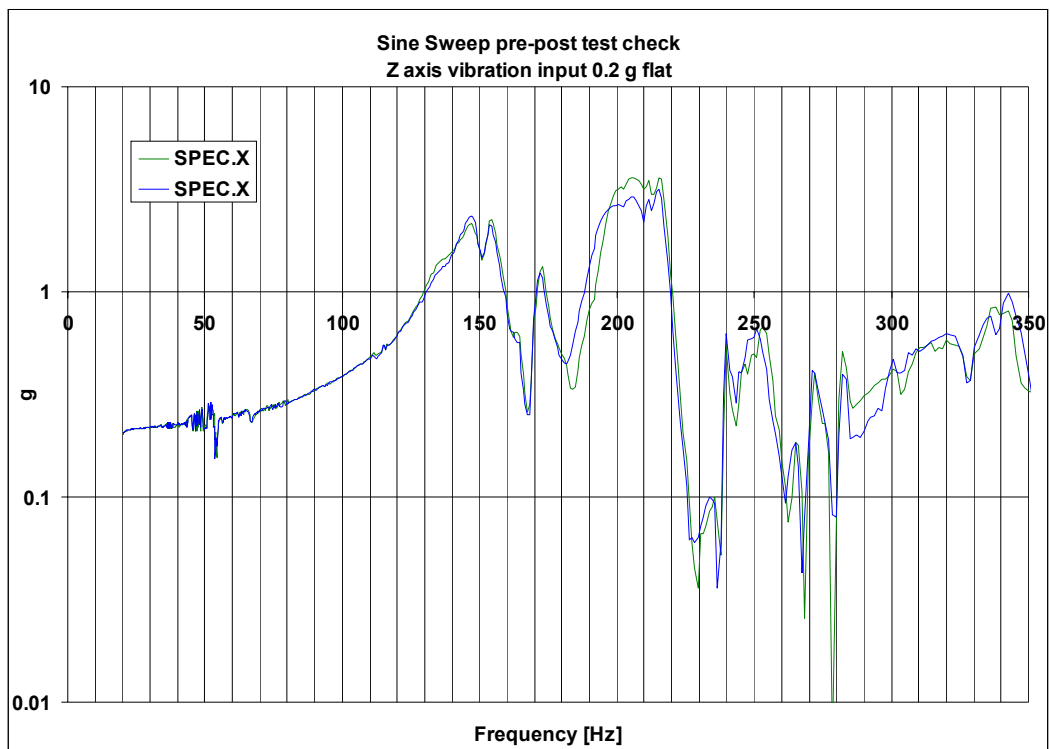
Figure B-10: Spec. det. box in excitation direction (accelerometer label Z is actually X)

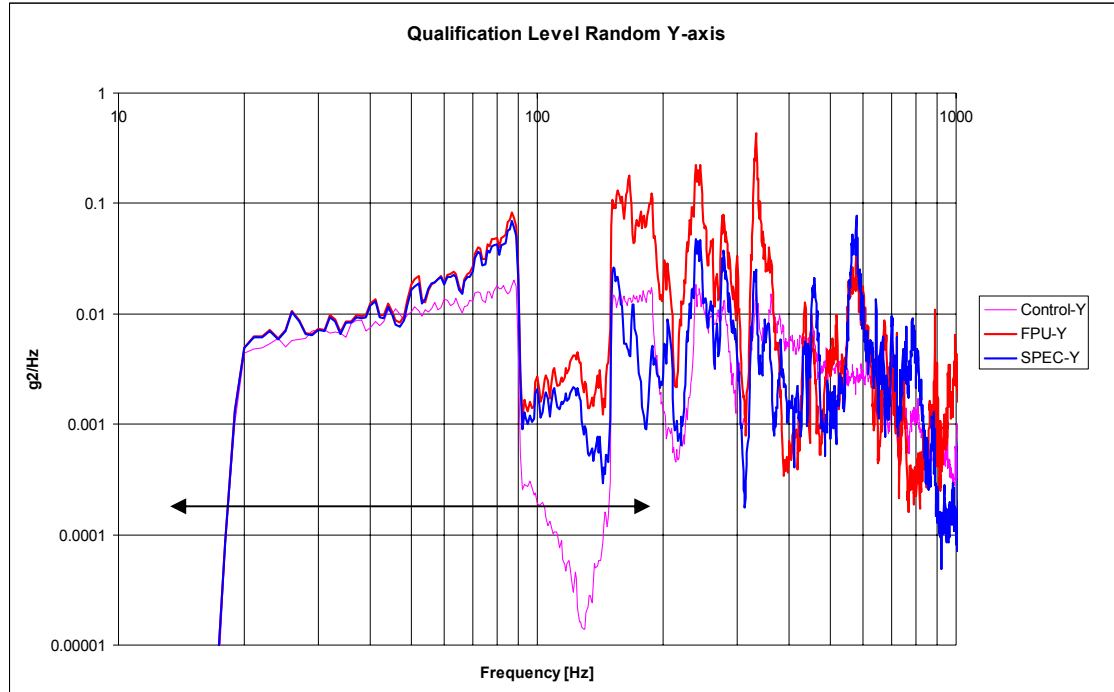
For the X-axis notching was applied to protect the detectors, no force notch was included. For the Y-axis as stated in the document and on plot here.

The double headed arrow indicates the area taken for the CoG response which gave for FPU-Y (ref CoG) 3.0 g-rms taken between 20 and 250 Hz. SPEC-Y gave 2 g-rms in the same range. Required is for the CoG at least 2 g-rms.

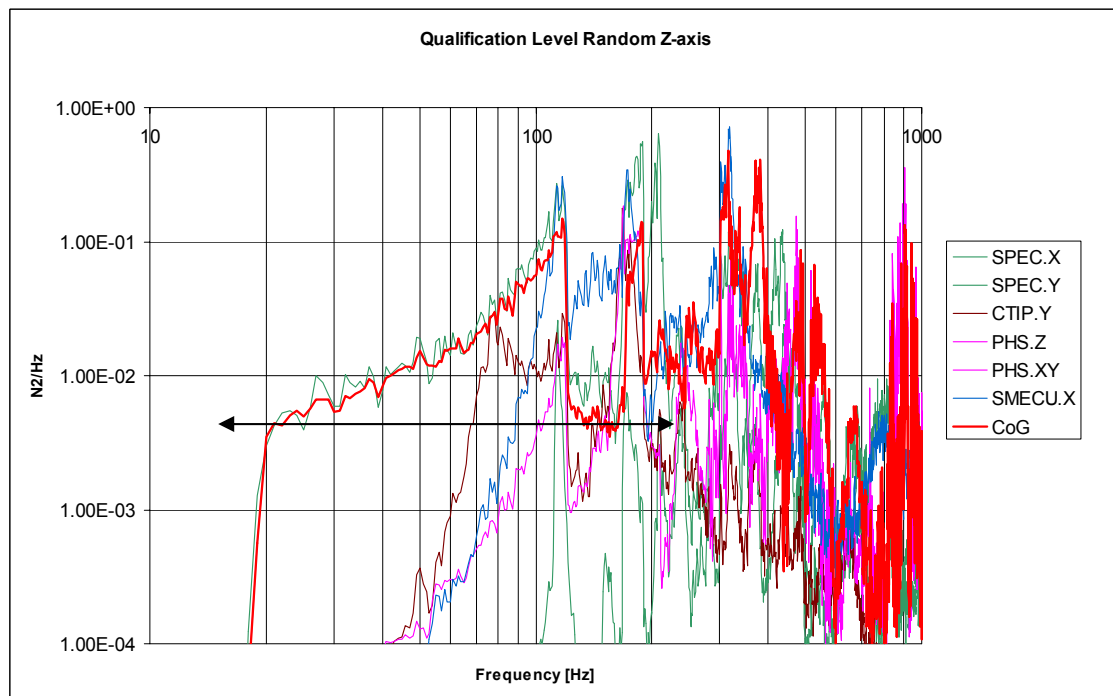
Same as for Y-axis, integration interval for CoG acceleration is indicated.
