Title: **Evaluation of H-EPLM STM TB/TV Test Results**

CI-No: 120 000

This technical report describes the evaluation of the measurement results obtained from the H-EPLM STM TB/TV qualification test performed in the LSS chamber at ESTEC. The performance evaluation described in this report is based on the measured data reported in RD 01. It contains the test evaluations which don't rely on the TMM.

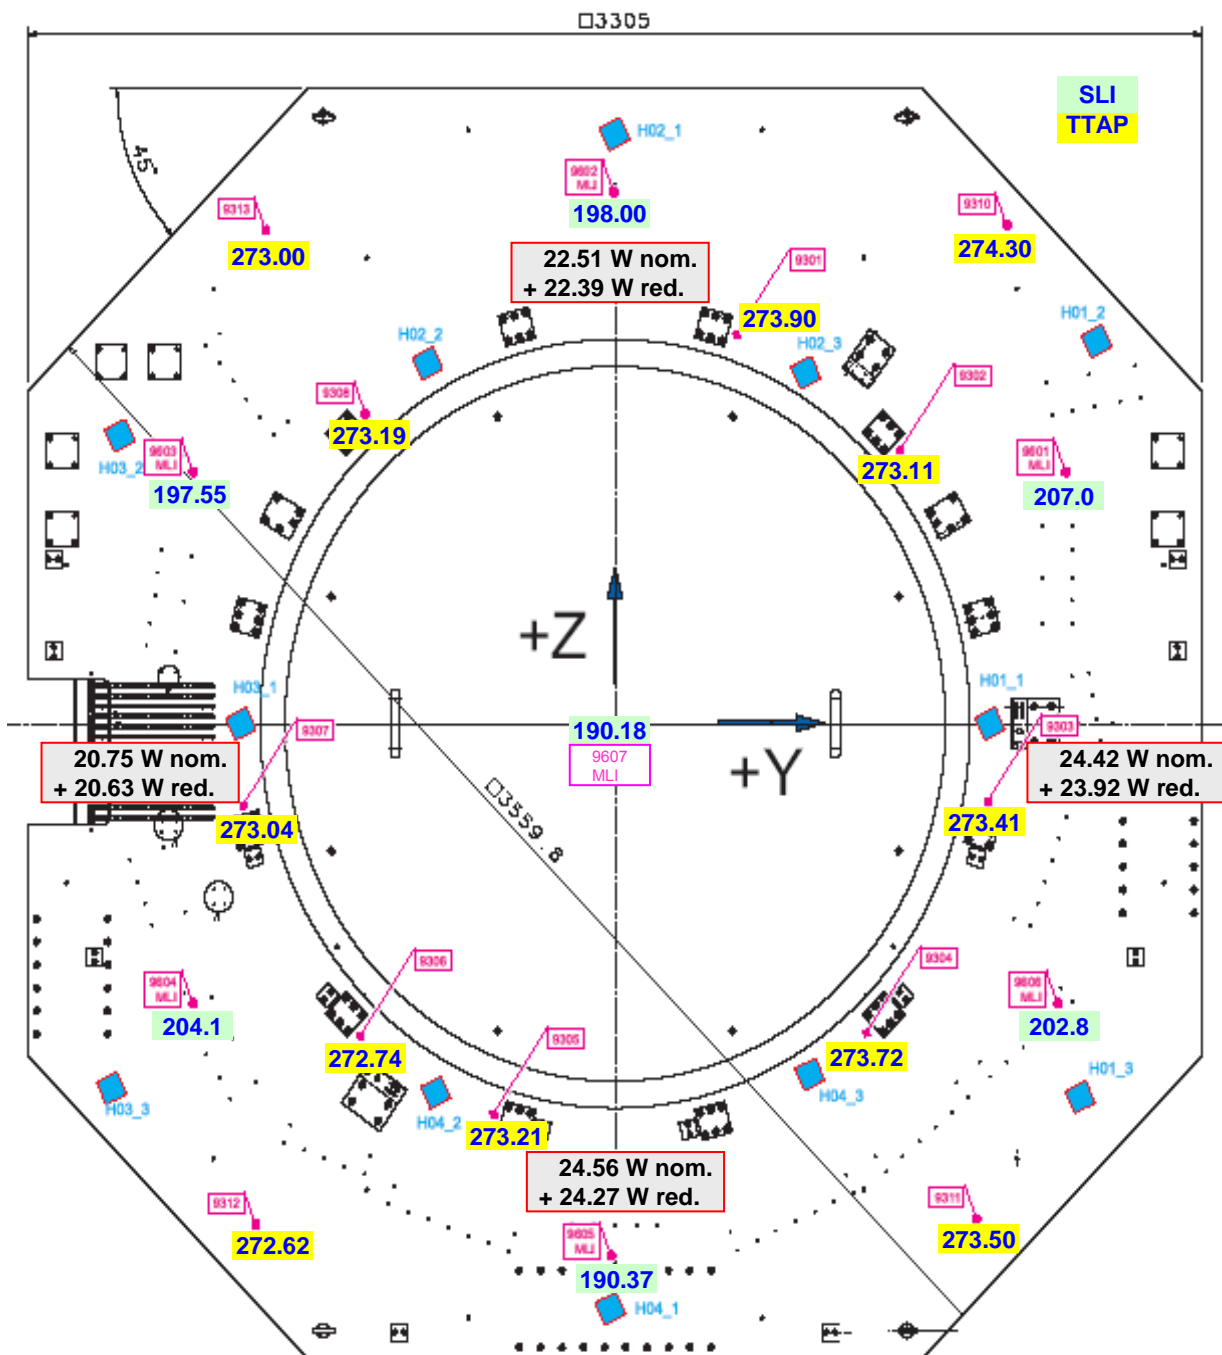
Figure 5.1-1: Temperature and Power Distribution on TTAP and TTAP SLI during TB1

The temperature distribution within the TTAP (yellow background) and the TTAP SLI (blue background) is given in **Figure 5.1-1**. The measured gradient within the TTAP is less than 2 K and within the SLI the maximum measured gradient is about 17 K. To keep the TTAP at 273 K it was necessary to switch on the redundant heater circuits in addition. The applied electrical power is shown in **Figure 5.1-1**, too.

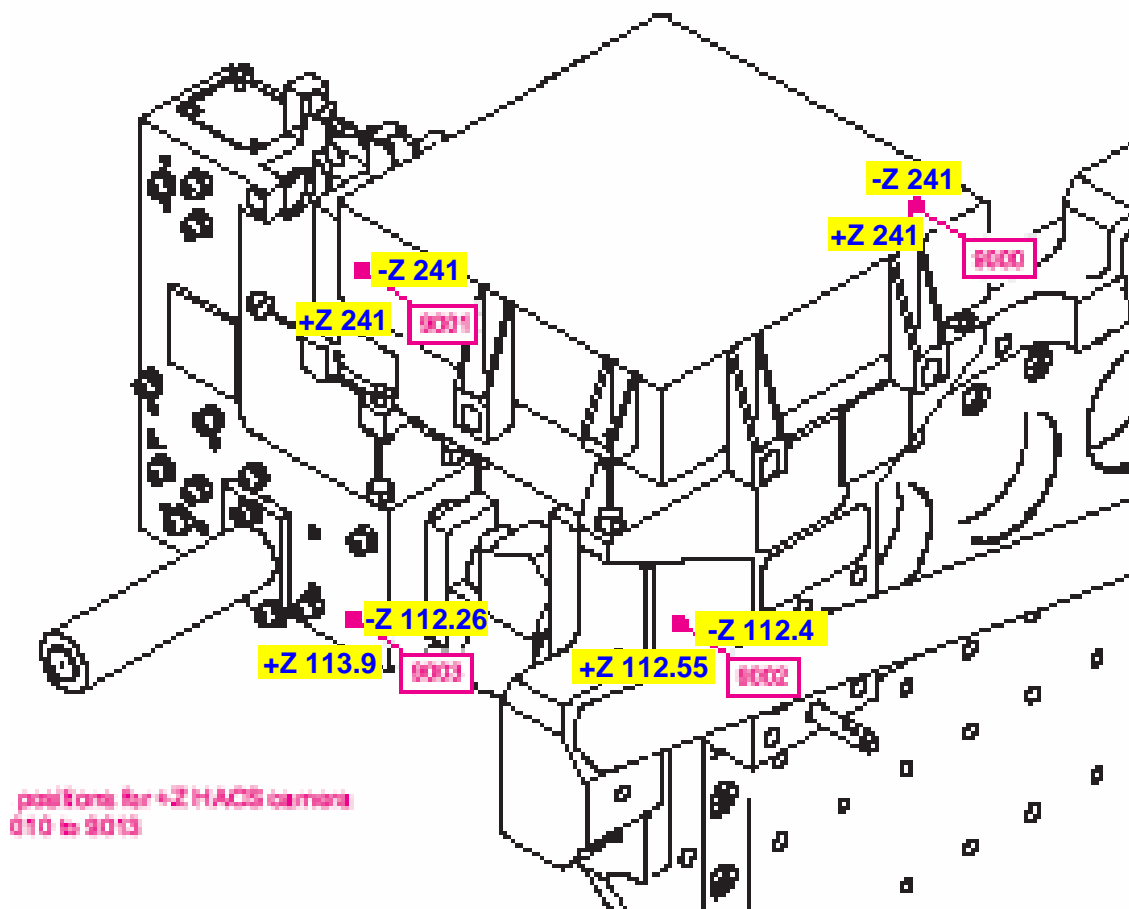
Figure 5.3-1: Temperature Distribution on HACS Units during TB1 Test Phase

During the whole TB/TV test the two HACS units were temperature controlled by electrical heating. The measured temperature distribution for the +Z and -Z HACS unit is given in **Figure 5.3-1** showing that the temperature of the electronics modules is constant at 241 K. The temperature of the optics modules is 122-114 K.

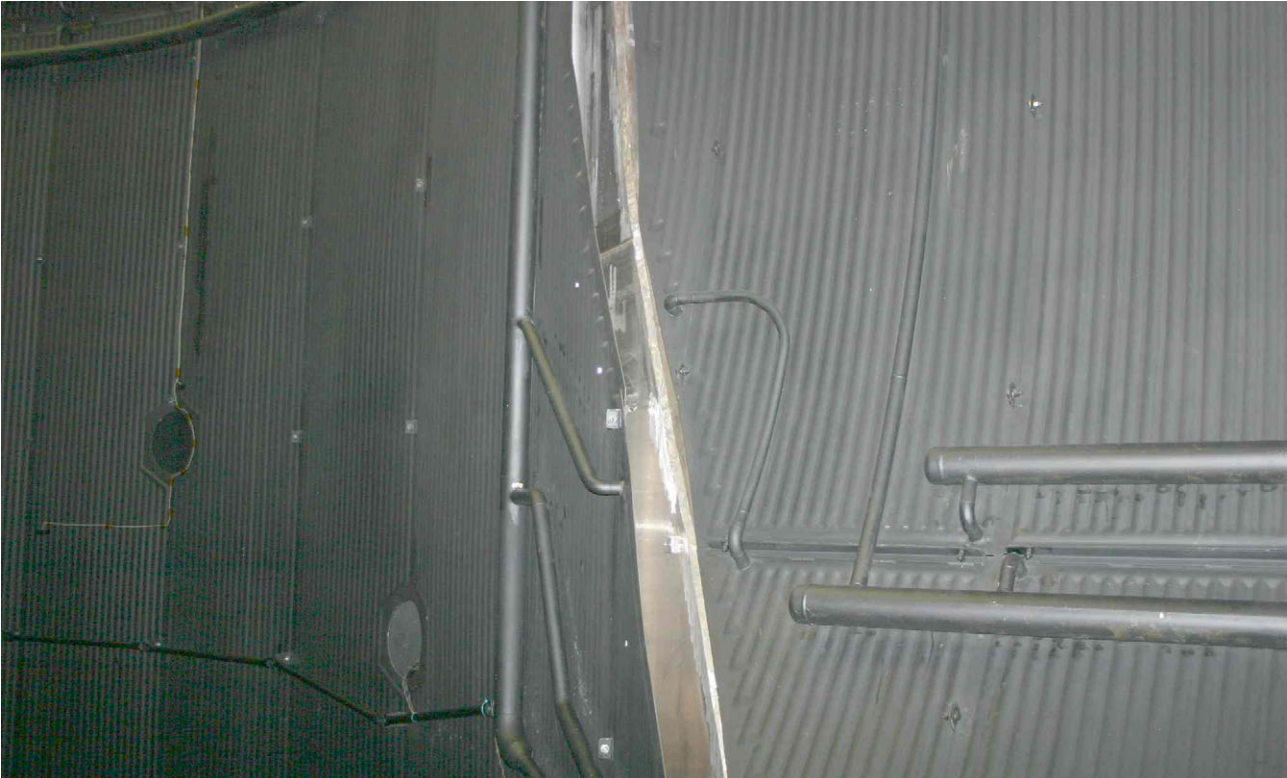
Figure 6.4-6: Circumferential gap in connection from nozzle to cylinder

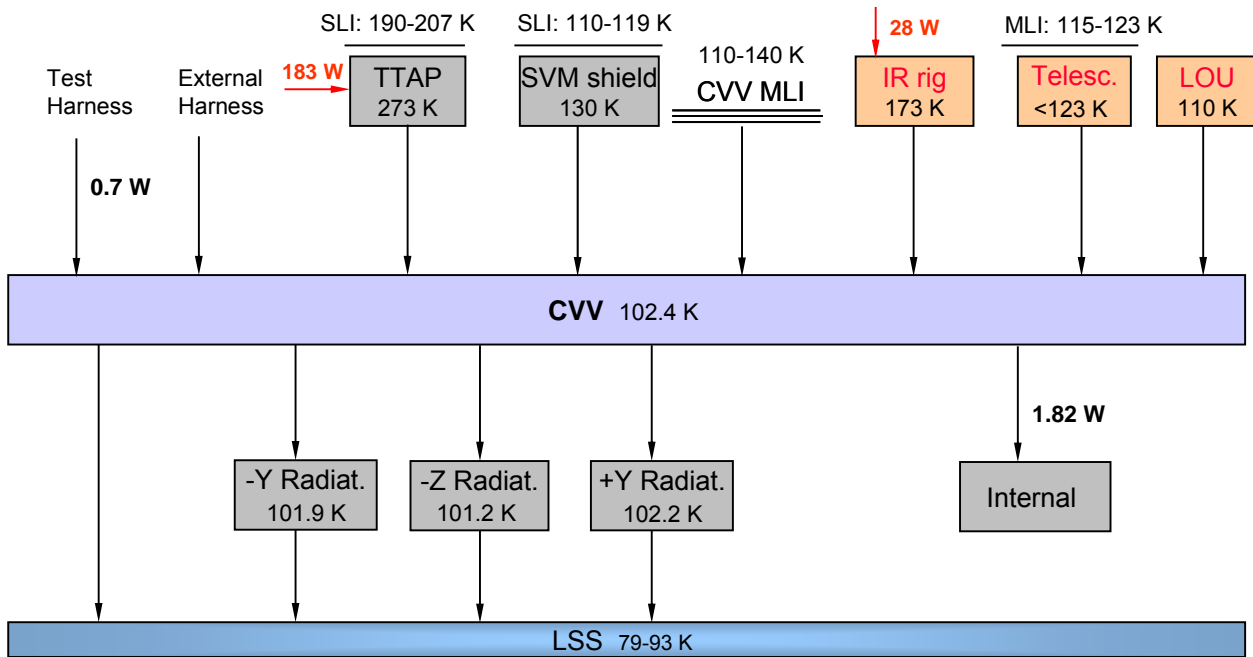
Figure 10.2-1: CVV External Thermal Conditions during TB1

The relevant conclusions are compiled at the end of each sub-section. An overview of the measured CVV external conditions is given in **Figure 10.2-1** (TB1) and **Figure 10.2-2** (TB2). The heat towards the CVV internal is the heat absorbed by the helium (gas and evaporation) and by the temperature drift of the liquid helium inside the HTT. The heat via the test harness is calculated by the harness cross section and temperature gradients along the harness bundles measured with dedicated sensors inside the bundles.

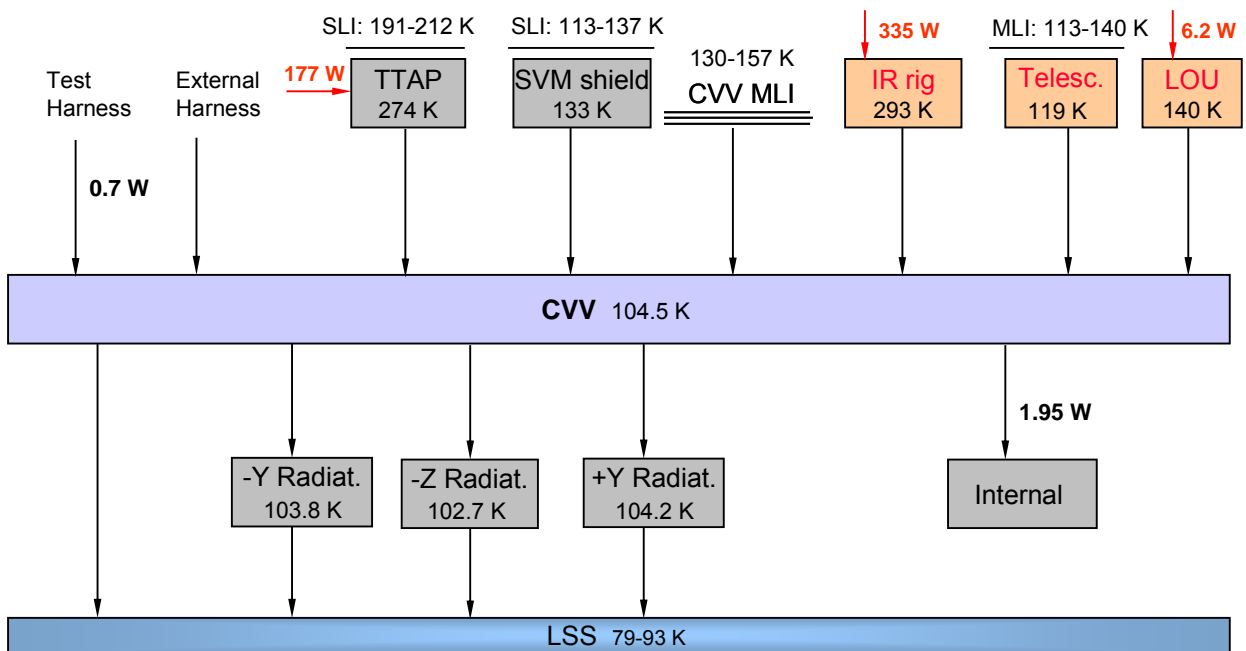
Figure 10.2-2: CVV External Thermal Conditions during TB2
